Errors in radiation oncology: a study in pathways and dosimetric impact

Eric E. Klein

Washington University School of Medicine in St. Louis

Received 27 January 2005; accepted 4 March 2005

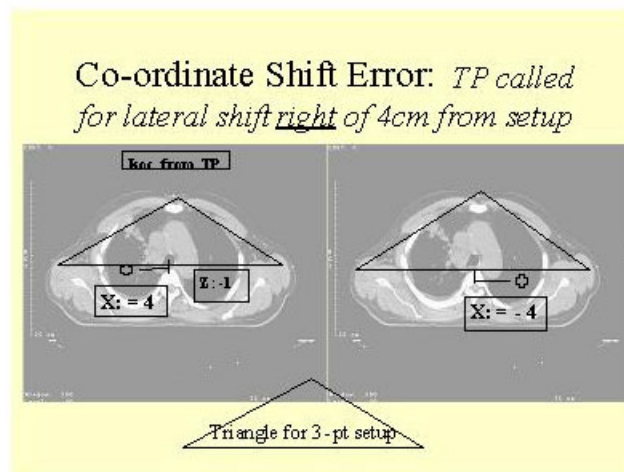
During CT simulation, an initial reference is scribed in image planes denoting a projected isocenter. If subsequent treatment planning requires that the isocenter be placed 4.0 cm to the patient's left, requiring a need to shift the table lateral coordinates +4.0 cm, this will lead to the table coordinates to be used for treatments. However, due to a misinterpretation, a value of -4.0 cm could be used to determine the lateral table coordinate.

- Dosimetry staff incorrectly completes information sheet concerning shift. Incorrect table coordinates are calculated and entered. (Note: If the treatment plan was completed before treatment commenced and a direct DICOM transfer including table coordinates could be made, this error would be avoided.)
- Physics staff member fails to check shift instructions filled out by dosimetrist (reasonable process/training change).
- Therapist staff does not check DRR in room to ensure shift has been made correctly (definite process/training change).
- Diode does not facilitate error discovery.
- Port film taken and reviewed by physician who discovers error, which is corrected before subsequent fraction.

Fig. 1. Visual description of how a coordinate shift error, in this case a lateral shift of -4 cm instead of the planned $+4$ cm, would result in an incorrect isocenter placement.

There is no feasible electronic mechanism to catch this error before treatment, short of having the coordinates checked by the physicists or therapist staff pretreatment, or a more dramatic solution of placing the patient on a conventional simulator to confirm the isocenter location. This particular error was determined to happen rarely enough (<0.5%) that our clinic continues to rely exclusively on the therapists visually checking the new isocenter against

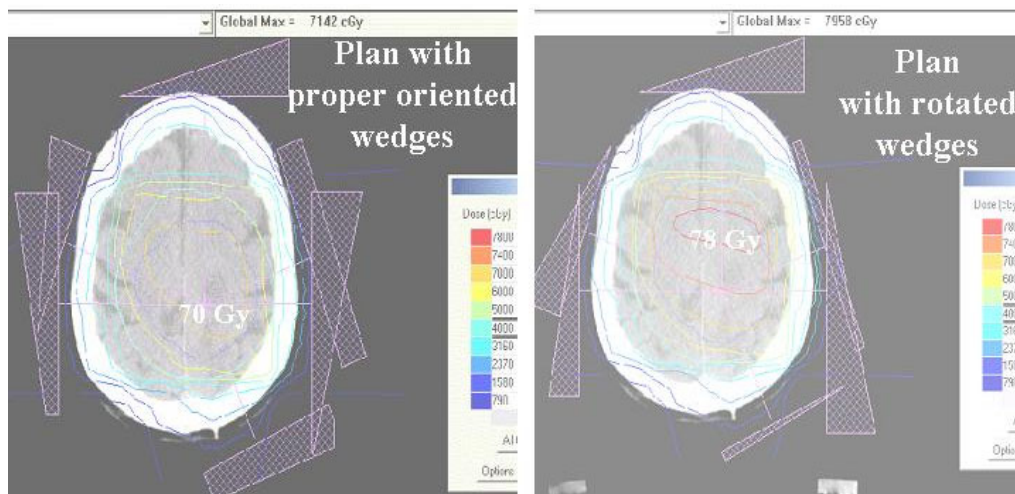
An additional problem with this type of virtual wedging is that the nomenclature used by treatment-planning systems is not intuitive and not necessarily correlated to the nomenclature used by the treatment machines and/or R&V systems. Therefore, a misappropriated wedge direction could possibly go undetected by physics checks and by therapists on the first day of treatment. Unfortunately, *in vivo* dosimetry performed with a diode on central axis will not catch this particular error. Although we had the therapists check the final jaw position at the end of treatment (indicating the “toe” of the wedge), this policy was not carried out sufficiently to catch these errors. For the scenario described, the dosimetric error could be as high as 80% to a point 8 cm off-axis, for opposed 60° wedged fields. We found this type of error occurred when the wedge orientation was not obvious in a 2D representation of the treatment, as is the case for central nervous system treatments requiring nonaxial fields. An example of a hypothetical intra-cranial treatment with incorrect wedge directions is seen in Fig. 2. In this case, there are a total of seven beams for which the wedge was reversed from the intended orientations for four of the seven beams. This would have resulted in an increased high dose region (7800 cGy) outside of the tumor volume as compared with 7000 cGy in the correct plan.

Fig. 2. Comparison of isodoses for a central nervous system treatment plan that had called for seven wedged fields. The isodose map on the right demonstrates the resultant isodoses if the wedge orientation was reversed for four of the seven fields. The original plan used 6 MV photons with a target dose of 7000 cGy.

- Dosimetry staff prepares intended plan for treatment based on MLC field shaping. After the planning is complete and the paper and electronic charts prepared, there is a decision to switch to cerrobend field shaping. In order to avoid having the weight of the block against the latch for some fields (a nonissue for MLC), the collimator is rotated 180° for these particular fields. Unfortunately, the original wedge direction is not corrected for the fields. (Mandated replanning would have avoided this error).
- Physicist checks individual R&V beam settings but does not detect the incorrect wedge direction.

- Therapists do not closely compare wedge directions as indicated on treatment plan and drawings with the icons on the treatment machine.
- Diode check does not facilitate error discovery as they are taken on central axis. (Change in procedure implemented, whereby diodes are now placed off-axis. Therapists are instructed to position diode 2 cm to 3 cm toward the “heel” of the wedge as they perceive, but then denote the direction of the diode placement according to anatomical direction (i.e., for a breast patient with treated wedges, diode is placed anterior).
- Subsequent weekly review of chart by physicist catches the error.

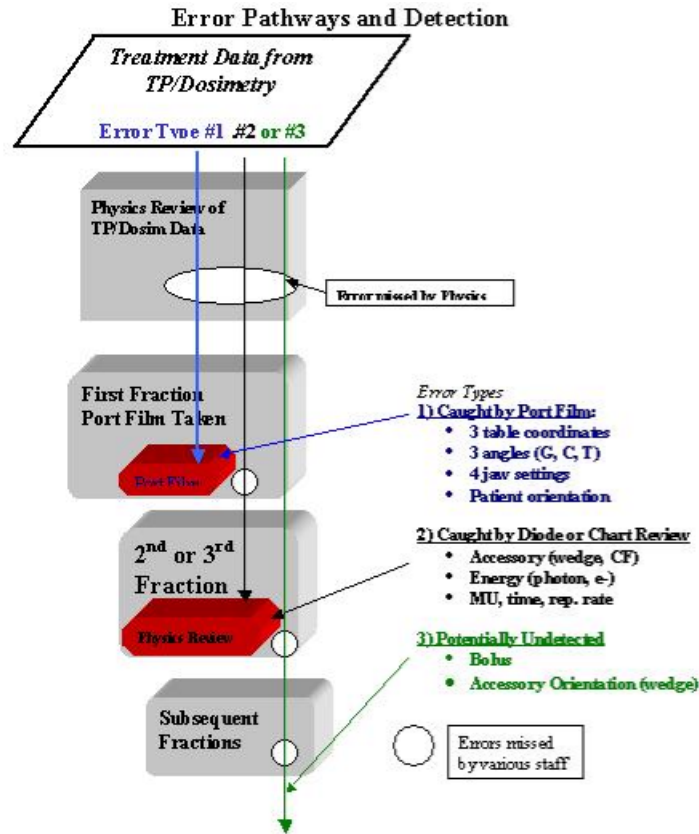
Figure 3 graphically demonstrates the various pathways of the various error types.

Fig. 3. Flowchart of various error types. (1) Caught by port film review; (2) caught by chart and/or diode review; and (3) potentially undetected, and how the processes either stop or miss such errors.

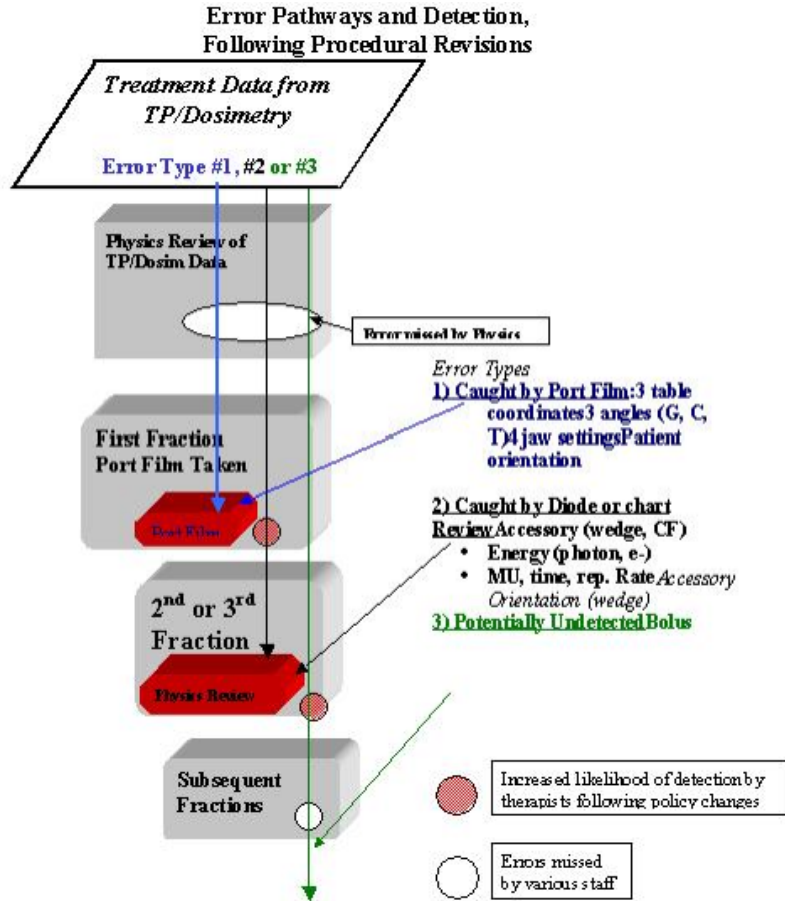
Fig. 4. Flowchart of the same error types following changes made to policies and procedures, whereby certain errors were stopped earlier or were hampered from progressing.

2. To reduce the likelihood of the infrequent (low frequency) but dosimetrically significant error (high dosimetric impact and high longevity) of an incorrectly oriented accessory (wedge or compensation filter), our policy was changed to require diodes be placed off-axis. This action requires the therapists to place the diode at a known distance off-axis, at a known SSD. The therapist records the direction off-axis relative to patient (e.g., anterior, superior, lateral). When the diode readings are reviewed, corrections are made for the off-axis accessory transmission. Since this change was

A revised error pathway chart (Fig. 4) demonstrates how some of these changes have altered potential paths. For example, by performing in vivo dosimetry off-axis rather than on central axis, we essentially closed the pathway for the error to propagate beyond the second fraction, thereby reducing the longevity from high to medium.
