## CORROSION OF CURRENT-COLLECTOR MATERIALS IN LI-ION CELLS

Jeffrey Braithwaite, Ganesan Nagasubramanian, Angelo Gonzales, Samuel Lucero, Wendy Cieslak

> Sandia National Laboratories Albuquerque, NM 87185-0340

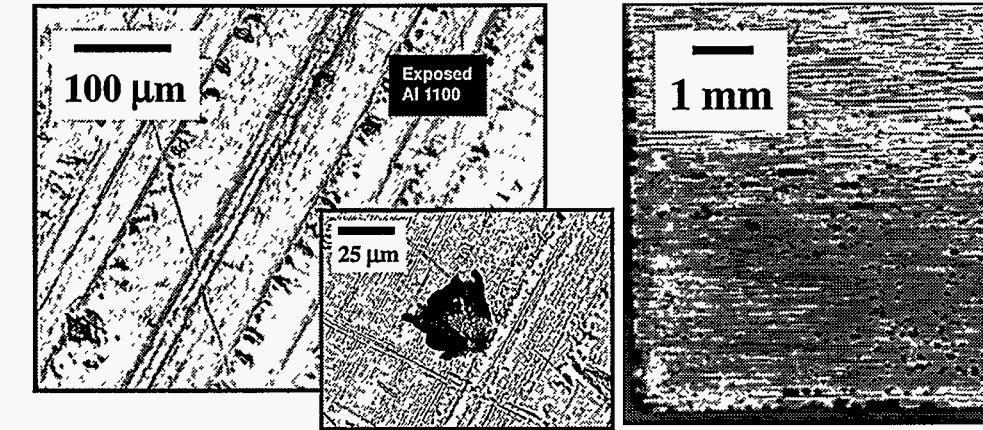
During electrical cycling, the aluminum current collector undergoes a form of pitting corrosion. After several days of cycling (40 LEO cycles), some general attack of the aluminum surface was visible in that an almost electropolished appearance existed, but more importantly, some scattered pitting had initiated (compare Figure 4 and Figure 5). With continued cycling, the pit density increased, as shown in Figure 6 for 690 LEO cycles in the PC:DEC electrolyte. Cycling in the EC:DMC electrolyte resulted in a higher pit density, as shown in Figure 7 for 150 LEO cycles. Curiously, what optically looked like pits after extended cycling in both electrolytes are actually mounds. Based on crosssectional SEM examination of the foil (as in Figure 8), these mounds appear to be filled in pits. XPS and Auger analyses are presently being performed to help understand this phenomenon. Initial results indicate that the mounds contain both Al<sup>o</sup> and Al<sub>2</sub>O<sub>3</sub>. Because of the primarily anodic conditions during LEO cycling, the existence of metallic aluminum implies that the mounds are electrically isolated from the foil. Two possible explanations are that 1) corrosion undermined the initial pit and caused the metal to bulge and break away, or 2) metal was redeposited on poorly conductive corrosion products during the discharge portion of the LEO cycle during which cathodic conditions exist (open circuit voltage for Al is between 3.2 and 3.6 V).

Figure 5. Photographs of the Al surface after 40 LEO cycles in PC:DEC electrolyte

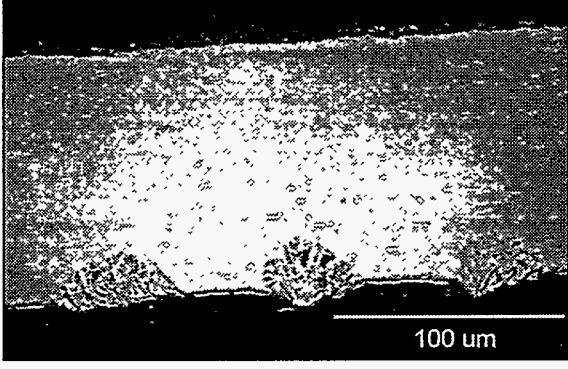
Figure 8. SEM cross-section of Al foil after 150 cycles in EC:DMC electrolyte

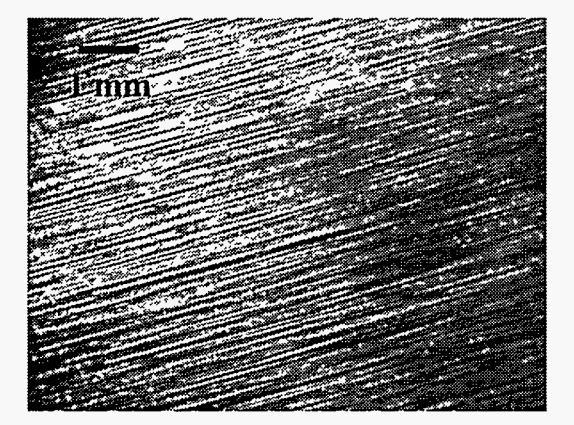
- The fluoro-carbon based coatings improve corrosion resistance. Figure 14 is a Bode phase plot showing that the uncoated electrode has a single dominant process (represented with a single capacitive/resistive combination and thus one pseudo-time constant), whereas the two coated electrodes show two processes: the non-polymerized with two overlapping time constants, and the polymerized with two distinct time constants. Quantitative modeling of the EIS data is thus a necessary activity to determine the pitting resistance portion of the total EIS resistance. Results indicate that pitting resistance can increase by close to one order of magnitude for coated electrodes. The corresponding increase in resistance was confirmed by a lack of pitting observed on one of the samples (Figure 15) after 445 LEO cycles in the PC:DEC electrolyte. Although not substantiated with surface analysis, a possible reason that these coatings improve the corrosion resistance of aluminum is that much of the active pit area becomes sealed. However, some interaction (swelling and delamination) did occur between the electrolyte and both coatings (Figure 16). As such, the ability to provide long-term protection is unknown.

Figure 15. Al substrate after polymerized C coating removed after 445 cycles

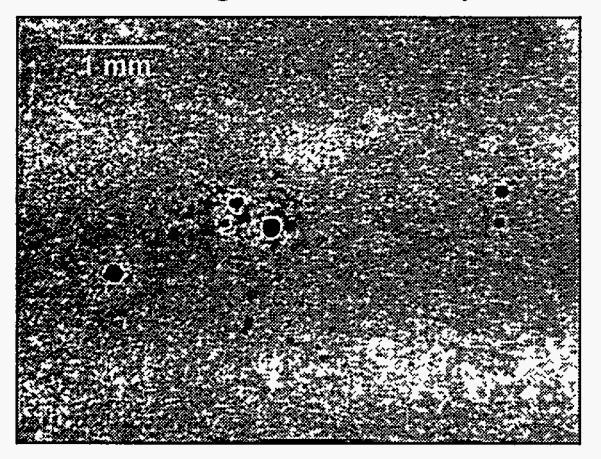
A final practical validation of these results comes from a section of a positive electrode taken from a commercial Sony Li-Ion cell (1991 vintage) that had been subjected to about 4000 LEO cycles. A representative photomicrograph is shown in Figure 17. Significant localized pitting corrosion of the aluminum occurred to the point that the foil had a large number of visible perforations. Whether or not the holes were at some time mounds is presently unknown because of the difficult nature of removing the active materials without physical disruption of the surface. However, this does prove that the pitting process is not self-limiting. An assessment of the final resistivity of the foil has not been made to determine if the limited general corrosion had a significant effect on cell resistance.

Figure 17. Al current collector from Sony cell after 4000 LEO cycles

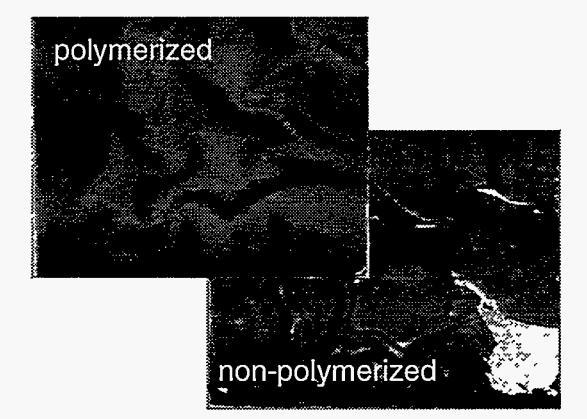
Figure 16. Polymerized and non-polymerized coatings after 445 LEO cycles

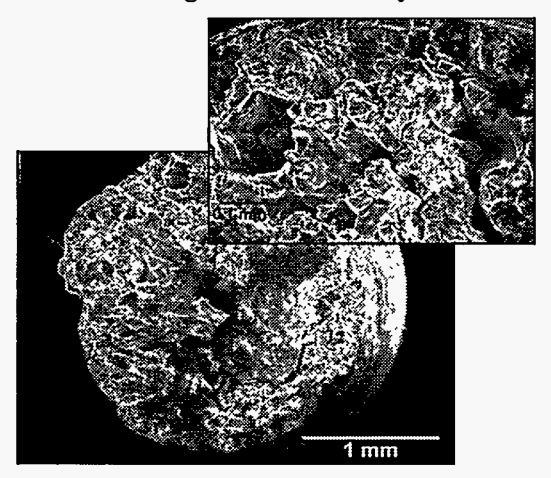
CERT revealed intergranular EAC of copper in large-grained, work-hardened material when tested at an applied voltage of 0V vs. Li/Li<sup>+</sup> (Figure 18). Lack of either of the two metallurgical factors was sufficient to eliminate EAC susceptibility in these tests. For example, the very ductile behavior of fine-grained, work-hardened material under the same electrochemical conditions is shown in Figure 19. The susceptibility conditions are consistent with those observed for Ni in Li/SOCl<sub>2</sub> cells [1], implying that the Cu EAC phenomenon is mechanistically similar, that is, Li-induced EAC.

Figure 18. SEM photograph of the brittle fracture surface of coarse-grained, work-hardened copper

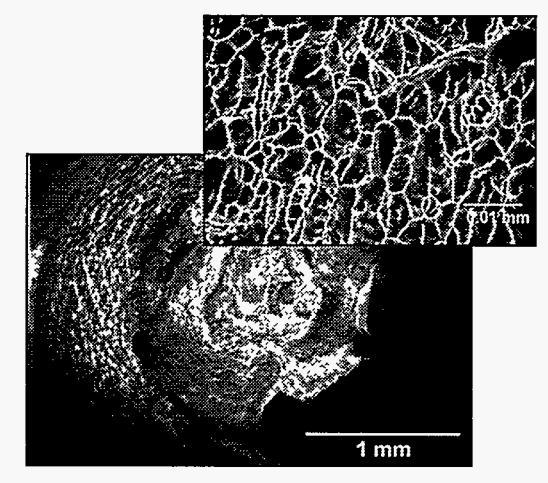
Figure 19. SEM photograph of the ductile fracture surface of fine-grained, work-hardened copper

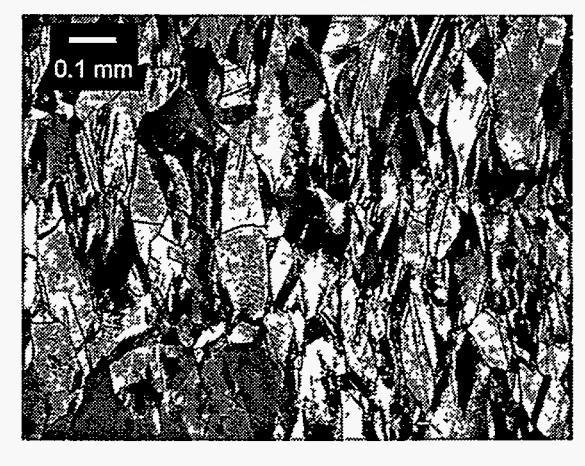
Because the conditions of CERT are so severe, intergranular cracking occurred despite an unfavorable orientation of the grains that were longitutudinally enlongated in the rod (Figure 20). An important effort to complete in the future will be to characterize the range of actual conditions that cause a susceptibility using u-bend samples of varying orientation and stress levels under various simulating cell environments. To date, EAC from the limited u-bend tests completed or from actual foil from commercial cells has not been observed.

Figure 20. Longitudinal cross-sectioned copper tensile bar that had brittle behavior
