Effect of Conductivity
Between Fasteners and Aluminum Skin
On Eddy Current Specimens

David G. Moore
Sandia National Laboratories
Federal Aviation Administration
Airworthiness Assurance NDI Validation Center
Albuquerque, New Mexico 87185
(505) 844-7095

M. C. Hutchinson ^{950 3821}
Boeing Commercial Airplane Group
P.O. Box 3707
M/S 9U-EA
Seattle, Washington 98124-2207
(206) 234-8392

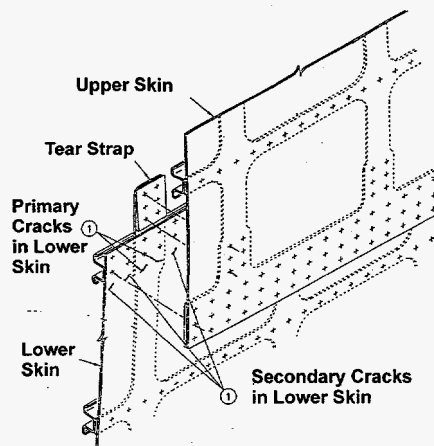
During a fleet survey of a Boeing 737 aircraft in September of 1994, cracks were found in the lower fastener row, lower skin (Figure 1) in a high cycle time aircraft. Because the primary crack location was covered by tear straps, a low frequency eddy current procedure was developed to detect this type of cracking from the exterior of the aircraft. On November 8, 1994 Boeing Commercial Aircraft Group issued Service Bulletin 737-53A1177 which specified the inspection of the lower fastener row of 737 lap splices for line numbers 292 through 2565. During a 1995 NDI Reliability Workshop sponsored by the FAA, the AANC was asked to assist the Seattle Aircraft Certification Office in developing Probability of Detection (PoD) curves for primary inspection called out in the Service Bulletin.

Figure 1. Crack locations in the Boeing lap joint.

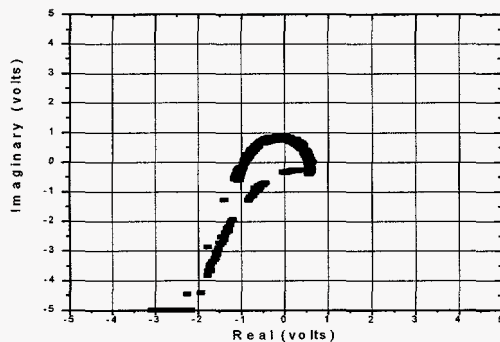
However, most sites produced a smaller than expected signal. Of course this meant that the amount of signal variation among similar sites on the specimen panels is much greater than found on an aircraft. It was concluded that the specimen panels had not been properly lubricated. Therefore, the generation of artificially aged fastener sites was not obtained on the test specimens. Figure 3 documents the characteristics of a rivet site with an abnormal conductivity between the rivet and hole. This impedance plane signal is not representative of sites found on aircraft.

Figure 3. Signal from rivet that exhibits high conductivity between the hole and rivet.

To remedy the signal response discrepancy found during the initial characterization, each top and bottom row of rivets was removed. Following is the removal process developed for these specimens: 1) remove the back side of the rivet using an air powered metal shaver and 2) drive out each rivet using a rivet press. After this process is complete, the specimens were re-inspected. Each hole and rivet was then coated with Sharpie® permanent marker. Petroleum lubricant was applied to each site and rivets were then driven back into the existing holes. The specimens were re-inspected using the low frequency eddy technique and data acquisition software. The re-inspection data was compared to the original data. The purpose of this comparison was to document that removal and re-installation of rivets does substantially change the impedance plane signal and the most significant factor affecting original response in the lap joint specimens was the result of poor lubricant during rivet installation. Figure 4 displays the results of the re-manufacturing process (removing the rivet, applying permanent marker to the hole and rivet, adding petroleum lubricant to the rivet hole and re-installing the rivet). The impedance plane signal is representative of fasteners found on actual aircraft.

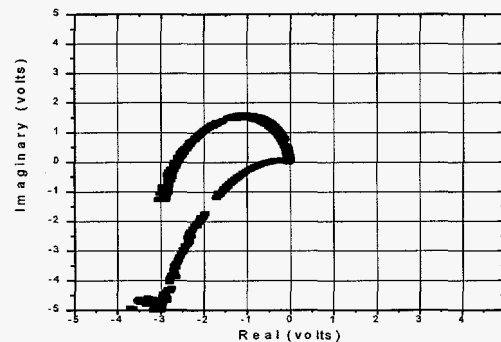
Figure 4. Signal from the same rivet site after remanufacturing.
