Spray Foam in Accessible Spaces: Best Practices and Case Studies for Retrofit in Mixed-Humid Climates

October 2011

**Prepared by
Jeffrey E. Christian
Kathy S. Gant**

Prepared by
OAK RIDGE NATIONAL LABORATORY
Oak Ridge, Tennessee 37831-6283
managed by
UT-BATTELLE, LLC
for the
U.S. DEPARTMENT OF ENERGY
under contract DE-AC05-00OR22725

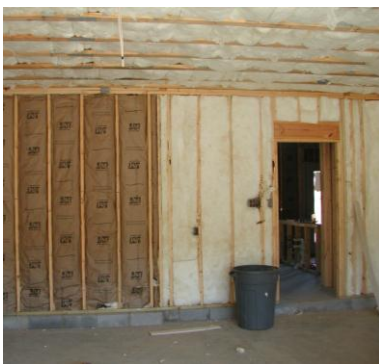
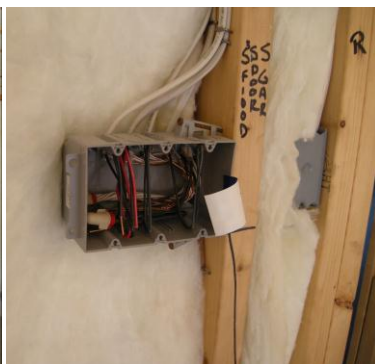
Fig. 10. Wall between garage and kitchen and close-up of electrical box. (Notice electrical switch boxes form a potential short leakage path.)

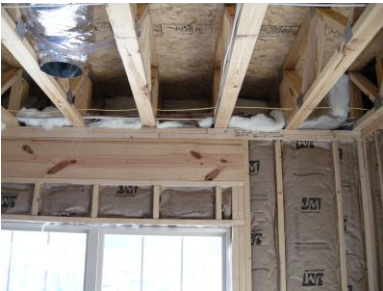
Fig. 12. Cantilevered floor improperly insulated and sealed.

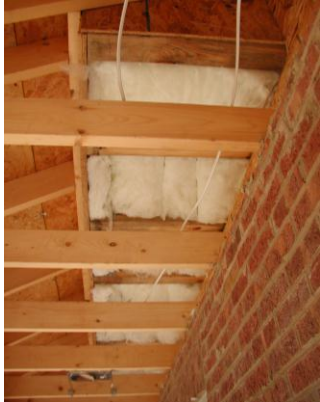
Fig. 13. Improperly insulated cantilevered floor from outside.

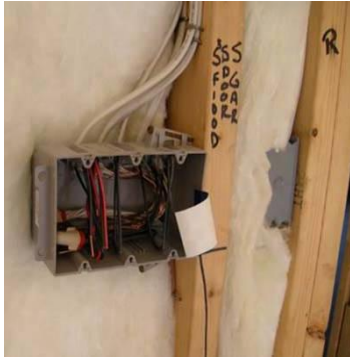
Several problems were identified in the process of retrofitting. Sealing was needed in the area around the electrical box on the wall between the house and the garage (Fig. 28). Another potential problem identified involved the box beam from the front porch that penetrated the house envelope. Additional foam for sealing could have been applied around the beam shown in Fig. 29 and Fig. 30.

Fig. 28. Electrical box compressing insulation and lacking seal.

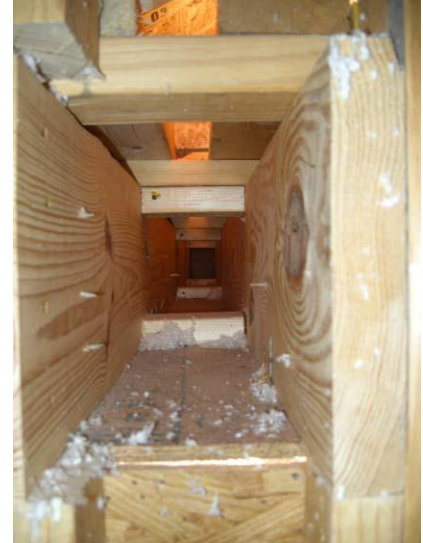
Fig. 30. Box beam penetrating house.

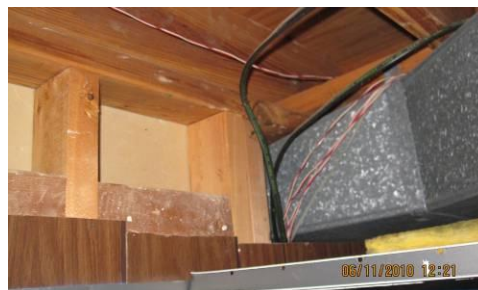
Open wall cavities, ducts, and wiring penetrations allow outside air to move in and around, eventually leaking into the living space (Fig. 34). The initial energy evaluation recommended sealing the rim/band joint on the basement and entry levels to stop air leaks.

Fig. 34. Open wall cavities, ductwork, and electrical penetrations support unwanted air flow.

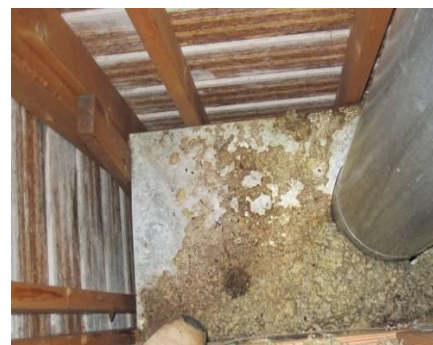
Fig. 40. Uninsulated chimney enclosure.

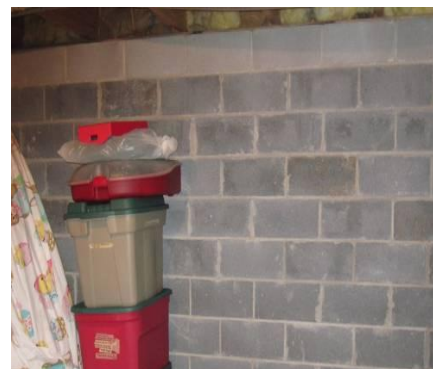
Fig. 41. Uninsulated cinder block basement and band joist.

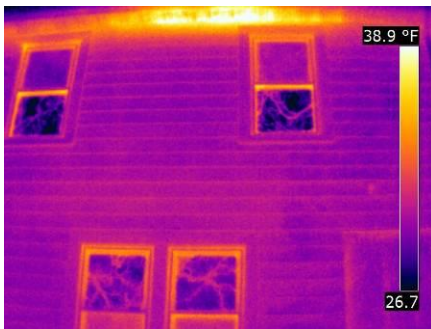
In Fig. 53, there is a bright area under the eave on the east end of the rear of the house. During the retrofit, soffit vents under the eaves were stuffed with fiberglass insulation and then sealed with spray foam. The insulation seems to be missing in this location. The contractor redid this area from the attic.

Fig. 53. Bright area indicates less effective insulation and sealing of soffit vent.

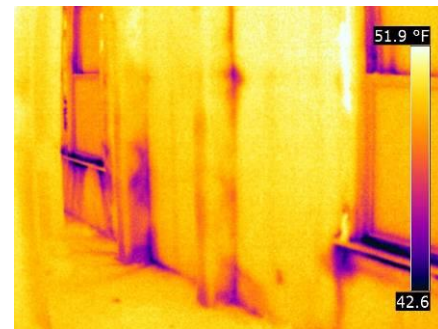
Fig. 56. Air intrusion at junctures and studs with blower door at 40 Pa.

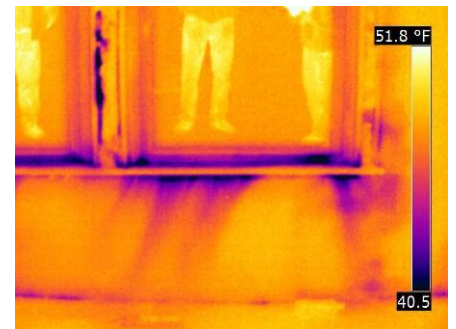
Fig. 57. Thermal "fingers" from air intrusion around windows. (Body heat from data takers is reflected from window.)

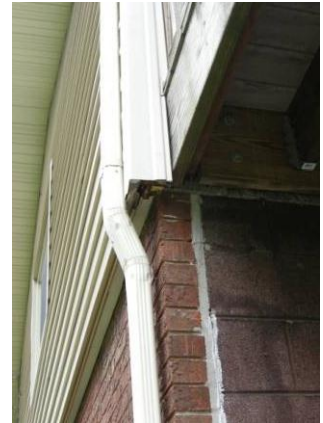
Fig. 60. Rim joist/sill area needs to be sealed and insulated.

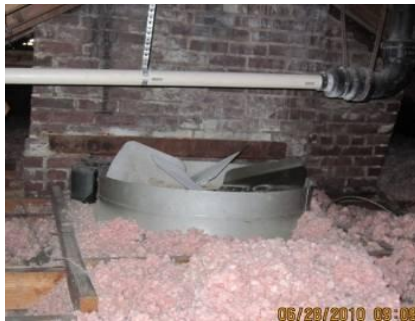
Fig. 65. Fan and gaps around chimney allow air to move freely between house and attic.

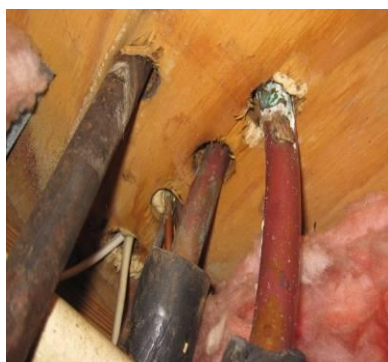
Fig. 68. Electrical and plumbing penetration provide airways between the house and the crawl space.

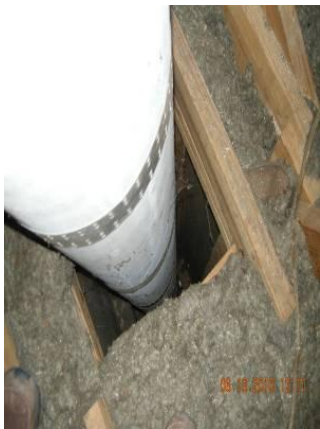
Fig. 71. Utility penetration into unconditioned attic.

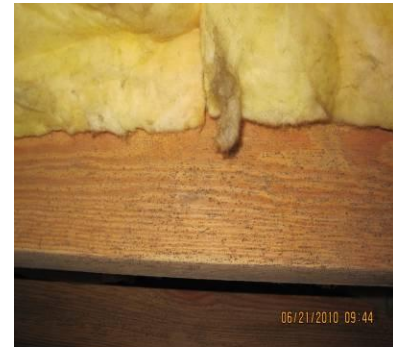
Fig. 73. Moisture allows mold to discolor the floor joist.

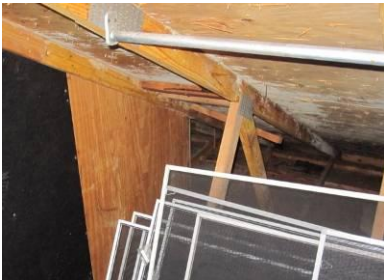
Fig. 75. Open chase into home from attic.

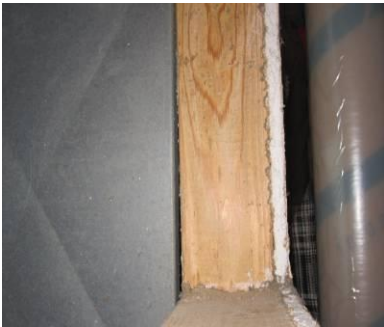
Fig. 76. Crack in return plenum (between metal and wood).

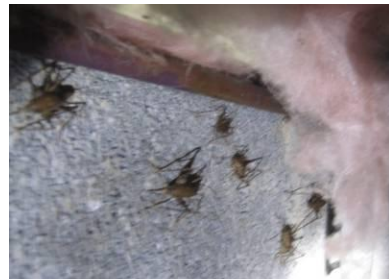
Fig. 78. Uninsulated ductwork in crawlspace with crickets feeding on mold growth.

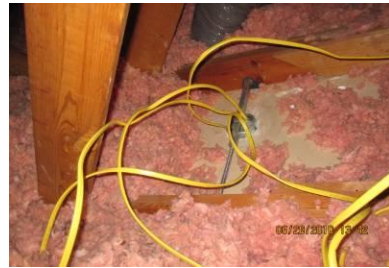
Fig. 79. Patchy, loose insulation in the attic.
