# Cracking and Corrosion of Composite Tubes in Black Liquor Recovery Boiler Primary Air Ports

October 2006

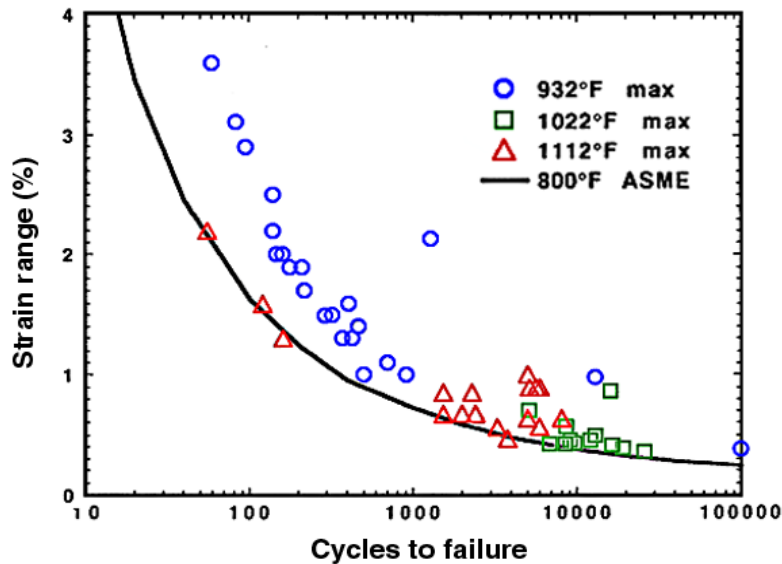
**Fig. 1. ASME fatigue design curve for 300 series stainless steels for 427°C.** Additional data for 304H and 304L have been added to the plot.

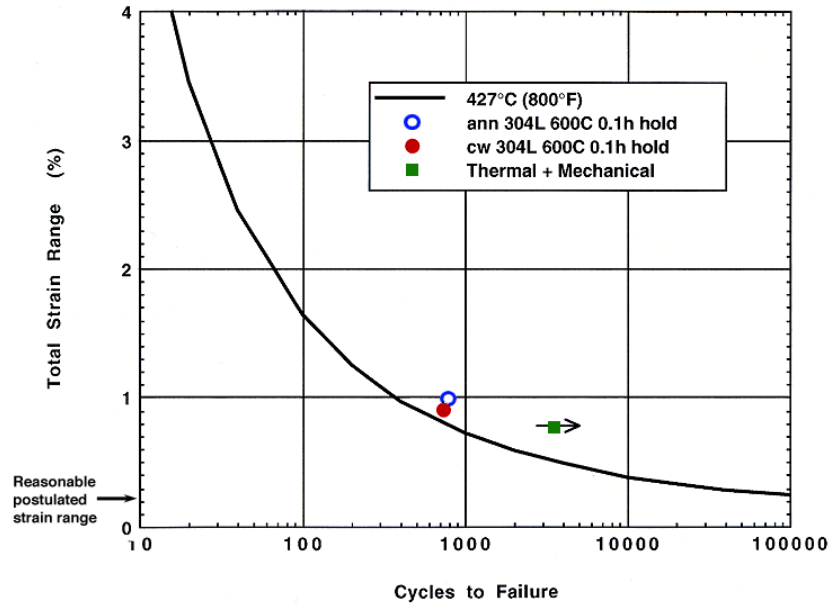
**Fig. 2. ASME fatigue design curve for 300 series stainless steels for 427°C with additional laboratory-generated data included.** Note that for cyclic strains of about 0.25%, the fatigue life is predicted to be about 100,000 cycles.

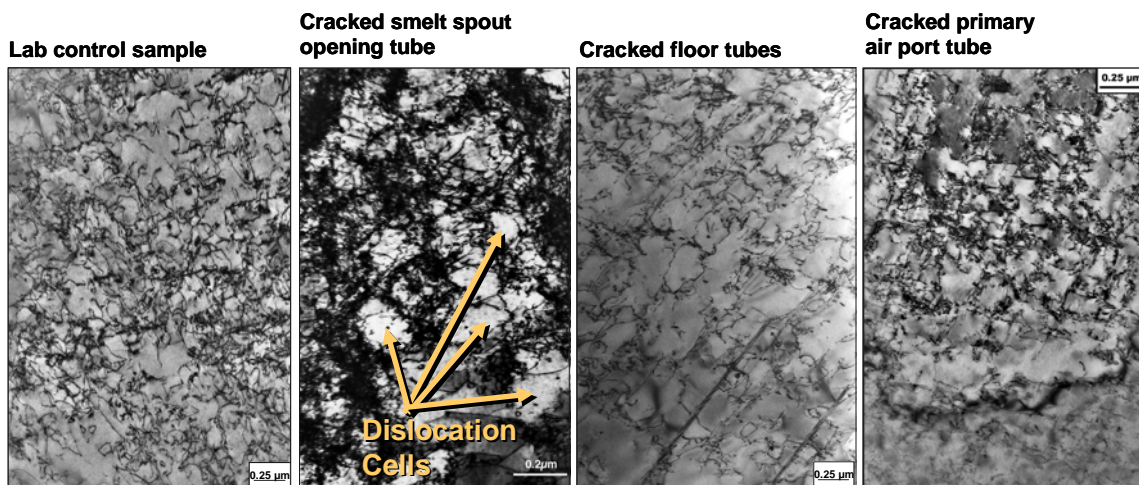
**Fig. 3. TEM examination of tube sample shows differences between spout opening tube, floor tube and air port tube.** The spout opening tube shows obvious evidence of thermal fatigue while the others only show evidence of thermal cycling.

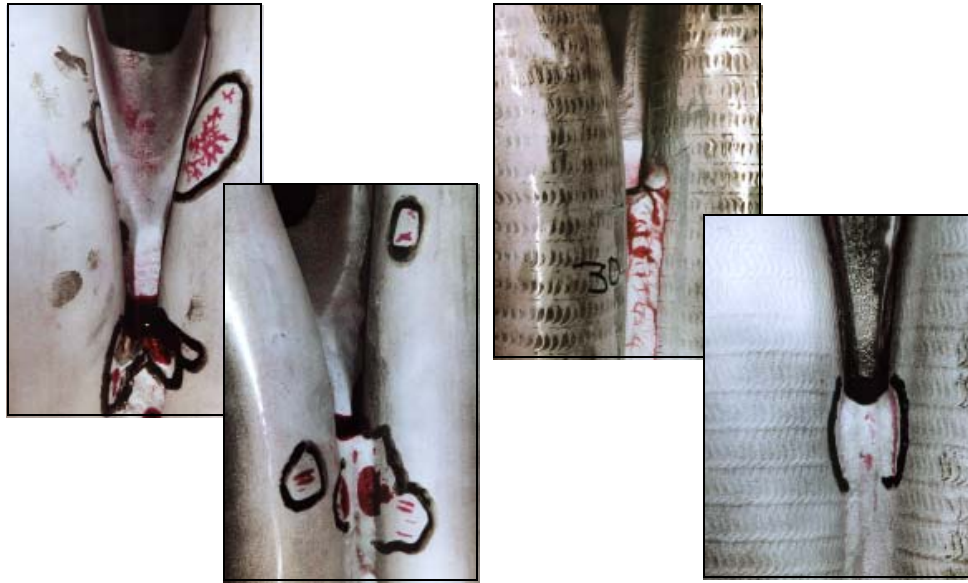
**Fig. 4. Examples of cracked primary air port opening tubes with (left to right) craze cracking, circumferential cracking, membrane cracking and cracking in the membrane to tube weld.**

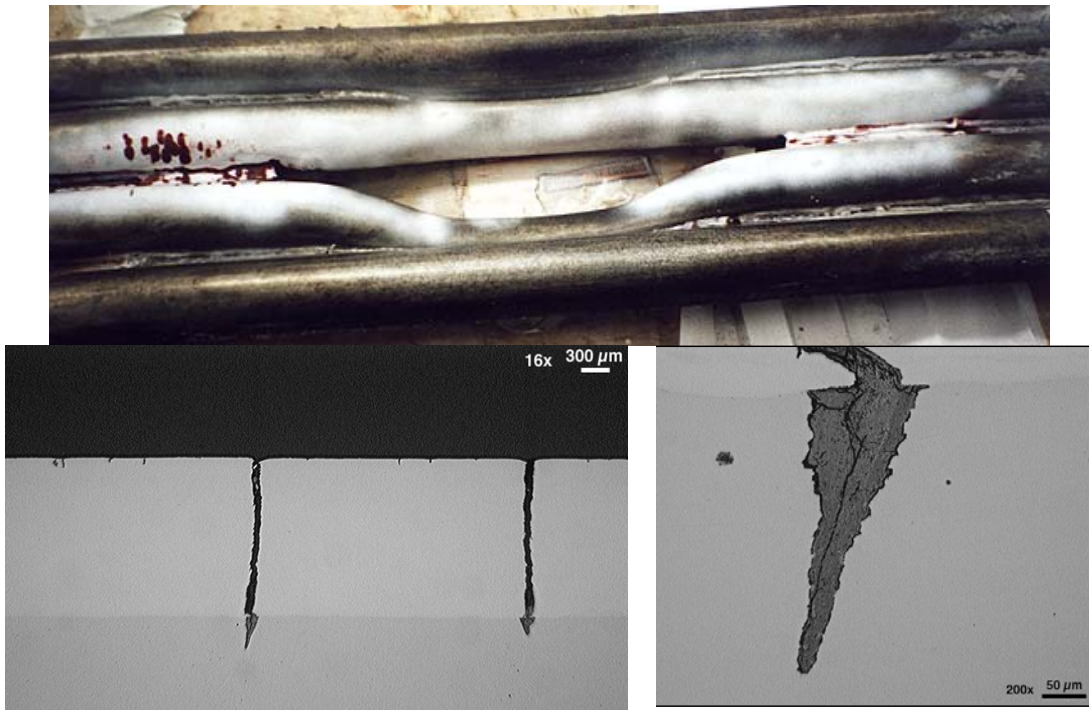
**Fig. 5. Cracks in 304L stainless steel clad tubes just below the air port opening.** Micrographs of the cross section of the tube show that these cracks penetrate into the carbon steel.

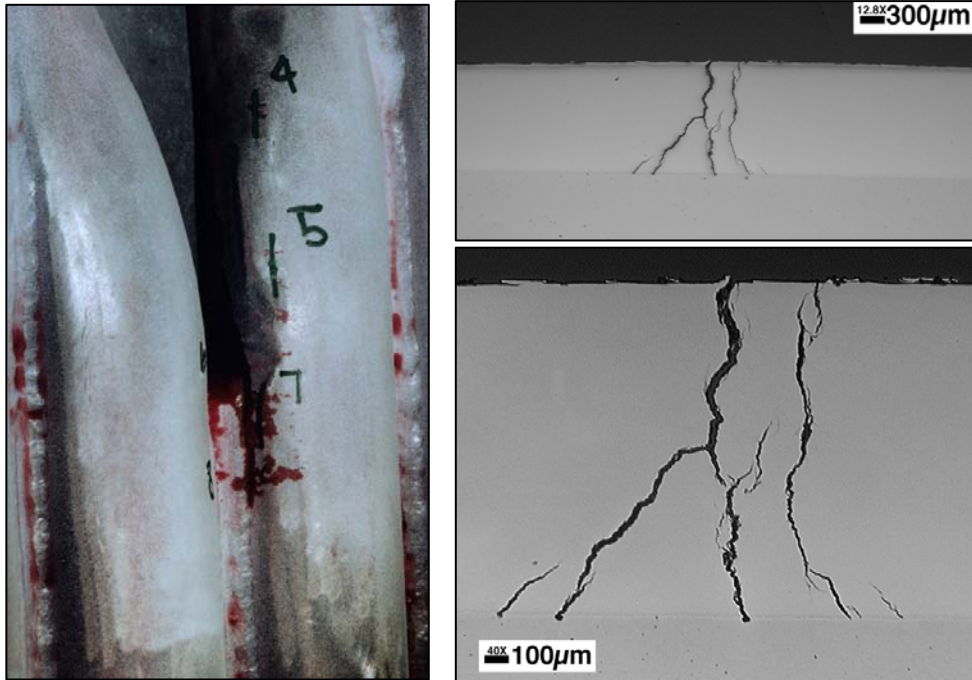
**Fig. 6. Cracks in a 304L stainless steel clad air port opening tube.** The cracks in location 4 are shown in cross section in the micrographs on the right. Note that many of these cracks terminate in a corrosion “pit” at the stainless steel/carbon steel interface.

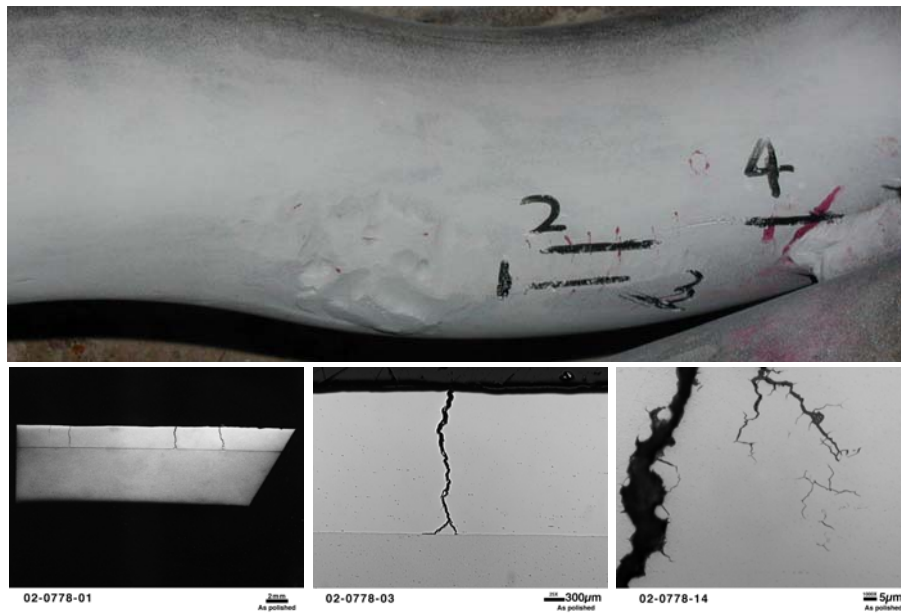
**Fig. 7. Cracks in an alloy 625 clad air port opening tube.** Many of these cracks continue through the alloy 625 layer to the interface. Note that the cracking is intergranular in nature.

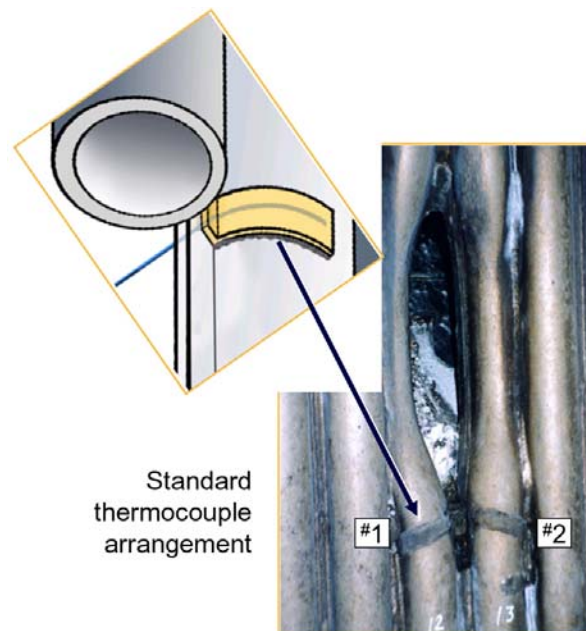
**Fig. 8. Thermocouples were mounted on the portion of air port opening tubes in the area where cracking was frequently observed.**

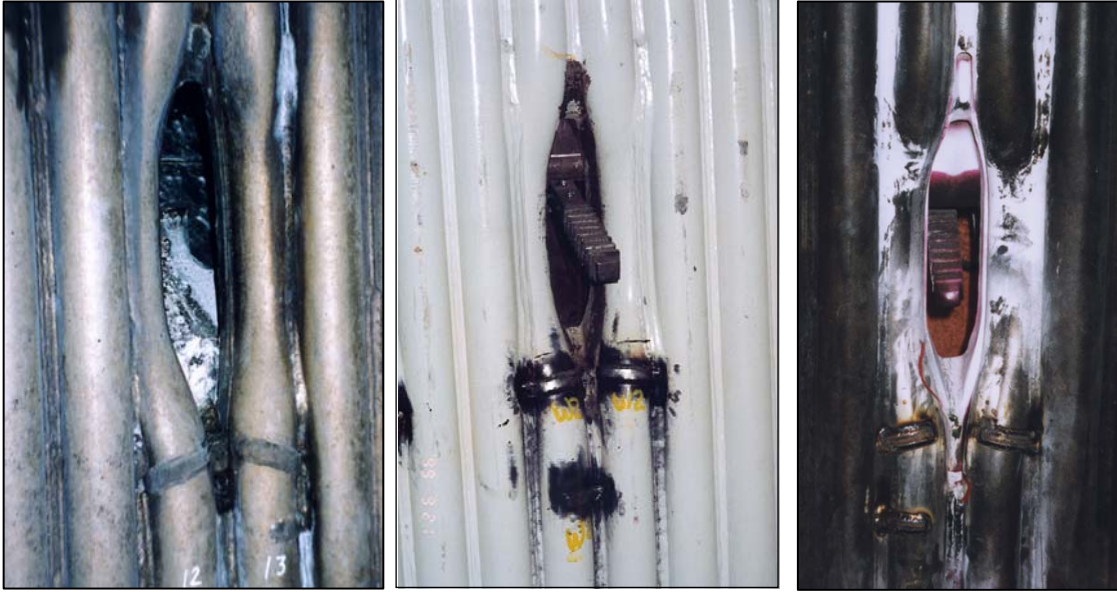
**Fig. 9. Examples of the thermocouple installations used in the first three boilers equipped with thermocouples on the primary air port tubes.**

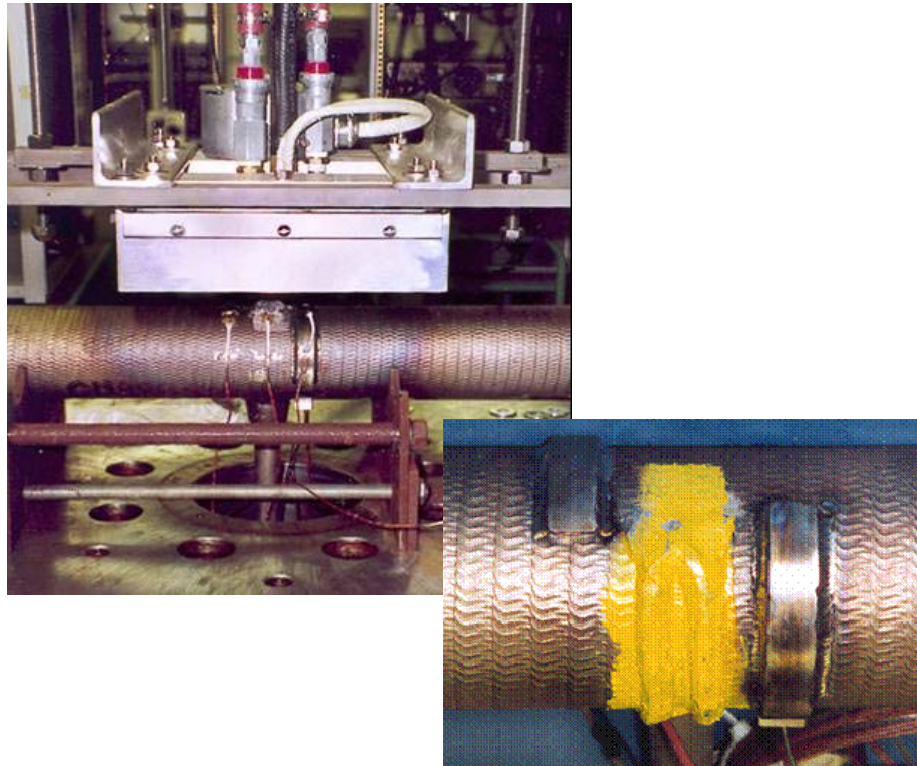
**Fig. 11. Assembly used to compare performance of chordal versus surface thermocouples.**

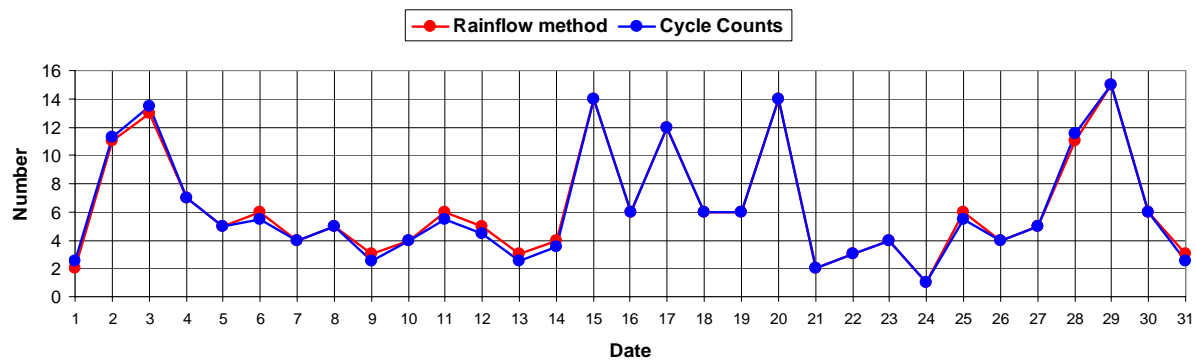
**Fig. 12. Cycle count and ASTM “rainflow” method lead to almost identical variations in number of cycles.** “Rainflow” method is more rigorous, but also more time consuming, and requires parsing of data to choose maximum value as first data point.

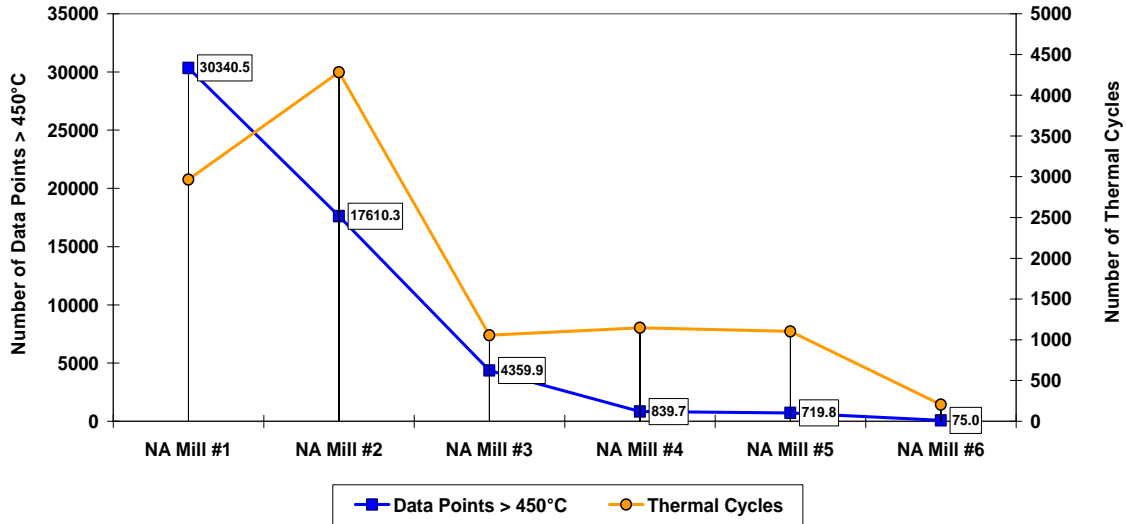
Fig. 13. Plot of cycles and data points >450°C for six North American recovery boilers for one year period.

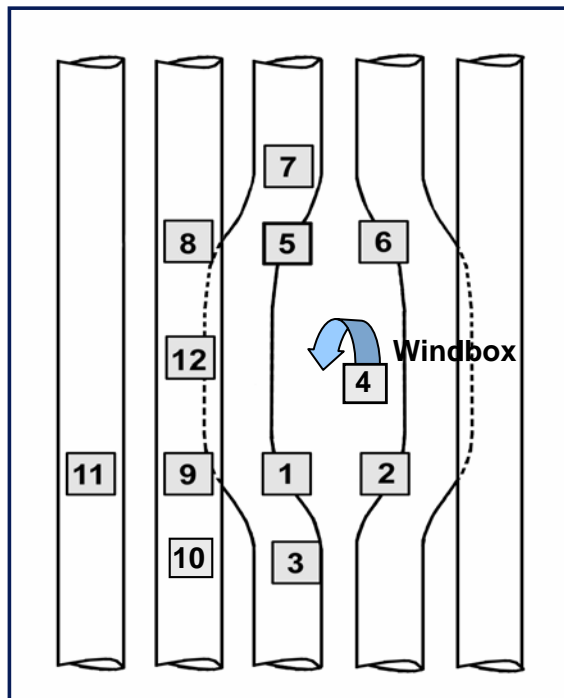
Fig. 14. The numbered thermocouple positions shown above were used to observe temperature variations around the air ports in one mill. Positions #1 and #2 were used in all boilers in this study. No single air port was instrumented with all available positions.

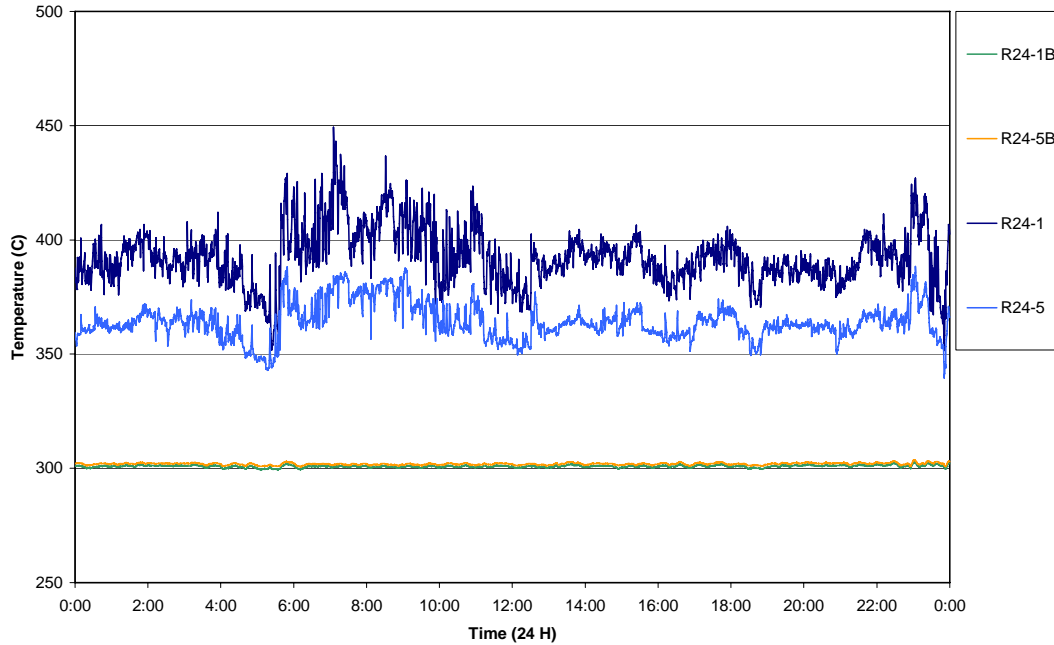
**Fig. 18. Plot of temperatures measured at two locations on the fireside of a primary air port tube (R24-1 and R24-5) and the temperatures measured at equivalent locations on the windbox side of the same tubes.** Note that negligible fluctuations were measured on the windbox side of the tubes.

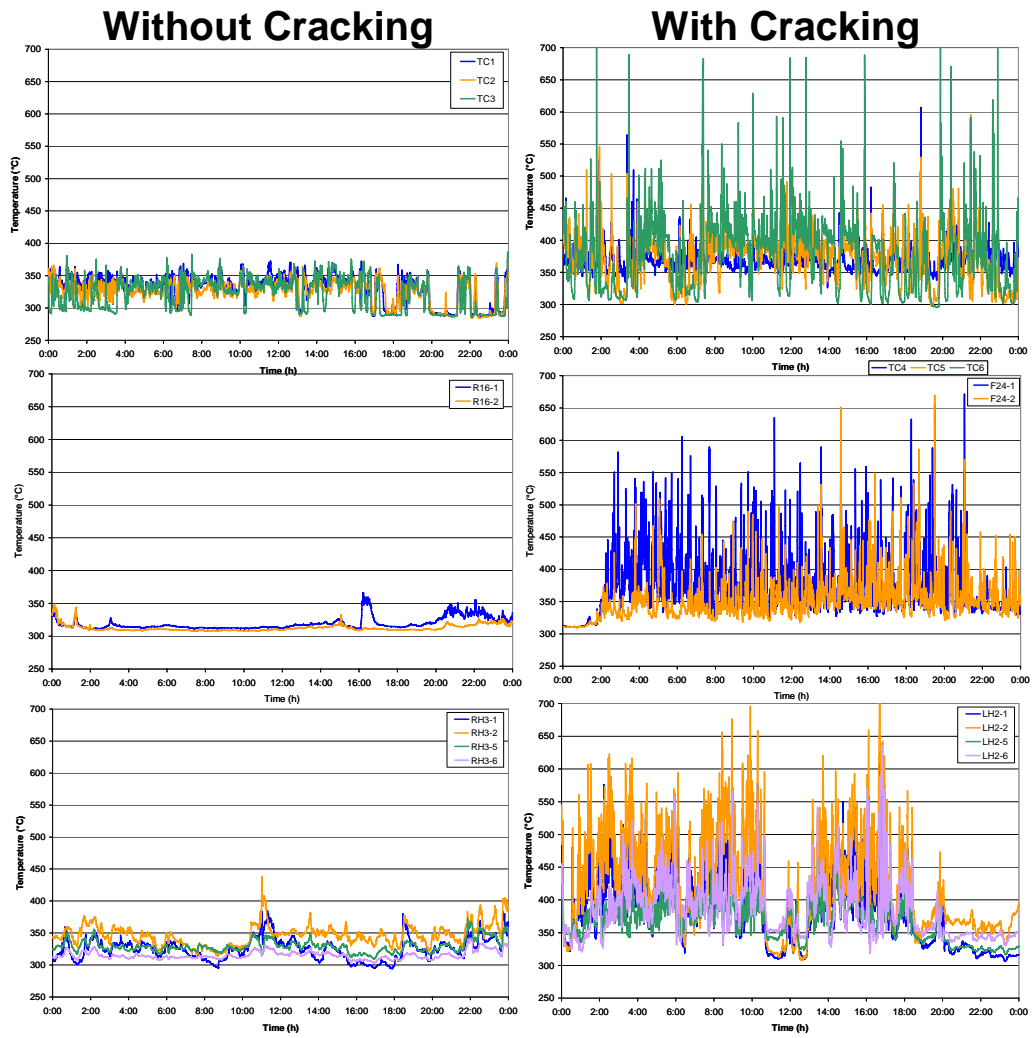
**Fig. 19. Data from three different mills show the difference in thermal fluctuations between air ports with and without a history of cracking.**

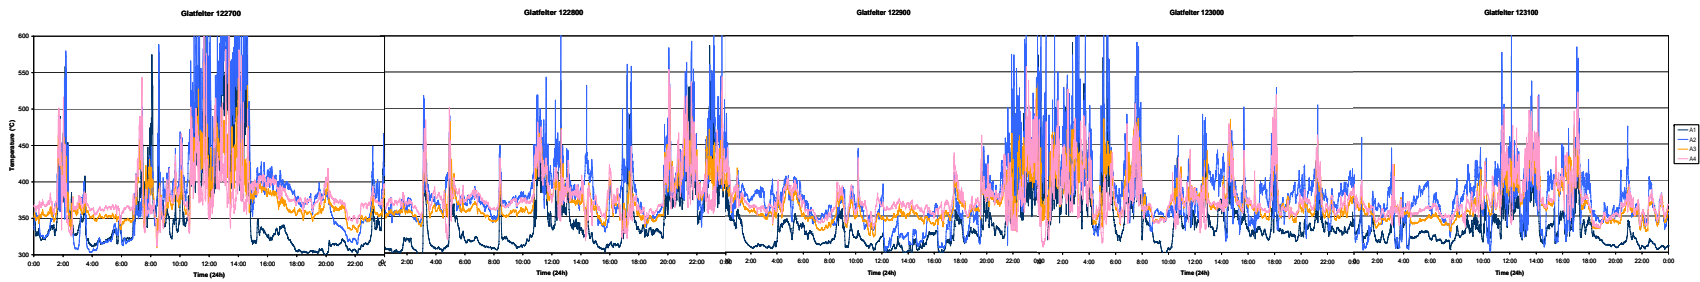
**PAP LW#2 has previously exhibited cracking.**

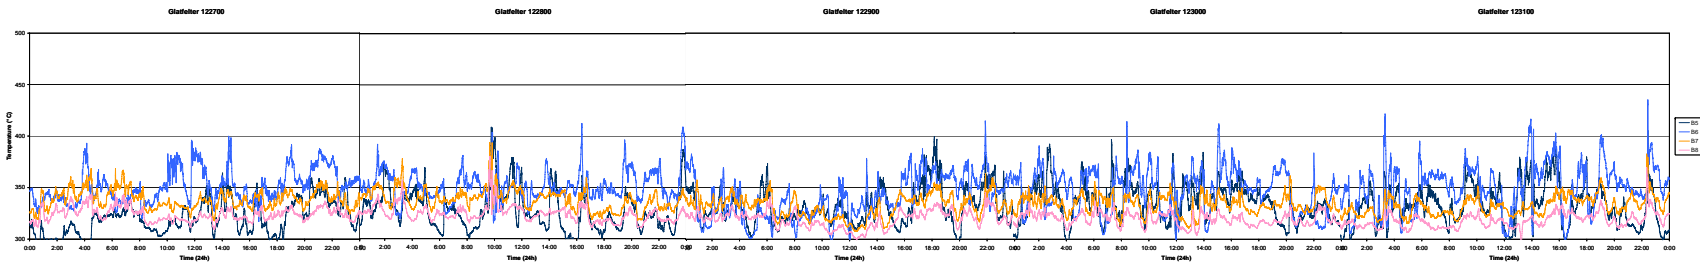
**Fig. 20. Activity from two different air ports compared over a five day period. The primary air port with no history of cracking exhibits much less thermal activity over the extended period of time.**

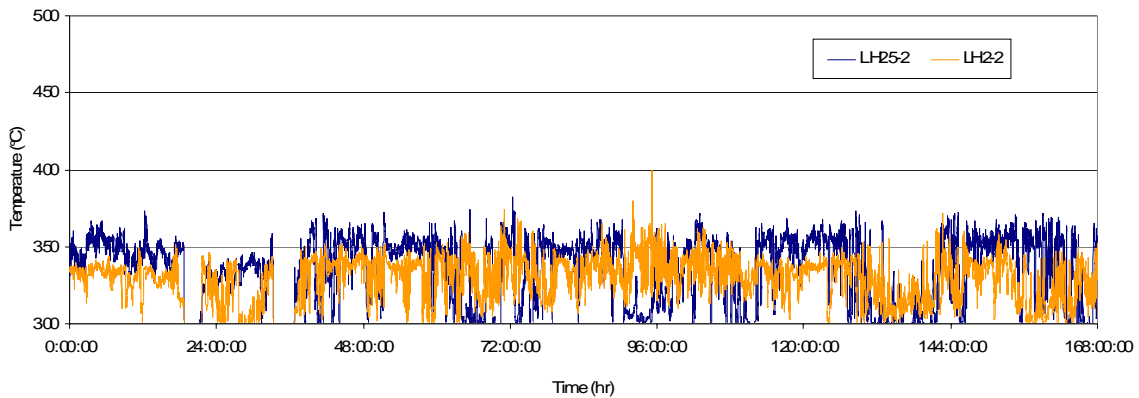
**Fig. 21. Plot of temperature versus time for two thermocouples on primary air port opening tubes in a boiler originally equipped with the longer, narrower air port design.**

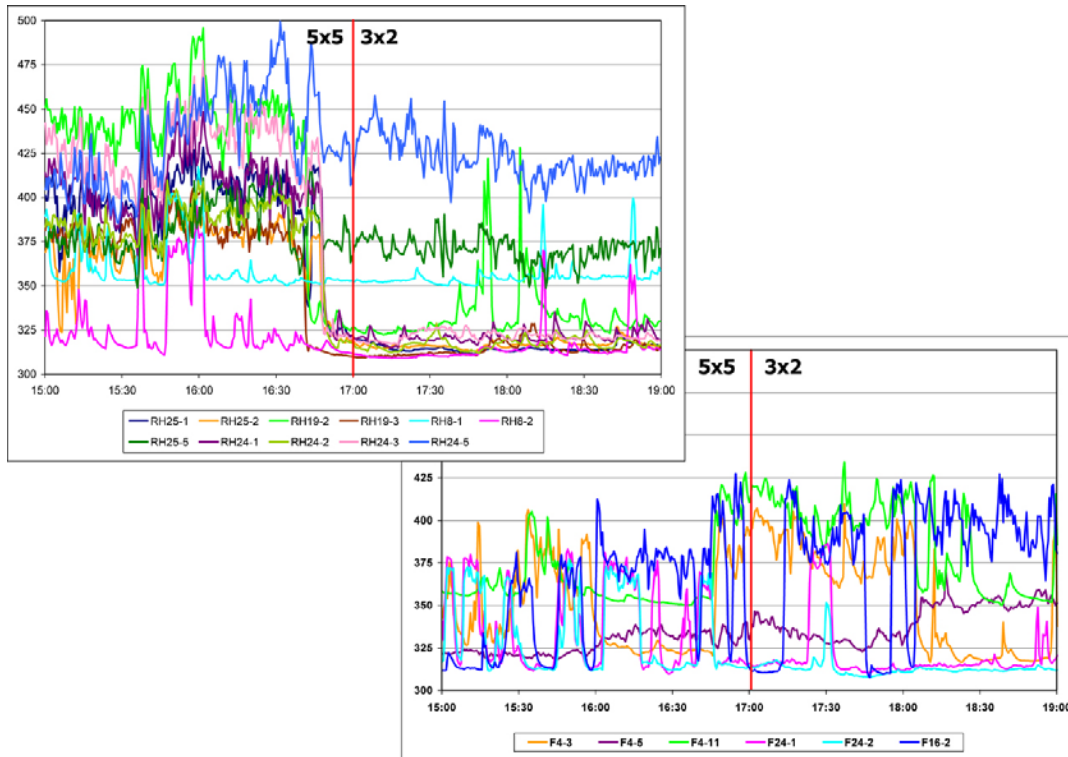
**Fig. 25. Plot of temperatures measured by primary air port thermocouples on the right hand side wall and the front wall when the secondary air pattern was changed from 5 versus 5 to 3 versus 2.**

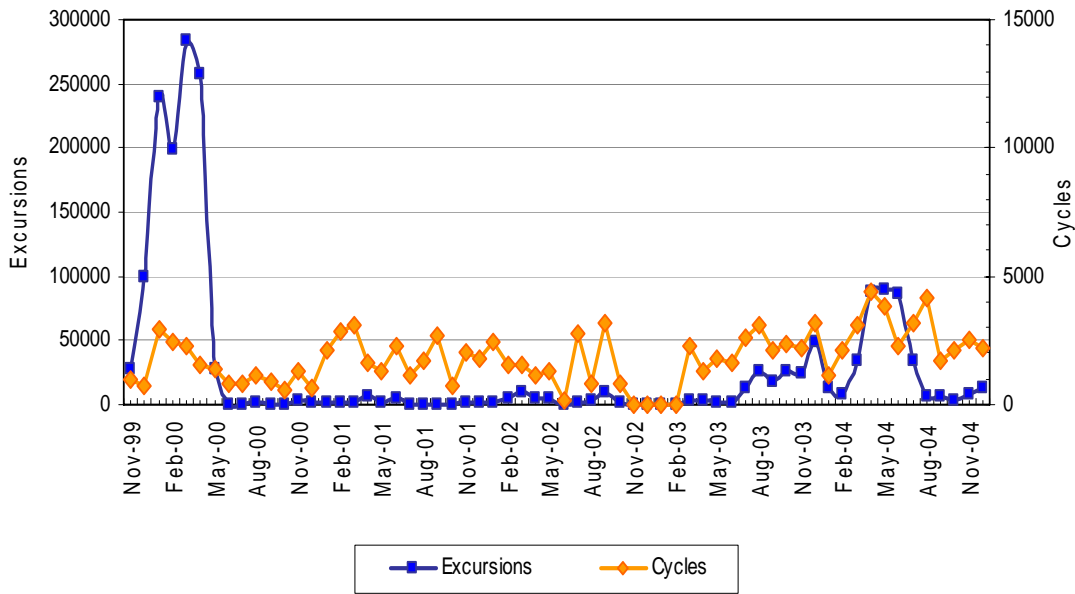
**Fig. 26. Cycles and excursions plotted for continuous in-service thermocouples over a five year period in one North American boiler.**

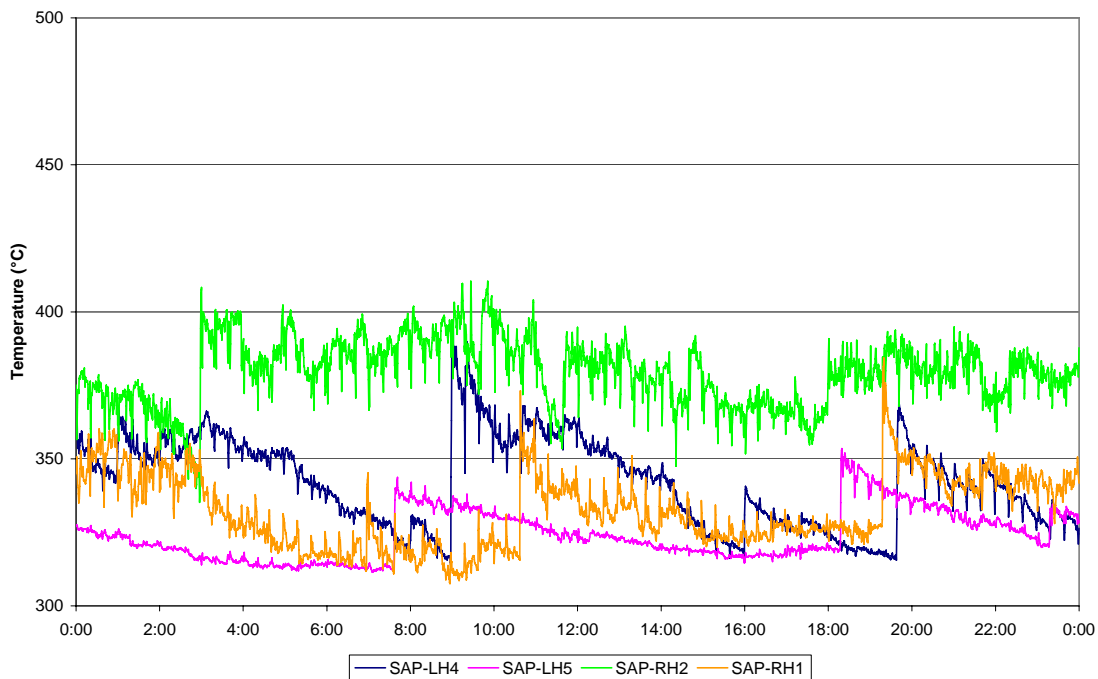
**Fig. 27. Temperatures measured in secondary air ports of boiler with history of primary air port cracking.**

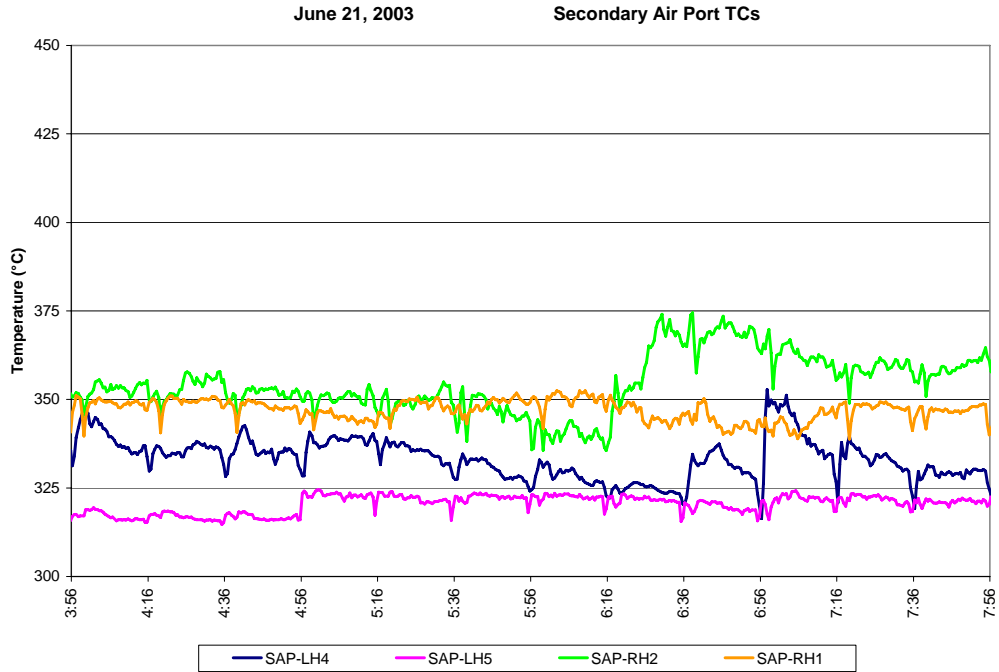
**Fig. 28.** Plot of temperature vs time showing apparent effect on secondary air port thermocouples of automatic secondary air port rodder operation at 20 minute intervals.

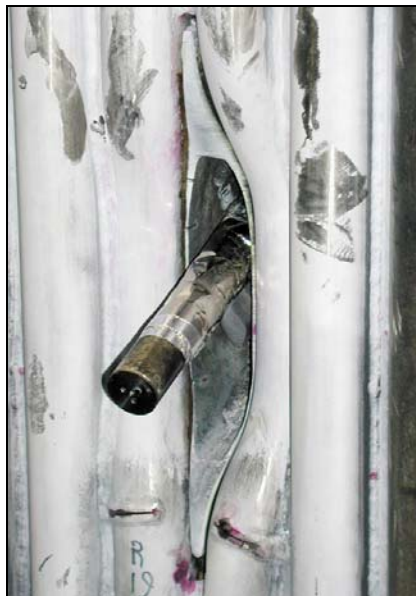
**Fig. 30. Camera probe inserted through primary air port opening during a shutdown; it records activities on the fireside of the primary air port.**

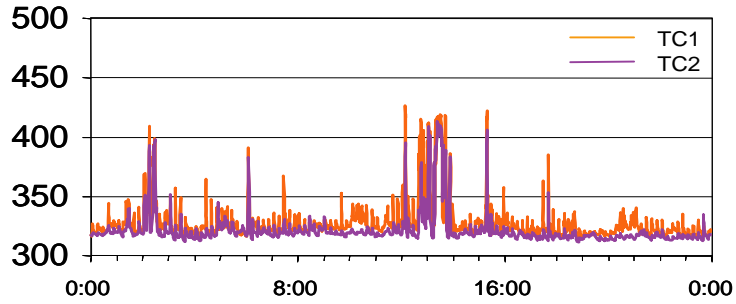
**Upper temperature band**—The thermocouple shields were exposed, except for the usual white coating on the surface. No particulate was landing on the surface of the thermocouple shields, the char bed was more than roughly 30 cm (1 foot) from the bottom of the primary air port, and very steady temperatures ( $\pm 5^\circ\text{C}$ ) were recorded, typically for periods of about 15 minutes (Fig. 33a). The actual temperature measured within the upper band appeared to vary with location of the thermocouple relative to the port and the port's location around the boiler. For Mill C's boiler, the temperature band was generally 380 to 420°C.

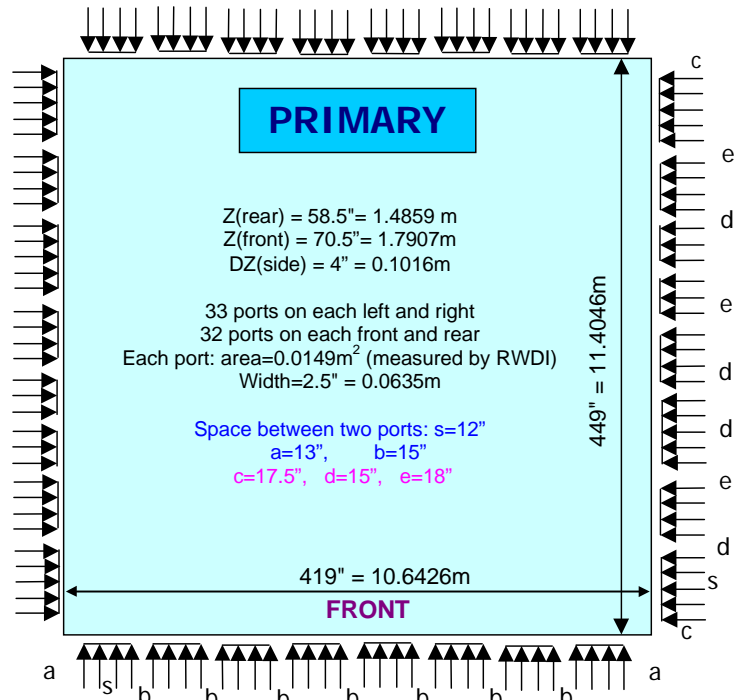
Fig. 35. Primary air system of Boiler-Q.

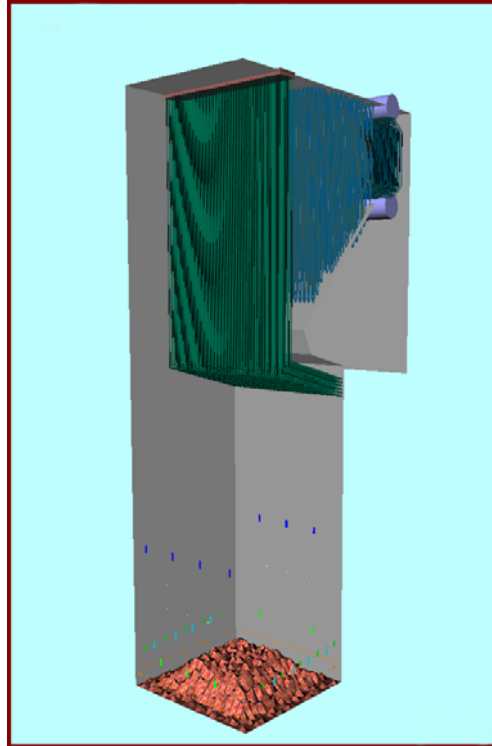
**Fig. 39. Model of Boiler-Q.**

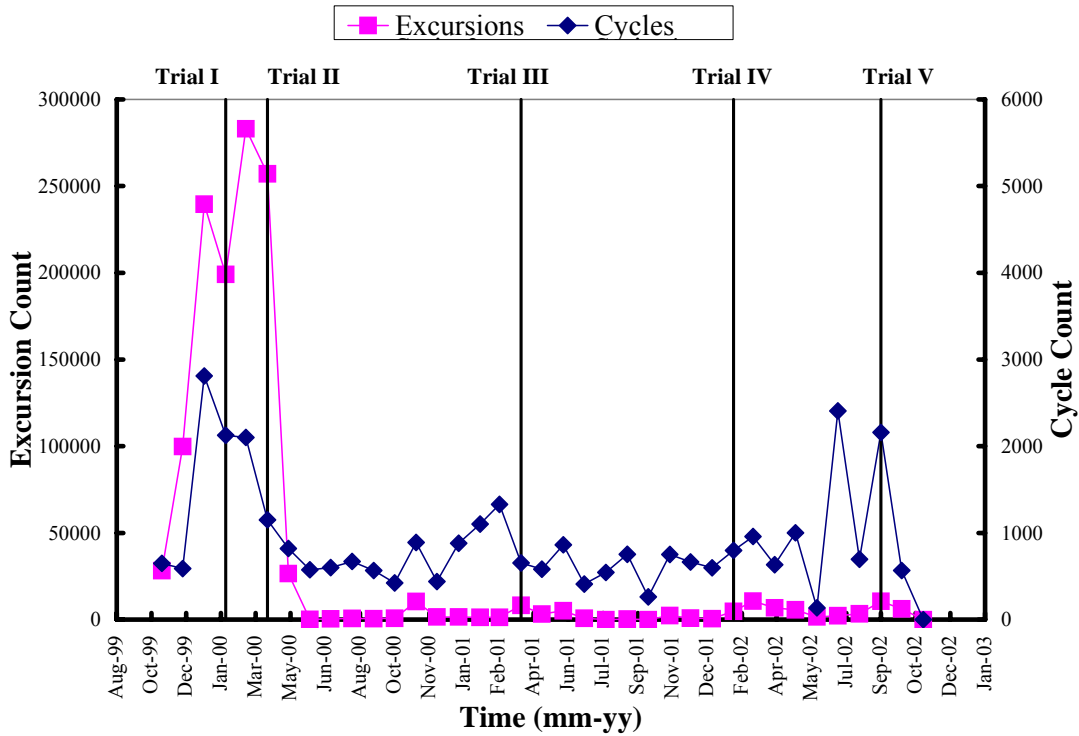
Fig. 40. Measured temperature excursions and cycles.

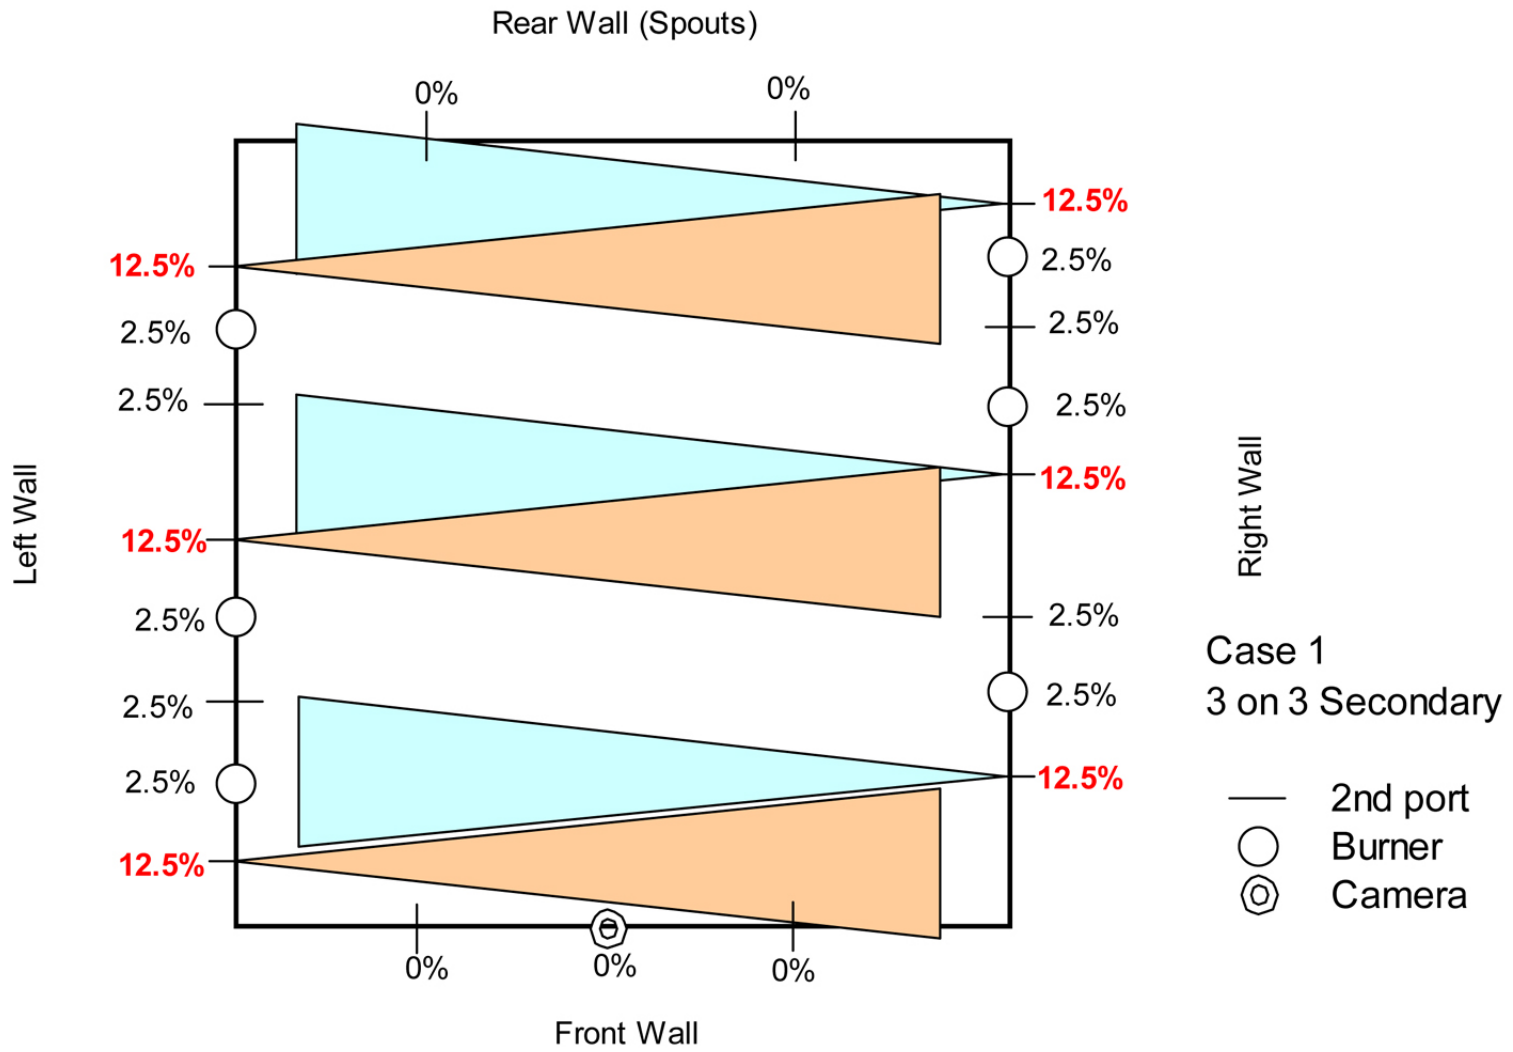
Fig. 45. Secondary air distribution in 3 on 3 mode in Boiler-Q.

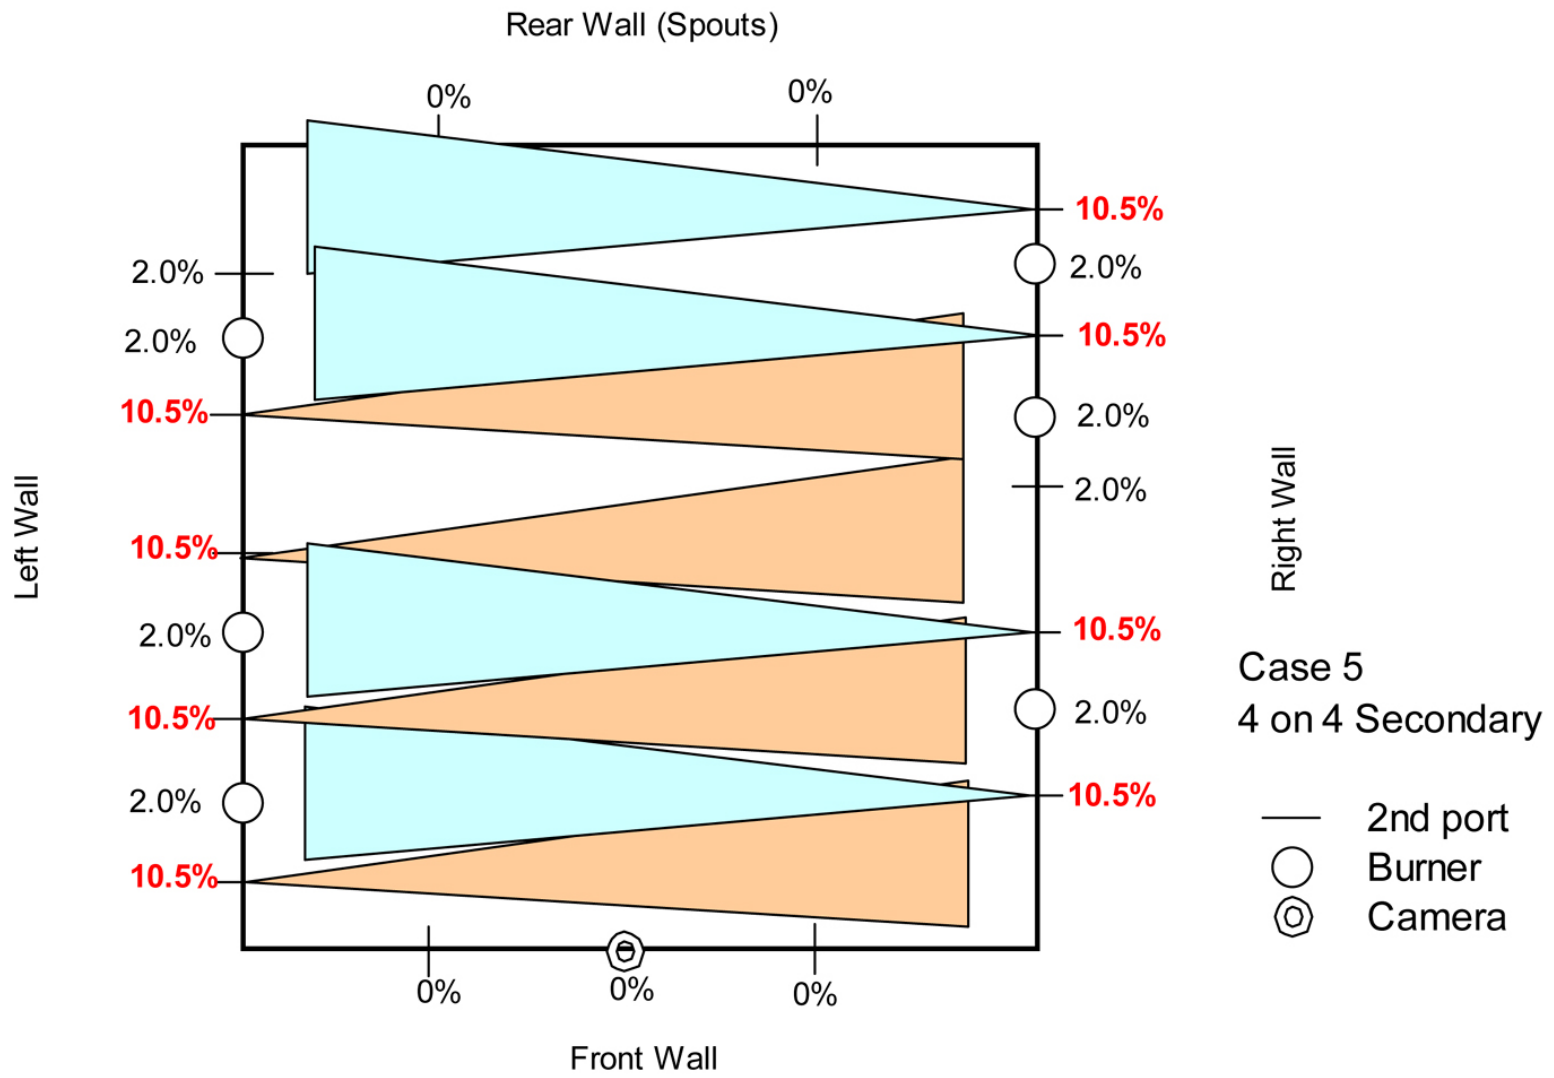
Fig. 48. Secondary air distribution in 4 on 4 mode in Boiler-Q.

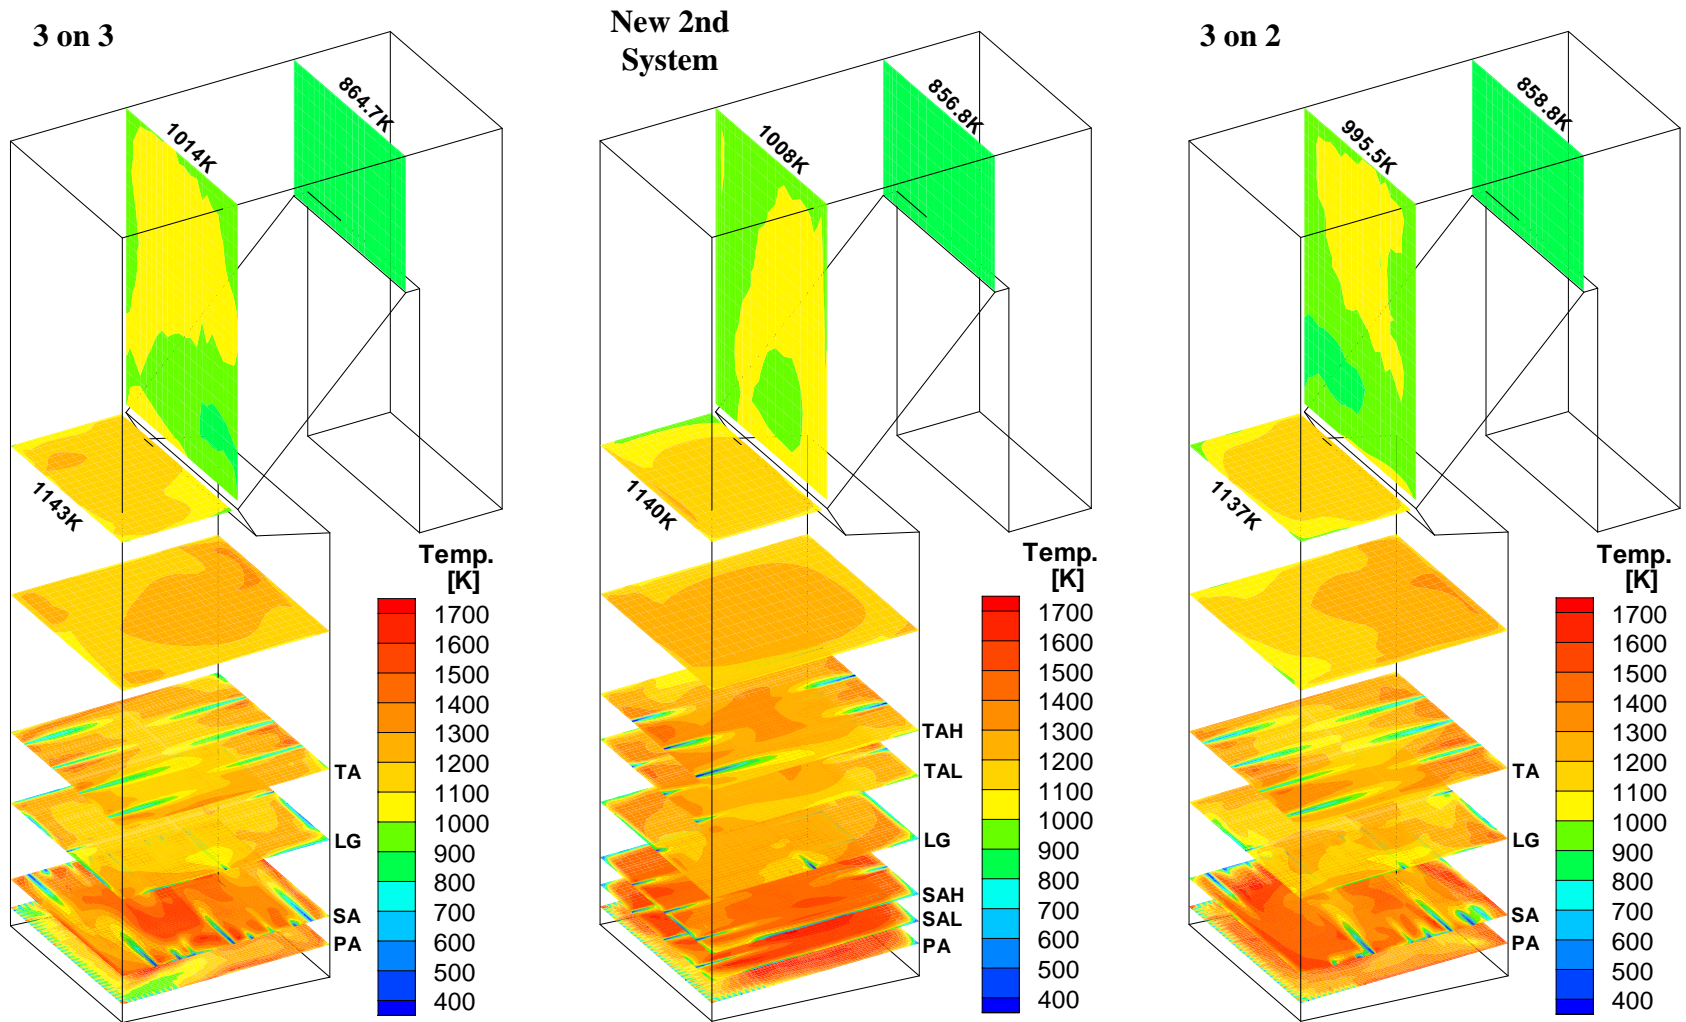
Fig. 49(a). Gas temperatures under different secondary air distribution modes in Boiler-Q.

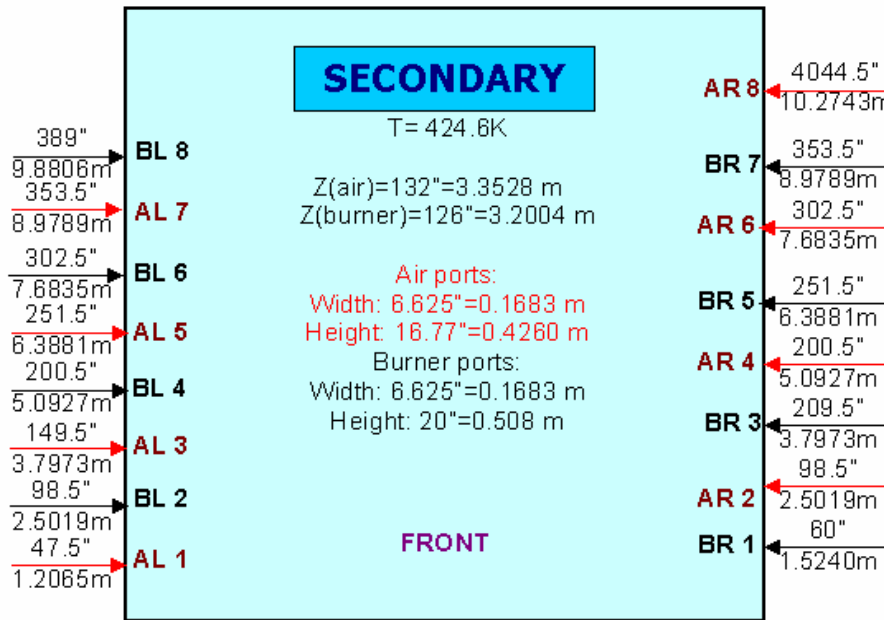
Fig. 55. Secondary air system of Boiler-P.

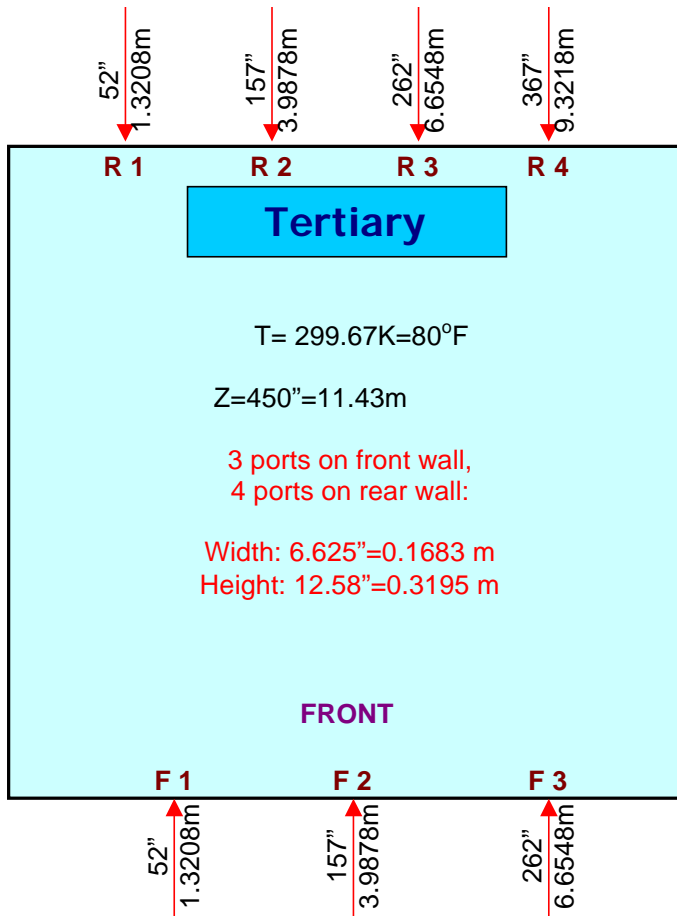
**Fig. 56. Tertiary air system of Boiler-P.**
