# Cracking and Corrosion of Composite Tubes in Black Liquor Recovery Boiler Primary Air Ports

October 2006

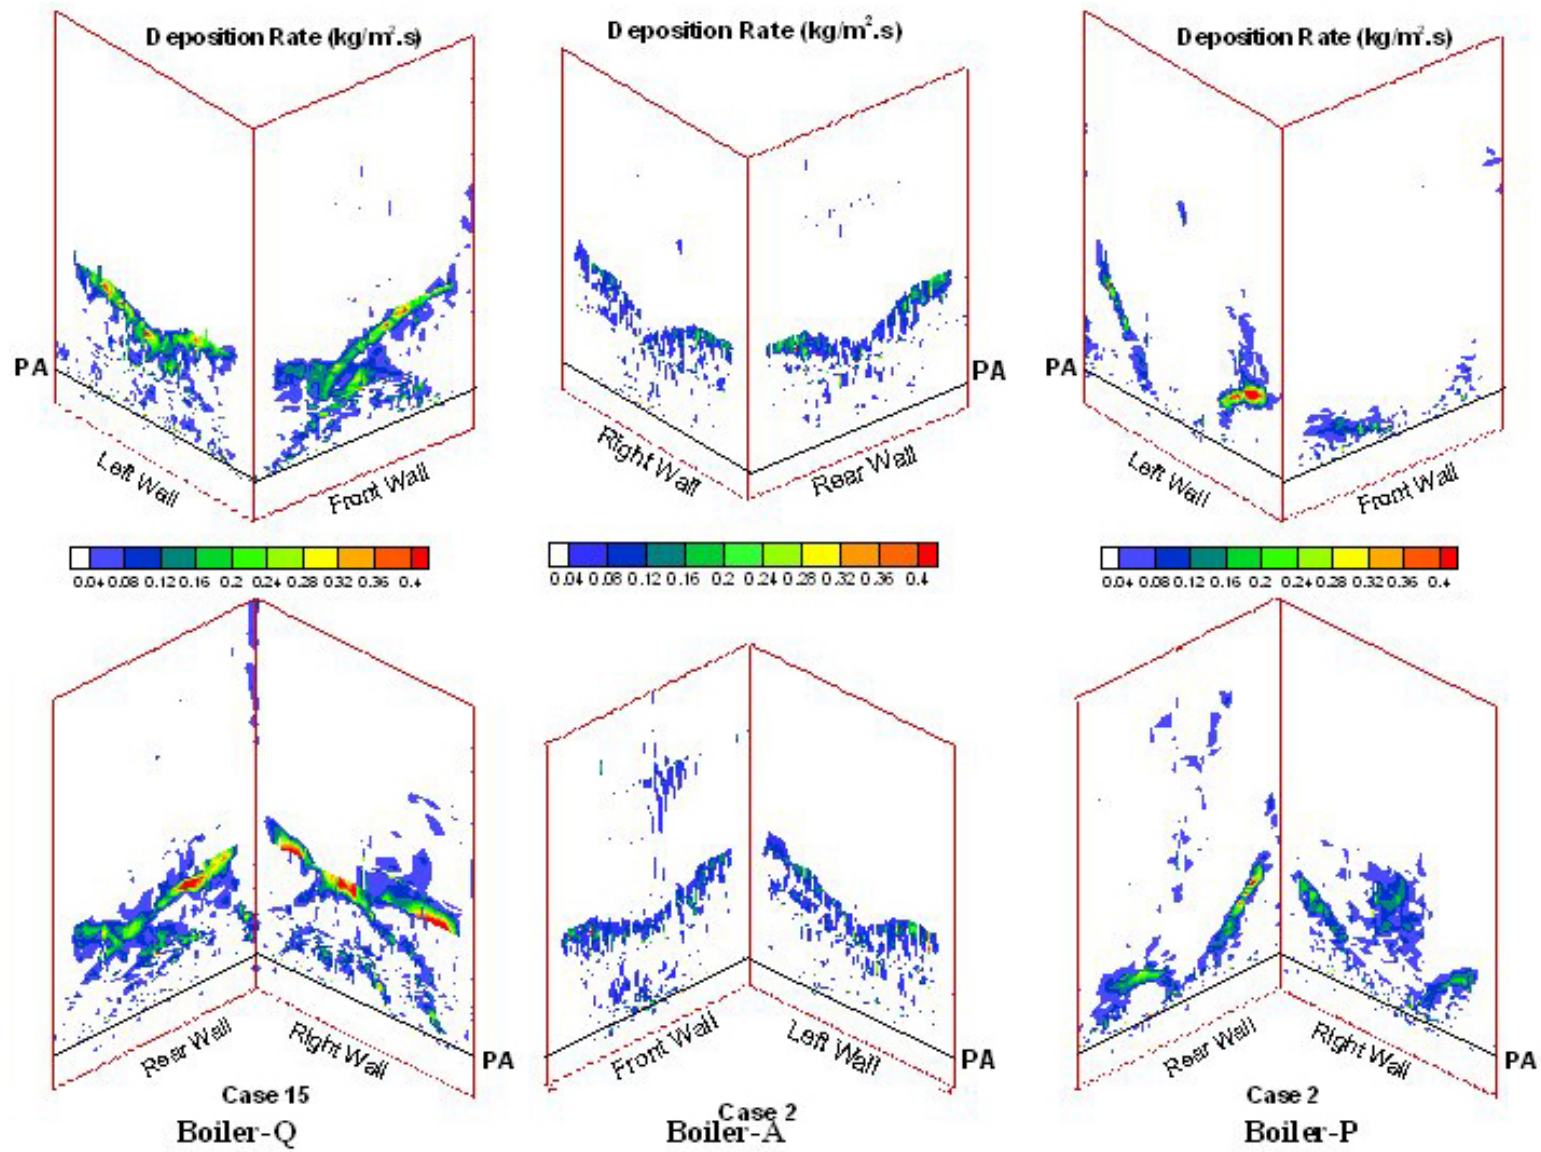
Fig. 67. Liquor deposition on the walls in three boilers.

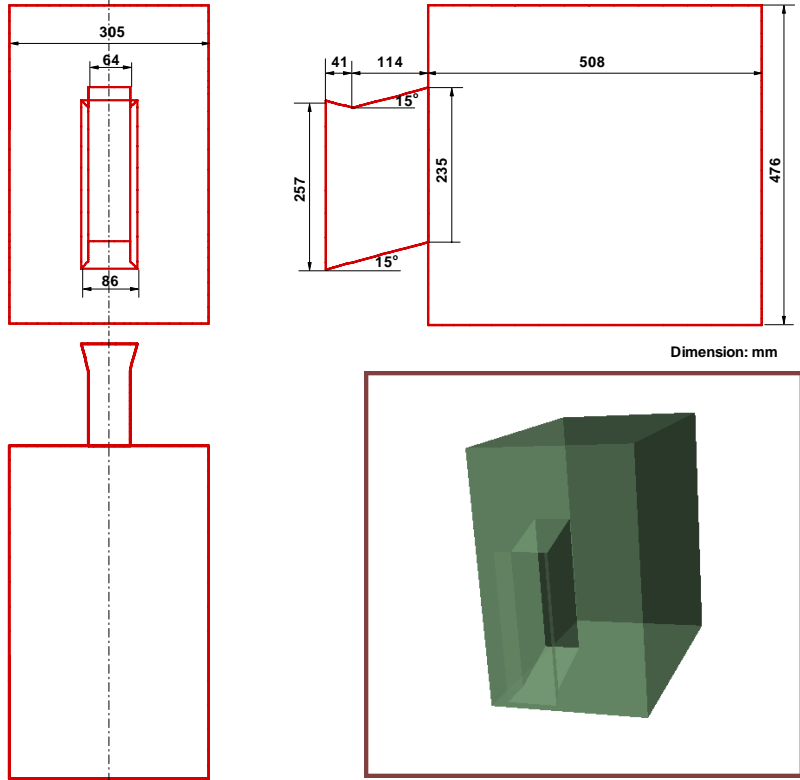
Smelt spout air leakage	kg/hr	2	0	0
Air temperature	°C	30	34	29
<b>Total air flow rate</b>	<b>kg/hr</b>	<b>386,753</b>	<b>380,019</b>	<b>446,342</b>
<b>Excess air ratio</b>	<b>%</b>	<b>17.0%</b>	<b>29.0%</b>	<b>34.3%</b>
Black liquor feed rate	kgDS/hr	77,099	69,681	88,830
Black liquor nozzle type		Splash	Splash	Splash
Number of liquor guns		4	4	8
Steam generation	kg/hr	250,000	250,000	306,627
Operation pressure	kPa	8,690	8,690	5840
Operation temperature	°C	480	480	447

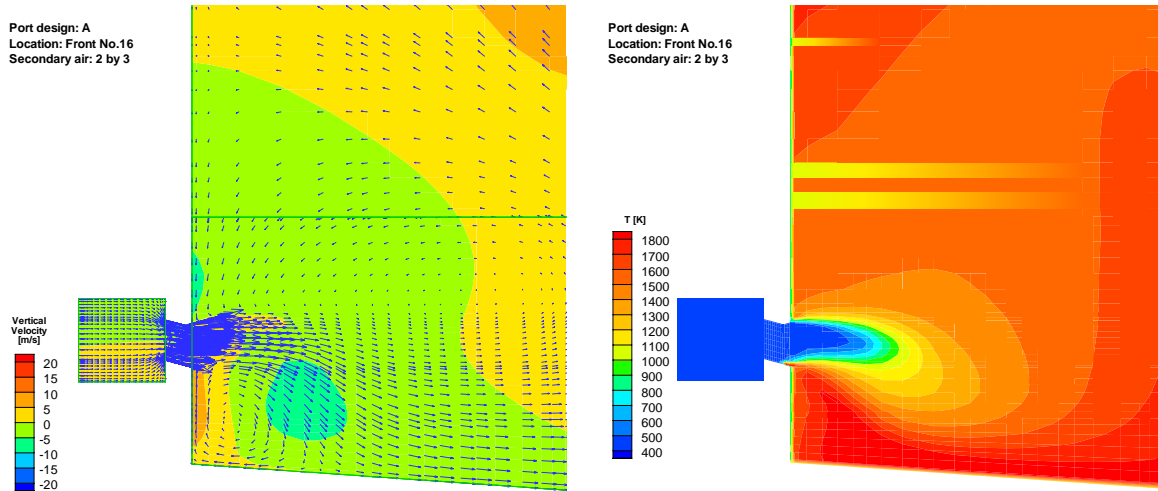
To prevent cracking in primary air port tubes, the CFD modeling study indicates the flow and combustion in the furnace needs to be stabilized by either adjusting the air split and/or air distribution among ports or updating air system design. Computer modeling can help to optimize the operation and design and to evaluate the stability of the flow and combustion. Avoiding strong recirculating gas flows below primary air jets can be achieved with an air port that is designed to remove burning droplets and local gas combustion from tube surface. It is also important to minimize the number of liquor droplets hitting the walls, which could be achieved by choosing different nozzle designs, or changing liquor properties such as temperature and solid content. Computer modeling can also help to evaluate the liquor combustion process in recovery boilers.

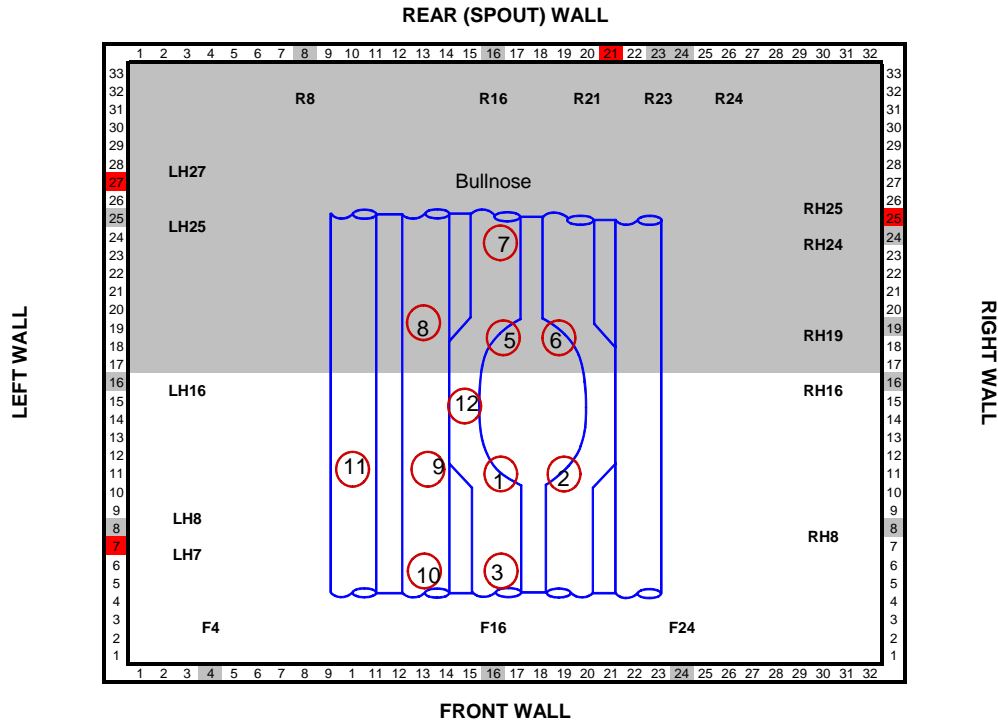
**Fig. 74. Schematic illustration showing primary air ports instrumented with thermocouples and their locations on tubes in and around primary air ports.** All ports were instrumented with thermocouples in the #1 and #2 locations. Ports highlighted in red identify those used to construct the thermal activity summary plot presented in Fig. 2. Circled numbers on port opening represent locations where surface-mounted thermocouples were installed.

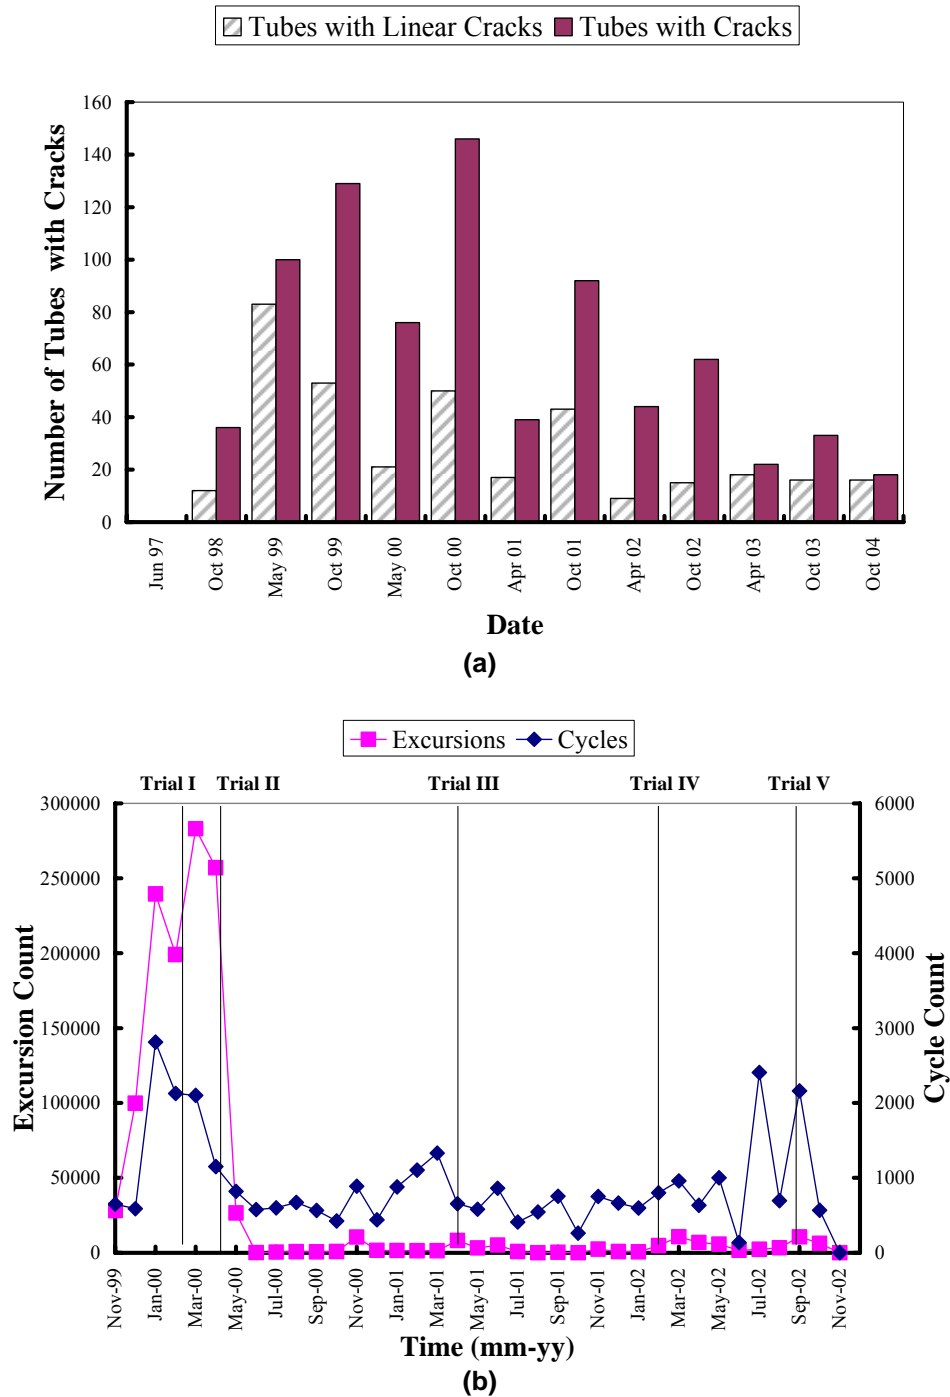
**Fig. 75. Plots comparing trend in cracking statistics with trend in thermal activity.** (a) number of tubes with cracks as a function of time (inspection period) and (b) cumulative thermal activity as a function of time.

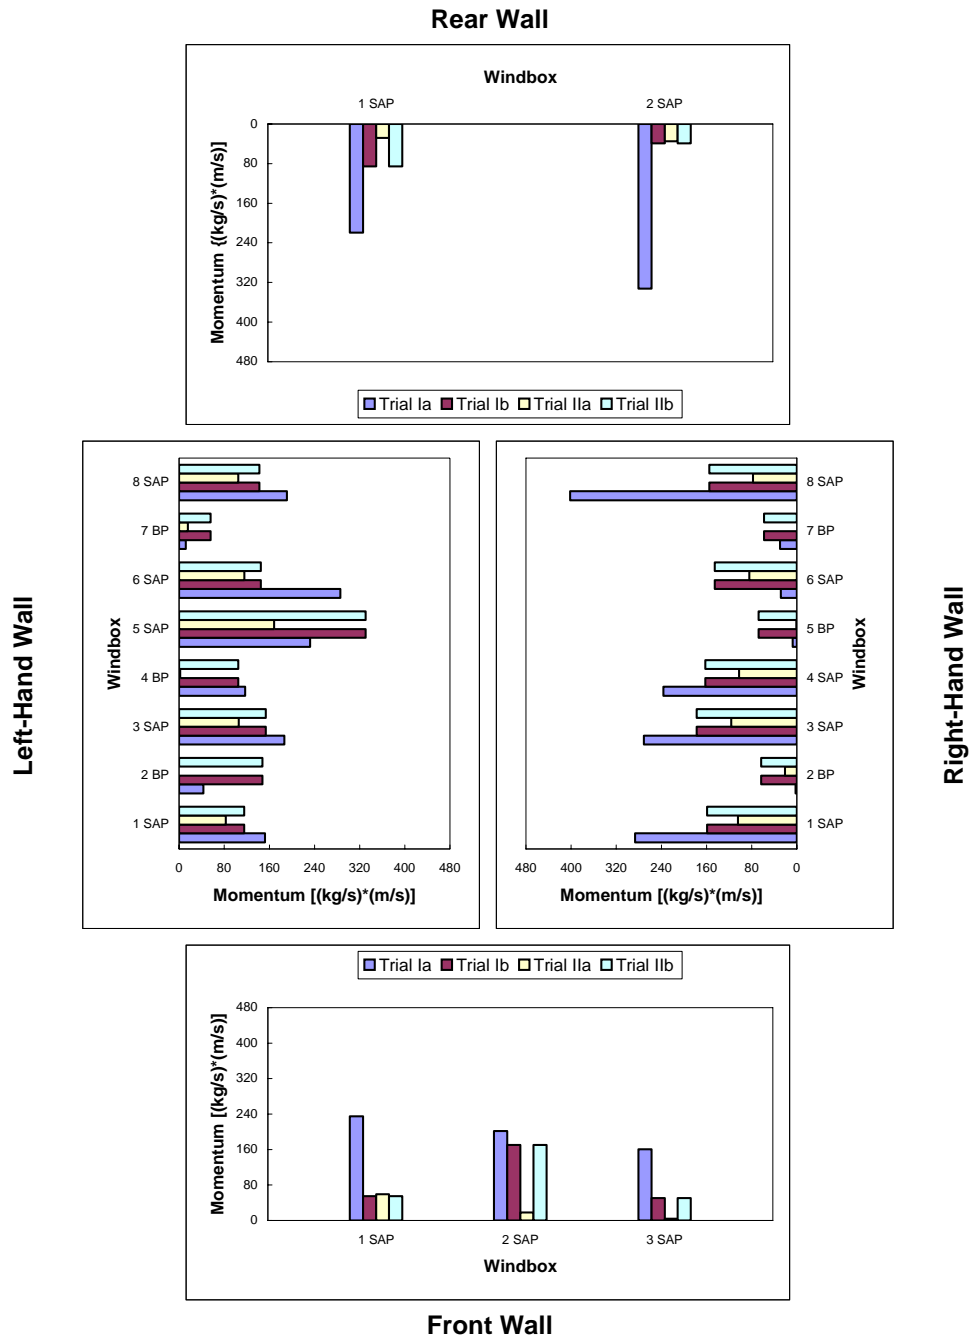
**Fig. 77. Plot of secondary air jet momentum as a function of the windbox showing influence of combustion air changes made to optimize system during Trials I and II. [a = initial operating mode of trial, and b = final operating mode of trial.] See Table 14 for parameters.**

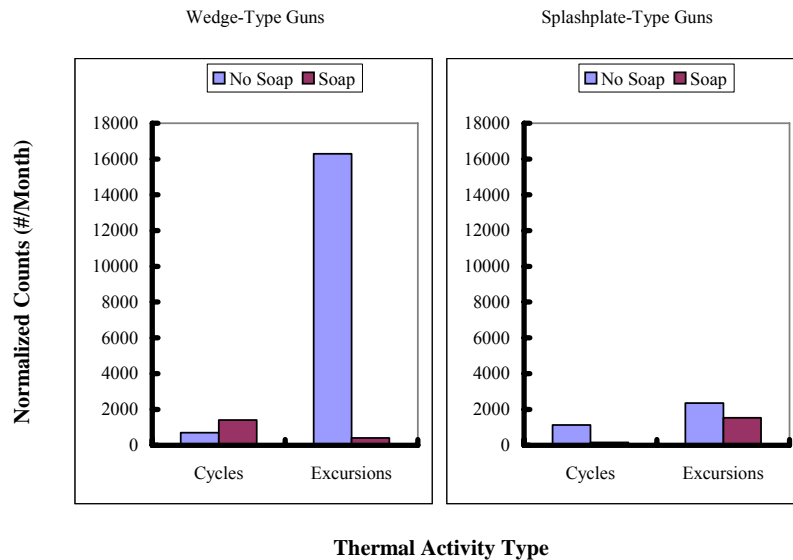
**Fig. 78. Plot comparing thermal activity for trial pairs showing the influence of burning soap in combination with black liquor for each nozzle type under study.** The thermal activity measured during Trial Ib (No Soap) and IIa (Soap) are compared in the “Wedge Nozzle” plot, whereas the thermal activity measured during Trial IIc (No Soap) and Trial IIb (Soap) are compared in the “Splashplate Nozzle” plot.

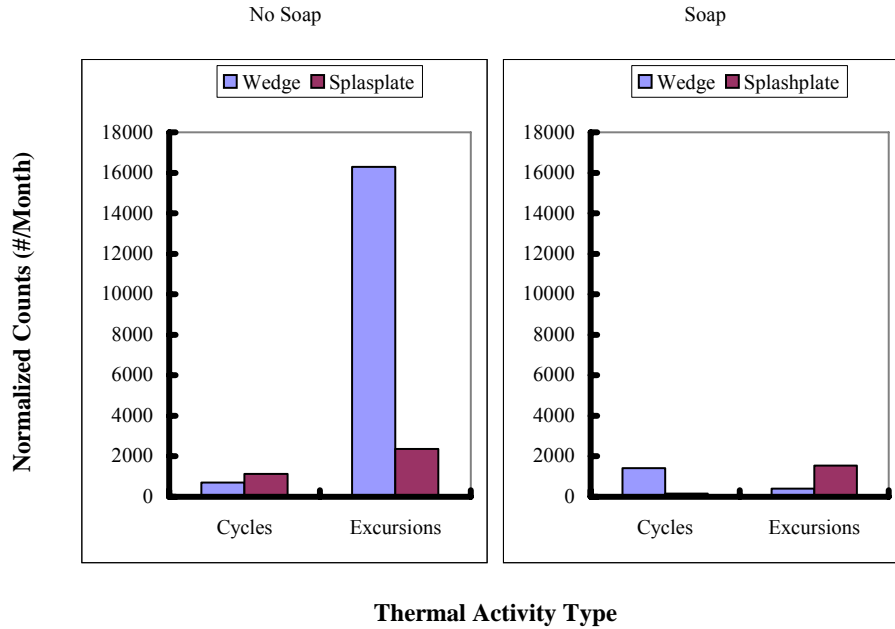
**Fig. 79. Plot comparing thermal activity for trial pairs showing the influence of nozzle type under study with and without the burning of soap in combination with black liquor.** The thermal activity measured during Trial Ib (Wedge) and IIc (Splashplate) are compared in the “No Soap” plot, whereas the thermal activity measured during Trial IIa (Wedge) and Trial IIb (Splashplate) are compared in the “Soap” plot.

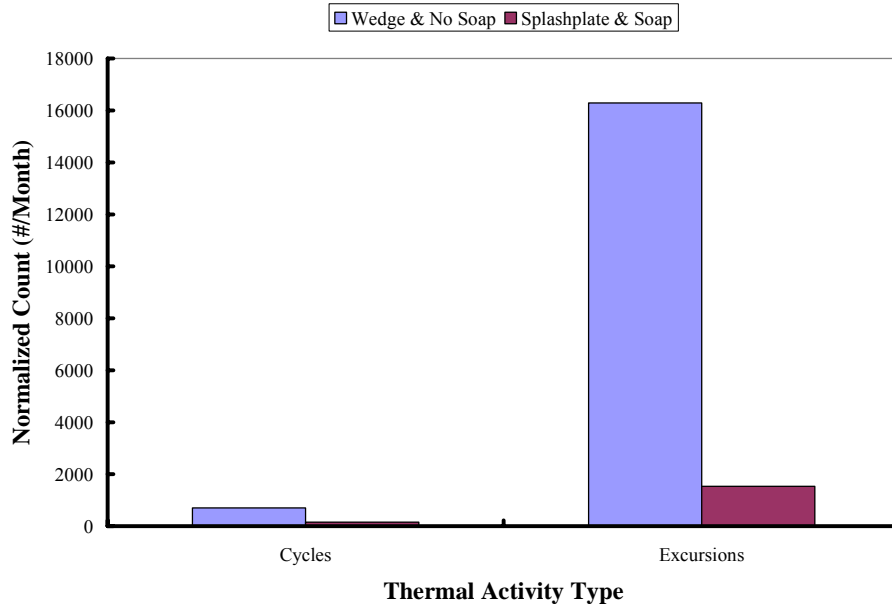
**Fig. 80. Plot comparing thermal activity for trial pairs showing the combined additive influence of nozzle type and burning of soap in combination with black liquor.** The thermal activity measured during Trial Ib (Wedge & No Soap) is compared with that measured during Trial IIb (Splashplate & Soap).

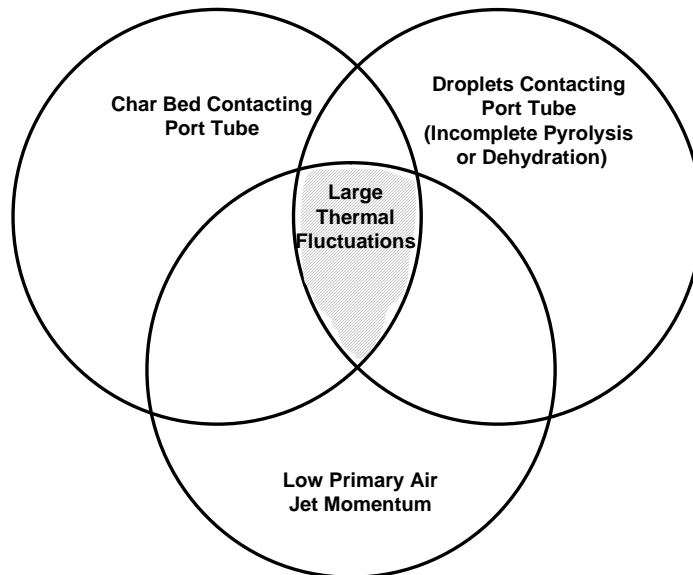
**Fig. 81. The three critical conditions required for the large thermal fluctuations associated with primary air port cracking: simultaneous char bed contacting the port tubes, a high flux of droplets contacting the port tube while pyrolysis and possibly dehydration is incomplete, and low primary air jet momentum.**

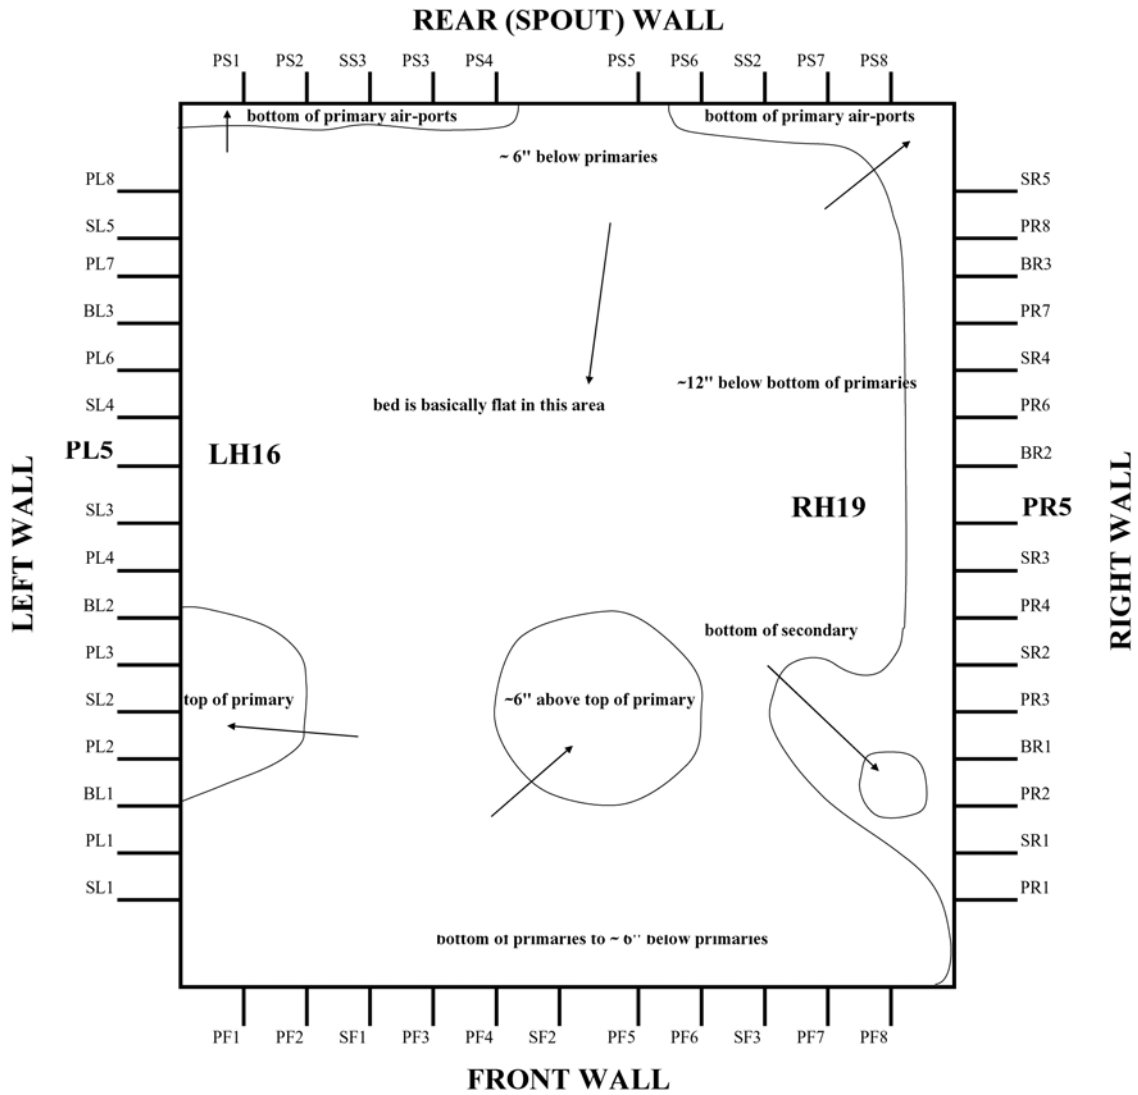
**Fig. 82. Schematic contour map of char bed shape and height around the time of the verification experiments.** Note that the height of the char bed is at the bottom of the primary air ports on the right wall and is about 6 inches below the primary air ports on the left wall along the majority of the wall. Arrows indicate direction of increasing char bed height.

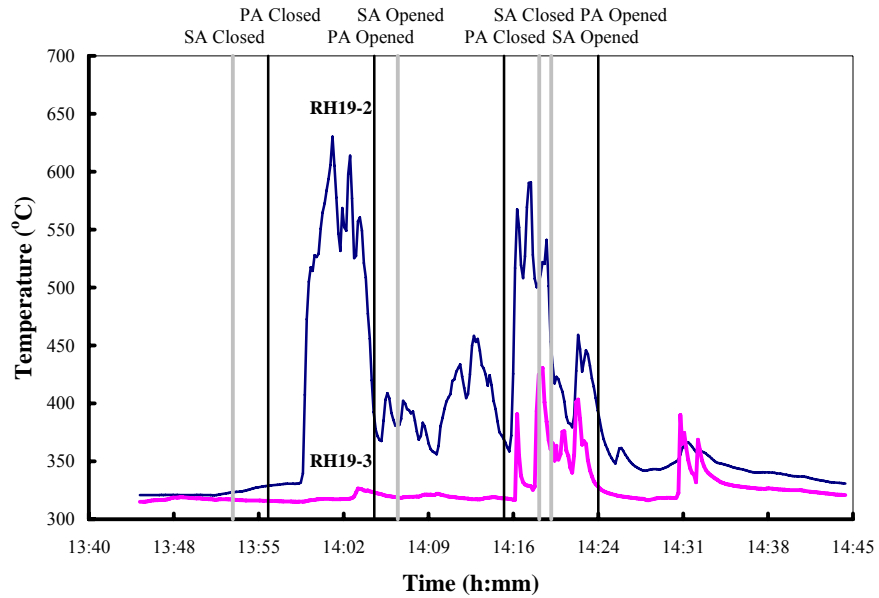
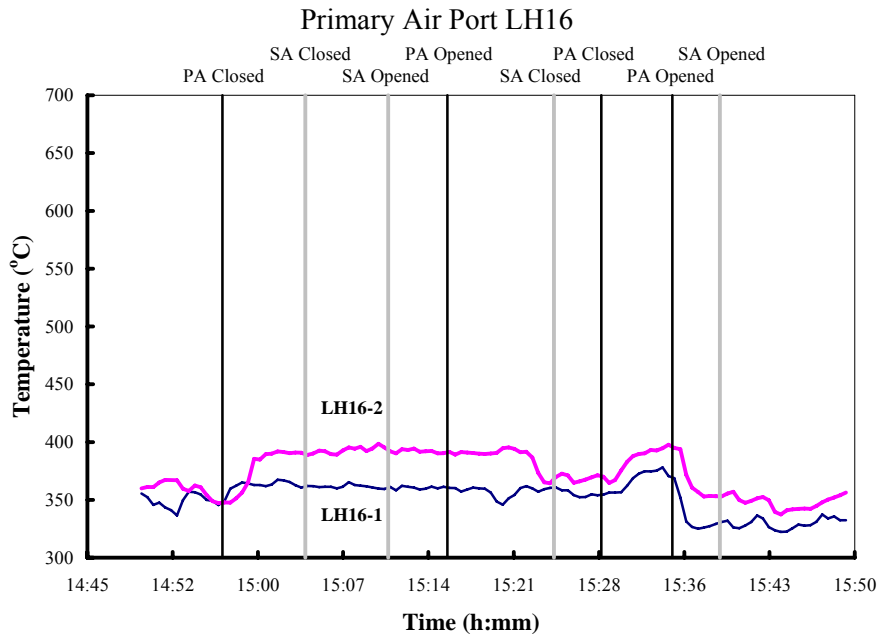
**Fig. 83. Plot of temperature transients recorded during the verification experiment.** Note the large temperature fluctuations observed for primary air port RH19 when all three critical conditions were met simultaneously. Also note the absence of large thermal temperature fluctuations for port LH16 when only two of the three critical conditions were met simultaneously (the condition of a high char bed contacting the primary air port was missing).

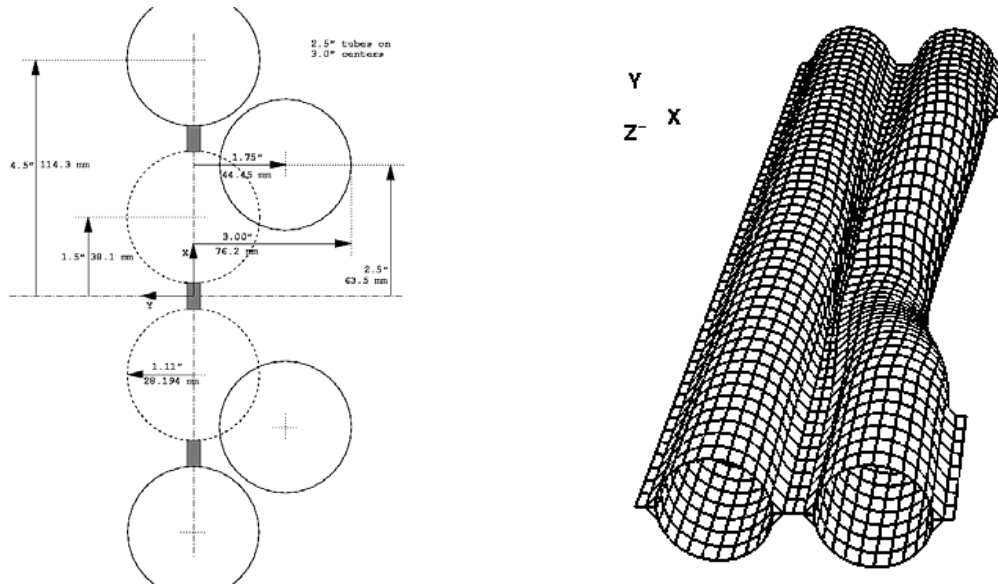
**Fig. 84.** Schematic representation based on measurements (left) was used to generate a finite element mesh for one side of the primary air port (right).

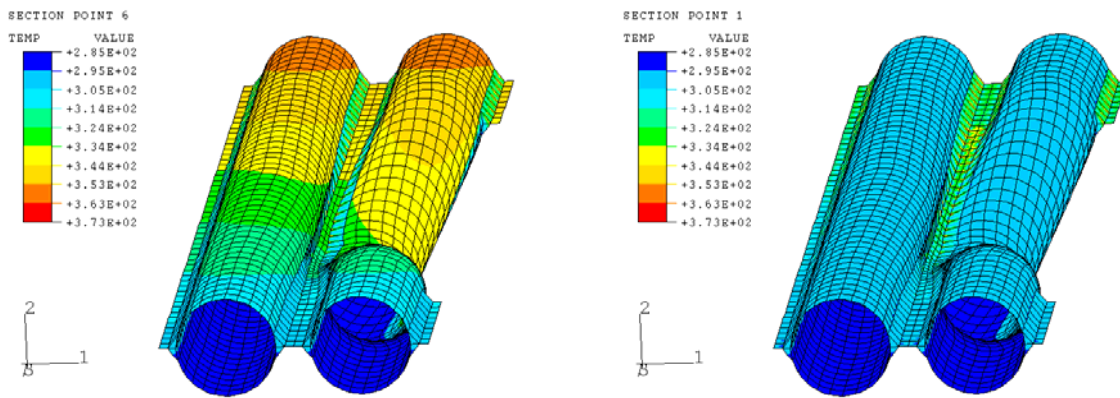
**Fig. 85.** Temperature [°C] contours on the outside (left) and inside (right) surface of the primary air port composite tubes under normal operating conditions.

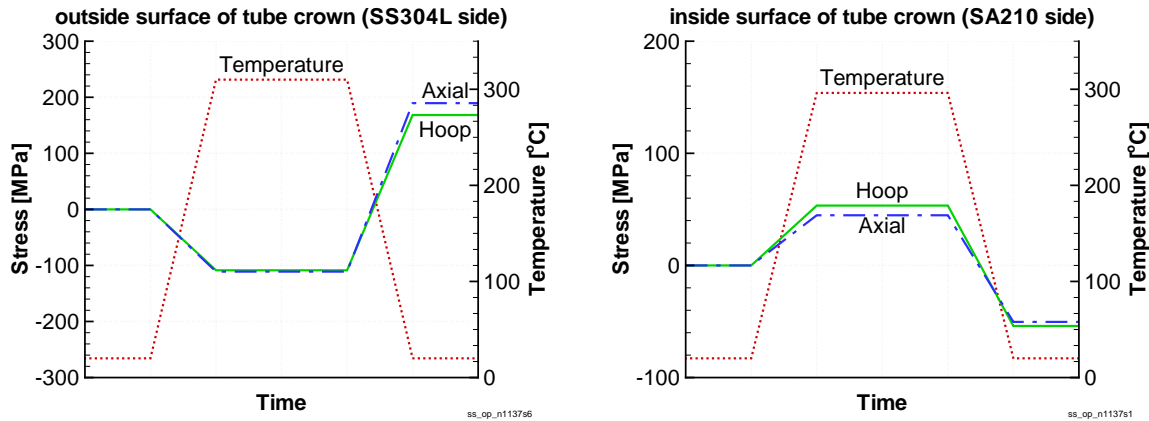
**Fig. 86. Variation of hoop and axial stresses during a normal operating cycle at the fireside surface (left) and at the inside surface (right), of a primary air port composite tube.**

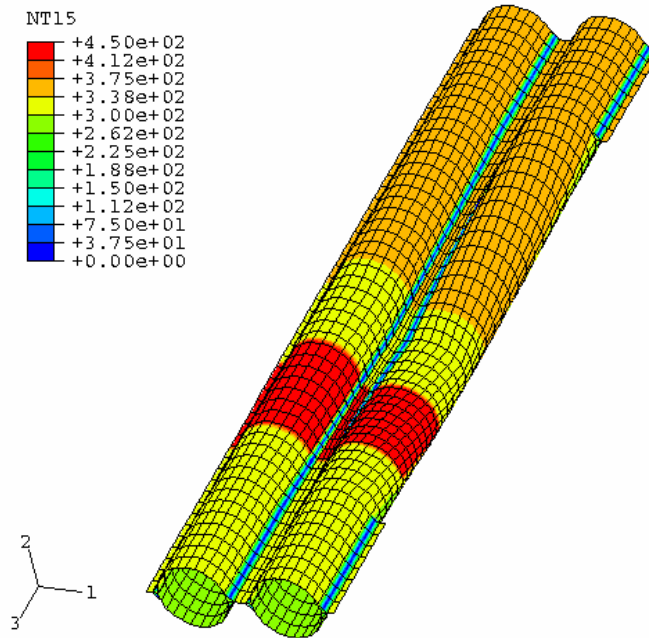
**Fig. 87. Temperature [°C] contours at the fireside surface of primary air port during localized heating.**

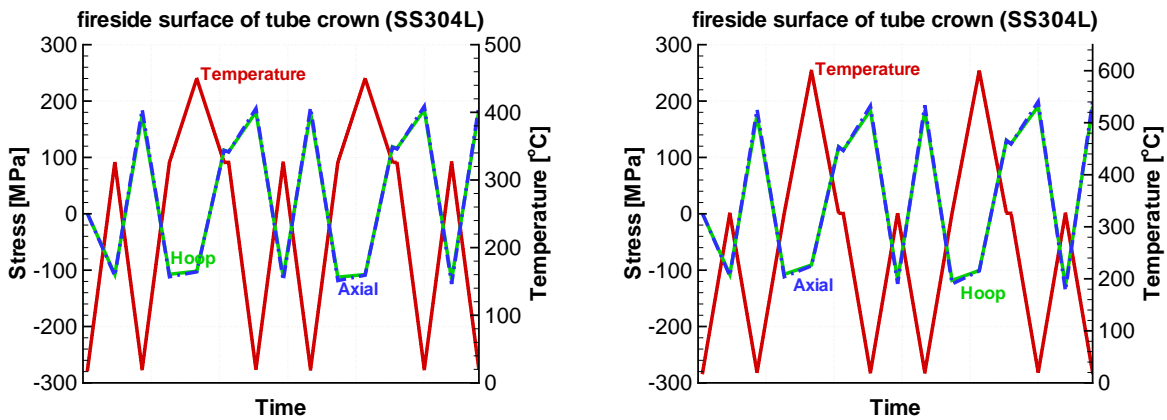
**Fig. 88. Stress variation at the fireside surface of the 304L clad composite tube during normal operating cycle and during localized heating to 450°C (left) and 600°C (right).**

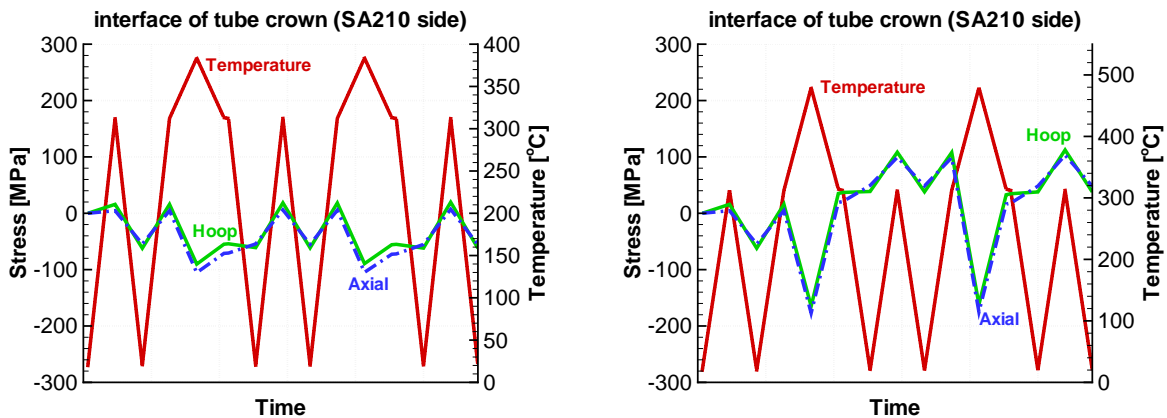
**Fig. 89. Stress variation at the interface on the carbon steel side of the 304L clad composite tube during normal operating cycle and during localized heating to 450°C (left) and 600°C (right).**

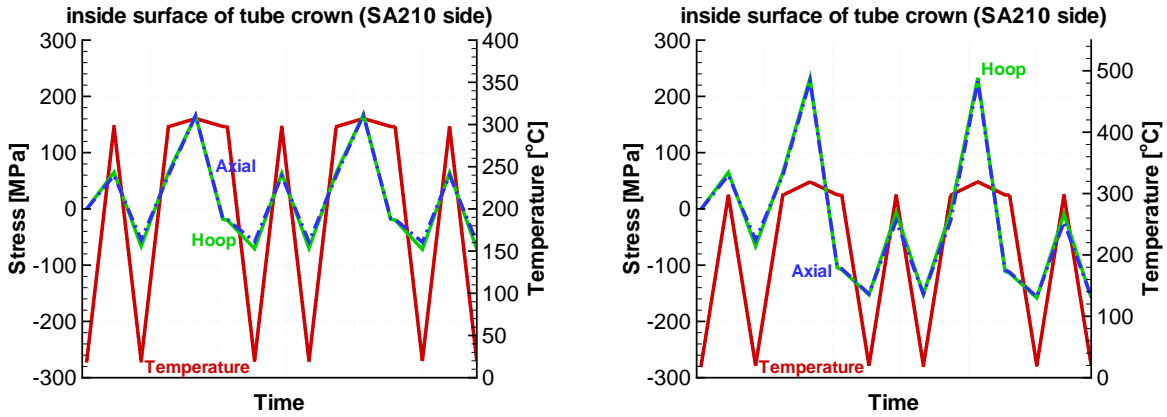
**Fig. 90.** Stress variation at the inside surface of the 304L clad composite tube during normal operating cycle and during localized heating to 450°C (left) and 600°C (right).

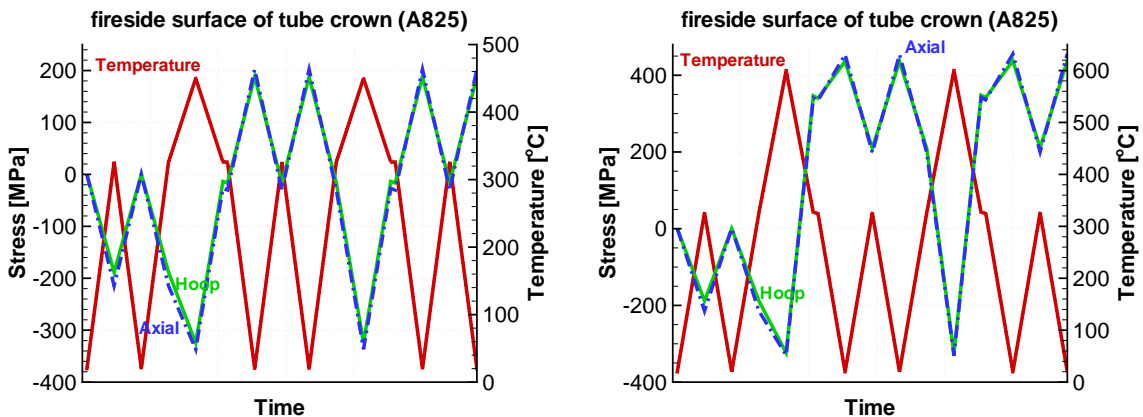
**Fig. 91.** Stress variation at the fireside surface of the alloy 825 clad composite tube during normal operating cycle and during localized heating to 450°C (left) and 600°C (right).

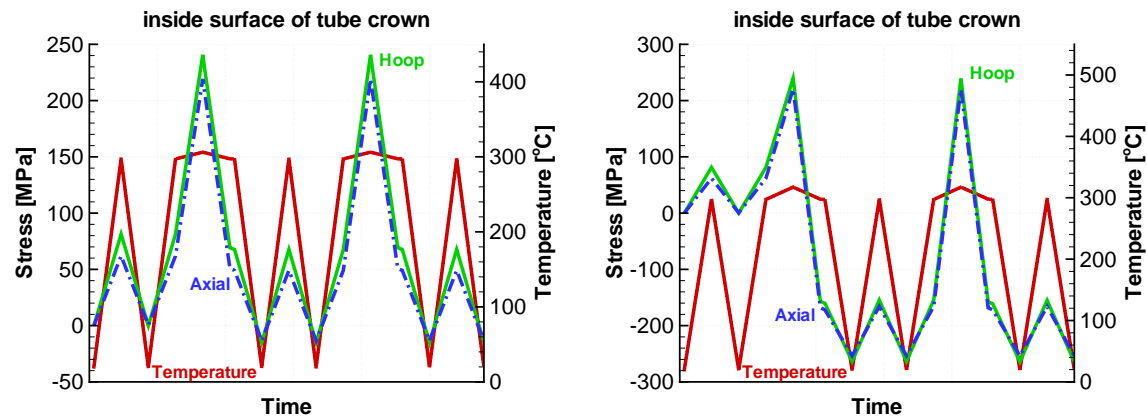
Fig. 93. Stress variation at the inside surface of the alloy 825 clad composite tube during normal operating cycle and during localized heating to 450°C (left) and 600°C (right).

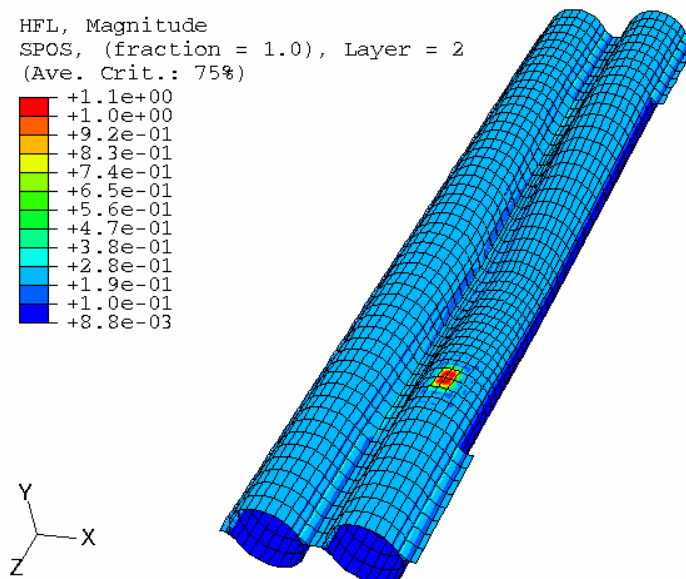
**Fig. 94. Heat flux [ $\text{W}/\text{mm}^2$ ] contours on the outside surface of primary air port showing region of increased heat flux on the lower portion of the bent tube.**

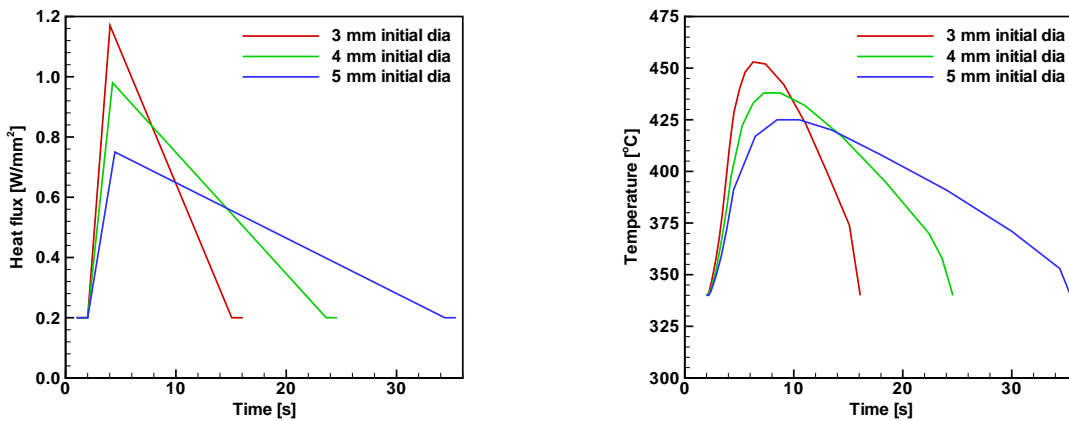
**Fig. 95. Variation of heat flux (left) and corresponding temperature (right) during localized heating due to combustion of black liquor droplets on the primary air port tube surface.**

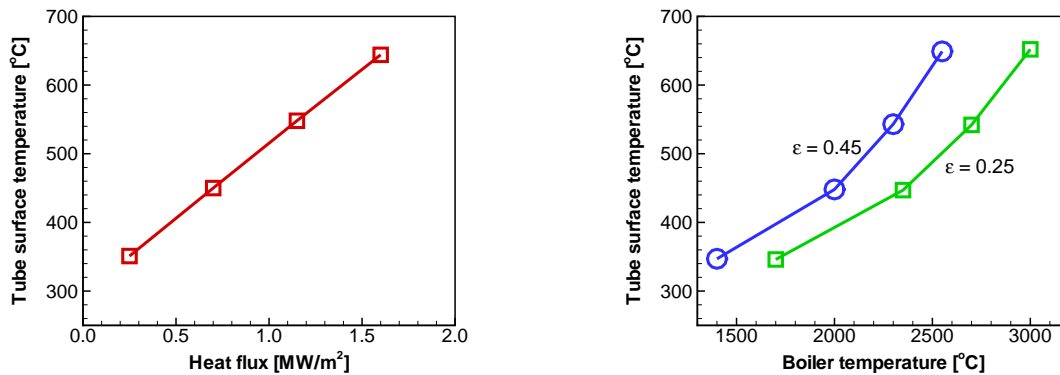
**Fig. 97. Change in temperature at the fireside surface of primary air port tubes due to increase in heat flux (left) and due to increase in the boiler temperature (right).**

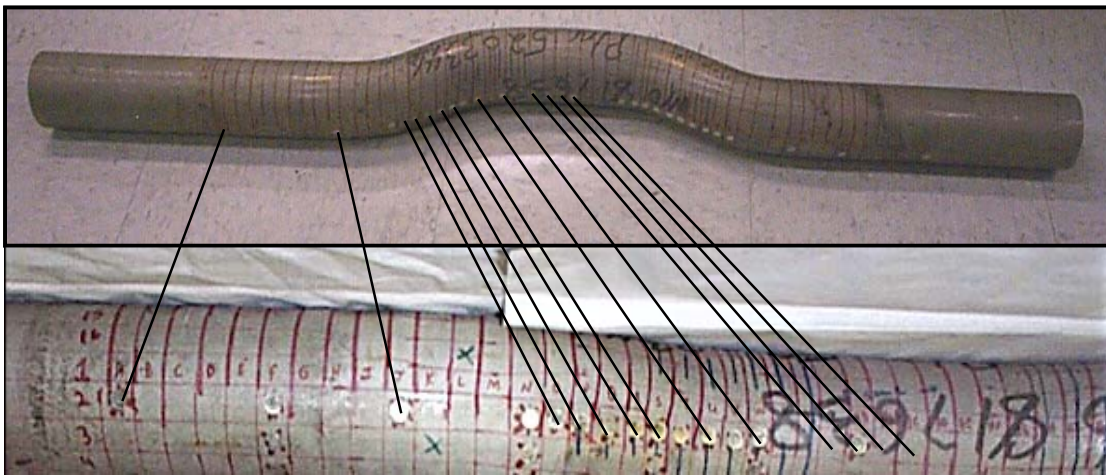
**Fig. 98. Photo of a 304L stainless steel clad tube bent in the shape required for the most common air port design used in North American boilers.** The shiny circles are the electropolished areas where X-ray diffraction residual stress measurements were made.

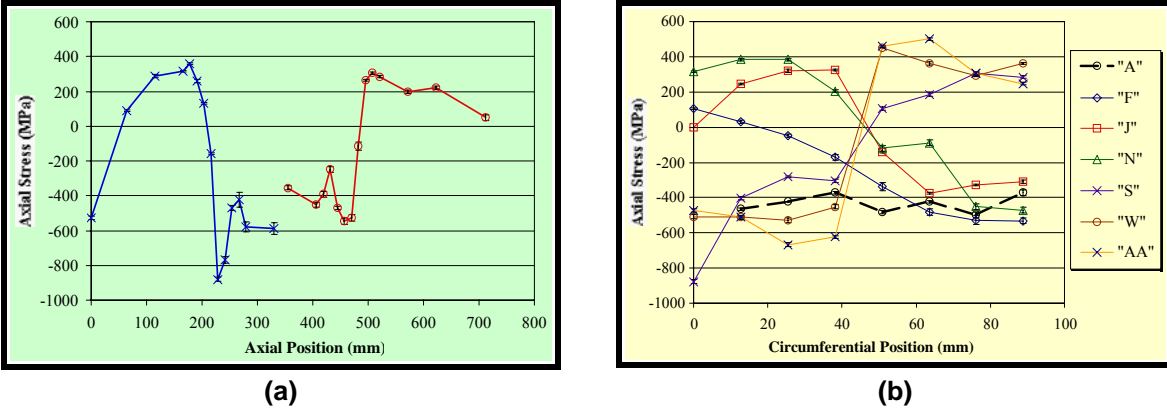
**Fig. 99. Surface residual axial stresses measured (a) at selected locations along the tube and (b) at selected locations around the circumference of the tube.**

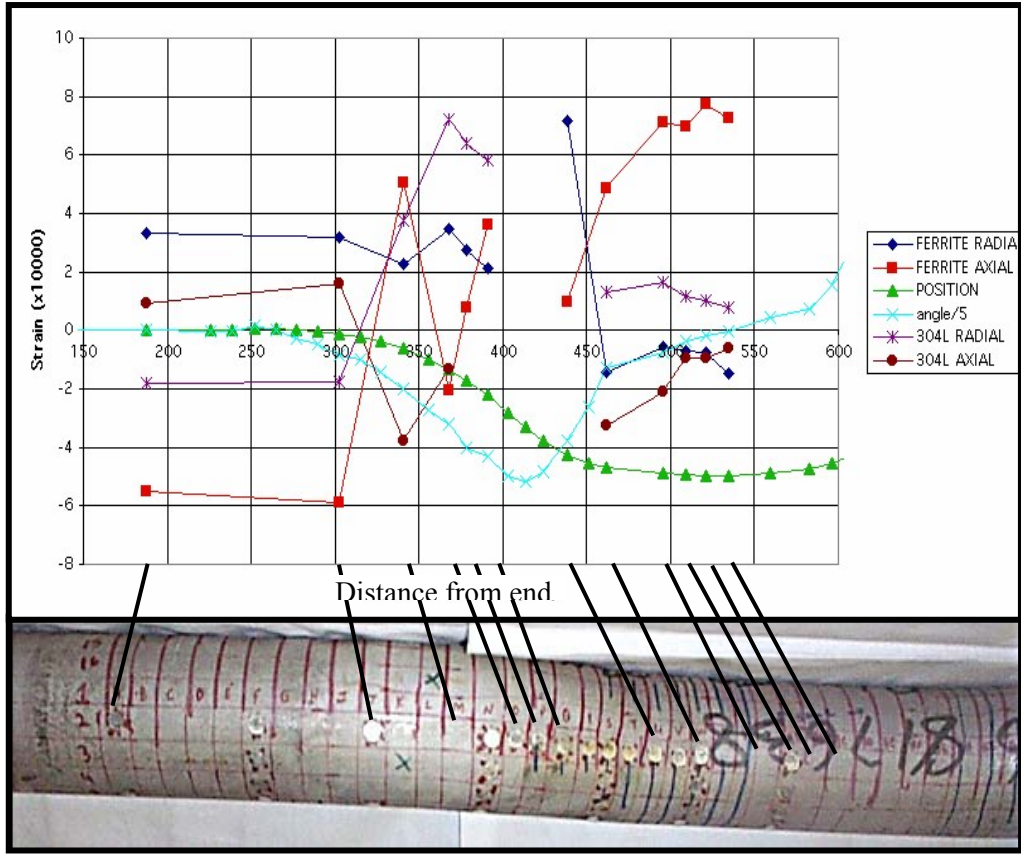
**Fig. 100. Results of neutron diffraction residual stress measurements showing stresses in both the 304L stainless steel and the carbon steel (ferrite) as a function of position along the tube.**

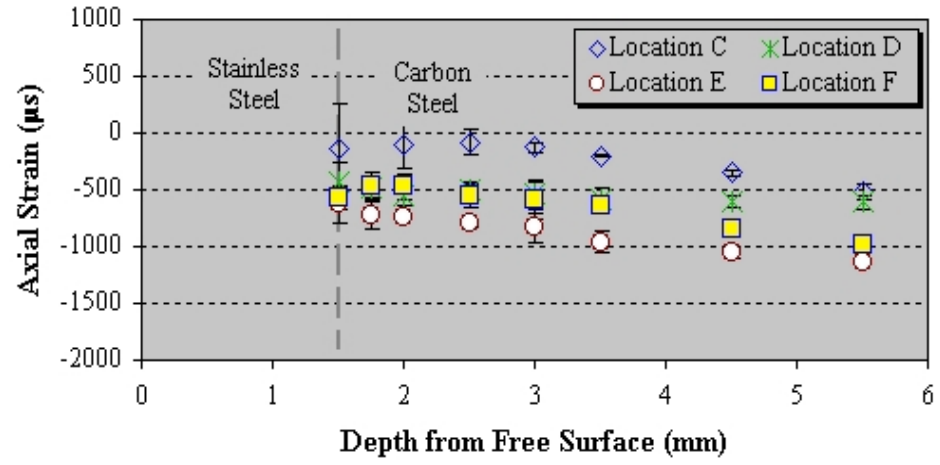
**Fig. 101. Axial strain measured at several points through the wall thickness of a previously exposed 304L stainless steel/carbon steel tube. The locations shown are near the bottom of the air port and the strains are near neutral near the interface. The strains measured at the top of the air port were more compressive.**

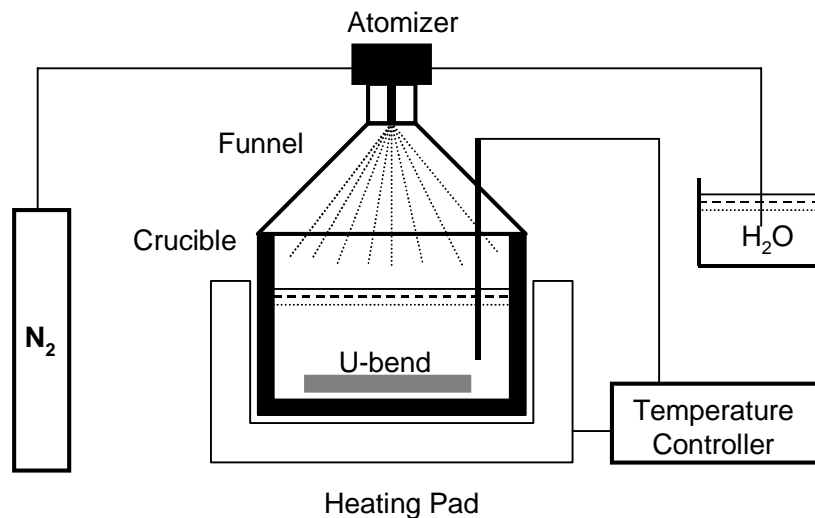
Fig. 102. Schematic drawing of U-bend SCC testing apparatus.

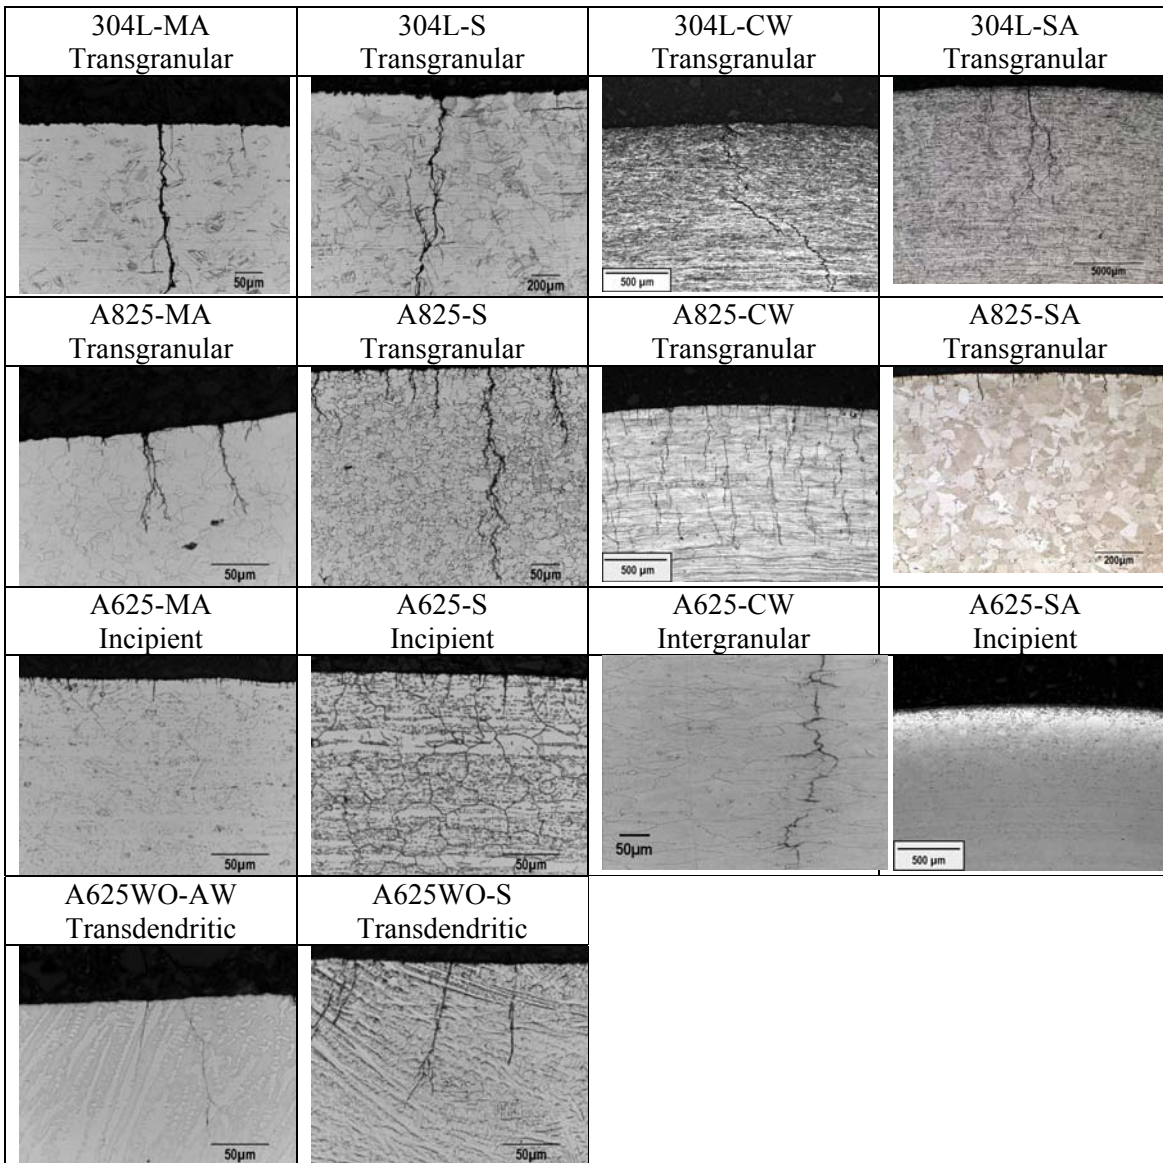
**Fig. 104. Micrographs showing nature of cracking found in U-bends after exposure to 75%/25% Na<sub>2</sub>S/NaOH molten hydrate mixture at 180°C for 48 hours.**

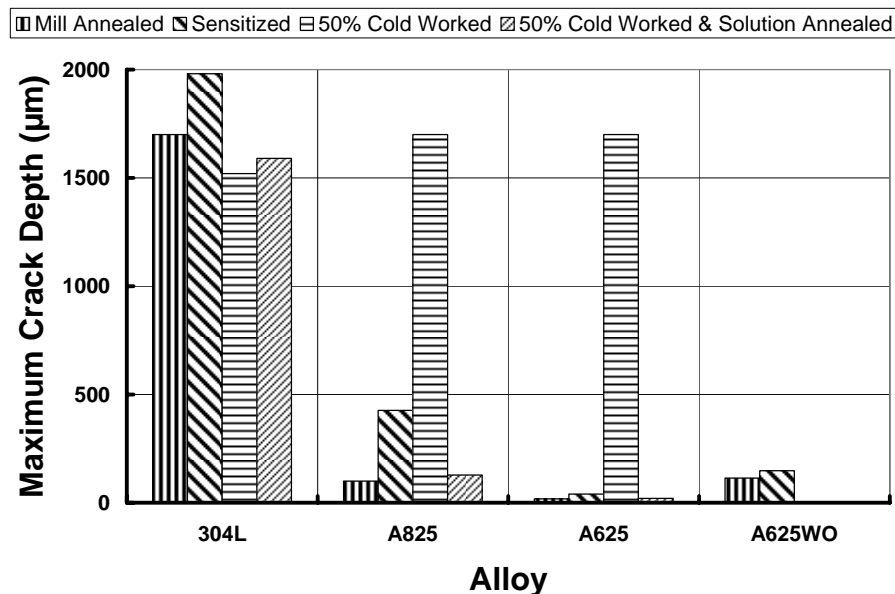
**Fig. 105. Bar chart comparing influence of metallurgical condition on the maximum crack depth recorded in U-bends after exposure in to 75%/25% Na<sub>2</sub>S/NaOH molten hydrate mixture at 180°C for 48 hours.**
