# Cracking and Corrosion of Composite Tubes in Black Liquor Recovery Boiler Primary Air Ports

October 2006

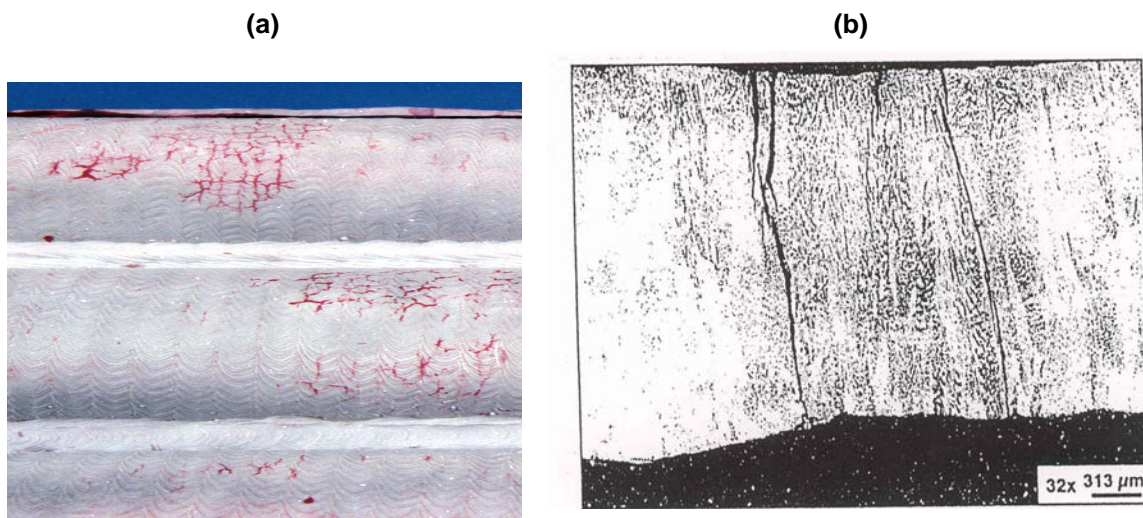
**Fig. 106. Cracks formed in weld-overlaid UNI309/CS composite floor tubes installed in Boiler 18 after 24 months of exposure.** (a) Crack indications as revealed by liquid dye penetrant inspection of the tube surface. (b) Micrograph of polished cross-section showing cracks, which have propagated through the weld overly and terminated at the carbon steel interface.

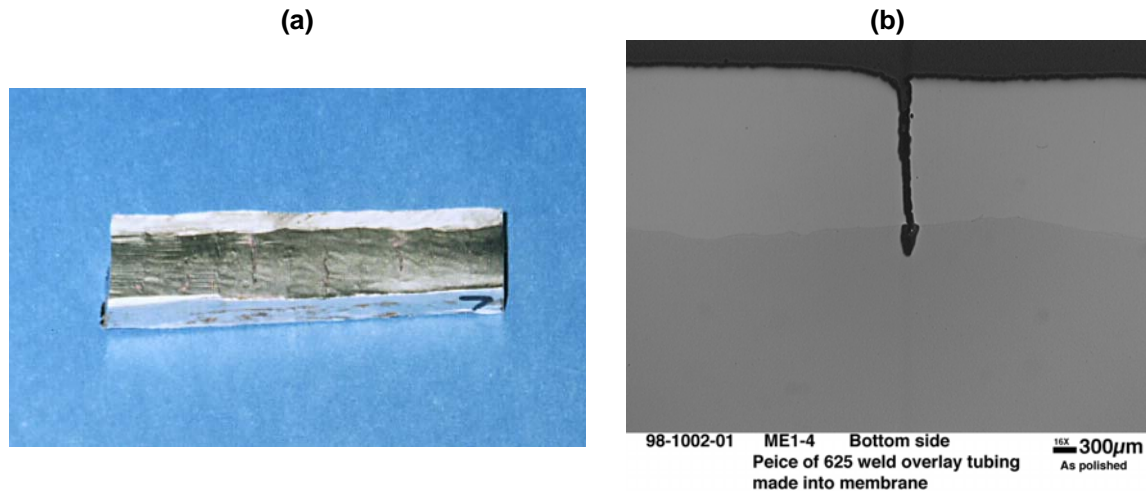
**Fig. 107. Cracks in weld-overlaid UNI625/CS composite floor membrane installed in Boiler 11 after 12 months exposure.** (a) Crack indications as revealed by liquid dye penetrant inspection of the membrane surface. (b) Micrograph of polished cross-sections showing a crack, which has propagated through the weld overlay and formed a corrosion “pit” at the crack tip in the carbon steel substrate.

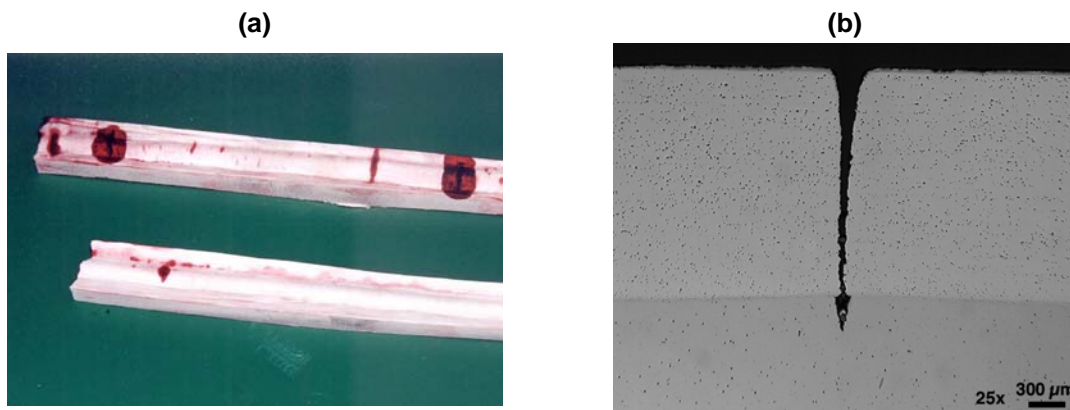
**Fig. 108. Cracks in co-extruded SAN65/CS composite floor membrane installed in Boiler 11 after 12 months exposure.** (a) Crack indications as revealed by liquid dye penetrant inspection of the membrane surface. (b) Micrograph of polished cross-sections showing a crack, which has propagated through the cladding and formed a corrosion “pit” at the crack tip in the carbon steel substrate.

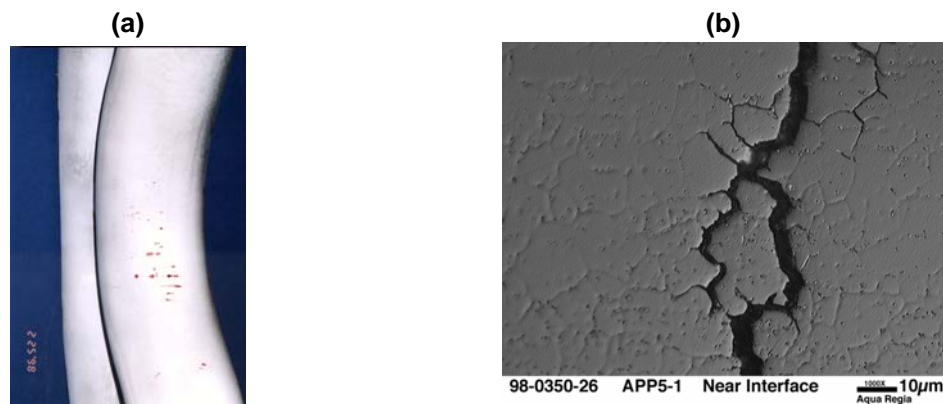
**Fig. 109. Cracks in co-extruded A625/CS composite tube installed in a spout opening after 48 months of exposure in Boiler 3.** (a) Crack indications as revealed by liquid dye penetrant inspection of the tube surface. (b) Micrograph of polished cross section showing a crack and its intergranular propagation mode. Examination of carbon steel microstructure reveals evidence of overheating.

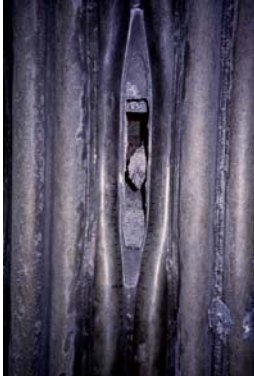
(D) B&W Membrane, 3" on 4," Fitted Casting	(E) B&W 3" on 4" Membrane, Fitted Casting	(F) Kvaerner (Götaverken) 2½" on 3" Membrane, Fitted Casting

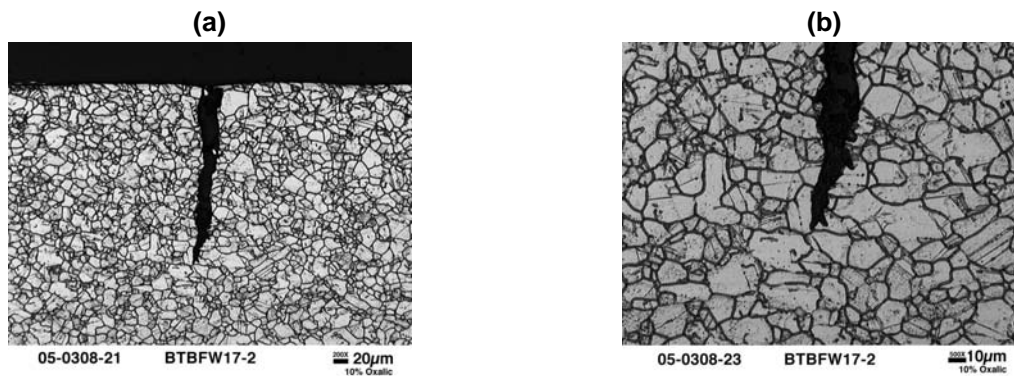
**Fig. 111. Cracks in co-extruded SAN38/CS composite tube fabricated into primary air port installed in Boiler 1 after 42 months of service. (a) Micrograph of etched cross section showing crack indication found in SAN38 exterior layer. (b) Micrograph showing ditched structure, surrounding the crack tip, typically associated with sensitization.**

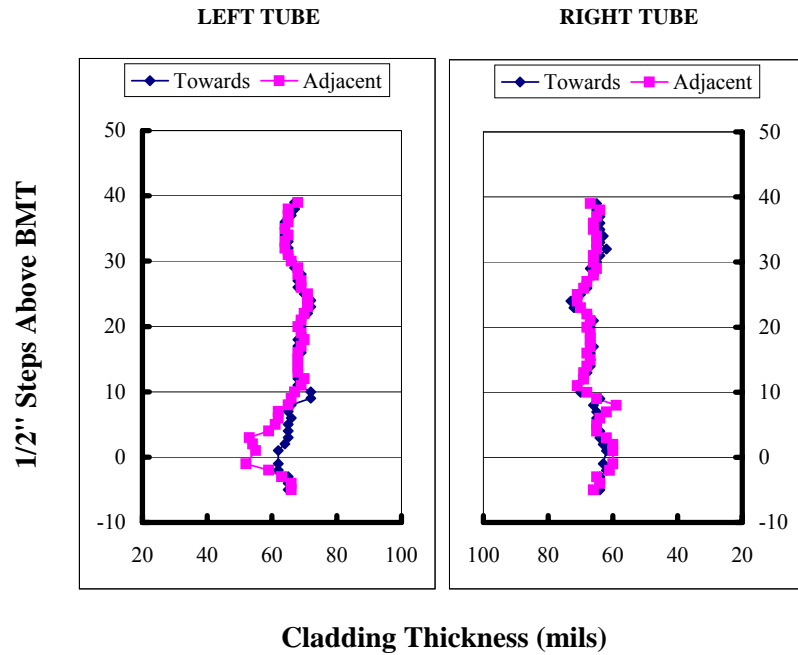
**Fig. 112. Cladding thickness of SAN38/CS composite tubes fabricated into Port B installed in Boiler 10 after 12 months of service. (BMT = bottom membrane termination, adjacent and towards = measurements made adjacent to membrane/casting, and towards fireside crown, respectively) (1 mils = 0.001 in = 0.0254 mm).**

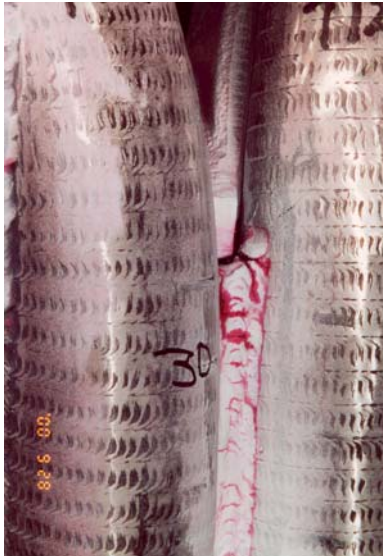
**Fig. 113. Photograph showing membrane-type cracking in primary air port comprised of weld-overlaid UNI625/CS composite opening tubes installed in Boiler 8 after 12 months of service.**

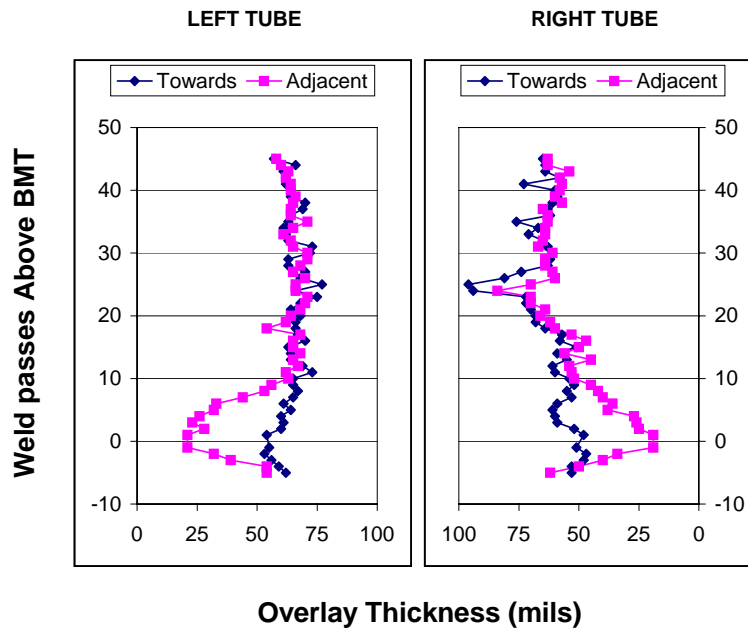
**Fig. 114. Overlay thickness of UNI625/CS composite tubes fabricated into Port B installed in Boiler 10 after one year service.** (BMT = bottom membrane termination, adjacent and towards = measurements made adjacent to membrane/casting, and towards fireside crown, respectively) (1 mils = 0.001 in = 0.0254 mm).

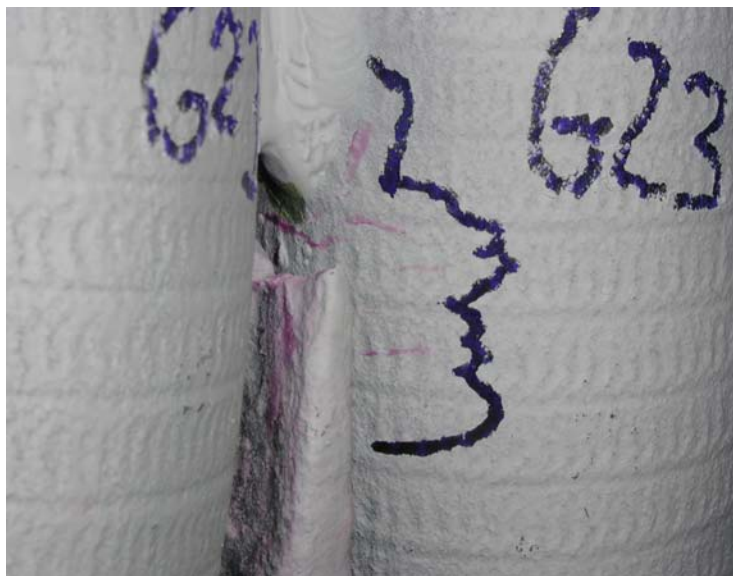
**Fig. 115. Photograph showing tube and membrane cracks in upper crotch of a primary air port (Port B) comprised of GBEST/CS composite tubes installed in Boiler 10 after 36 months service.**

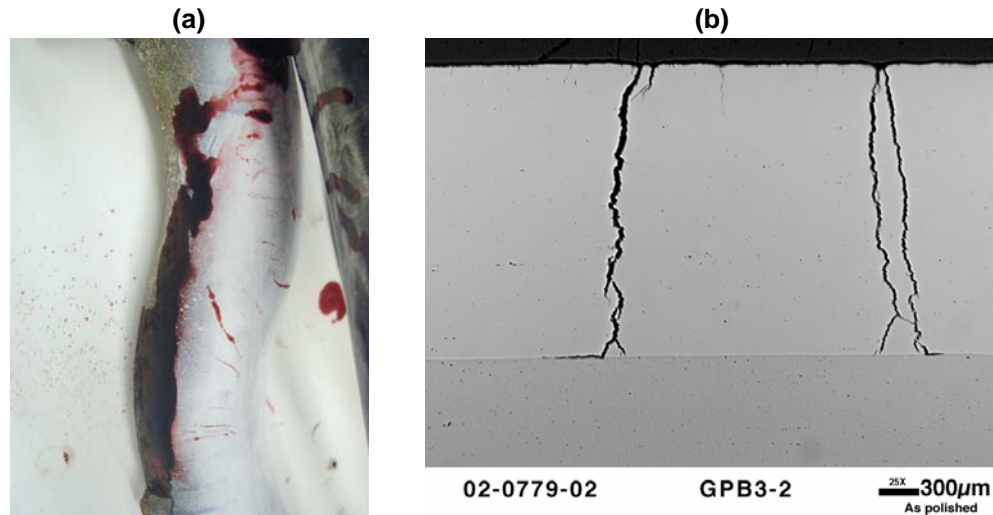
**Fig. 116. Cracks found in SAN63/CS composite tubes fabricated into Port H installed in Boiler 20 after 12 months of service.** (a) Crack indications as revealed by liquid dye penetrant inspection of the tube surface. (b) Micrograph of polished cross-section showing cracks, which have propagated through cladding, by an intergranular mode, and have either terminated at the carbon steel interface or continued to propagate along the interface.

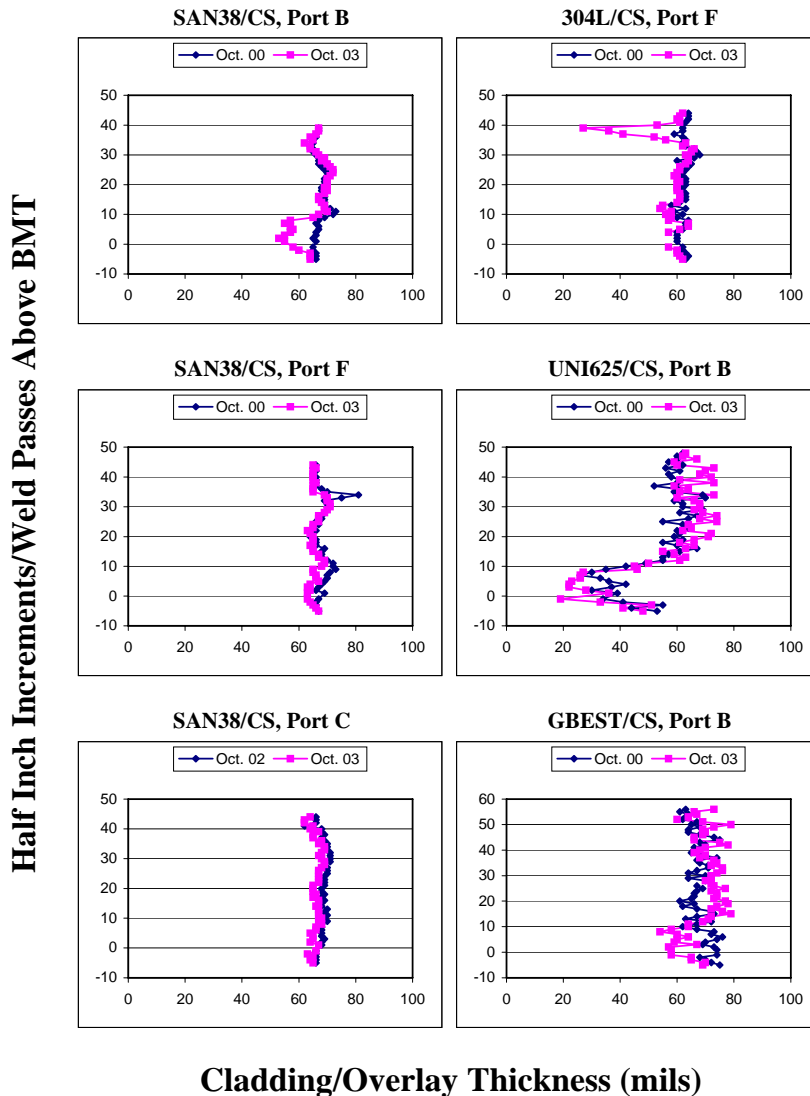
**Fig. 117. Cladding/Overlay thickness of “worse case” port tube from test panels installed in Boiler A.** (BMT = bottom membrane termination, adjacent and towards = measurements made adjacent to membrane/casting, and towards fireside crown, respectively) (1 mils = 0.001 in = 0.0254 mm).
