Comparison of two checklist methods for assessment of coastal dune vulnerability

M. M. Laranjeira¹, A. Ramos Pereira¹ and A. T. Williams²

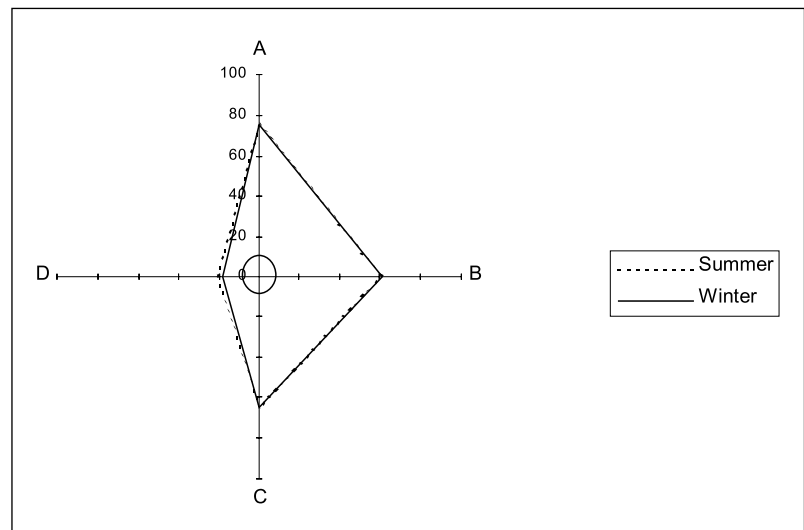
Figure 2. Graphic representation of CHK1-Areão. (A): site and dune morphology; (B): beach condition; (C): surface character of the seaward 200 m of the dune; (D): pressure of use; (Circle): recent protection measures

At Areão (figure 1), both beach and foredune sediment budgets are negative. The foredune's seaward face was recently cliffed by the sea and there are numerous natural breaches. Despite the fact that visitor pressure is low, degradation is already observable, related to a poorly managed path network. Large (2-6 m) and incised paths (> 1 m) are particularly active deflation corridors (anthropogenic breaches) and associated sand drifts are very characteristic.

CHK 1 showed that dune management intensity is very low (9.1 %) in response to a low level of pressure. However, this response must be regarded as not very effective within the context of the degree of vulnerability which the checklist identified for other parameters (figure 2). The very high VI/PM ratios of 5.6 (26 July 1996) and 5.4 (22 February 1997) indicates how this site is clearly undermanaged.

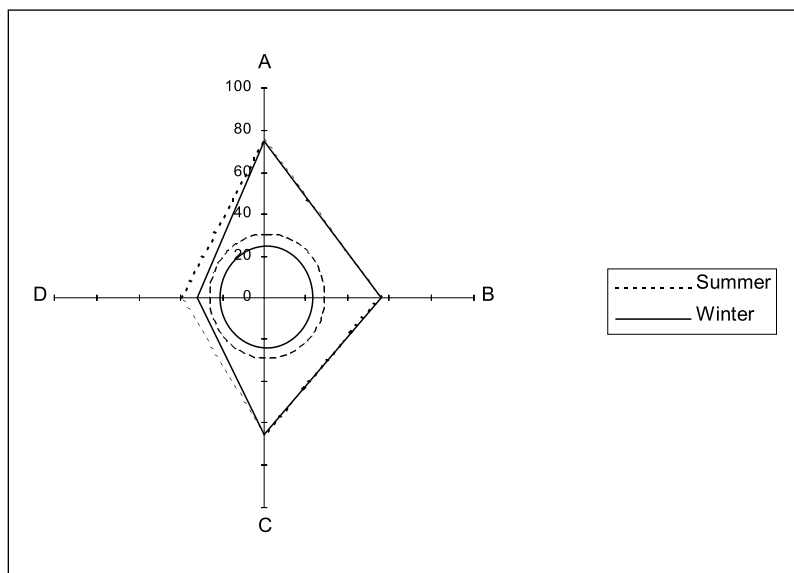
Figure 3. Graphic representation of CHK1-Poço da Cruz. (A): site and dune morphology; (B): beach condition; (C): surface character of the seaward 200 m of the dune; (D): pressure of use; (Circle): recent protection measures

At Poço da Cruz, both beach and foredune sediment budgets are negative. The foredune's seaward face is characterised by numerous incipient blowouts, some associated with the main beach-access paths. This is a rural beach, with incipient development. Although visitor pressure is still relatively low, degradation signs are already visible, related to an unmanaged path network, which is deeply incised (> 2 m) and highly dispersed (figure 1). Sand drifts characterise the foredune ridge's inland face, where paths have opened breaches. Sand traps (fences) have been installed in the main blowouts.

CHK 1 showed a slight difference between winter and summer human pressure and a poor balance between vulnerability and protection measures (figure 3). The VI/PM ratios of 2.0 (26 July 1996) and 2.3 (22 February 1997) indicated a negative disequilibrium.

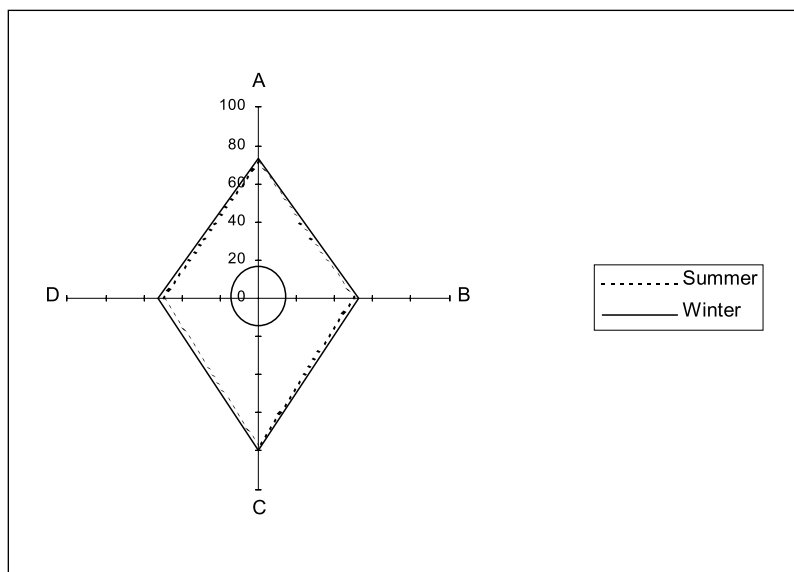
Figure 4. Graphic representation of CHK1-north Mira beach. (A): site and dune morphology; (B): beach condition; (C): surface character of the seaward 200 m of the dune; (D): pressure of use; (Circle): recent protection measures

North Mira Beach is a site where activities related to the traditional fishery still remain. Warehouses were built on the foredune ridge, and access paths opened to facilitate boat passage, leading to partial destruction of the system. As a result, sand blown inland from the system is invading the adjacent urban area (figure 1). Sand traps were recently installed to partially reconstruct a dune form, but their effectiveness has been low.

CHK 1 showed the importance of permanent human pressure (50 %), and that better beach con-

ditions existed than at Areão and Poço da Cruz (figure 4). The VI/PM ratio of 3.4 (26 July 1996 and 22 February 1997) indicated that this is clearly an undermanaged site.

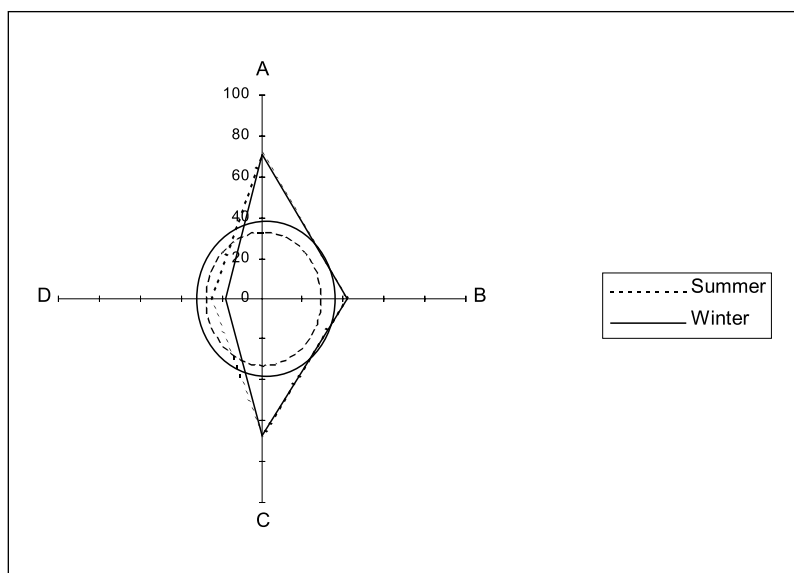
Figure 5. Graphic representation of CHK1-south Mira beach. (A): site and dune morphology; (B): beach condition; (C): surface character of the seaward 200 m of the dune; (D): pressure of use; (Circle): recent protection measures

South Mira beach is a site of great interest with regard to seaside summer recreation. This is a sector contiguous to the urban Mira beach (figure 1), where the level of tourist accommodation is high. The beach sediment budget had, more or less, stabilised since construction of a downdrift jetty in the 1970s (figure 1). The foredune's seaward face is characterised by the presence of recent dunes. However, ineffective management of beach access through the foredune ridge (distance between paths of 50 m, no walkways constructed) has produced numerous bare sand areas (sand drifts associated with the path network), which are already invading the inland brushwood. Therefore, the foredune sediment budget is negative. Windbreaks were recently installed at the foredune's seaward face, for sand trapping and to restrict access.

CHK 1 showed a better balance between vulnerability and managed response (figure 5). This is, apparently, a site where the dune system is in equilibrium, as indicated by the VI/PM ratios of 1.3 (26 July 1996) and 1.2 (22 February 1997). However, the dune protection measures are only evaluated and scored in terms of their presence or absence in the system, not in terms of effectiveness, therefore leading, as in this case, to an overestimation of the PM index.

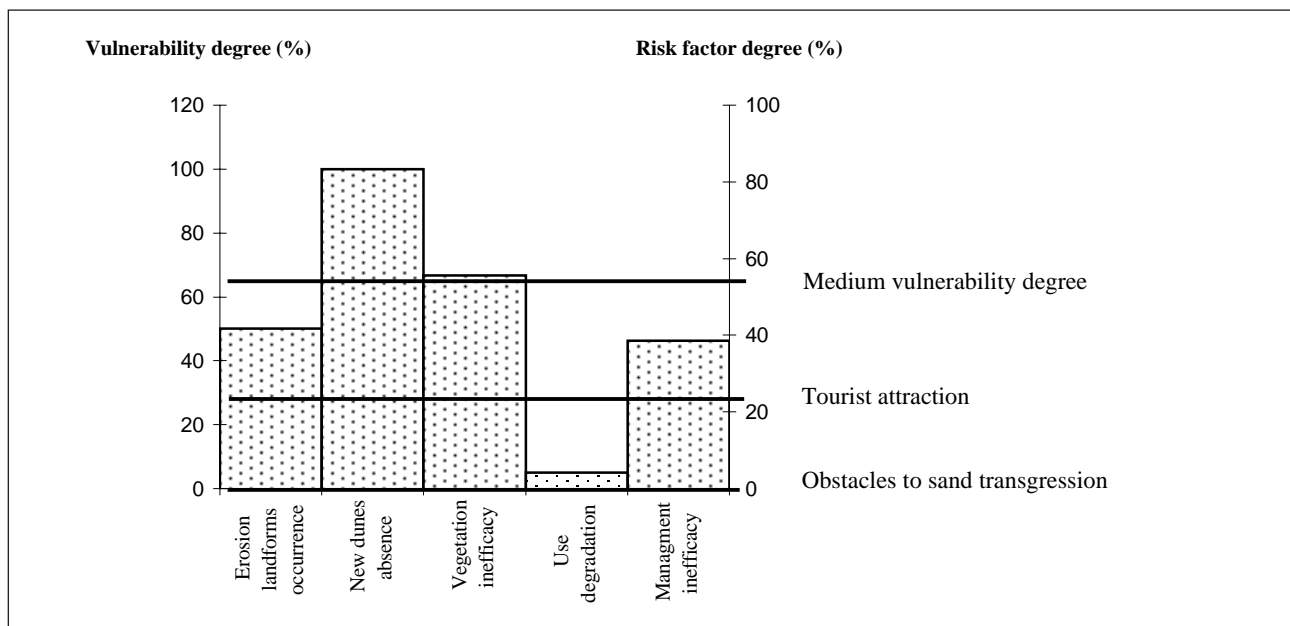
Figure 6. Graphic representation of CHK2-Areão

CHK 2 showed not only the importance of dune management inefficiency (46.2 %) to the medium degree category of vulnerability, but also that such a degree of vulnerability was mainly due to a highly negative sediment budget and poor sand retention by foredune vegetation (figure 6). CHK 2 also showed that properly managed and sign-posted paths and specific dune rehabilitation measures are needed if an increased number of visitors are to

be expected. Although relatively vulnerable, the system at Areão is not at risk, since there are not any obstacles to dune transgression and its tourist attraction is still low (figure 6).

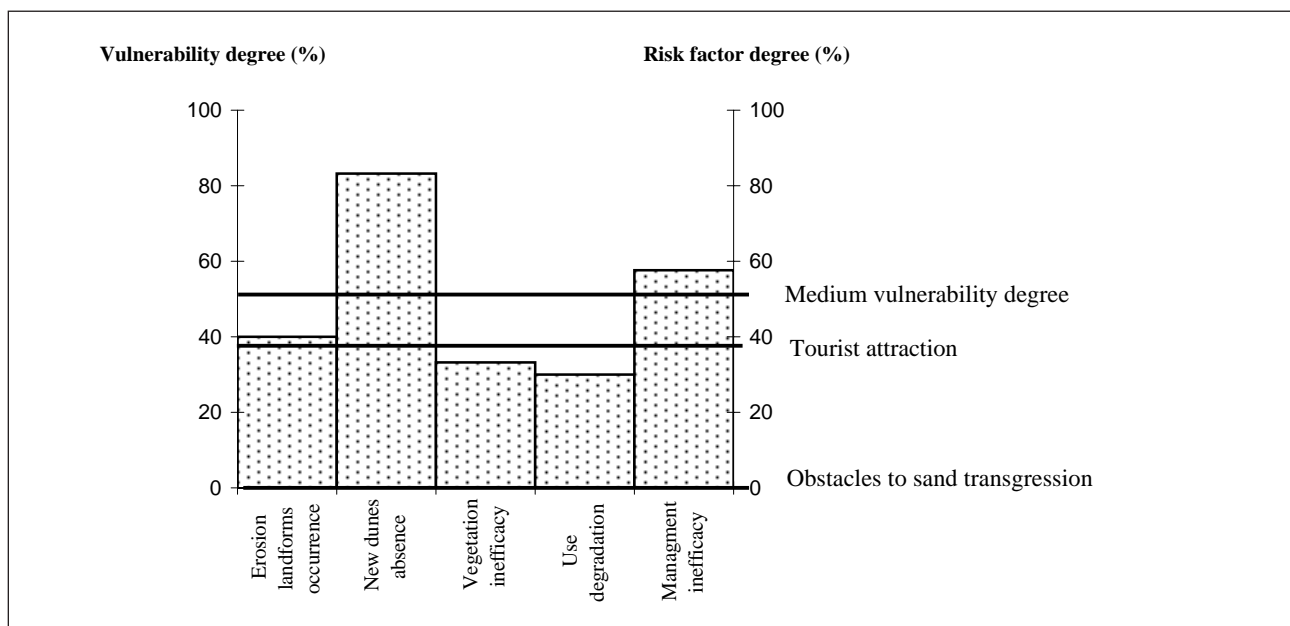
Figure 7. Graphic representation of CHK2-Poço da Cruz

CHK 2 showed a negative sand supply (83.3 %) together with very low management response (57.7 %) as determinants of dunes' medium degree of vulnerability. Poço da Cruz can be regarded as an under-managed site, but still not at risk (figure 7). CHK 2 has also stressed that properly managed and sign-posted paths, extensive fencing, vegetation planting and access restriction are needed if increasing numbers of visitors are to be promoted.

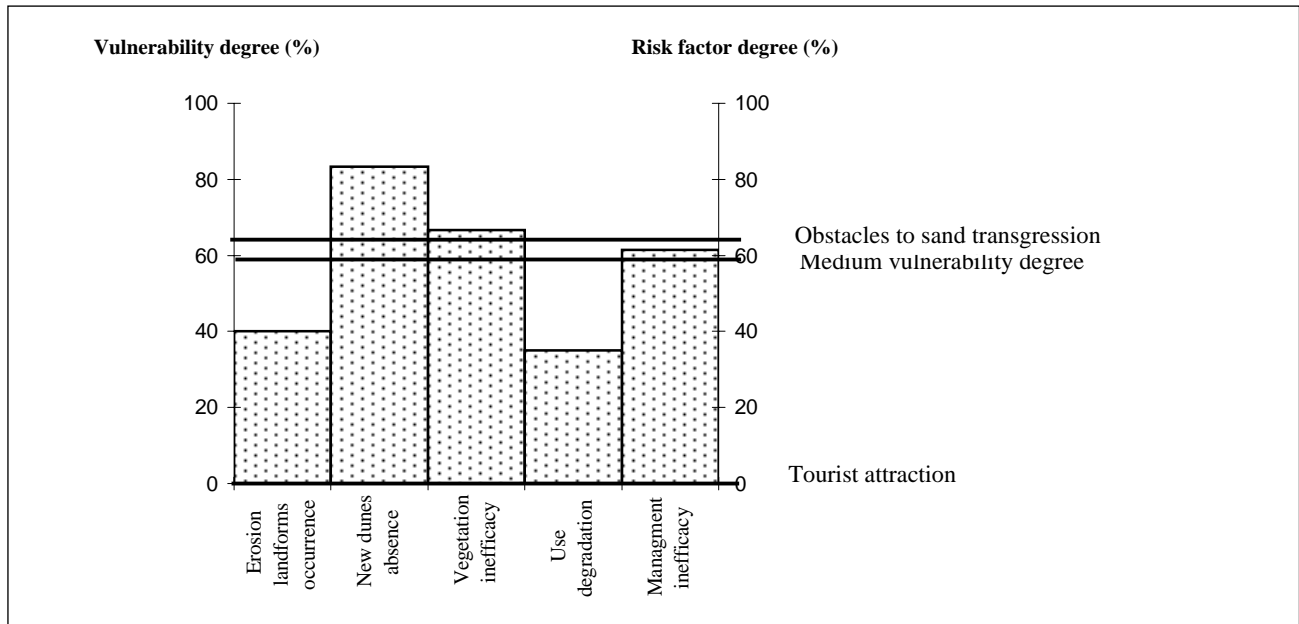
Figure 8. Graphic representation of CHK2-north Mira beach

CHK 2 highlighted the system's degradation, as all vulnerability components presented relatively high values (figure 8). Furthermore, CHK 2 showed the existence of obstacles to sand transgression (62.5 %), due to the presence of the urban concentrated area located inland from the system (figure 1). This leads to a risk situation (figure 8), because during the winter sand invades streets and houses. CHK 2 also highlighted the need to combine existing sand traps with vegetation planting, managed and sign-posted paths and access restriction if rehabilitation of the dune system is to be effective.

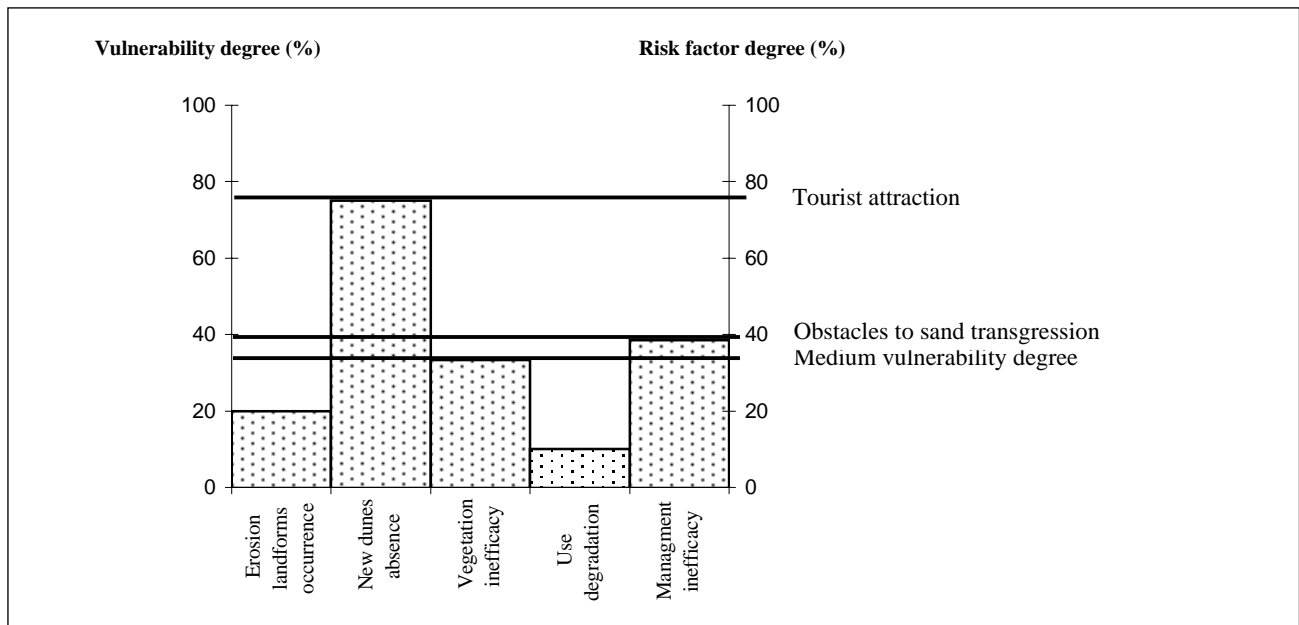
Figure 9. Graphic representation of CHK2-south Mira beach

CHK 2 showed that at south Mira beach, the dune system showed lower values of vulnerability, in spite of a somewhat deficient sand supply (75 %).

CHK 2 also showed the inefficiency of the management strategy and the poor conservation state of the foredune system (38.5 %), together with the ineffective sand retention by vegetation, as determinants of the system's medium degree of vulnerability (figure 9). Well managed and sign-posted paths and planting programmes are needed. Furthermore, CHK 2 suggested that the system is in a situation of potential risk (figure 9), since proximity of an urban concentrated area justifies a high level of tourist attraction (75 %) and the presence of camping and a somewhat important road may constitute significant obstacles to sand transgression (37.5 %).
