Experimental Wear Modelling of Lifeboat Slipway Launches B. Thomas, M. Hadfield, S. Austen.

Sustainable Product Engineering Research Centre, Bournemouth University, UK

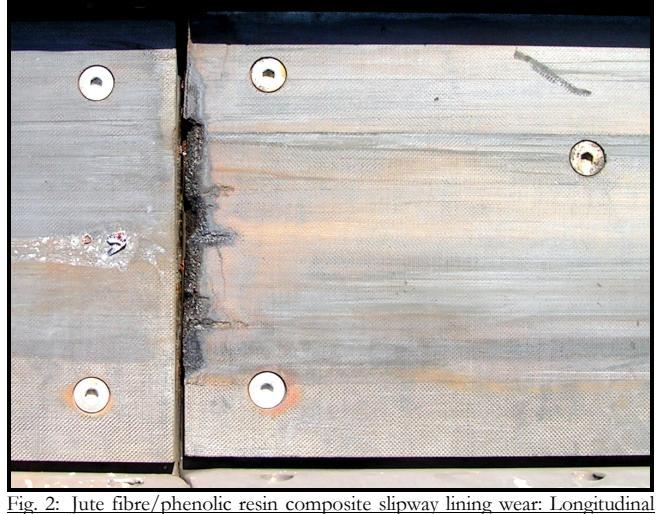
Fig. 2: Jute fibre/phenolic resin composite slipway lining wear: Longitudina panel edge wear

Longitudinal Panel Edge Wear:

It is observed that significant wear occurs in the area where the wear track passes over the panel end edge as shown in fig. ? below. It is theorised that this is likely to be due to the effects of geometric stress concentrations. To examine this the panels are modelled under normal loading using FEA techniques, the results indicate that the areas of increased stress correlate well with the wear in the real world slipway as shown below in fig. ?.

Of these wear regimes the dominant cause of slipway lining failure is the cracking and material loss at the end of each composite section. This can progress to the fixing bolts and can cause the slipway lining panel to separate from the keelway. Gouging wear from a raised section of the lifeboat keel, while removing a significant amount of material from the lining panels, has not been observed to cause sufficient damage to separate the panels from the keelway. Subsequent investigation has revealed that the keel of the initial test Tamar used on both the Tenby and Padstow slipway trials was damaged and this accounts for the similar gouging wear seen on both these slipways. Cracking at the edges of the composite panels is observed at the lower end of the slipway where the lifeboat keel can impact the lining under the action of waves. The edges of the lining panels do not bear any weight during normal launch and recovery. Delamination wear was observed only in a very few isolated areas where swelling through water absorbtion or misalignment had resulted in raised areas of lining which were under far higher pressure than intended. Because of the very few examples of delamination wear observed at limited damage in each case this is not considered to be a primary wear mechanism. Panel misalignment at areas of high wear was observed suggesting that this could be a major contributor to wear.

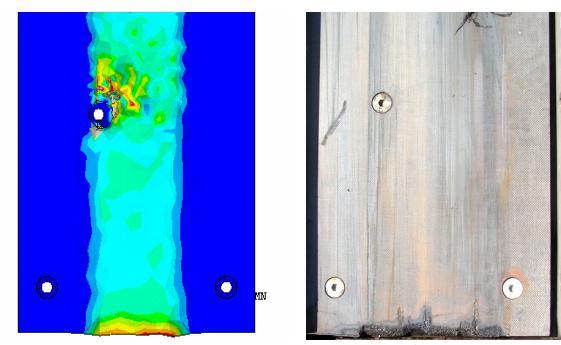
Fig. 3. FEA simulation vs. typical worn jute fibre/phenolic resin composite lining section from Tenby slipway

In future work it is intended to combine the wear coefficient results from the tribometer contact force tests with the FEA model in order to more accurately simulate the wear at these geometric concentrations.

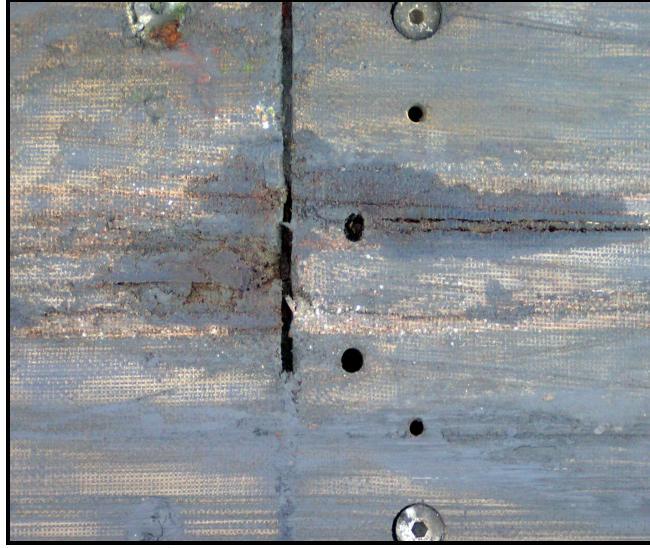
Fig. 4. Jute fibre/phenolic resin composite slipway lining wear regimes: Delamination wear

Panel Delamination Wear:

A few isolated incidents of panel delamination were observed. These tended to occur in areas where water absorbtion had led to swelling and the resulting panel misalignment and higher contact stresses.

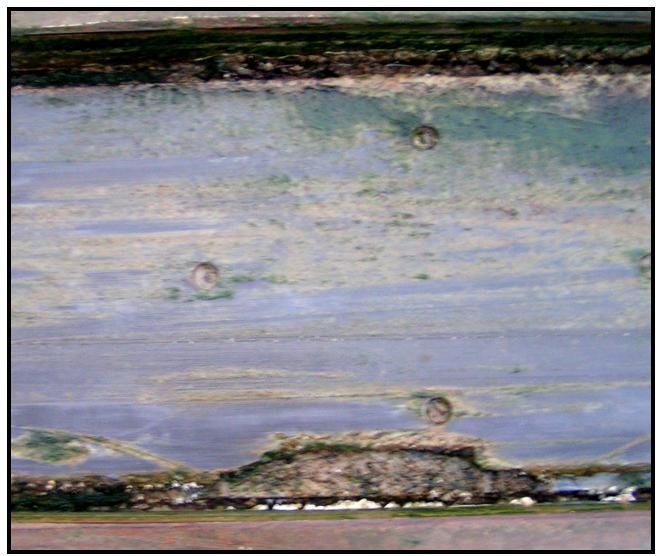
Fig. 5. Jute fibre/phenolic resin composite slipway lining wear regimes: Keel locating area panel side wear

Keel Locating Area Panel Side Wear:

Wear at the edges of the slipway lining sections is observed at the region where the lifeboat keel initially mounts the slipway during recovery. From observation it is seen that this is due to the impact of the keel on the slipway panels, particularly when the keel slides from the surrounding slipway superstructure into the keelway to locate before hauling begins rather than sliding wear effects.

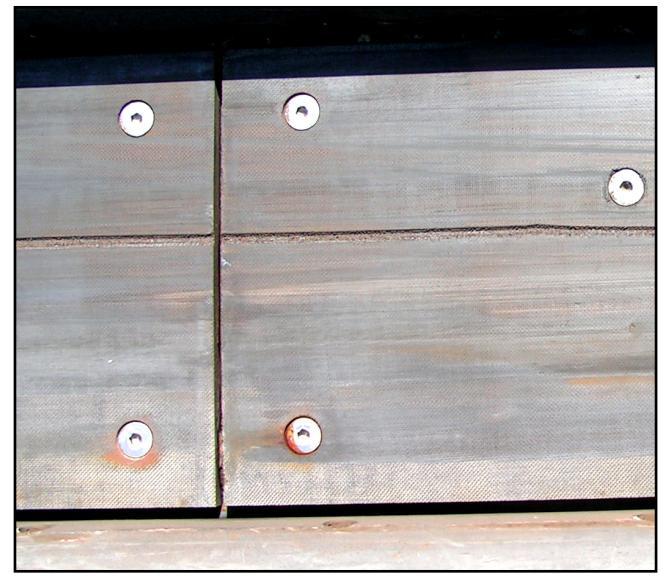
Fig. 6. Jute fibre/phenolic resin composite slipway lining wear regimes: Gouging wear

Gouging Wear:

This is thought to be caused by either damage to the lifeboat keel to generate a protruding section, or the presence of 3 body wear due to a foreign body becoming trapped between the keel and the slipway lining.

An even ploughing scar from a raised section on the keel is noted on the composite panel slipways of Tenby and Padstow. From inspection the scar is determined to be roughly conical in profile and so will contribute to the friction coefficient:

From measurements of the slipway scar the theoretical ploughing friction coefficient for this contact is 0.408. Slipway trials indicate that this is seldom reached in normal operation so it can be assumed that ploughing friction is an infrequent phenomenon. In fact, subsequent investigation shows that the keel of the initial Tamar prototype was damaged forming a protruding section of the right size and shape to generate the wear scars seen after the initial slipway trials at Tenby and Padstow, this may have generated the stick-slip phenomenon on recovery associated with high friction coefficients. The lifeboats currently in use at these locations now have smoother keels and it is evident that the ploughing wear initially observed was an isolated incident related solely to the damaged keel of the Tamar prototype.
