## CASE REPORT

# Detection of incorrect manufacturer labelling of hip components

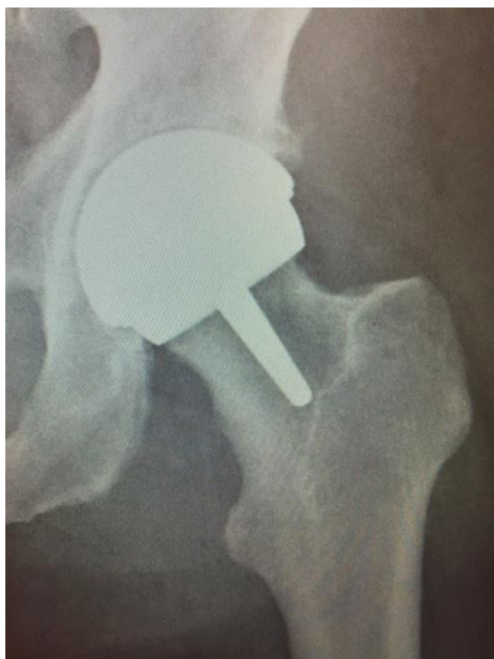
**Fig. 1** Post-operative anterior–posterior plain film radiograph of the patient’s left hip. No cause of the patient’s mechanical symptoms was detected

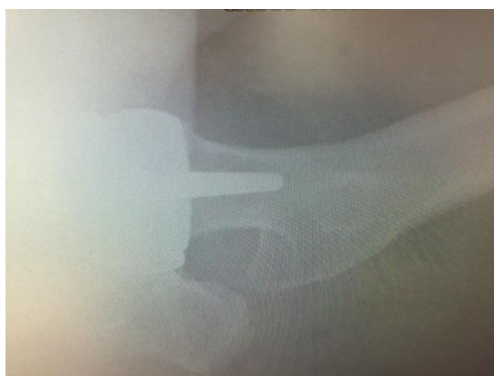
**Fig. 2** Post-operative lateral plain film radiograph of the patient’s left hip. No cause of the patient’s mechanical symptoms was detected

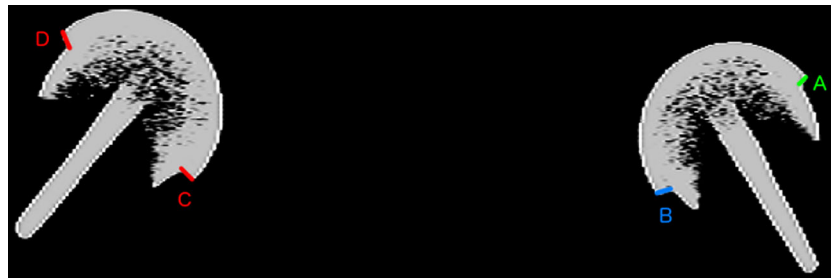
**Fig. 3** A 2D CT coronal slice of the patient with the mismatched left hip resurfacing (*right*) and the patient's previous right hip resurfacing (*left*) in view. The femoral head of the mismatched component is not sitting

The same principle can be applied to 2D CT slices (Fig. 3), by comparing the distance between the outer surface of the acetabulum and the femoral head (AC–FH). Owing to metal artefact this was only possible at the edge of the acetabulum. For this reason, patients with mismatches due to oversized heads may go undetected because at the acetabular edge oversized femoral heads are centrally located and the AC–FH distance is equal (Fig. 7). We therefore recommend that 3D models are still generated to accurately visualise the difference between the femoral and acetabular centre of rotations in all planes.

centrally in the acetabular component with *B* being 1.5 times greater than *A*. On the previous right hip resurfacing, with correctly paired components, the femoral head is centrally placed (*C* to *D*)

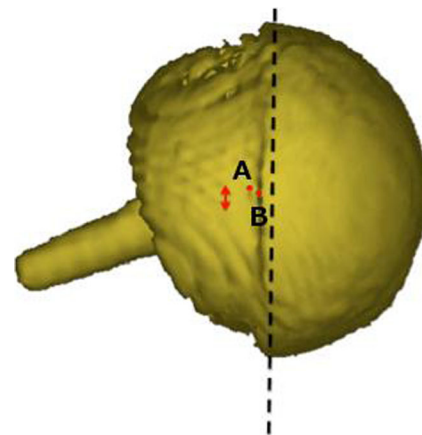
Three-dimensional analyses of the CT scan indicated a potential CSM (Figs. 4, 5). Results suggested that the acetabular-bearing diameter was 50 mm, highly suggestive of a 2-mm CSM, with the acetabular bearing surface 2 mm greater than the femoral head. Revision was recommended on this basis.

**Fig. 4** Three-dimensional model of the patient's metal-on-metal (MoM) resurfacing. The acetabular (*A*) and femoral head (*B*) centres of rotation have been marked and the *red arrow* demonstrates that the two points are not overlapping, which indicated component size mismatch (CSM)

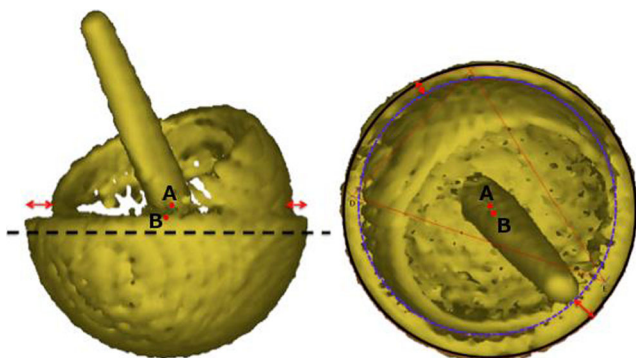
**Fig. 5** Lateral (*left*) and true anterior–posterior of the acetabular cup (*right*) views of a three-dimensional model of the patient's MoM resurfacing. *A* is the acetabular centre of rotation and *B* is the femoral head centre of rotation. The *red arrows* indicate that the femoral head is not centred in the acetabulum, which suggests CSM

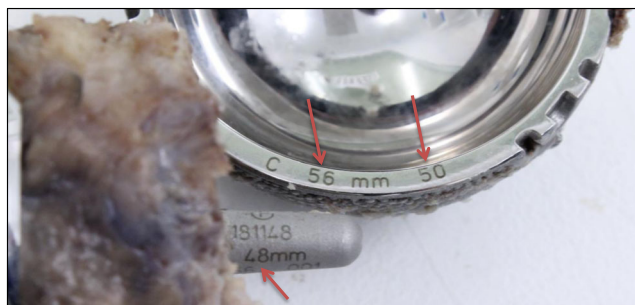
Currently, proper procedure dictates that only the labels on the boxes are checked and noted. This is because, while the engravings on the acetabulum (Fig. 6) can be seen at revision,

**Fig. 6** Photo of the revised Adept hip resurfacing removed from the 53-year-old gentleman. Manufacturer labels in the surgical notes record the components as being a 56-mm cup designed for a 48-mm head and a 48-mm head. Engravings (*red arrows*) and coordinate measuring machine measurements confirm the CSM, as the cup is actually a 56-mm cup designed for a 50-mm head

To reduce the incidence of CSM, we recommend that component sizes are documented on the whiteboard in theatre (in the same way the swab count check is performed). In addition, this case highlights the importance of attempting to check the engravings on the acetabular component after insertion and not just relying on the boxes/stickers. However, this is not

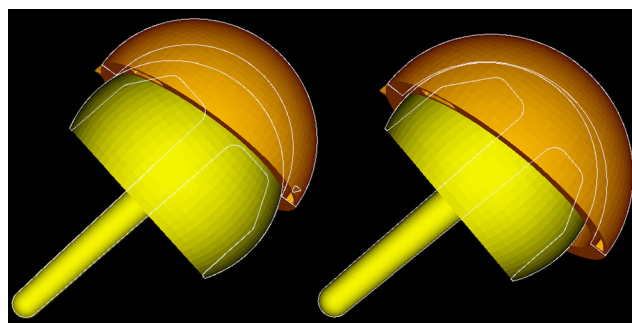
centrally in the acetabular component (Figs. 4, 5). If the femoral component was oversized, the centres of rotation of the acetabulum and femoral head components would not overlap, but the femoral head would remain centrally positioned in the acetabulum (Fig. 7).

**Fig. 7** Two 3D models of potential CSMs: oversized femoral head (*left*); oversized acetabulum (*right*). The *white outline* reveals that the femoral head sits centrally in the acetabulum in cases where the femoral head is oversized. In CSM cases where the acetabulum is oversized (as presented) the femoral head does not sit centrally
