Performance Testing of Window Installation and Flashing Details.

DuPont Tyvek® Weatherization Systems Richmond, VA

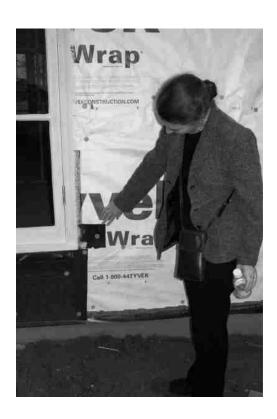
Figure 5: Gaps between flashing and weather barrier

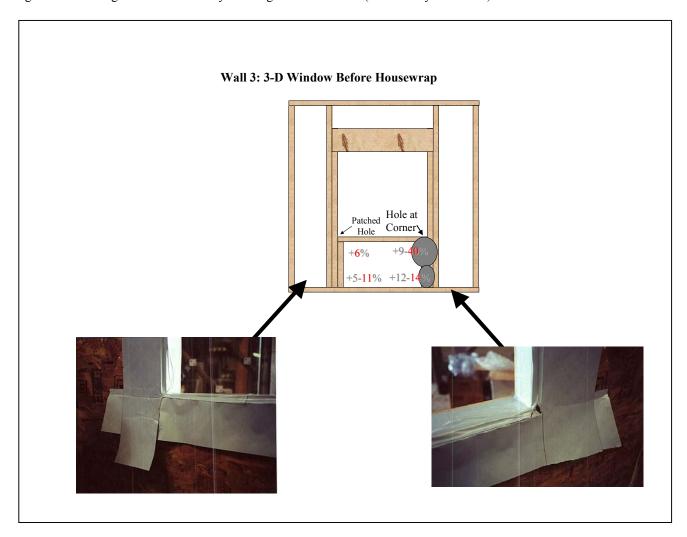
Figure 12: Flashing "Holes" Created by Framing Inconsistencies. (Preliminary Wall Test)

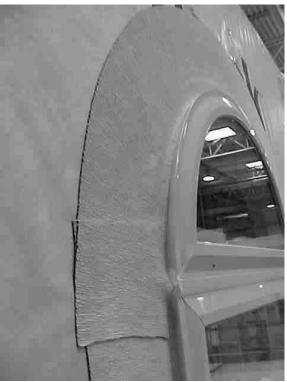
Figure 22: Self-adhesive modified asphalt flashing after thermal cycling (Wall C2)

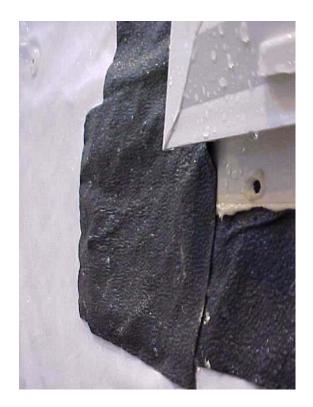
Figure 23: Water entering between the weather barrier and the jamb flashing.
