Opportunities for Energy Conservation and Improved Comfort From Wind Washing Retrofits in Two-Story Homes - Part I

Charles R. Withers, Jr.
Sr. Research Analyst

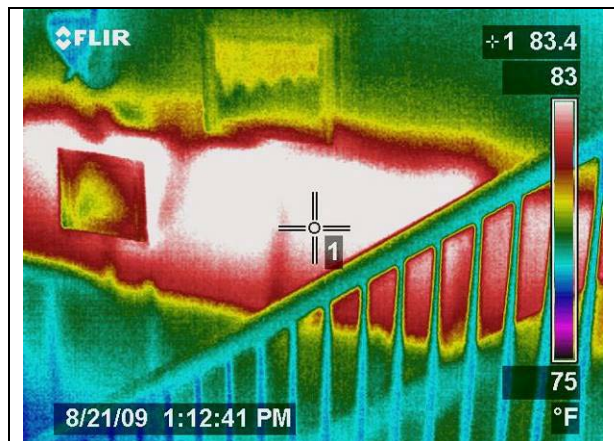
Figure 1 Infrared image shows that floor space behind wall is very warm. (Image credit C. Withers)

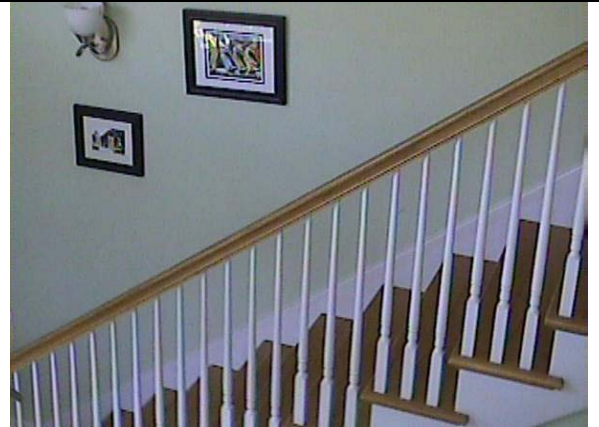
Figure 2 Photograph of IR image above. Floor space begins under the hung picture at top. (Withers)

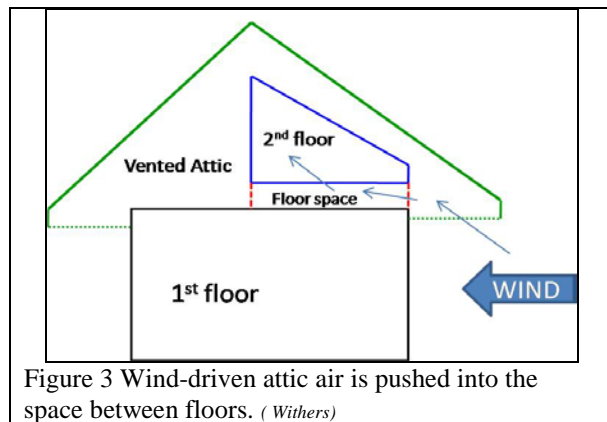
Repairs were implemented by application of open-cell foam over the openings between the interstitial floor cavity and the attic space, isolating the floor cavity from an adjacent attic. In some cases, foam insulation is also applied to the adjacent knee wall that separates the attic space from the indoor space. Repairs are discussed in more detail in Part II of this paper.

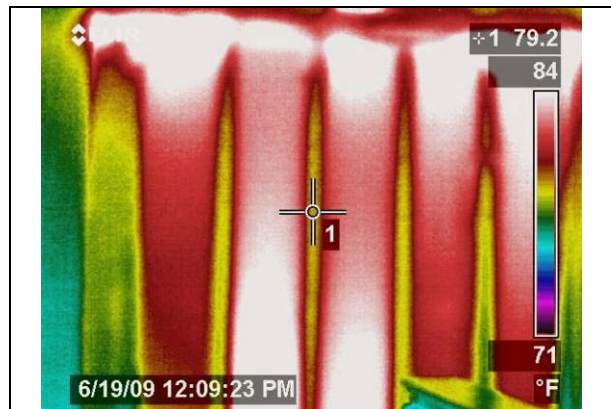
Figure 4 IR image of wood frame wall adjacent to unconditioned space. (Image credit Withers)

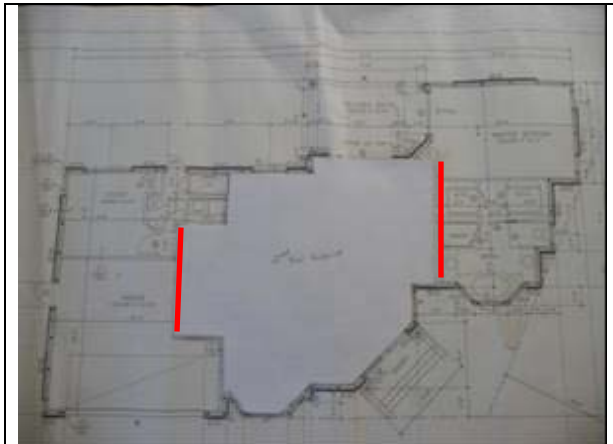
Figure 6 Floor plan of 2nd floor on top of 1st floor. Red lines show location of open floor cavity on east and west sides of House H23. Left side is to the east.

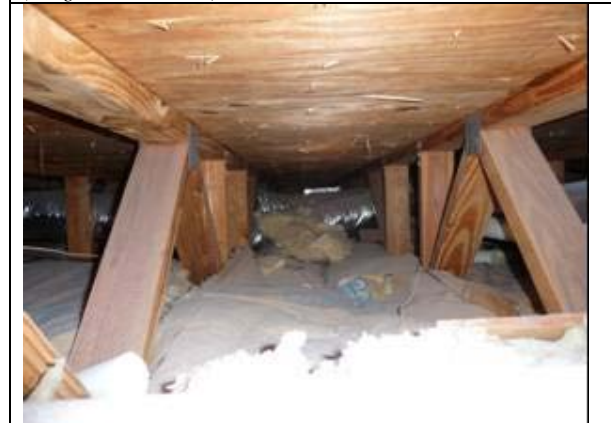
Figure 10 Photo of image above. The floor space is between conditioned space above and below. (Withers)

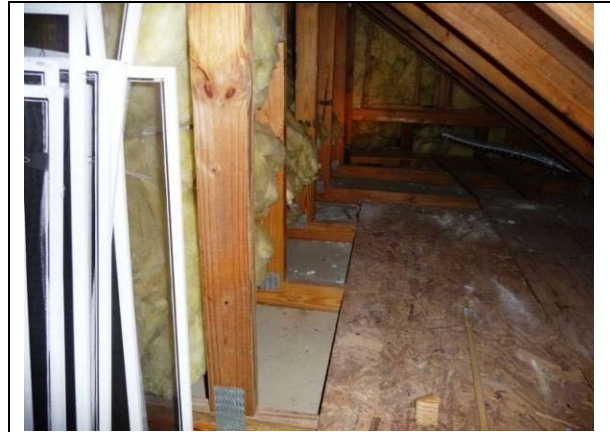
Figure 1 View of kneewall and main floor space (far), and bonus room wall and floor cavity (left).

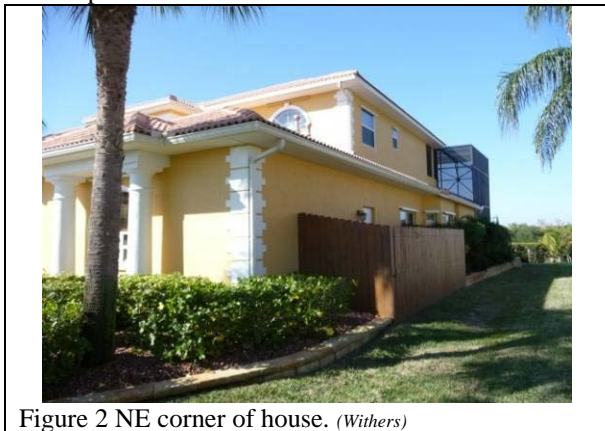
Figure 2 NE corner of house. (Withers)

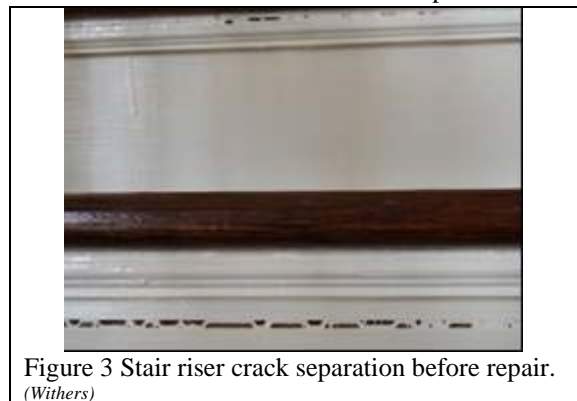
Figure 3 Stair riser crack separation before repair. (Withers)

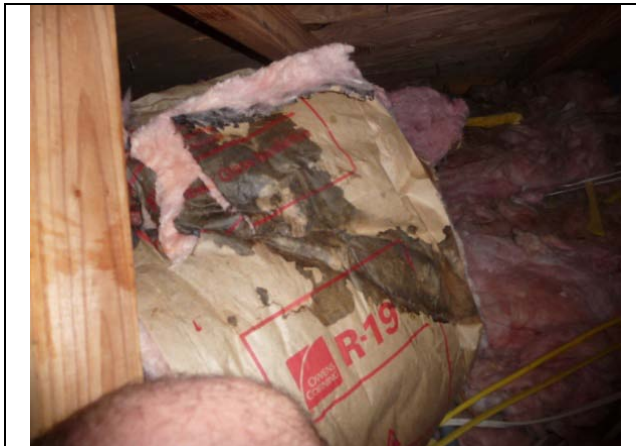
Figure 4 Moisture condensed on flex ducts and accumulated on insulation materials placed in contact with the supply ducts by the homeowner. (Withers)

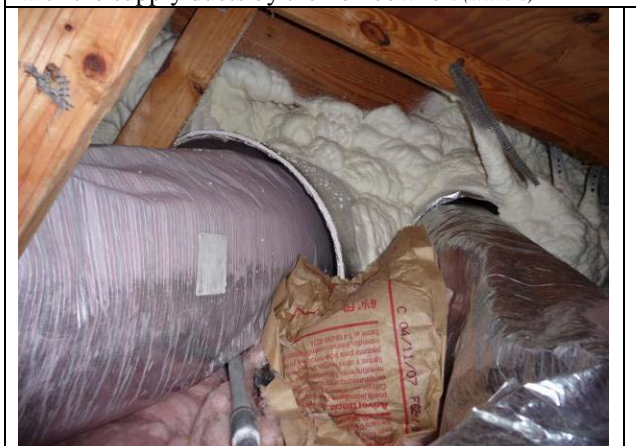
Figure 5 East side floor cavity isolated from the garage attic; a protective vapor barrier/thermal barrier sleeve isolates the foam from the exterior of the supply ducts to reduce the condensation potential. (Withers)

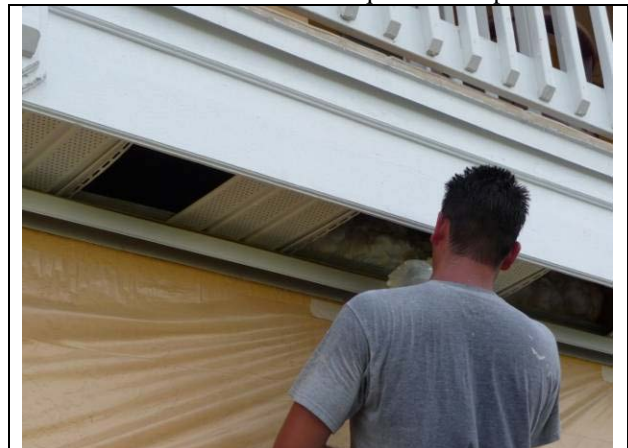
Figure 6 Foam application into west soffit area. (Withers)

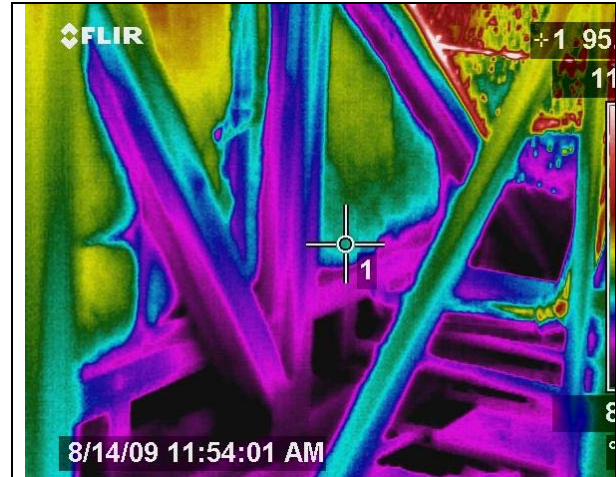
Figure 7 IR view inside the attic shows cool temperatures in the floor space and cooled surfaces low in attic. (Withers)

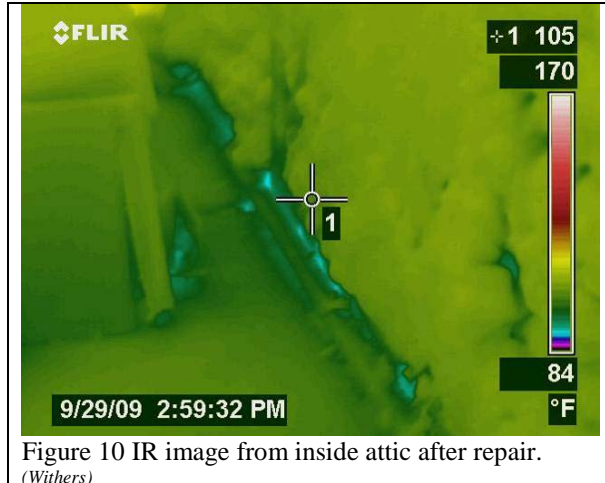
Figure 10 IR image from inside attic after repair.
(Withers)

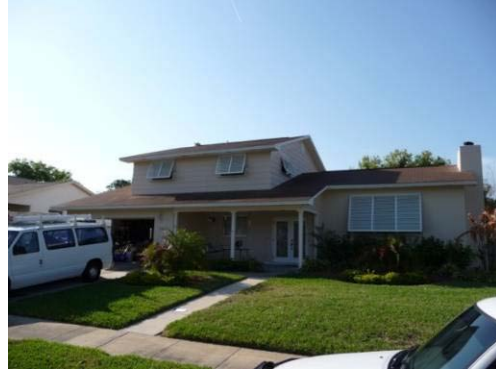
Figure 11 Front of split level home faces north. There is a small attic space above the front porch and garage which is open to the interstitial floor cavities.

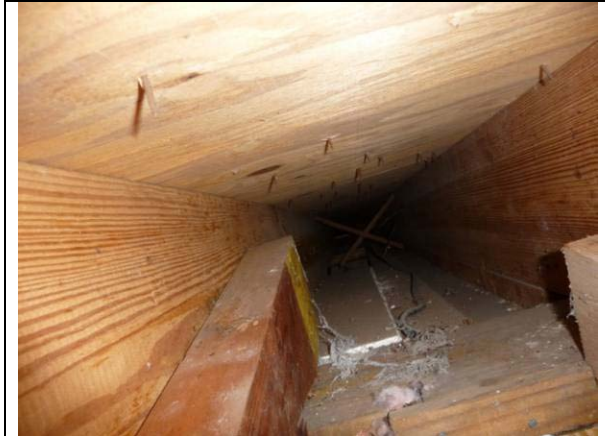
Figure 14 View from soffit vent looking inside towards floor space in area having no batts. (Withers)

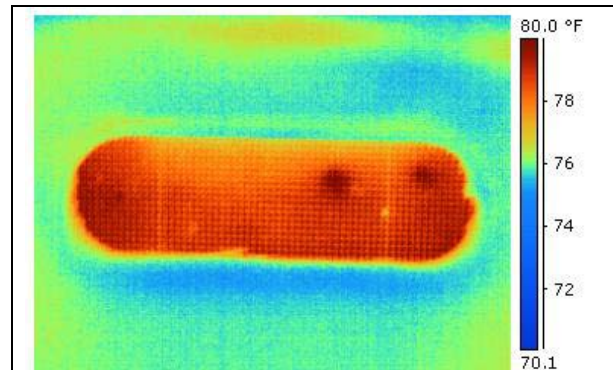
Figure 15 With 10 mph wind from the north, the north soffit vent shows interior surface temperatures about 78-80°F. Outside air temperature =80.1°F and interior air temperature=71.0°F. (Withers)

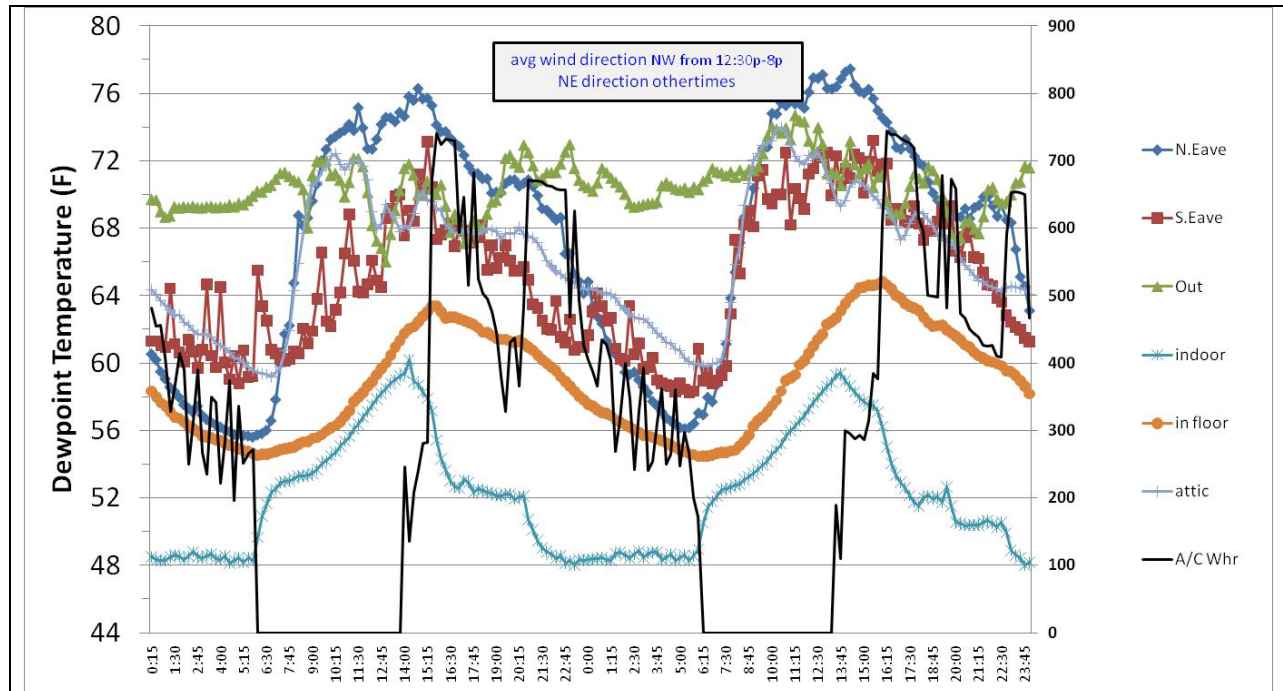
Figure 17 Graph of H11C dew point temperatures and A/C energy over two days shows patterns between A/C runtime and cool dry air from indoors making its way out to the soffit eave areas. Right Y-Axis is cooling energy in Watt-hours.

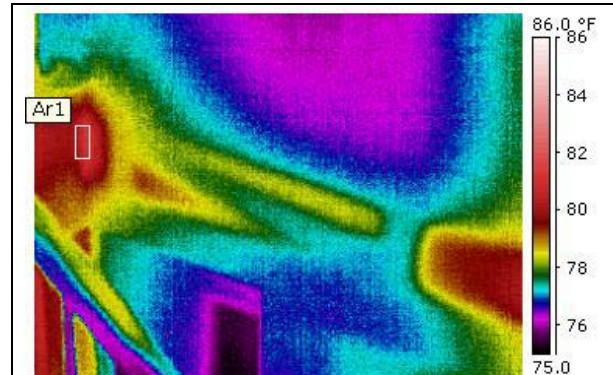
Figure 19 IR image of floor space area at stairwell shows areas of elevated surface temperature before retrofit. Area in box "Ar1" is about 81.4°F while the indoor set point was 77.3 °F on average. (Withers)

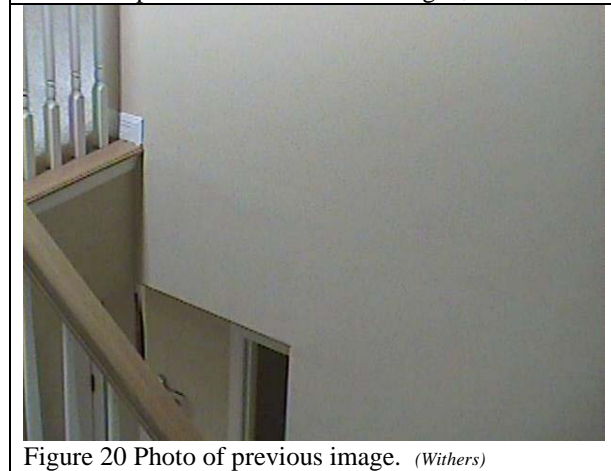
Figure 20 Photo of previous image. (Withers)

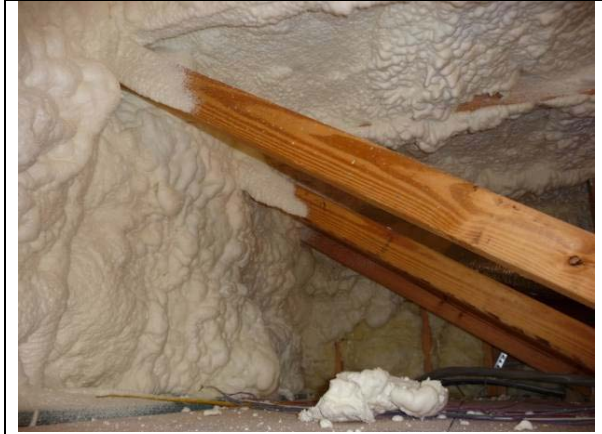
Figure 21 Foam applied to wall and ceiling of the bonus room floor cavity (3' high). (Withers)

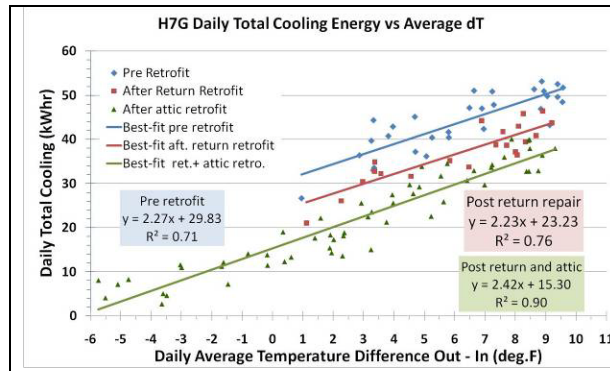
Figure 22 H7G cooling vs. temperature difference for pre-repair, for post duct repair, and for post wind washing repair.

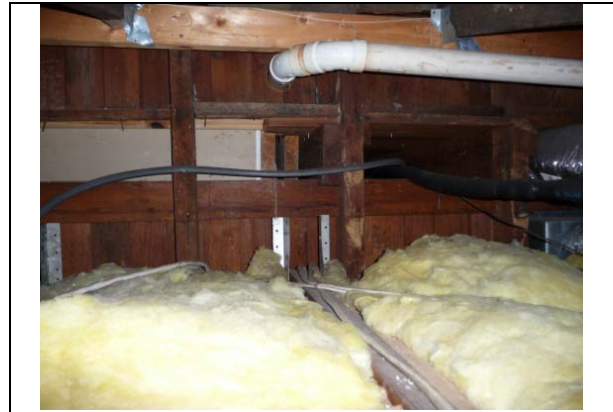
Figure 24 Floor cavity connected to attic space before repair. (Withers)

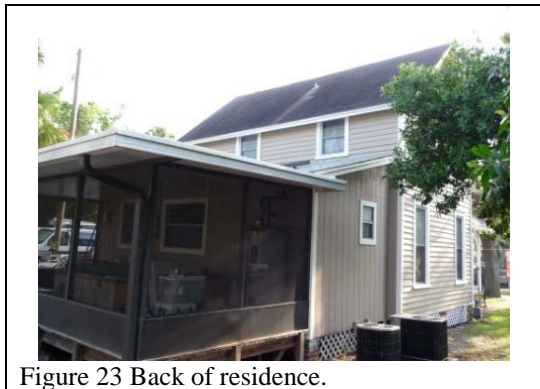
Figure 23 Back of residence.
