# Ultrasonic Phase Array and Eddy Current Methods for Diagnostics of Flaws in Friction Stir Welds

Valery Rubtsov<sup>1, a)</sup>, Sergey Tarasov<sup>1, 2, b)</sup>, Evgeny Kolubaev<sup>1, 2, c)</sup>,  
and Sergey Psakhie<sup>1, 2, d)</sup>

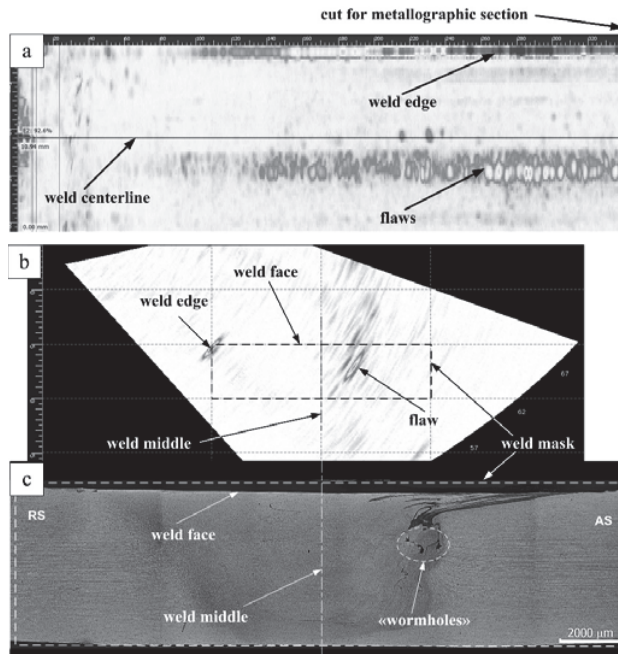
**FIGURE 1.** “Wormhole” weld defects: (a) US “top-view”, (b) US S-scan, and (c) metallographic section

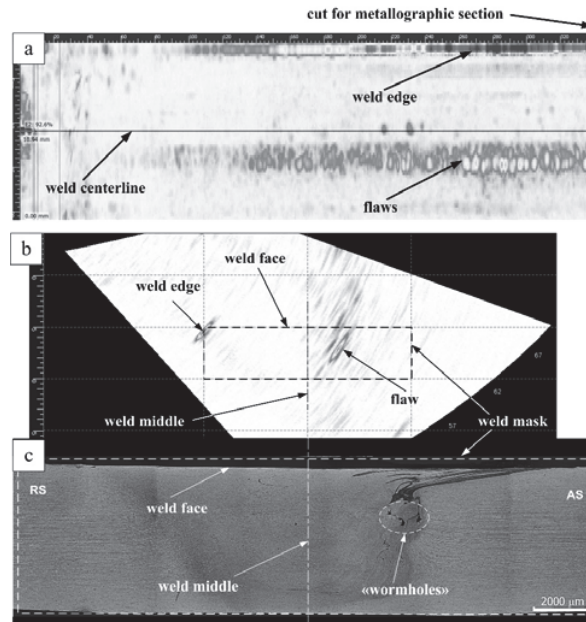
**FIGURE 2.** Lack of penetration internal weld defects: (a) US “top-view”, (b) US S-scan, and (c) metallographic section

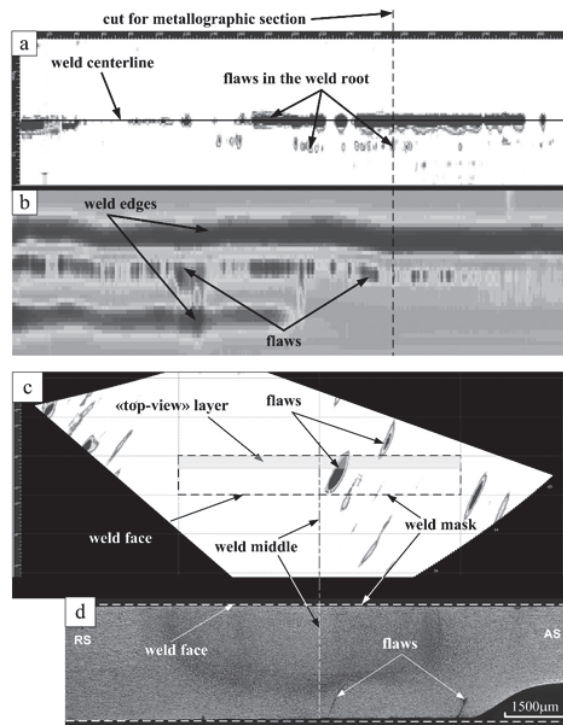
**FIGURE 3.** Lack of penetration internal weld defects: (a) US “top-view”, (b) eddy current scan, (c) US S-scan, and (d) metallographic section
