Morfološko stanje tekućica u poriječju Ilove

Morphological State of Rivers in the Ilova River Catchment

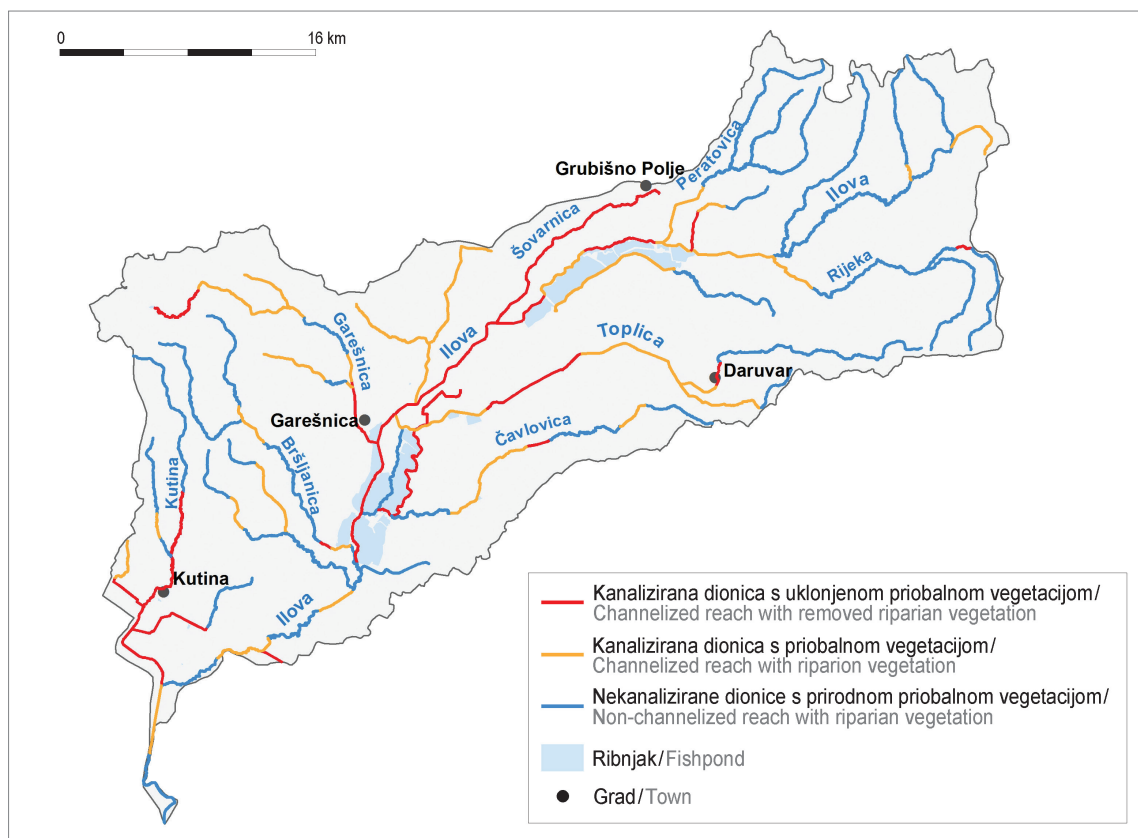
Od ukupno 534 km vodotokâ u poriječju Ilove kanalizirano je oko 250 km. Od 250 km kanaliziranih vodotoka na oko 109 km uklonjena je priobalna drvenasta vegetacija (sl. 3). Kanalizirane dionice nalaze se u većim naseljima i ribnjacima koji su u središnjem dijelu promatranog poriječja i oko njih, odnosno u srednjem dijelu toka Ilove

From the total of 534 km of watercourses in the Ilova River catchment, 250 km have been channelized. Out of those 250 km, bank (riparian) vegetation has been removed on around 109 km (Fig. 3). Channelized reaches are mainly in and around bigger settlements and fish farms in the central part of the catchment, i.e. the middle course of the Ilo-

Sl. 3. Kanalizirane dionice vodotokâ i dionice s uklonjenom priobalnom vegetacijom u poriječju Ilove

Fig. 3 Channelized river reaches and reaches with removed riparian vegetation in the Ilova River catchment.

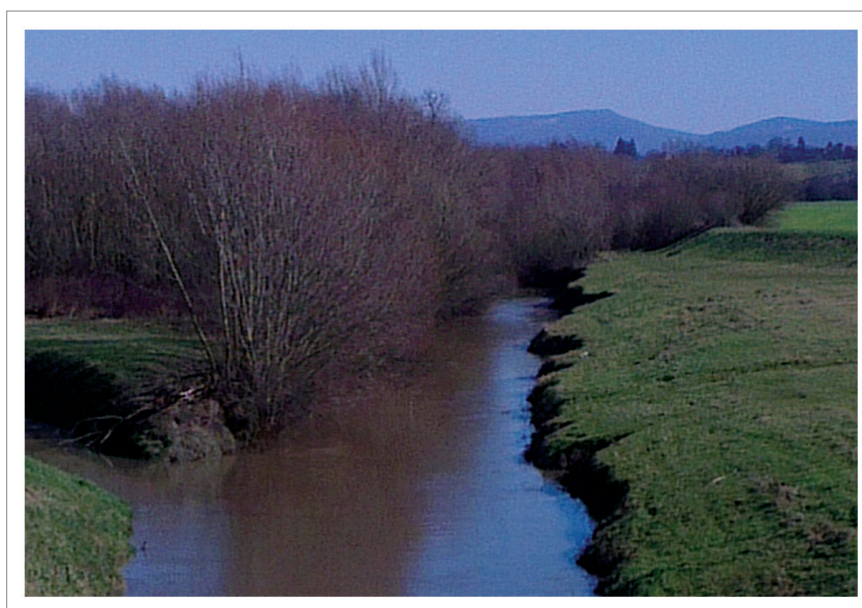
Ilovski Klokočevac (sl. 4). Na tom je mjestu nakon hidrotehničkih radova došlo do urušavanja i erozije desne obale, na kojoj je uklonjena vegetacija. Uklanjanje priobalne vegetacije izrazito utječe i na temperaturu vode tijekom ljetnih mjeseci (Pusey i Arthington, 2003; Sabater i dr., 2012) (sl. 5). Ilova ima Panonski kišni režim, s minimumima protoka upravo u srpnju i kolovozu (Čanjevac, 2013), te kombinacija minimalnih protoka i izravne izloženosti Sunčevu zračenju ugrožava riječni ekosustav (Bonacci, 2003).

Ilovski Klokočevac (Fig. 4). Following the hydrotechnical works and removal of vegetation, the river bank eroded and collapsed. Removal of bank (riparian) vegetation also affects the river water temperature, especially during summer months (Pusey and Arthington, 2003; Sabater et al., 2012; Fig. 5). Ilova has a Panonian rain regime with a minimum discharge in July and August (Čanjevac, 2013) and a combination of minimal discharge and direct exposure to solar radiation endangers the river ecosystem (Bonacci, 2003).

Sl. 4. Erozija obale Ilove kod naselja Ilovski Klokočevac uslijed uklanjanja vegetacije na lijevoj obali (desni dio fotografije)

Fig. 4 Eroded left bank of the Ilova River at Ilovski Klokočevac after removal of the riparian vegetation (shown right on picture).

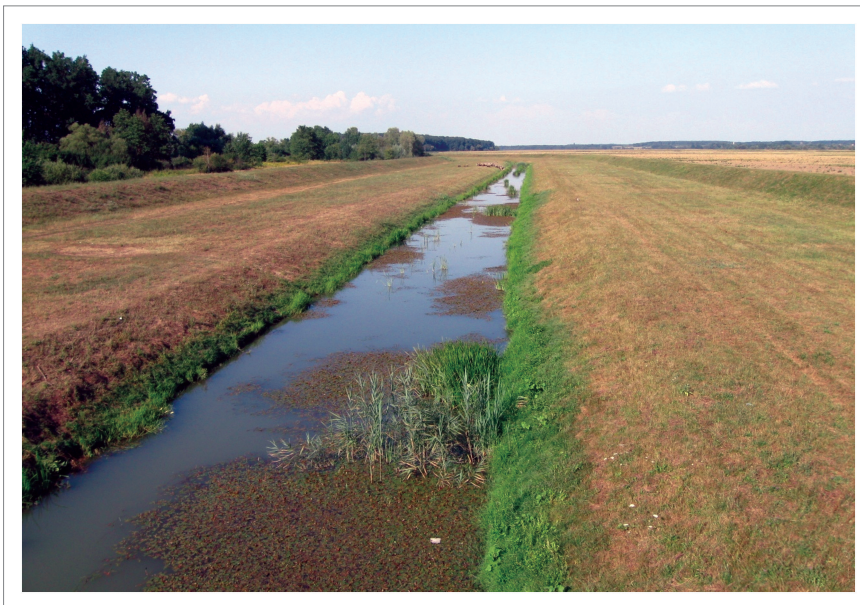
Sl. 5. Primjer kanalizirane rijeke Ilove bez priobalne drvenaste vegetacije između naselja Sokolovac i Tomašica

Fig. 5 Example of a channelized reach of the Ilova River between Sokolovac and Tomašica where woody riparian vegetation has been removed.

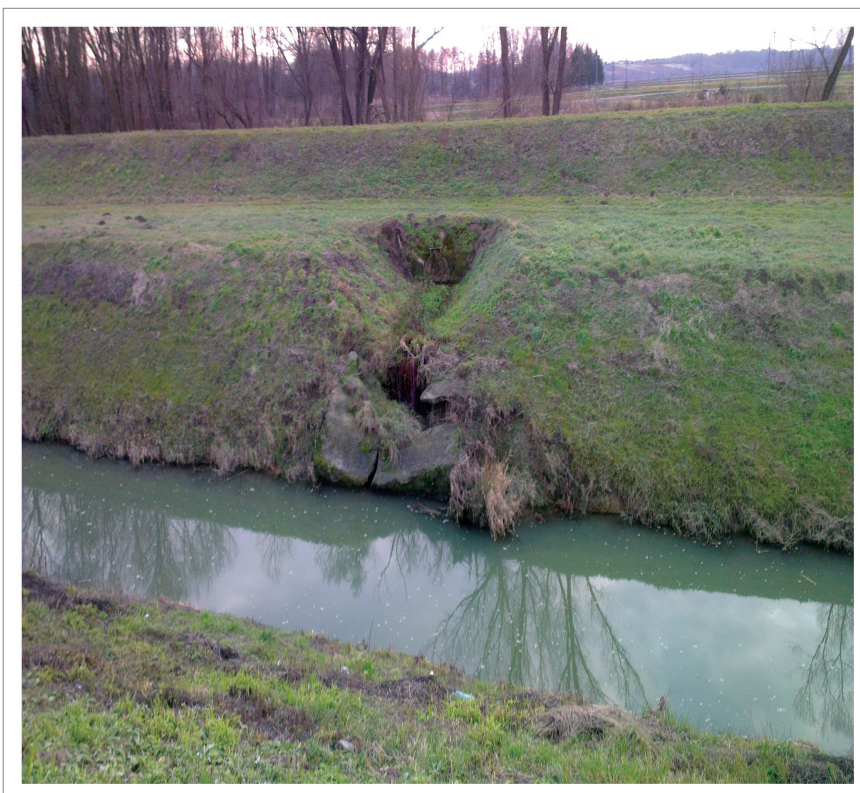
Sl. 6. Stari sifon iz ribnjaka Končanica i današnja razina rijeke Ilove

Fig. 6 An outlet (siphon) from the Končanica fish farm and the Ilova River water level.

pedesetak godina i nakon nedavnih regulacija. Mjerenjem razine starog sifona iz Ribnjaka Končanica i današnjeg dna korita utvrđeno je da je na toj lokaciji korito produbljeno oko 1,4 metra, što može utjecati na pad razine podzemnih voda, učestaliju pojavu suša te pojačanu eroziju. Na kanaliziranim dijelovima također nedostaje prirodnih morfoloških karakteristika unutar korita, odnosno raznolikosti staništa koje uključuje dublje i pliće dijelove, brzice, prudove i sl., što negativno utječe na riječni ekosustav.

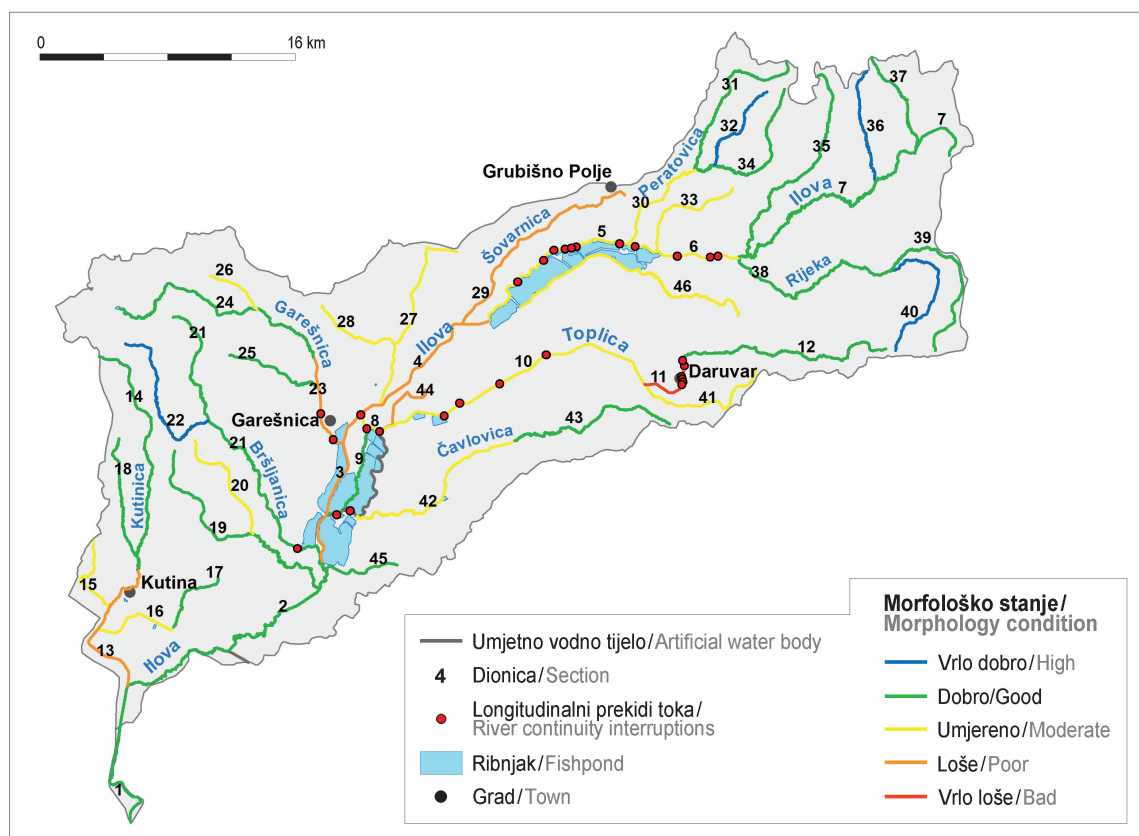
The results of morphological assessment and classification of 534 km of watercourses, i.e. 48 water bodies (reaches) in the Ilova River catchment are presented in Tab. 3 and on Fig. 7. In total, 4.3 km of watercourses (Toplica 3 reach) received a final score of Bad morphological condition; 58.2 km of watercourses, i.e. seven water bodies - Poor; 143.5 km, i.e. thirteen water bodies - Moderate; 278.7 km, i.e. nineteen water bodies - Good and 38.4 km, i.e. six water bodies received a final score of Very Good. In total, 38.5% of watercourse length in the Ilova River catchment, i.e. twenty-one water bodies, do not meet the objectives of the EU Water Framework Directive (WFD) as they were classified as Moderate, Poor or Bad with respect to morphological condition. Rivers in the vicinity of larger settlements expectedly received the worst, respectively failing scores. In addition, the assessed reaches directly associated with the fish farms also received failing scores. These areas are around the largest rivers (Ilova, Toplica), where the most extensive and long-term human impact is present. The fact that many assessed river reaches far beyond settlements also have a failing morphological condition is worrying and calls into question the purpose, effectiveness and implications of the water works in these remote areas. The reaches assessed with Good and Very Good morphological conditions are generally located over 200 m above sea level and are mainly smaller streams near the spring area.

Sl. 7. Ukupna morfološka ocjena vodotoka u poriječju Ilove

Fig. 7 Total morphological status of rivers in the Ilova River catchment.
