NASA TECH BRIEF

Cracks in Glass Electrical Connector Headers Removed by Dry Blasting with Fine Abrasive

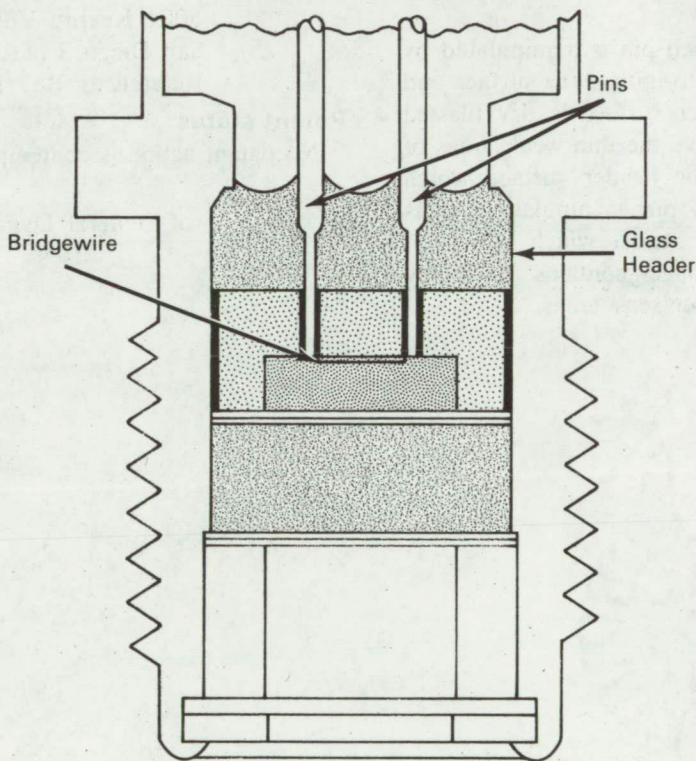
Explosive cartridges that have two or four pin bridgewire connections, designed to mate with female connectors, contain a glass header which insulates the pins from the case. These connectors typically exhibit cracking of the glass around the pins. If left alone, these cracks can propagate through the glass

header causing a pressure leakage failure of the insulator. Failure analyses have shown that most of these cracks, with few exceptions, are superficial and do not affect the integrity of the glass header. However, no satisfactory inspection criteria have been available to nondestructively distinguish between these and serious cracking. The only previous solution was to accept no cracks.

The major source of the cracking is the relatively minor flexing of the electrical pins after the header is fused. Slight pin movement, which occurs during operations such as cleaning, attachment of mating connectors for electrical tests, and installation of shorting devices, easily chips and cracks the thin glass meniscus around the pin. The cracks produced in these areas propagate for various distances away from the pins through the relatively high stressed surface area. Surface cracking or spalling may also occur independently of meniscus cracking due to the stress level on the surface.

Manipulate each pin, following the fusing operation, to initiate the surface and meniscus cracks. Then dry blast the header surface with a fine abrasive, such as a household cleanser.

To remove the cracks, each pin is manipulated by hand with a cylindrical tool to initiate the surface and meniscus cracks. The header surface is dry blasted with a fine abrasive to remove the thin weak areas of the meniscus cracks and the header surface which have been loosened by the pin manipulation. This treatment results in a glass header which is free of superficial cracks, and no longer contains the highly stressed surface or weak meniscus areas.
