NASA/CR- 1298 208272

THERMOGRAPHIC QUALIFICATION OF GRAPHITE/EPOXY INSTRUMENTATION RACKS

James L. Walker¹, Samuel S. Russell² and Gary L. Workman¹

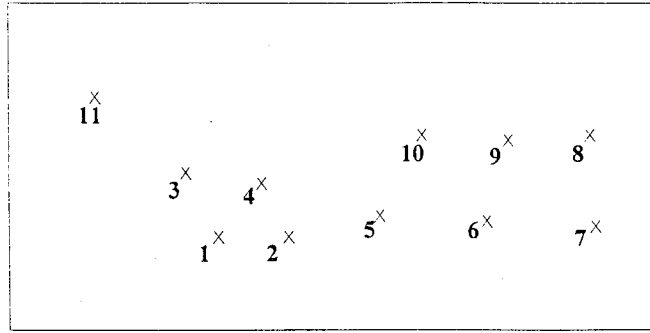
Figure 1. Impact locations for level determination.

Selection of the impact energy level was determined by performing a series of tests with different impact tups, drop heights and boundary "panel support" conditions on a section of the instrumentation rack. Table 1 outlines the thirteen impact levels used to determine the correct drop height and Figure 1 shows their locations on the sample rack section. Figure 2 contains the resulting thermograms produced by flash heating the impacted panel. Note that in Figure 2, none of the 9 and 12 inch drop height impacts (impact numbers 5, 6, 9 and 10) produced any detectable thermal indications. These impacts also produced no visual indications and when tested ultrasonically gave no sign of damage. The smallest detectable impact level was produced from a 13.5 inch drop (impact number 3 and 4) using a rubber mat to support the panel at the impact site.

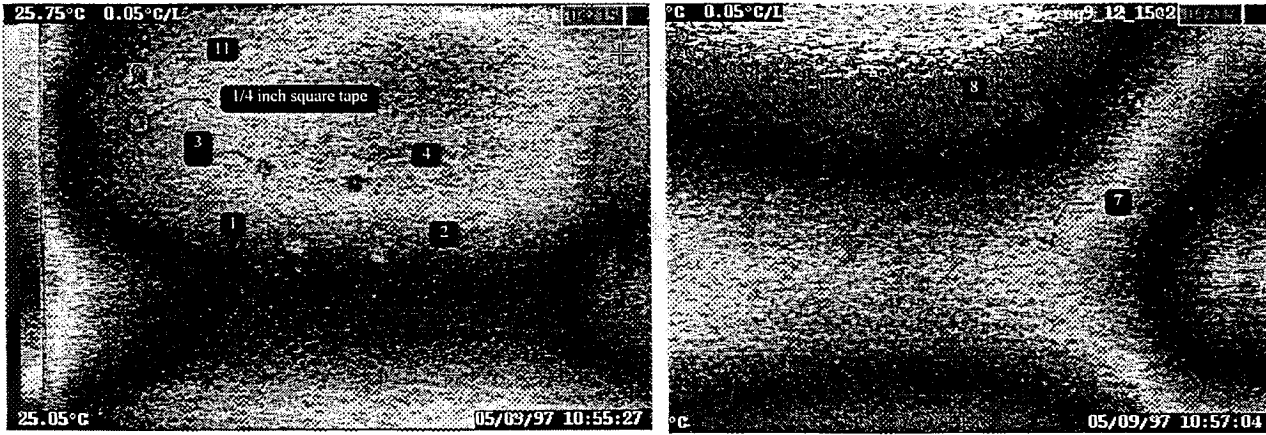
Figure 2. Thermograms of impact damage.

An impact produced by a 0.25 inch tup weighing 2.67 lb, dropped from a height of 13.5 inch (impact number 1), was found to best match the desired defect size and shape. A series of thirty impacts, in a 6 x 5 array, were performed on a section of rack (Table 2) to establish statistically the ability to thermographically locate and evaluate the damage zones. The visible damage area shown in the fiberglass cover ply was measured for reference. The areas ranged from 0.01 to 0.058 inch² on the outer "impact" side of the rack to between 0.015 to 0.078 inch² on the inner surface of the rack panel. In all, only four of the damage areas exceeded the desired defect size limit of 0.0625 inch².

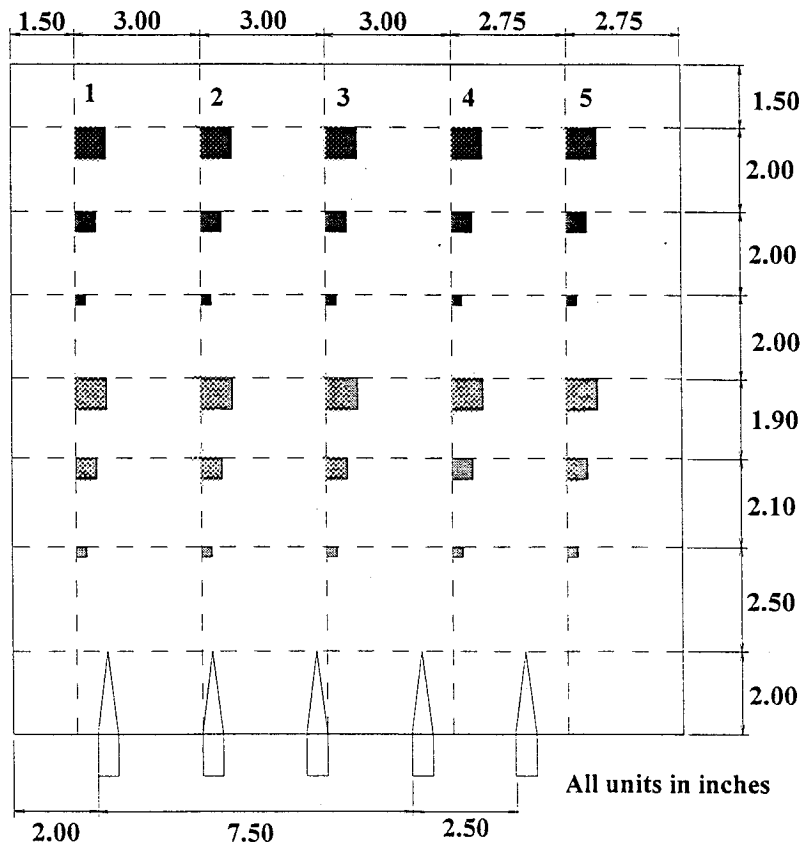
3. Fabricated test panel.

to determine the limits of thermographic NDE for detecting porosity two tests were performed. First, a section of a rack own porosity documented through an ultrasonic map was thermographically examined. Second, a 24 ply monolithic el was created with simulated porosity of known size and depth into the laminate. The panel was constructed from onal graphite/epoxy (22 plies) and E-Glass (2 cover plies) similar to that of the actual racks. The simulated defects ed around the critical area by using 0.25, 0.50, 0.75 inch square regions yielding areas of 0.0625, 0.25 and 0.5625 he pattern of planned defects is shown in Figure 3.

at gray regions in Figure 3 depict where the simulated porosity "microballons" (7.0 nm diameter fused silica SiO₂ ere placed in the panel. The dark Gray regions in Figure 3 are folded plastic backing material (0.001 inch thick ylene), used to simulate inclusions and disbond areas. Wedge shaped stainless steel shims (0.006 inch thick) ere inserted into the laminate to create void regions when they were removed after cure and are visible at the bottom of the he defects were placed in five columns so that the depth of inspectability could be investigated. The defects were etween plies (2-3), (5-6), (11-12), (16-17) and (21-22).

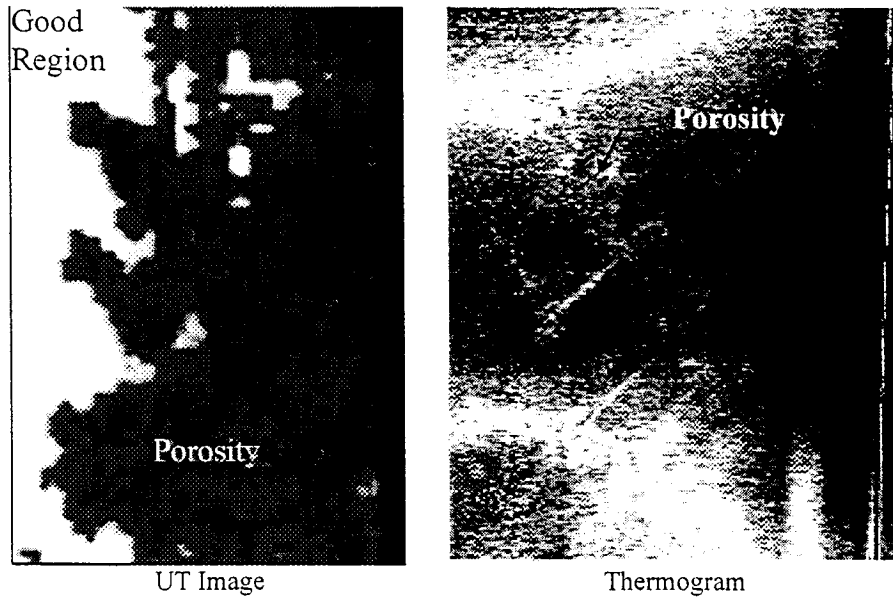
Figure 6. Comparison of Actual Porosity detected by UT and Thermography

A section of a rack panel with known porosity was inspected thermographically and compared against the UT results. As shown in Figure 6 a close match to the pattern of porosity is given between the UT image and thermogram. In Figure 6 the porosity shows up as a dark patch for the UT image and as a white "hotter" zone on the thermogram. The single thermogram does not show all the details of the UT image since the porosity actually resides throughout the thickness. The UT image measures the complete thickness of the panel while the thermogram shows only the effects from a single slice the cross-section. When several thermograms are viewed over time though, by rastering through the scan history, most if not all of the details in the UT plot can be seen on the thermography image.
