NASA/TM—2010-216071

Current Space Station Experiments Investigating Component Level Electronics Repair

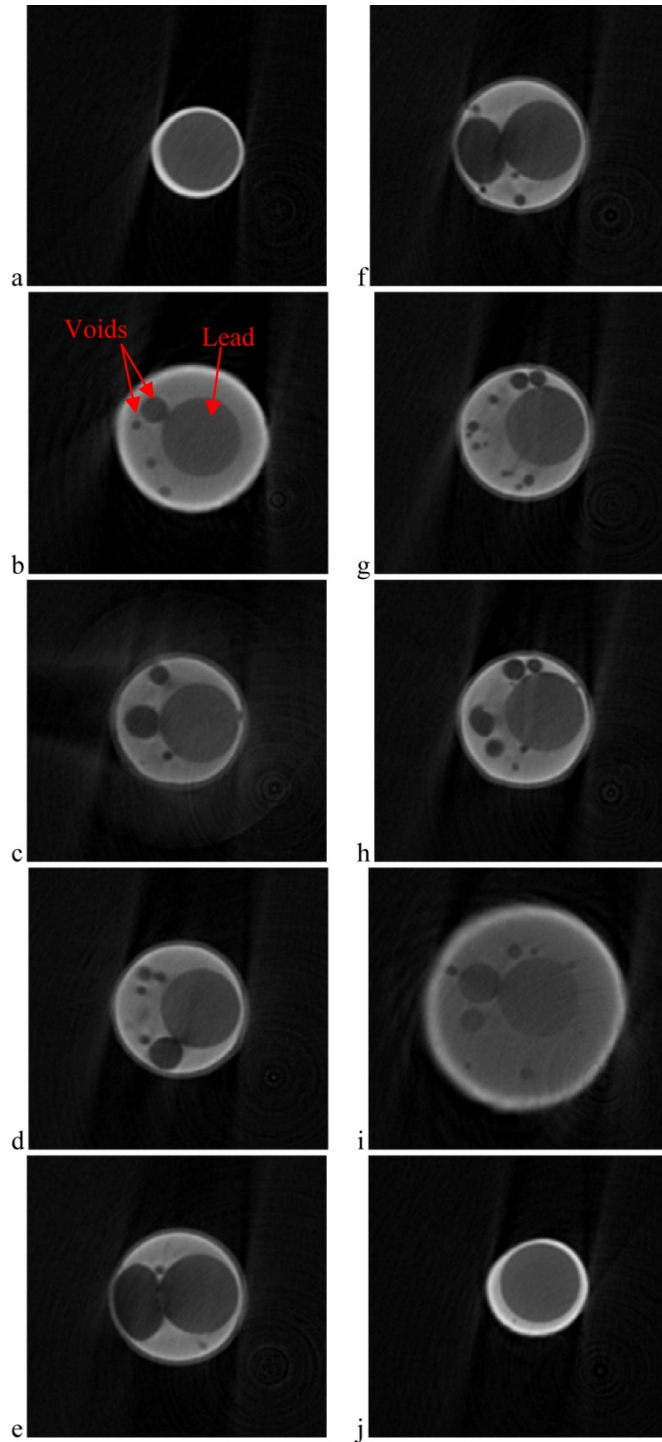
Figure 5.—Sequence of images describing the interior of a solder joint. The images show the lead and voids within the equally spaced images. Images a and b are taken from the soldered fillet, images c through h from the annular region, and images i and j from the flowed fillet. Image b demonstrates the lead and typical voids.

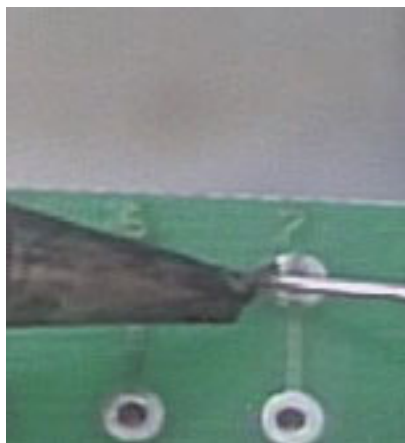
Figure 7.—Close-up image of the ISS Solder Kit soldering iron tip. The bent section of the tip is in contact with the solder wire, component lead, and circuit board plating.

The video record showed a problem with the ISS Soldering Iron Kit tip that was not expected by the SoRGE team, and may have negatively impacted the performance of the operator. As seen in Figure 7, the soldering iron tip used was curved, with a bend at the approximate middle of the tip. The ISS Soldering Iron Kit does not include any soldering iron tips with a bend; all provided tips are straight. This indicates that the soldering iron tip was damaged prior to use on the SoRGE experiment. The damaged soldering iron tip has a number of implications in terms of effectiveness for both the SoRGE experiment and general use during other ISS operations. First, the bend could indicate a change in tip temperature. The soldering iron tip is resistively heated, and the action that caused the tip to bend may have damaged the electrical connection between the tip and the soldering iron, connections between layers of material in the tip, electrical connections within the tip, or any combination of these effects. The change in tip shape could also affect the contact between the soldering iron tip and the circuit components—the resistor leg and circuit board through-hole or land—in a way that reduces the rate of heat transfer from the soldering iron tip to the joint area. While the tip used did provide enough heat to melt the solder wire and form solder joints, the potential reduction in performance of the tip may have made the astronaut's task more difficult than expected, and adversely affect the results of the experiment.

NASA should also improve the tools and facilities provided to the crew for electronics repair work. One area for improvement is the U.S. Soldering Kit. A new soldering iron should be improved to provide a hotter iron tip (at least 700 °F) with better temperature control. The hotter soldering iron tip will allow for operations with multilayer circuit boards which could not be done in the CRE-1 work and are more common in industry and in flight avionics. The higher temperature tips are more common in general use, and for this reason more shapes and sizes of the higher temperature tips are available, expanding the types of components that may be worked as well as making work currently possible easier to perform and more reliable. In addition to the soldering iron, other hand tools should be included. CRE-1 provided a number of small hand tools for use with the experiment, and they remain in the ISS tool kit for future use by the crew. The number and types of tools provided should be expanded, providing tools for manipulating smaller components or performing other tasks such as forming and inserting component legs in a circuit board to repairing damaged circuit traces and lands on a circuit board.

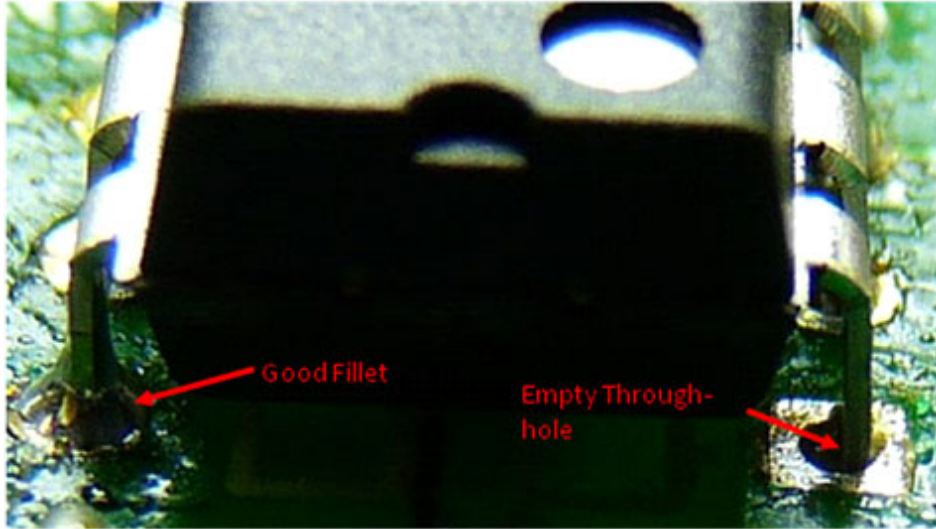
Figures 8 through 10 show some of the soldering issues found in the initial inspection. Figure 8 shows both a good solder joint, and a solder joint that failed inspection and would require rework. The good solder joint shows a fillet on the top side of the circuit board, wetting the leg of the component. The second solder joint does not have sufficient solder filling the plated through-hole; in practice, this solder joint would require rework to ensure proper wetting of the solder and a functional circuit, but is functional as-is.

Figure 8.—A replacement U2 component on a CRE-1 circuit board. The image shows a joint which passes the NASA standard as well as one joint that does not pass because the board through-hole is not filled with solder, but is functional.

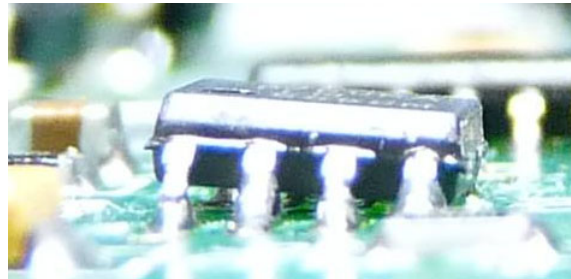
Figures 9 and 10 show an issue found in working with U4, a surface mount device. In many cases, the new component is not flat on the circuit board. This requires solder to flow between the bottom of the chip leg and the circuit board pad, which does occur in the case shown in Figure 9. In other cases, such as that shown in Figure 10, the solder does not wet both the raised chip leg and the circuit board pad, leading to an open circuit and faulty installation. This would require a repeat attempt to complete the repair, which the crew were instructed not to do as part of the experiment design.

Figure 9.—A replacement U4 on a CRE-1 circuit board. This image shows the component not resting flat on the board surface. The joints do not pass NASA standard, but are functional.

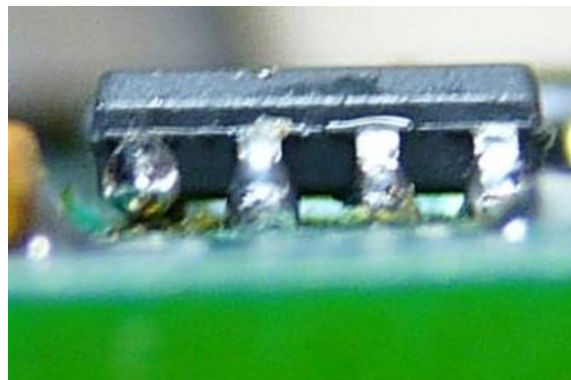
Figure 10.—A replacement U4 on a CRE-1 circuit board. In this case, the first leg is not soldered to the circuit board, requiring rework.
