CLEANING STUDY OF GENESIS SAMPLE 60487. K. R. Kuhlman¹, M. C. Rodriguez², C. P. Gonzalez², J. H. Allton², D. S. Burnett³; ¹Planetary Science Institute, 1700 East Fort Lowell, Suite 106, Tucson, AZ 85719; kim@psi.edu, ²NASA/Johnson Space Center, Houston, TX 77058; ³California Institute of Technology, Pasadena, CA.

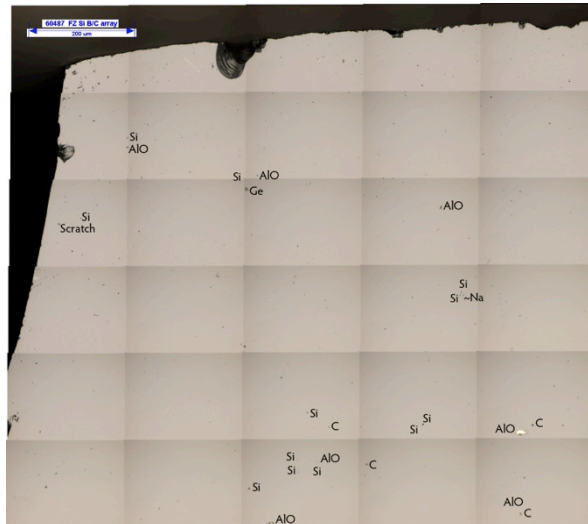
Figure 2. 50X Optical micrograph consisting of multiple high-resolution images of sample 60487. Particles that could be analyzed with low energy EDX are indicated.

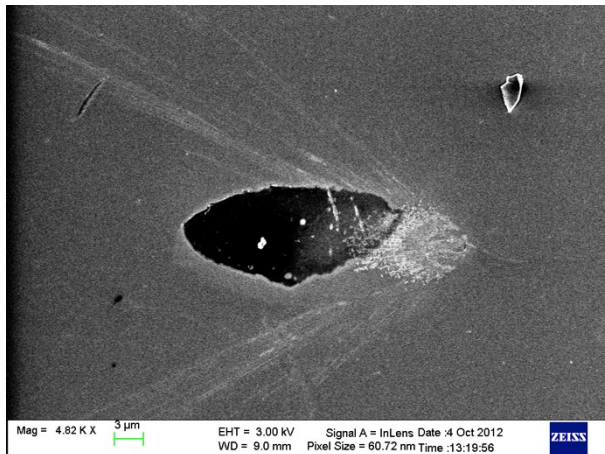
One set of particles of interest are the white ovals seen in both the 5X and 50X optical images. Qualitative EDX indicated that these particles are composed of Al and O that appears to have wetted the sample upon deposition (Figure 3). The source of the Al and O is still unknown.

Figure 3. Al and O contamination of surface of 60487. The impact-like feature is unexplained as it does not occur with other particles of Al and O on this sample.

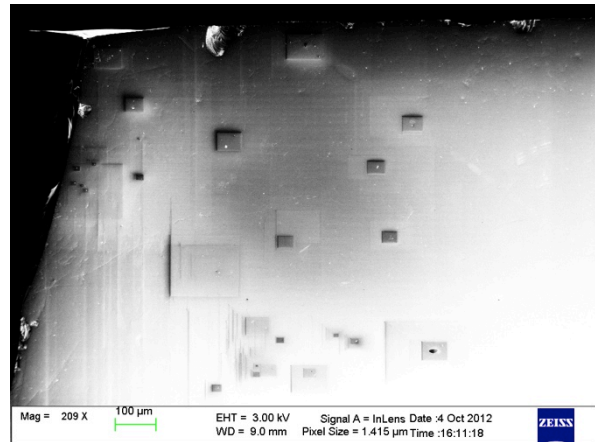
During imaging and analysis of the particles, the electron beam deposited a fair amount of hydrocarbons on the surface of the sample (Figure 4).

Figure 4. In-lens image of 60487 after SEM and EDX analysis. Note the distinct rectangles of hydrocarbons deposited by the electron beam during imaging and analysis.

UV/Ozone cleaning. Sample 60487 was returned to NASA JSC for UV/O₃ cleaning [2] to check the efficacy of this technique to remove the hydrocarbons deposited by the SEM during imaging and analysis. It was exposed to UV/O₃ for 30 min.

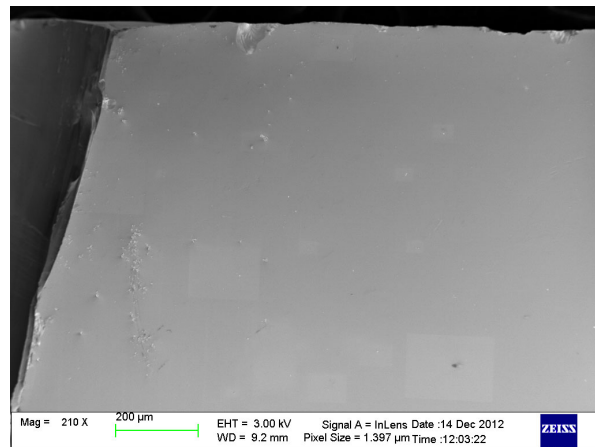
SEM study of remaining residue. Sample 60487 was returned to the Univ. of Wisconsin for further SEM study. A series of SEM images was quickly taken to avoid adding more hydrocarbons to the sample. One of these images from the in-lens detector is shown in Figure 5. While subtle, the rectangles made during the first SEM analysis are still visible, indicating that the UV/O₃ cleaning was only partially effective.

Figure 5. In-lens micrograph of 60487 after UV/O₃ cleaning. The rectangular boxes deposited by the electron beam during the first SEM analysis are more subtle, but can still be seen using the in-lens detector.
