AN EVALUATION OF THE FRACTURE OF THE 179 BACK CHANNEL GIRDER

AND THE ELECTROSLAG WELDS IN THE 179 COMPLEX

Report No. 425-1(80)

Project 77-5: Evaluation of Glenfield Bridge Fracture

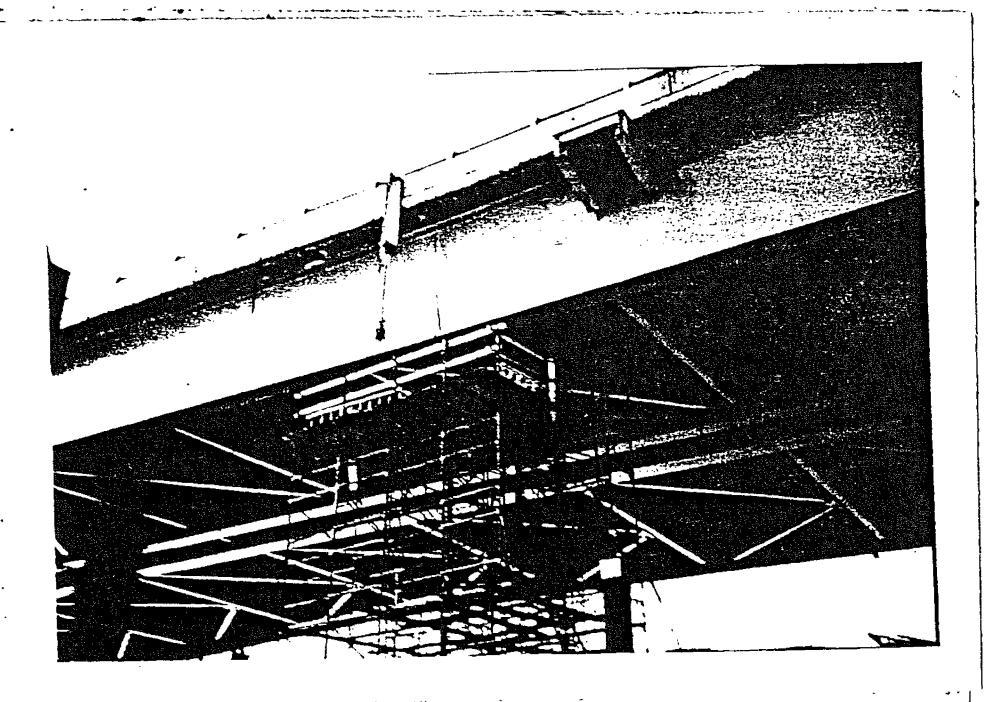
Due to the fractured girder, the deflection at midspan increased about 5 in. (127 mm) without significant damage to the road surface. The crack in the tension flange was opened about 2 in. (51 mm) when discovered. Figure 2 shows the cracked girder and the flange separation.

Fig. 2b Cracked Girder Showing Separation of the Flange and Lower Web

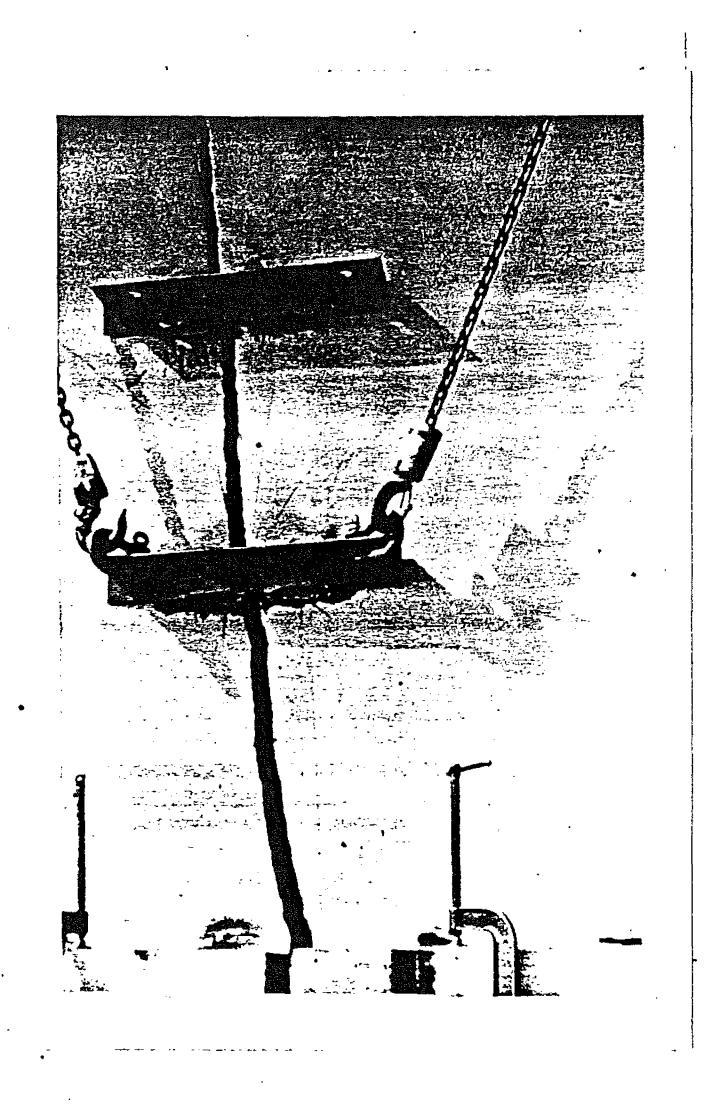
A large section of the girder containing the crack in the tension flange was removed from the structure for investigation. Prior to removal of the fractured section, pieces of angle were welded to the girder web as illustrated in Fig. 4. This prevented the crack surfaces from being rubbed together when the section was cut from the member. Figure 5 shows the sections of the casualty girder that were removed. Material from these sections was used to evaluate the characteristics of the base metal and weld metal. These results are discussed in Section 3. Detailed fractographic studies were conducted on the fracture surface and these results are discussed in Section 4. The section adjacent to one fracture face was disected and detailed. Metallographic studies and exploration of the material was made to assist in assessing the causes of the fracture.

Fig. 4 Angles Welded to Girder Web Each Side of Crack to Prevent Damage to Fracture Surface

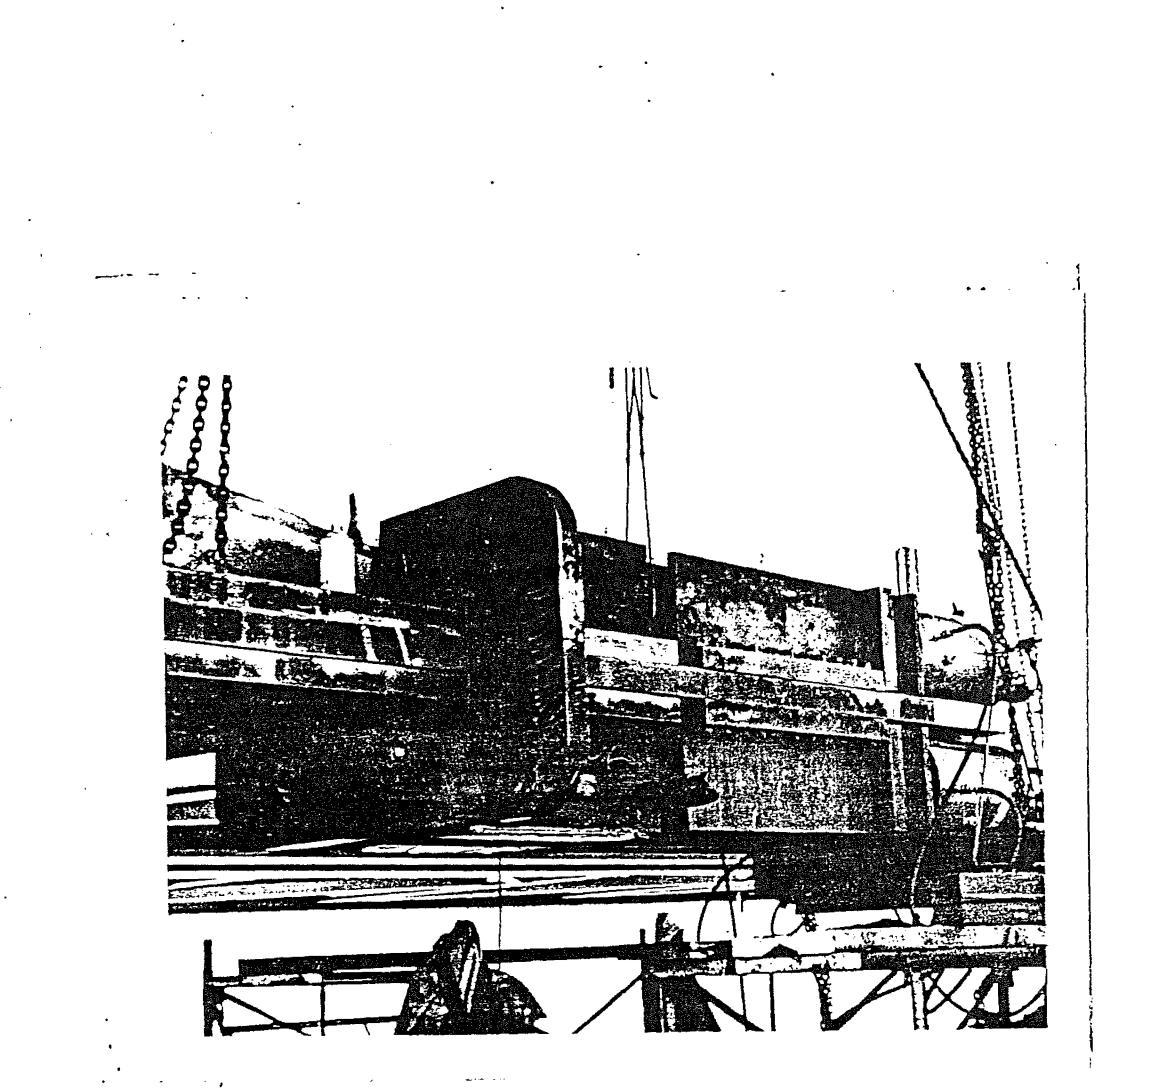
Figure 6 shows the horizontal hydraulic jacking equipment mounted to the tension flange of girder G4. The two heavy C-clamp yoke plates installed to hold the splice plates together are to the left. Four jacking rods passed through the yokes and attached to the four 300-ton (2669 kN) capacity center hole jacks that were positioned on the north (right end) side of the fracture. The jack reacted against the jacking abutments and brackets attached to the girder at that point. Greater detail is given in Ref. 2.

1. The pull rods are eccentric to the splice plates as shown in Fig. 6. The large "C" shaped plates, connecting pairs of pull rods top and bottom, are designed to minimize separation between the splice plates and the tension flange under the "C" plate. It was observed during jacking, however, that both "C" plates distorted and opened up. It was apparent that the splice plates were bending and that a compressive force was being developed between the ends of the splice plates (just left of the anchor block bolted to the tension flanges as shown in Fig. 6) and the tension flange. A lubricant placed on the surfaces of the splice plates to relieve the resulting friction forces was ground off prior to jacking.

Fig. 6 Horizontal Hydraulic Jacking Arrangement Mounted on Tension Flange of Girder G4

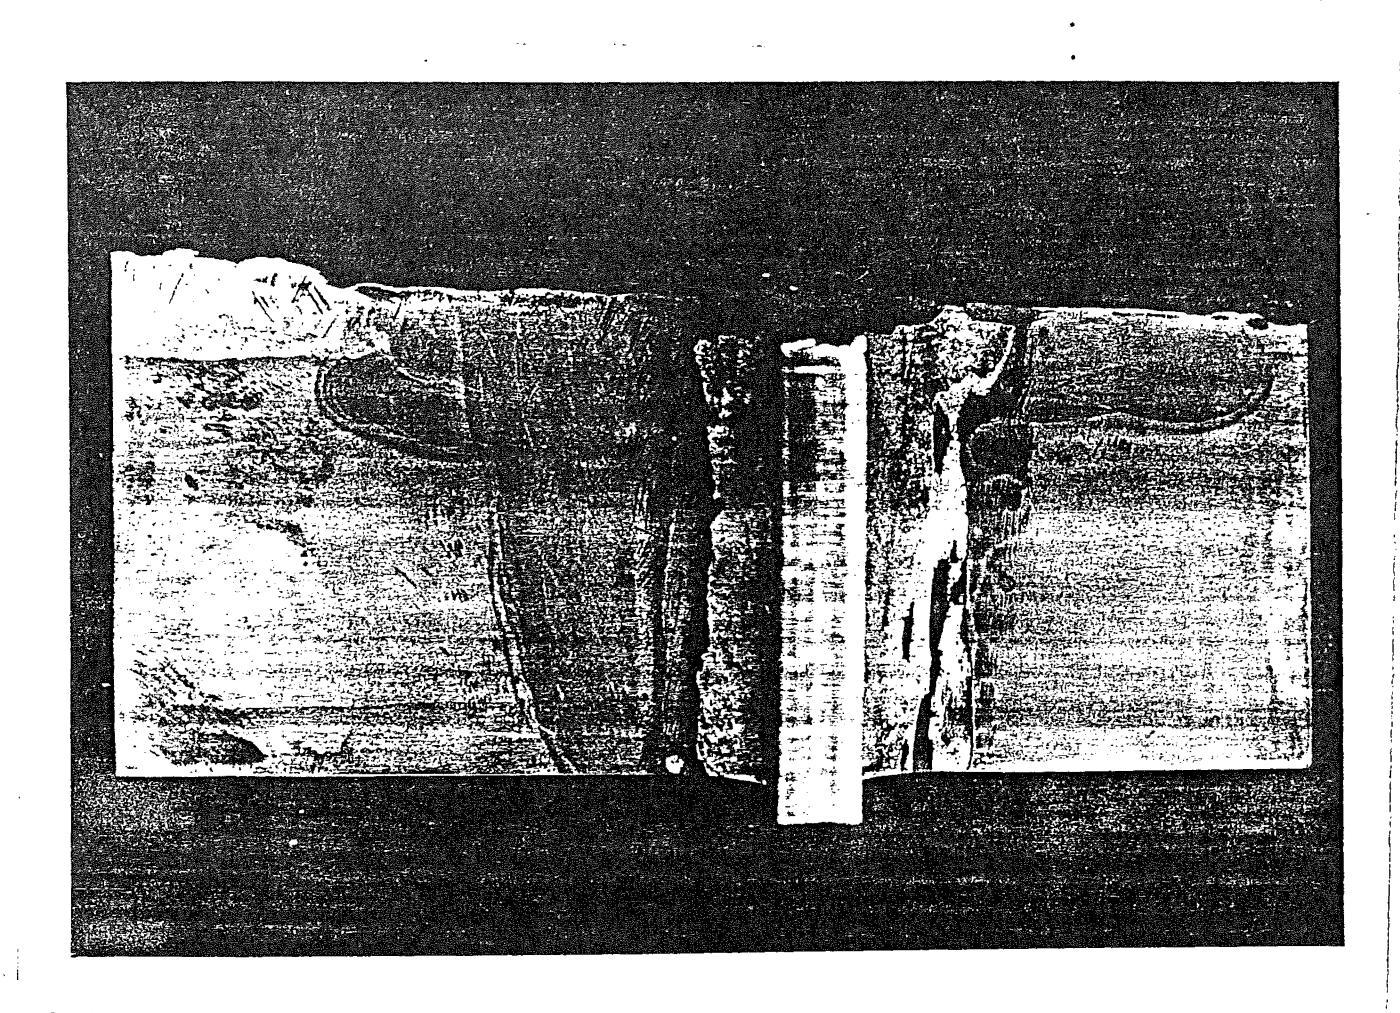
Fig. 31a Etched Top Flange Surface Showing Weld Repair Passes and Edge of Crack

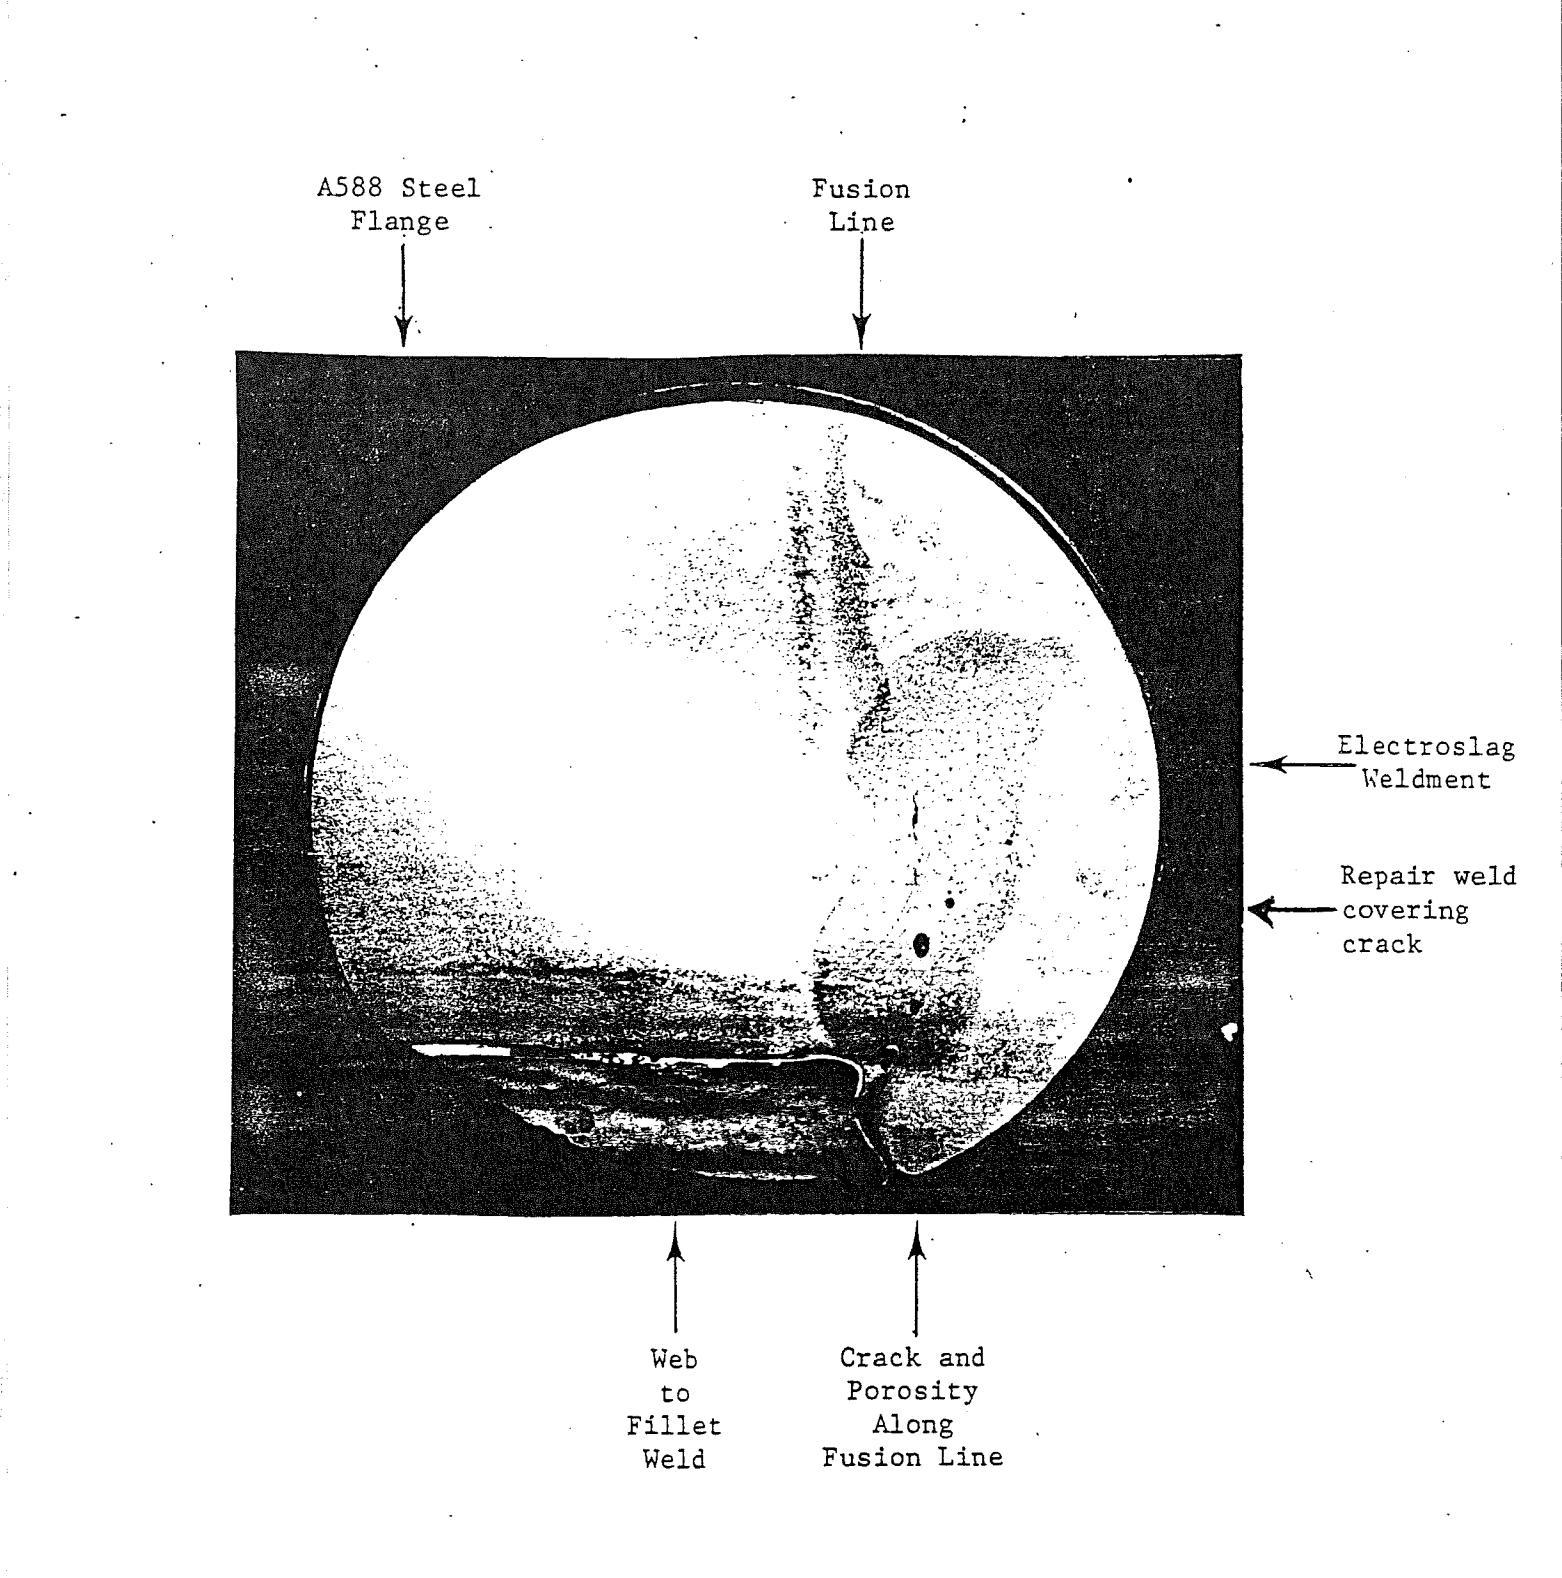
Fig. 38 Polished and Etched Surface of Top of Tie Girder Core Showing Porosity and Crack Along Fusion Line

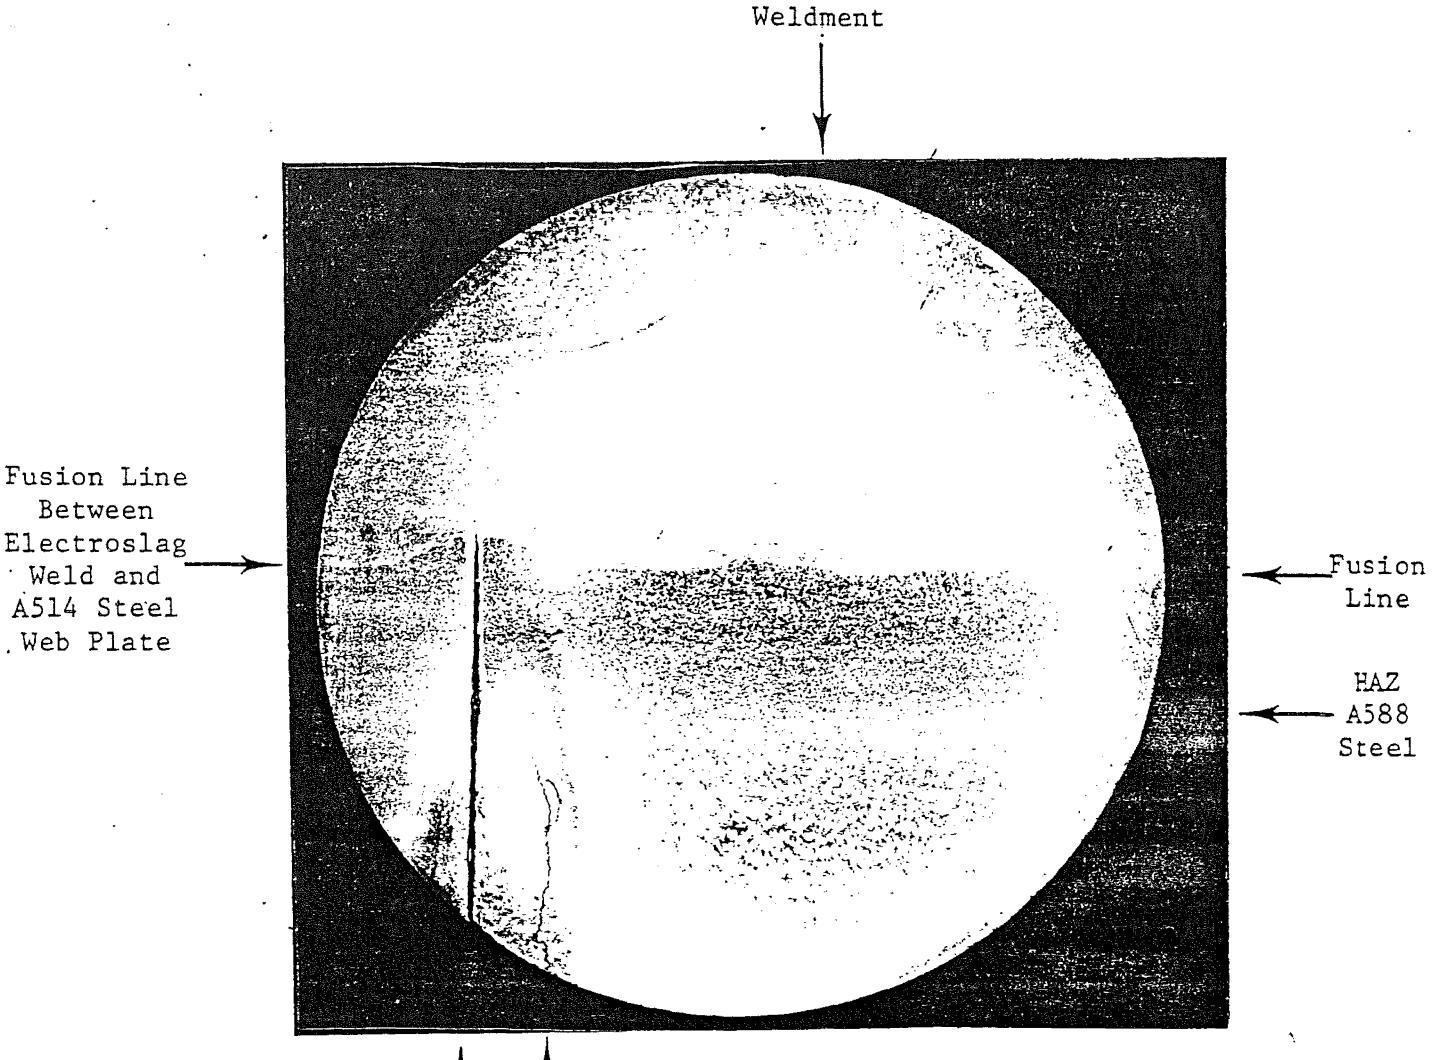
Fig. 39 Polished and Etched Surface of the Bottom Surface of Tie Girder Core Showing Crack in A588 Steel Flange Plate

Between Electroslag · Weld and A514 Steel .Web Plate

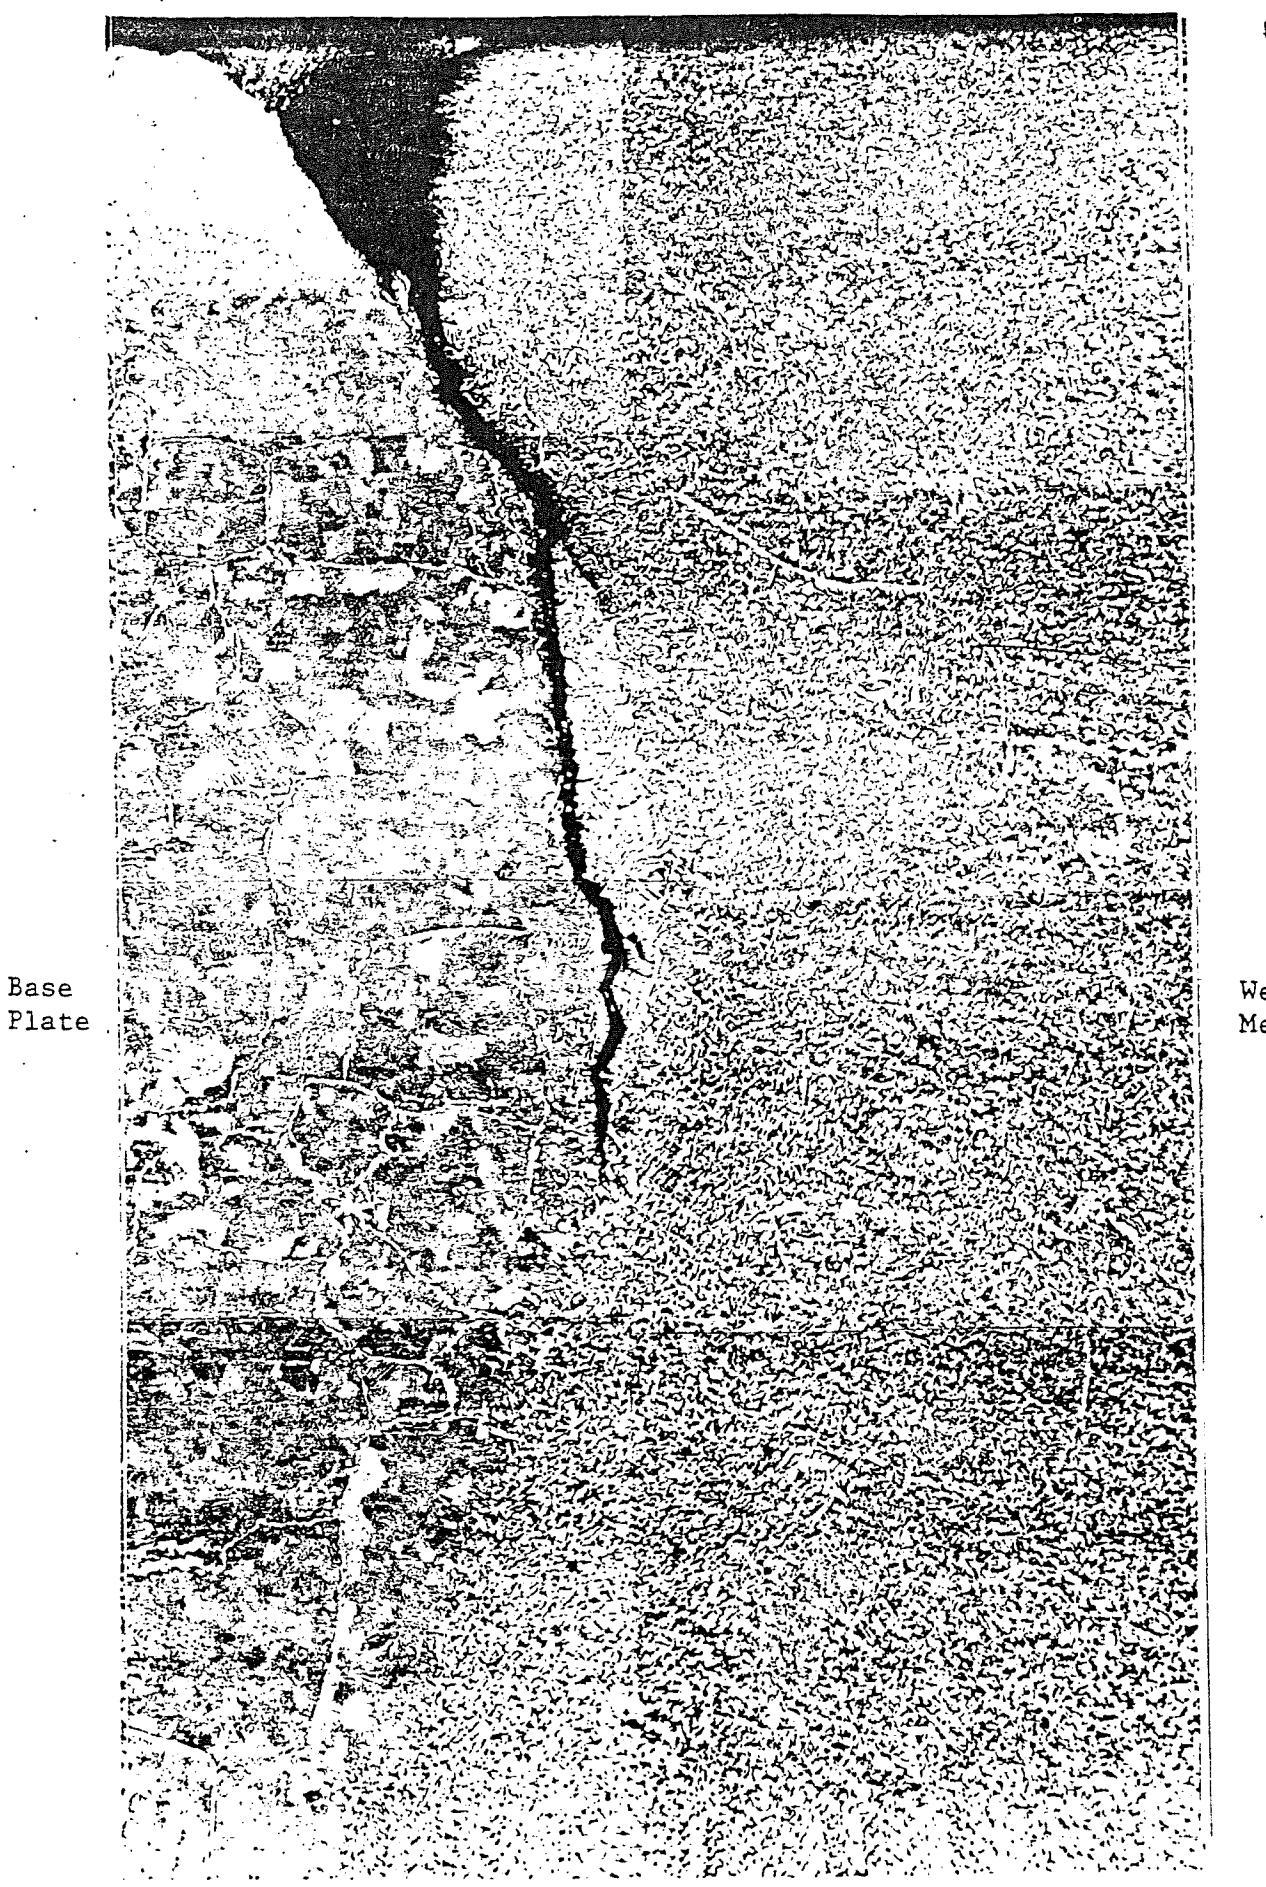
Fig. 40b Higher magnification view of natural crack in weldment after preparation of small beam specimen.

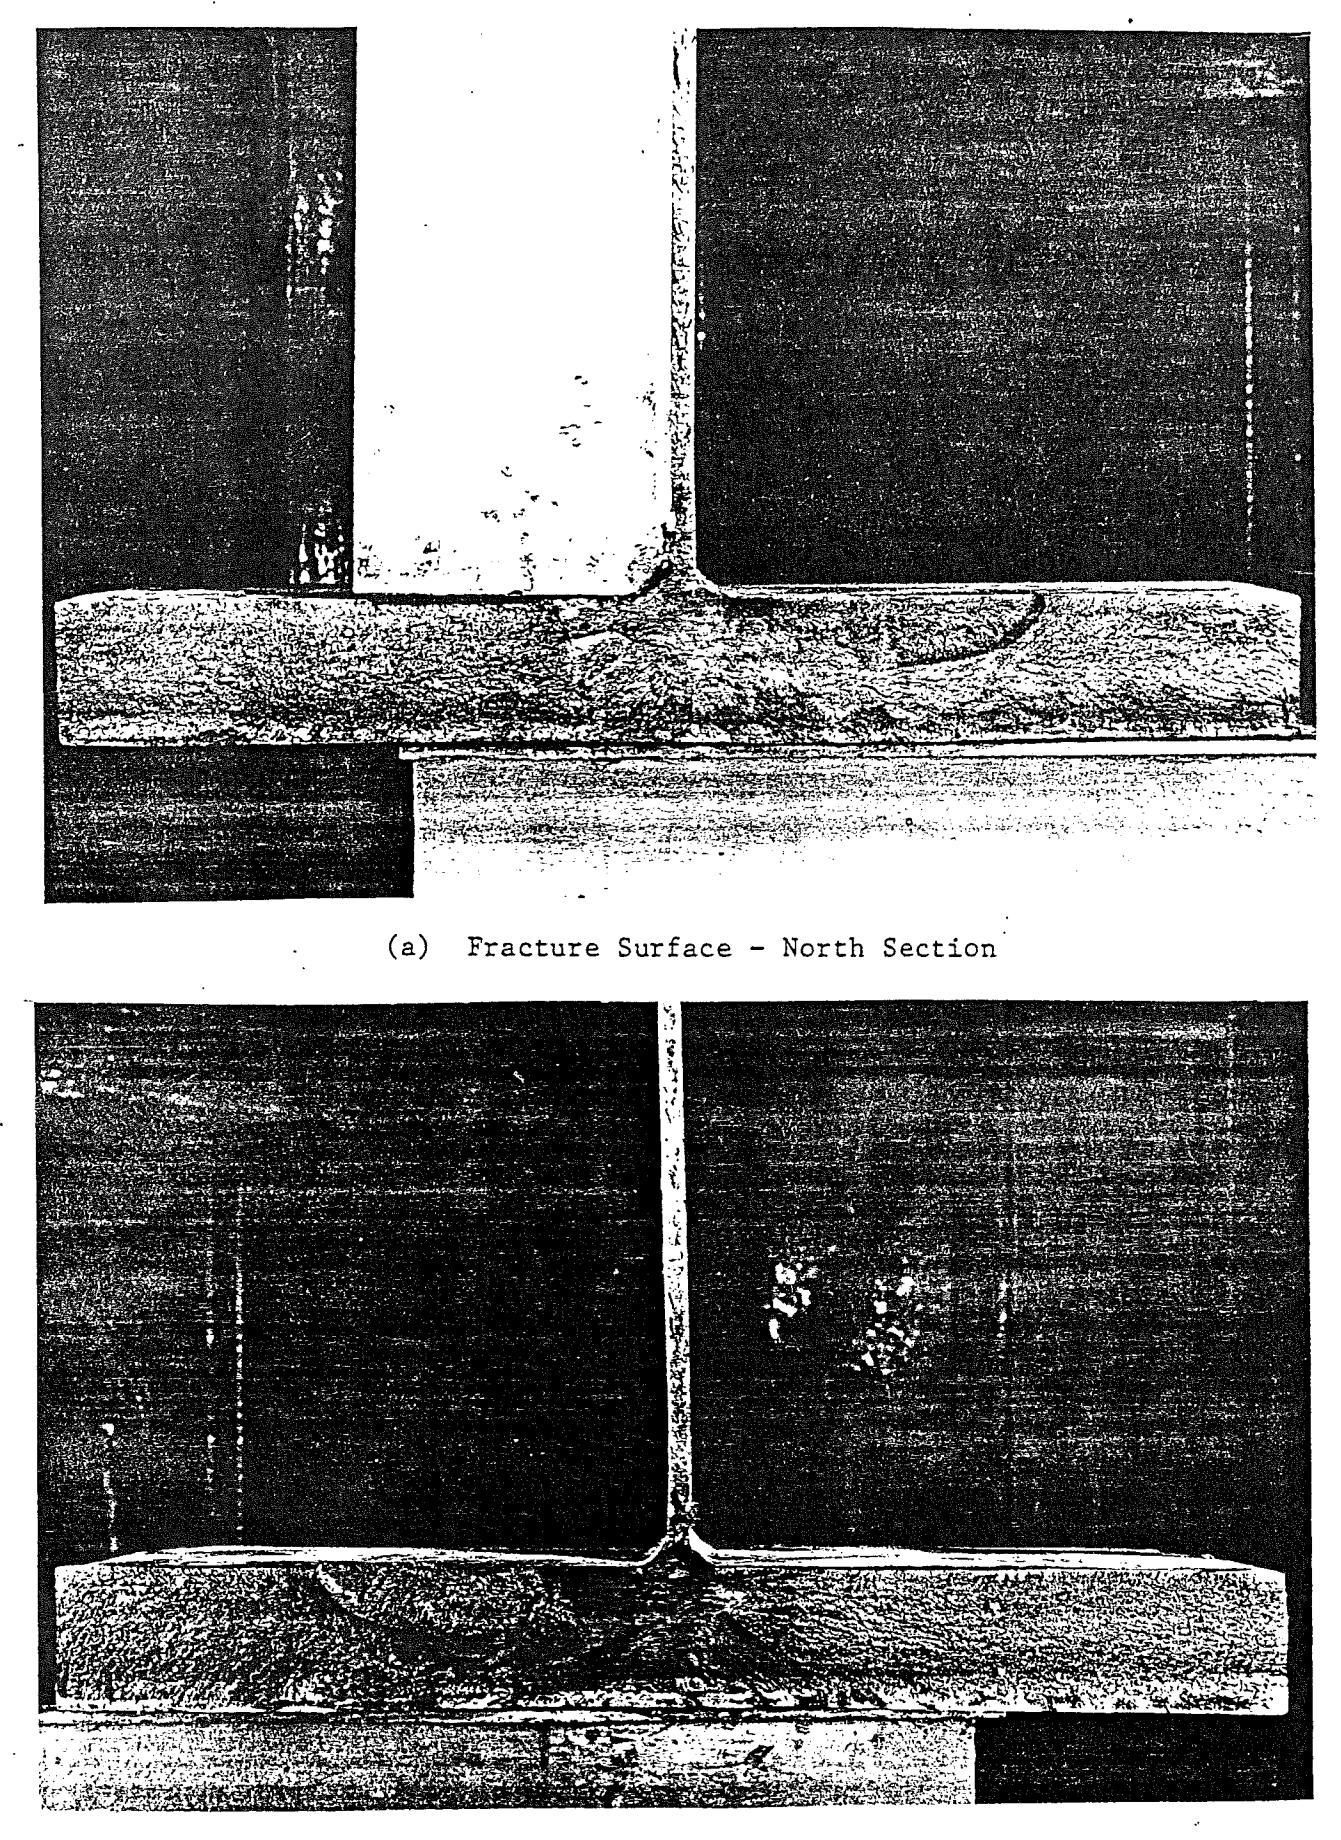
Fig. 46 Photographs of the Fracture Surface of Back Channel Girder 25G4C

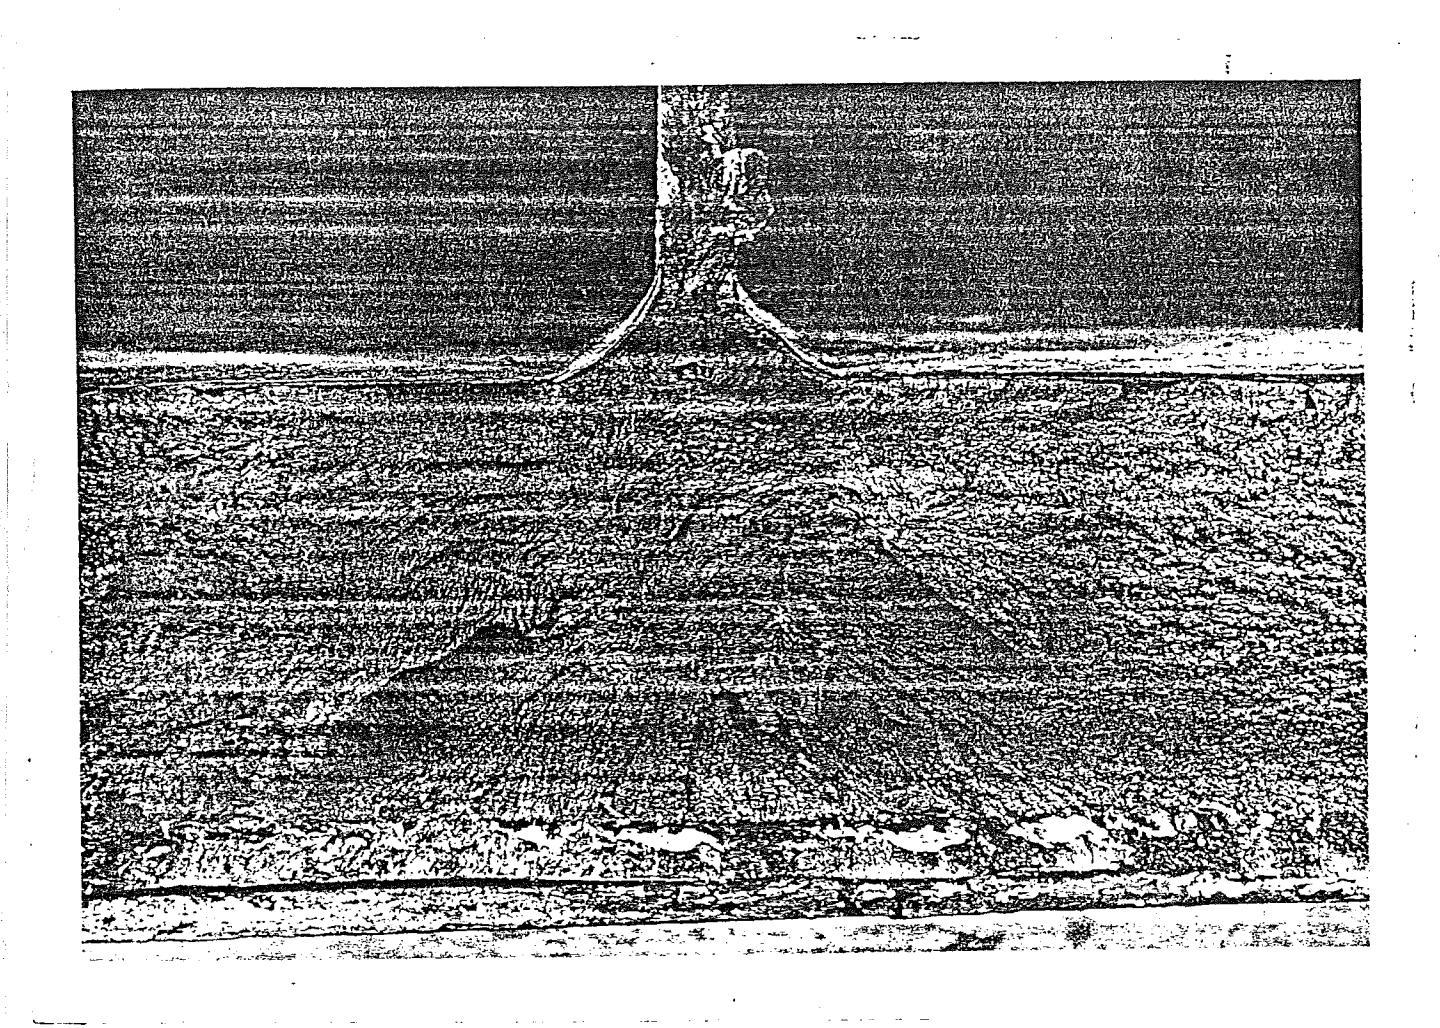
Fig. 47 Close-up of Flange and Web Fracture Surfaces from South Section Showing Probable Initial Crack and Half Circular Crack Arrest Zone

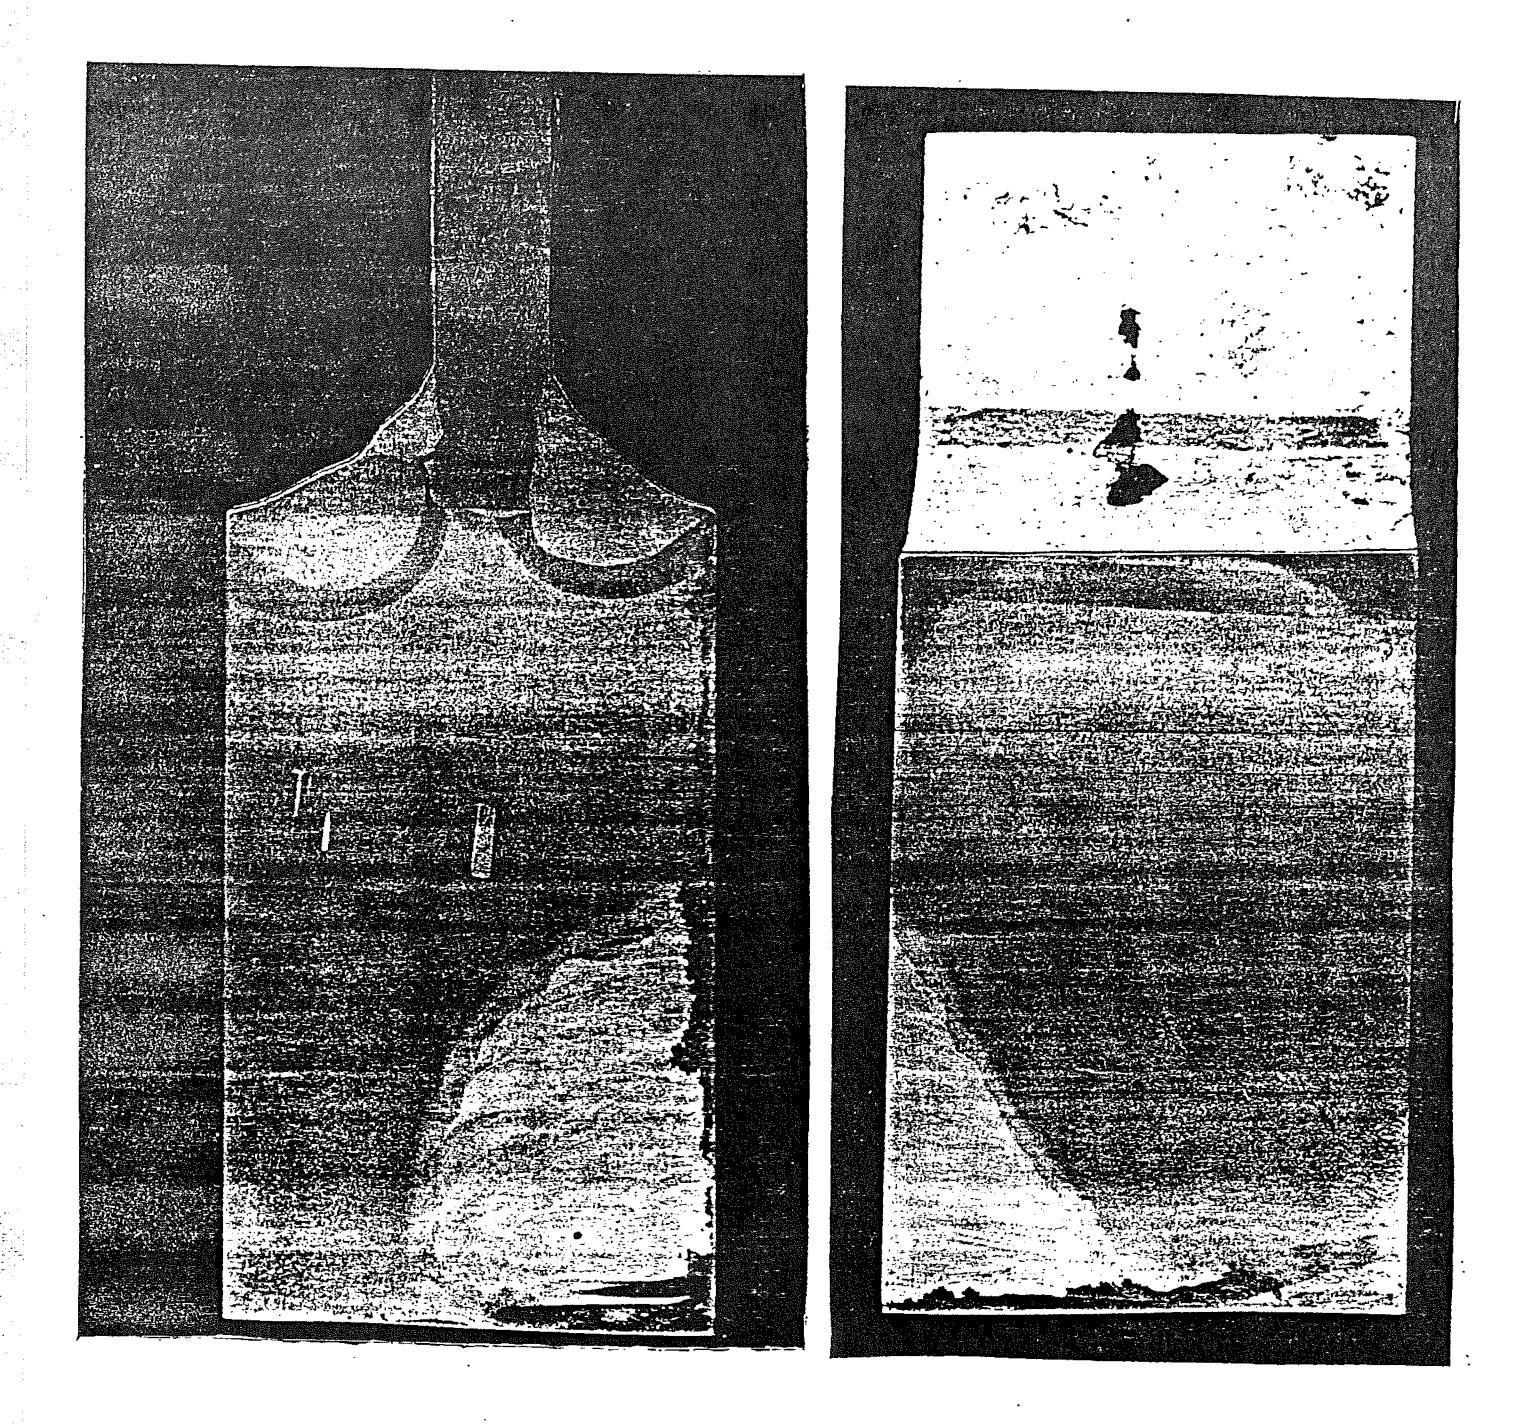
Fig. 53 Polished and Etched Surface of Piece K (see Fig. 25) Showing Weld Repair

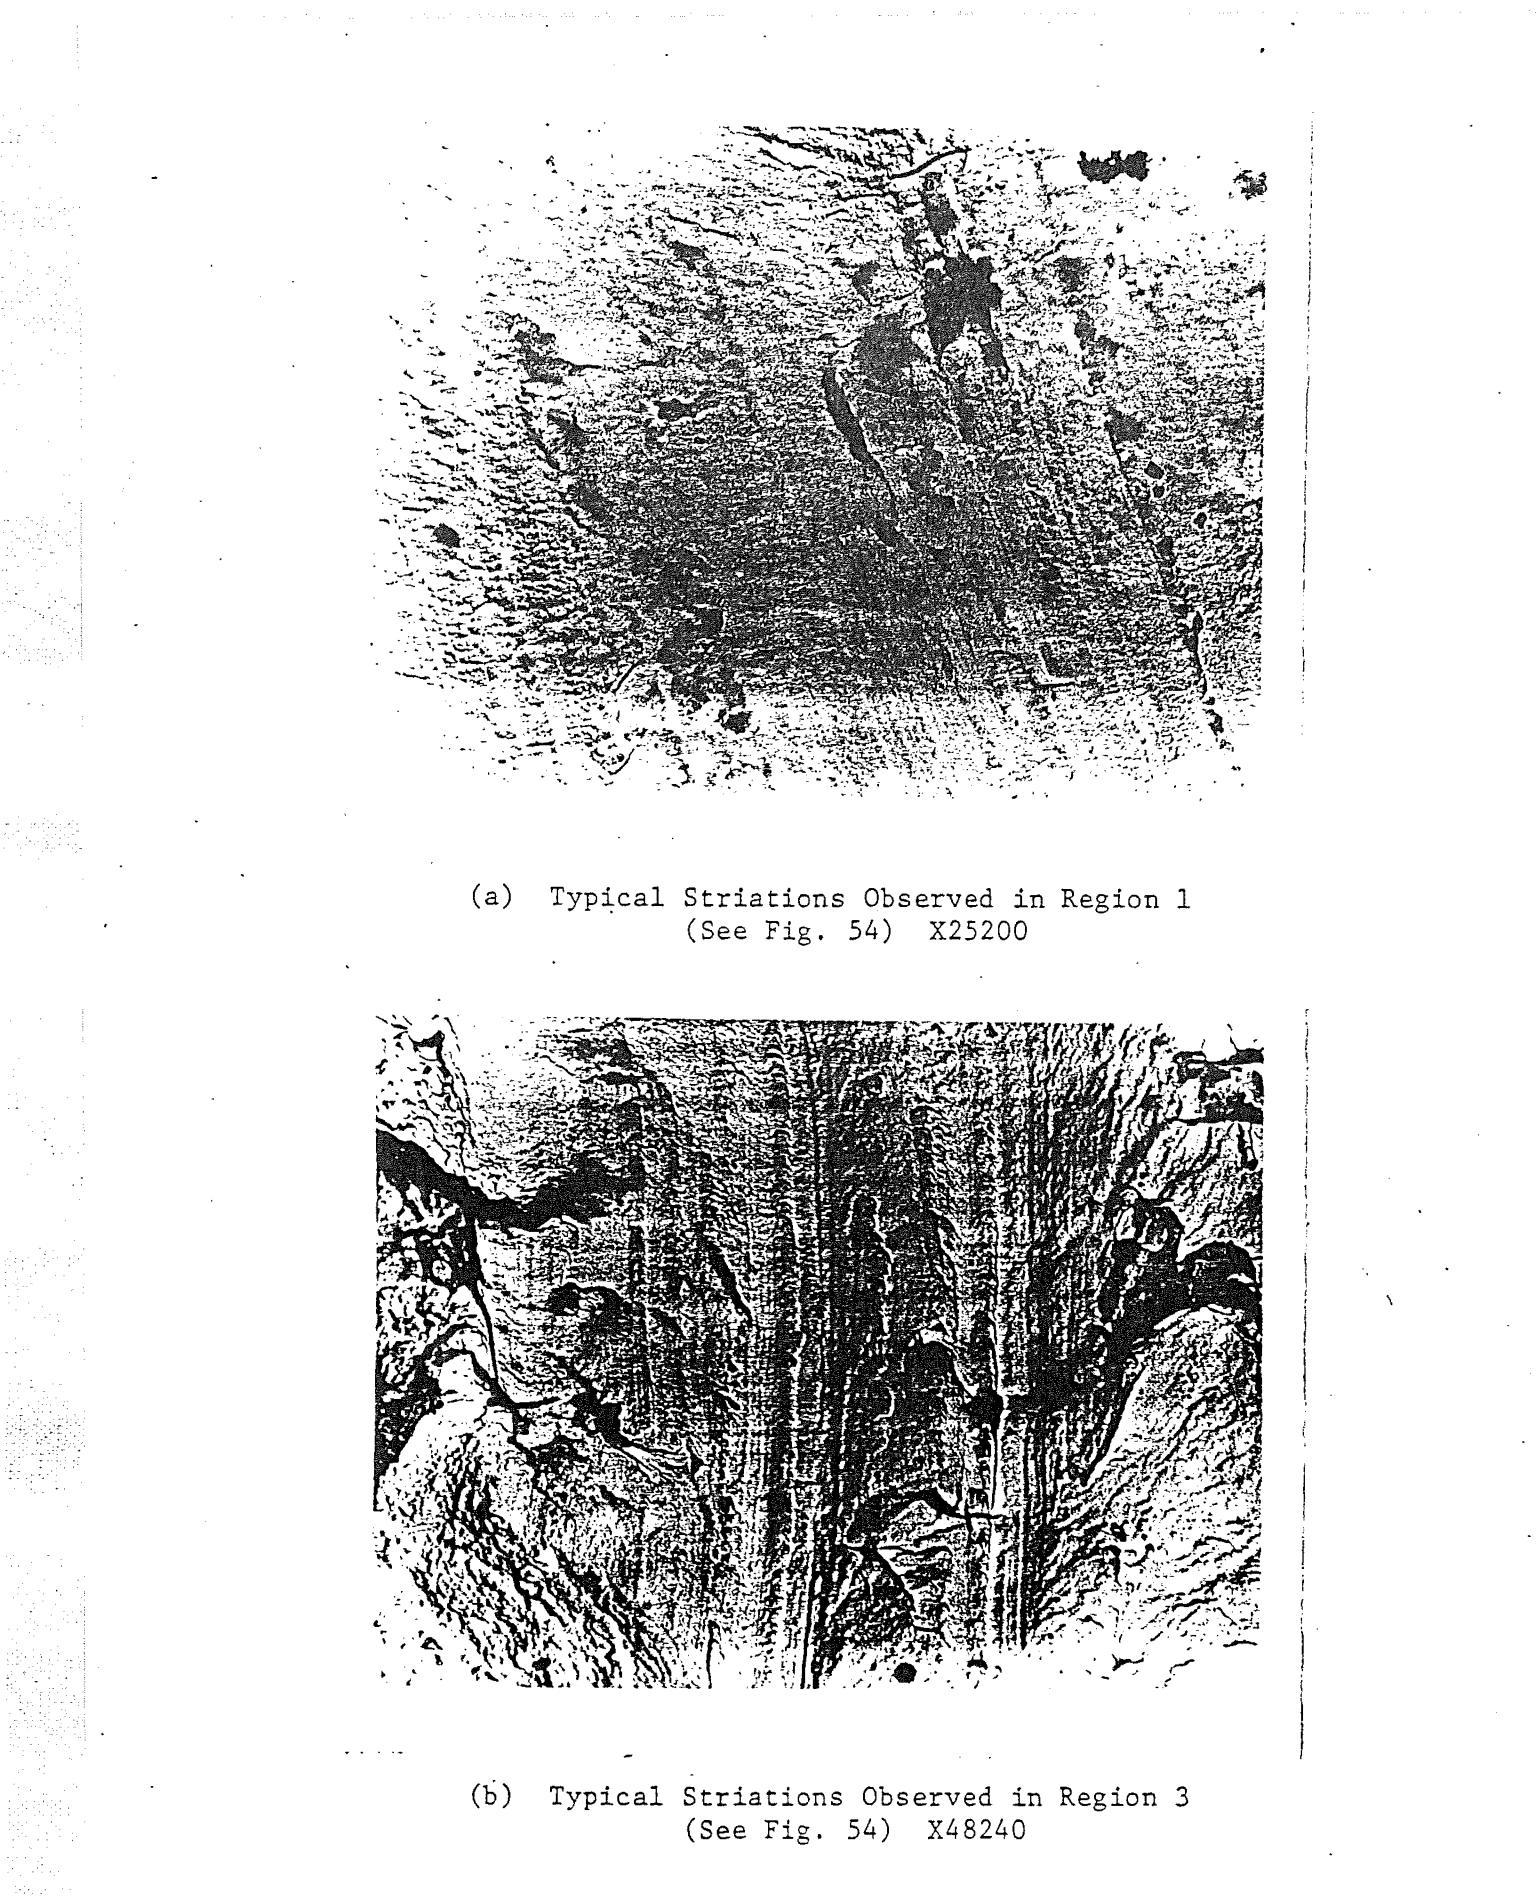
Fig. 55 Fatigue Crack Growth Striations Around Boundary of Initial Flaw

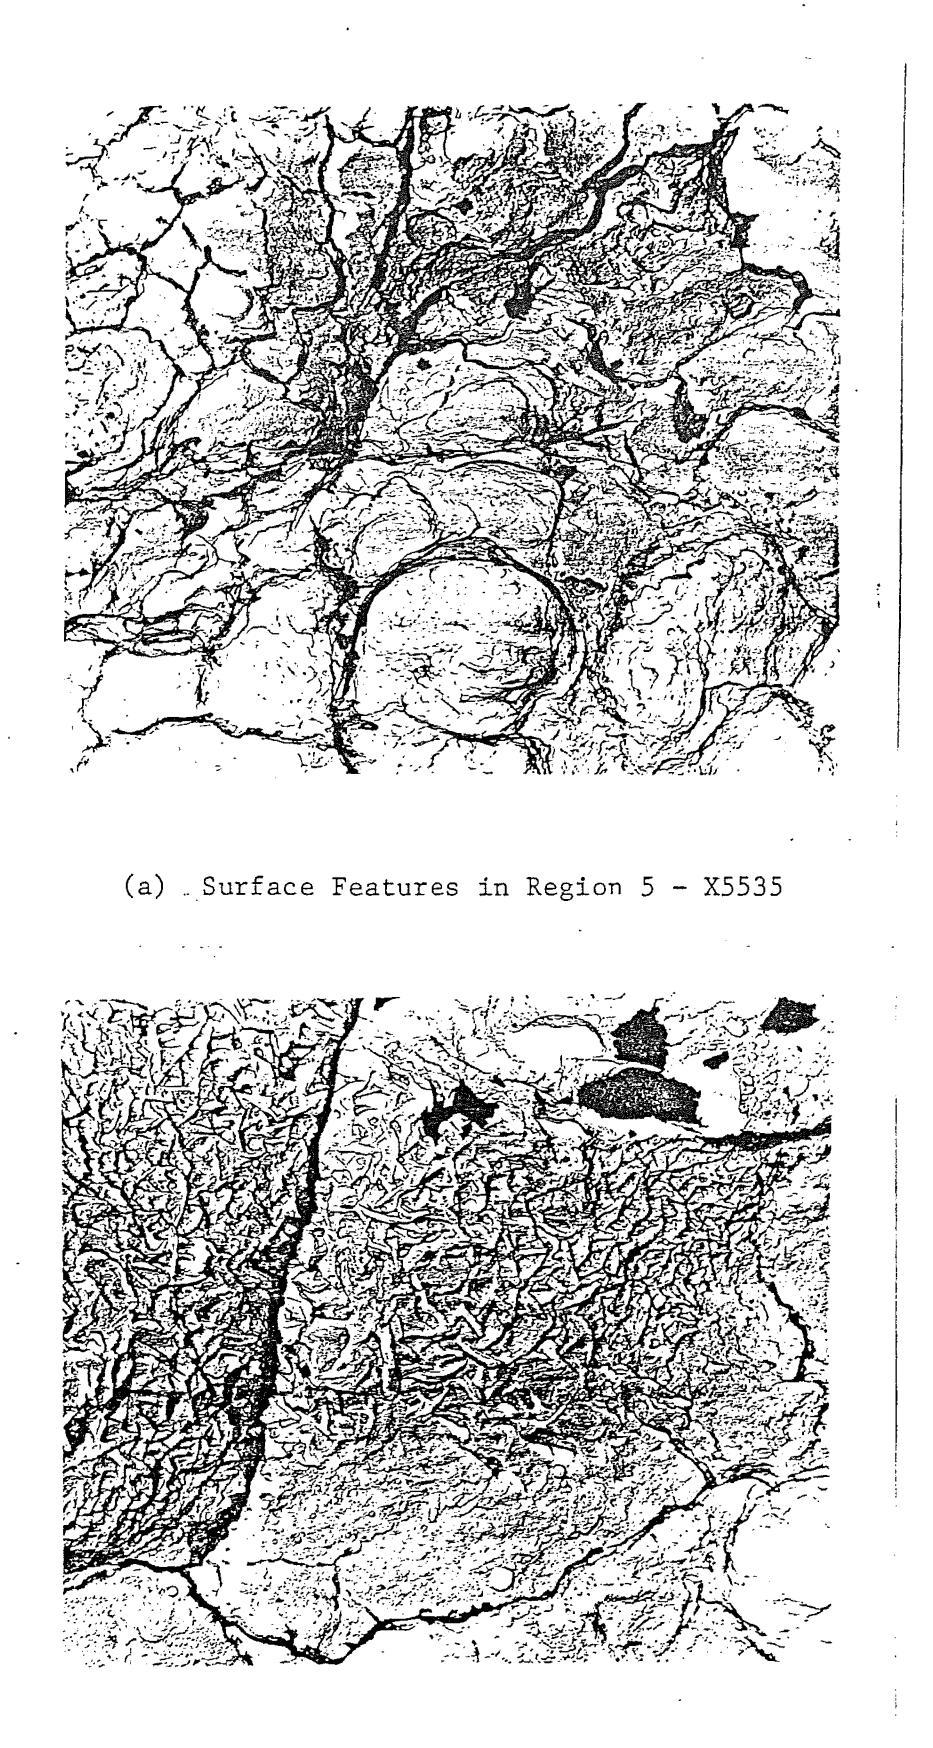
(b) Surface Features in Region 5 Showing Corrosion Product X2618

Fig. 56 Transmission Electron Microscope Photomicrographs of the Surface of Initial Flaw
