AN EVALUATION OF THE FRACTURE OF THE 179 BACK CHANNEL GIRDER

AND THE ELECTROSLAG WELDS IN THE 179 COMPLEX

Report No. 425-1(80)

Project 77-5: Evaluation of Glenfield Bridge Fracture

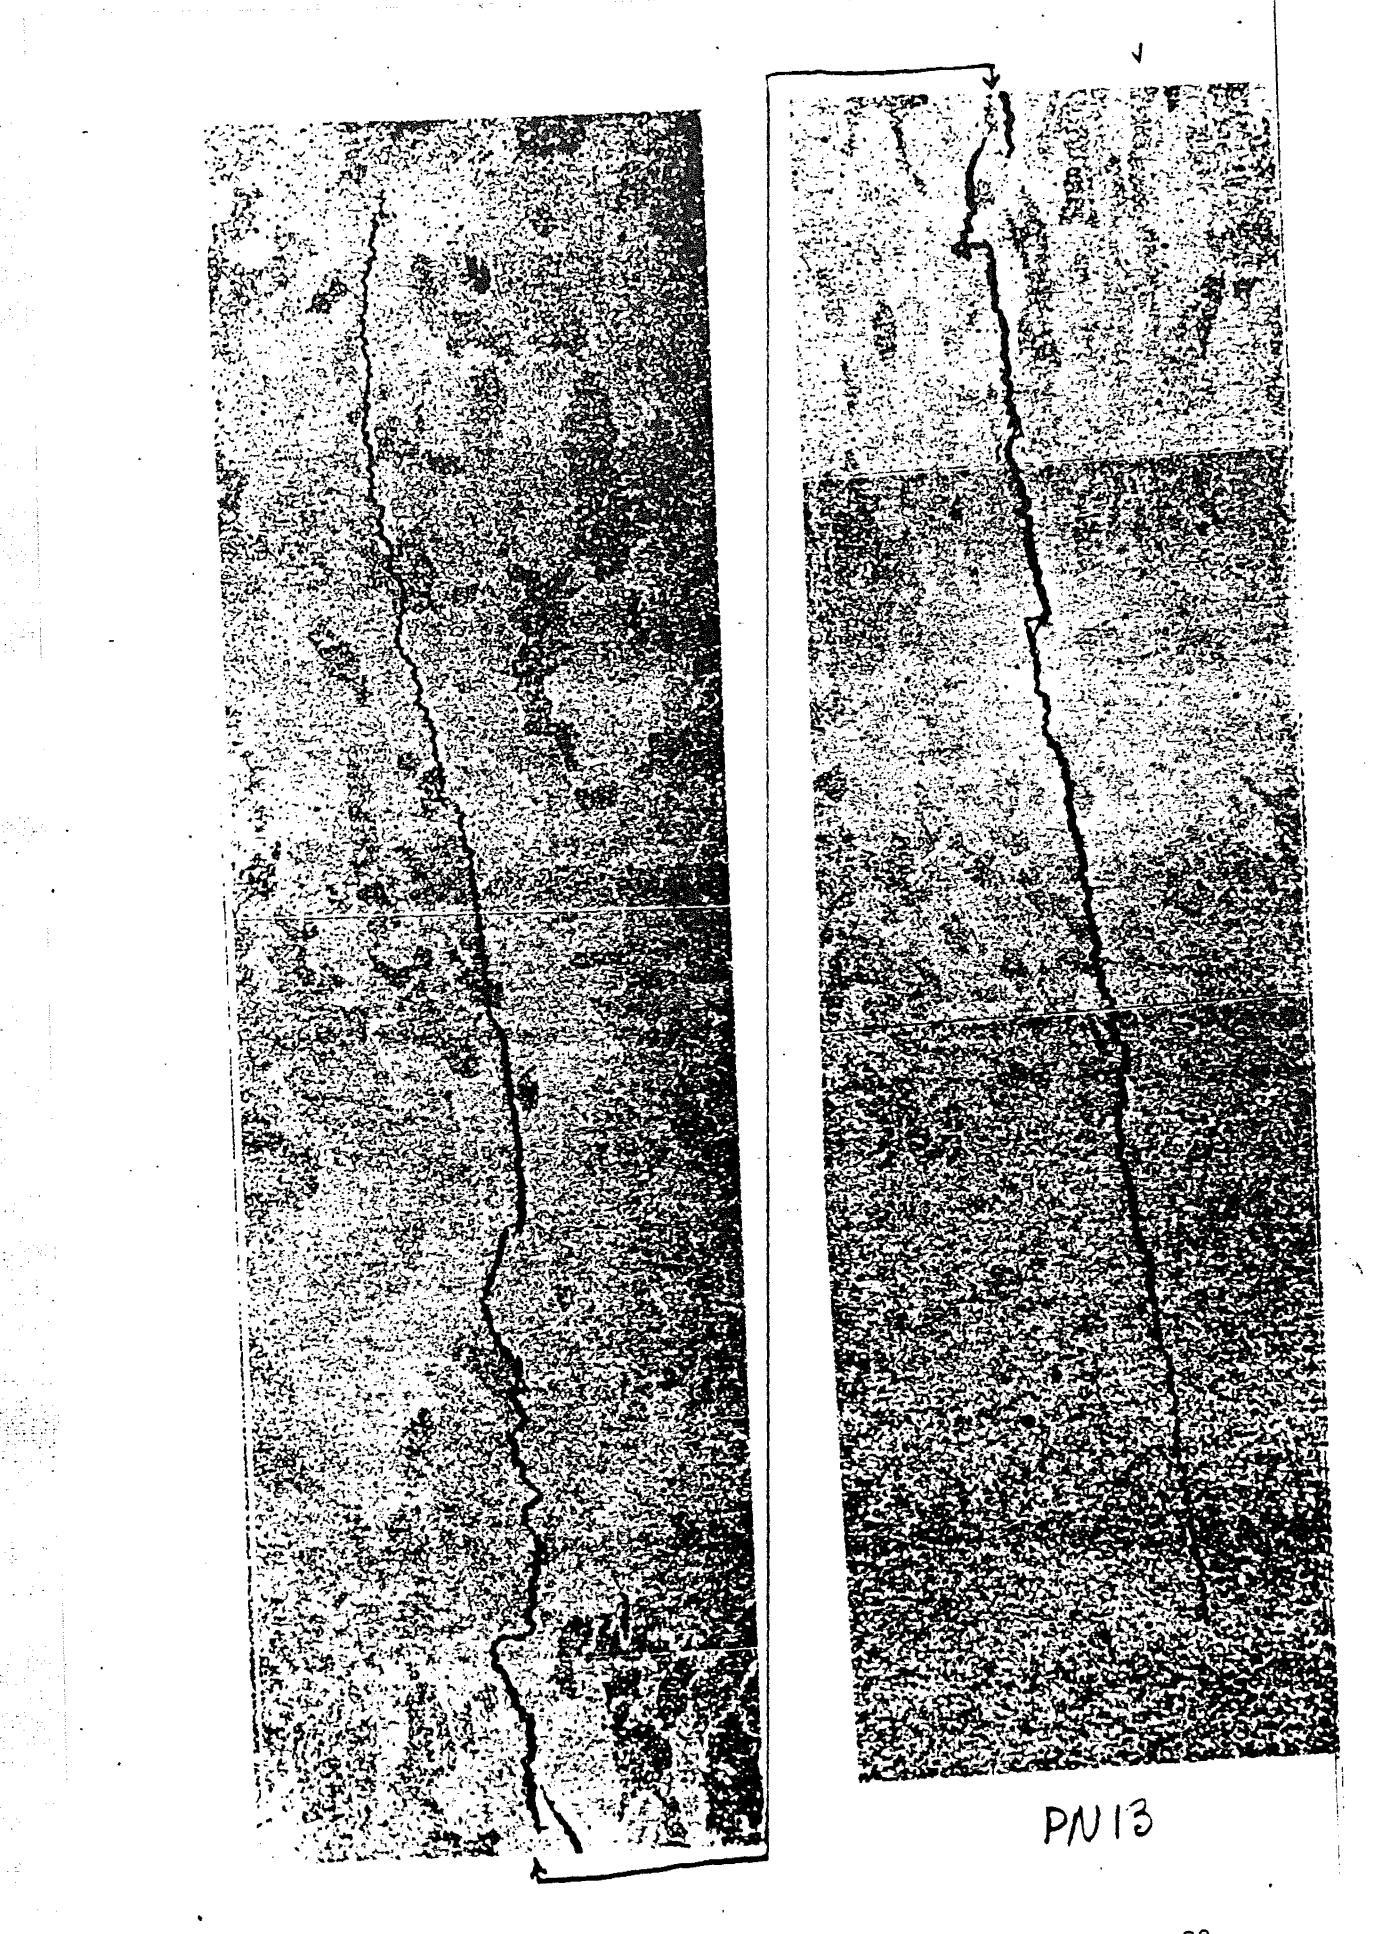
Fig. 58 Cross-section view of crack in area C2. (at C2-D2 surface) 40X Nital Etch

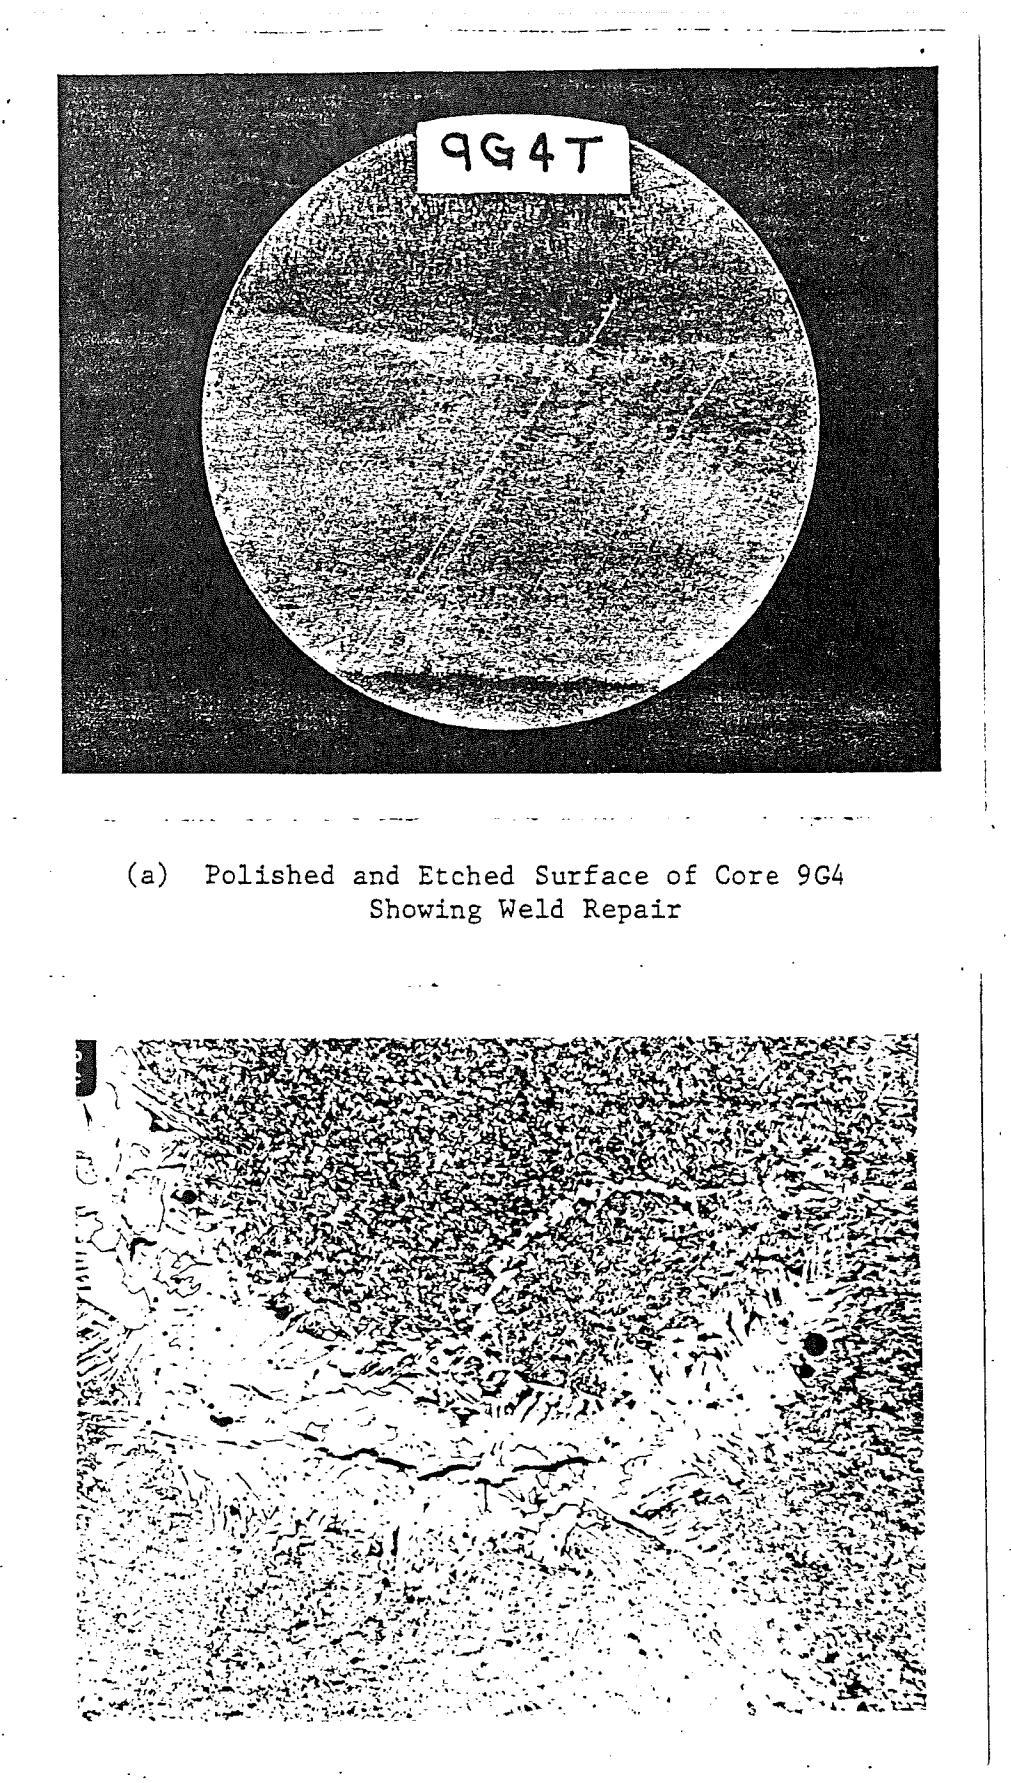
(b) Polished and Etched Surface of Core 9G1A Showing Small Grain Boundary Fissures

Fig. 61. Polished and Etched Surfaces of Electroslag Welds From Back Channel Structures

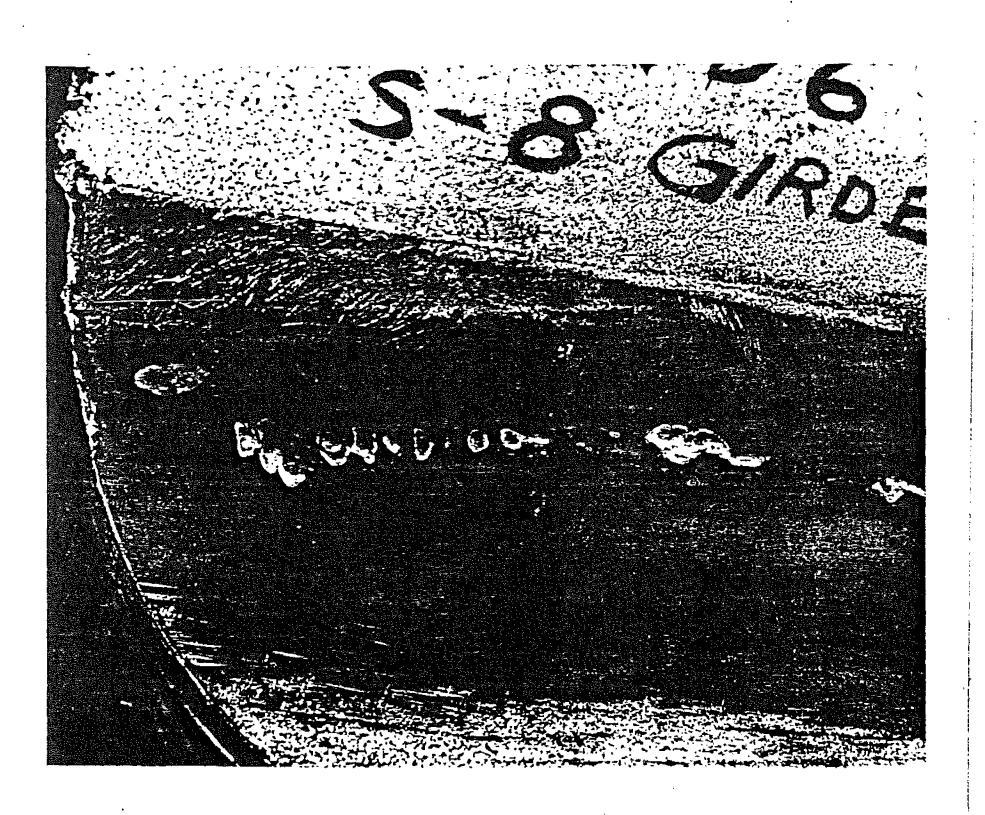
Fig. 64 Close-up View of Defect Region Showing Paint Filled Holes in Core

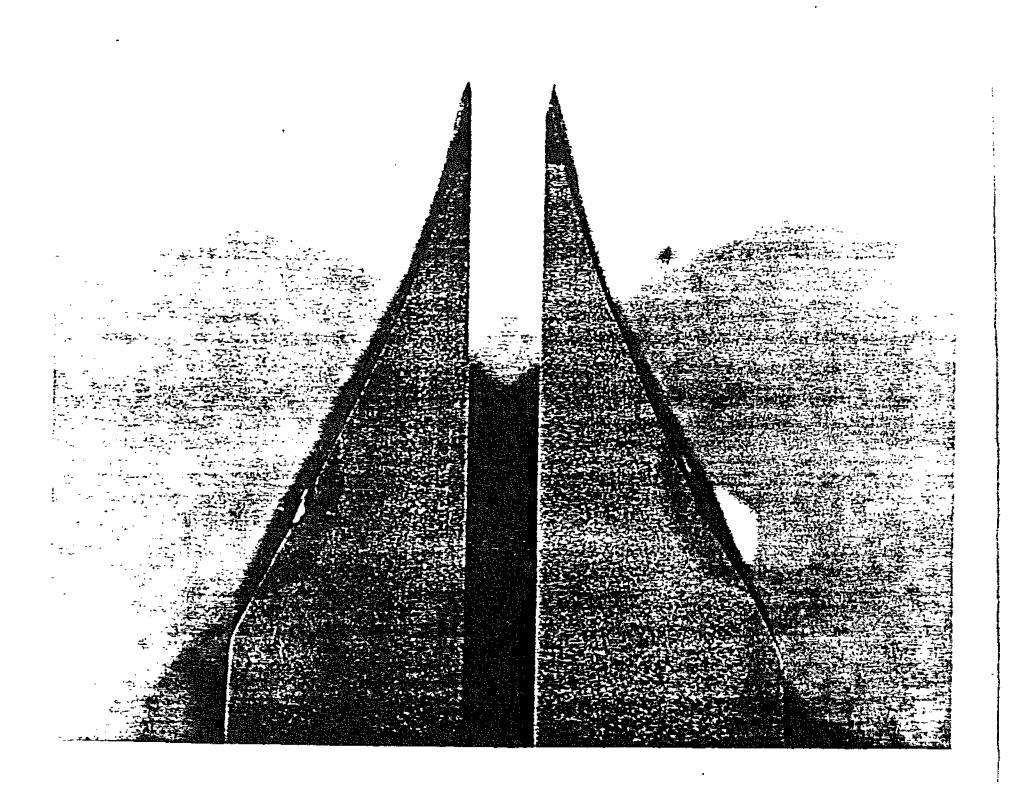
Fig. 66 Photographs of Weld Defects in Core Sample $"\ensuremath{\texttt{D}}"$
