Strength of rectangular composite box girders: testing of large size composite box girders

**TESTING OF LARGE SIZE
COMPOSITE BOX GIRDERS**

Report No. 380.11

1. Report No. FHWA/PA 82-012 ⁰¹⁰	2. Government Accession No.	3. Recipient's Catalog No.	
4. Title and Subtitle Testing of Large Size Composite Box Girders		5. Report Date April 30, 1982

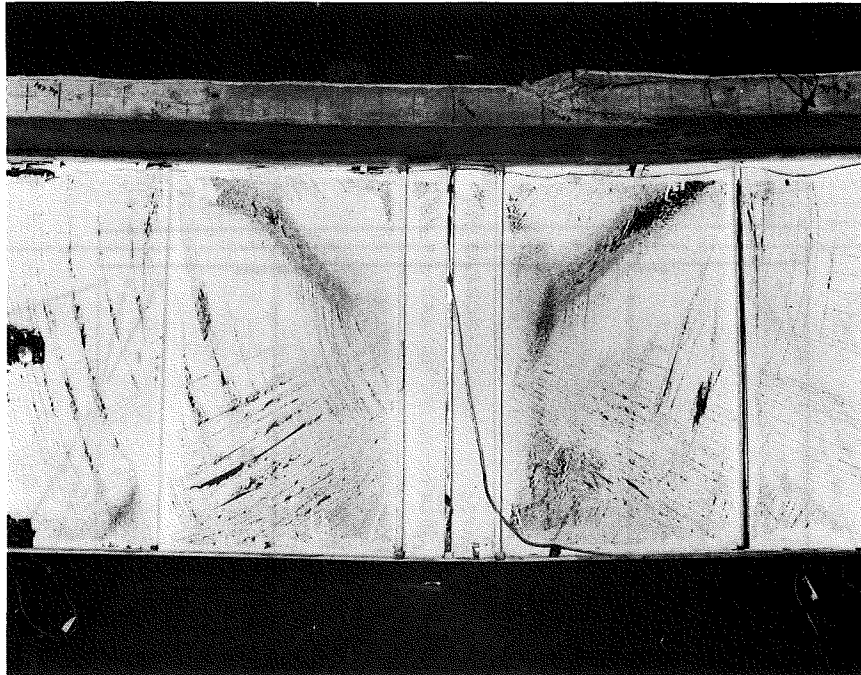
The general appearance of the failed area after testing is shown in Fig. 4.4. The crushed concrete deck, the typical tension field yield lines in the web,^(4.3) and the permanent deflected curve of the bottom flange can all be seen.

Fig. 4.4 Failure of Composite Box Grider

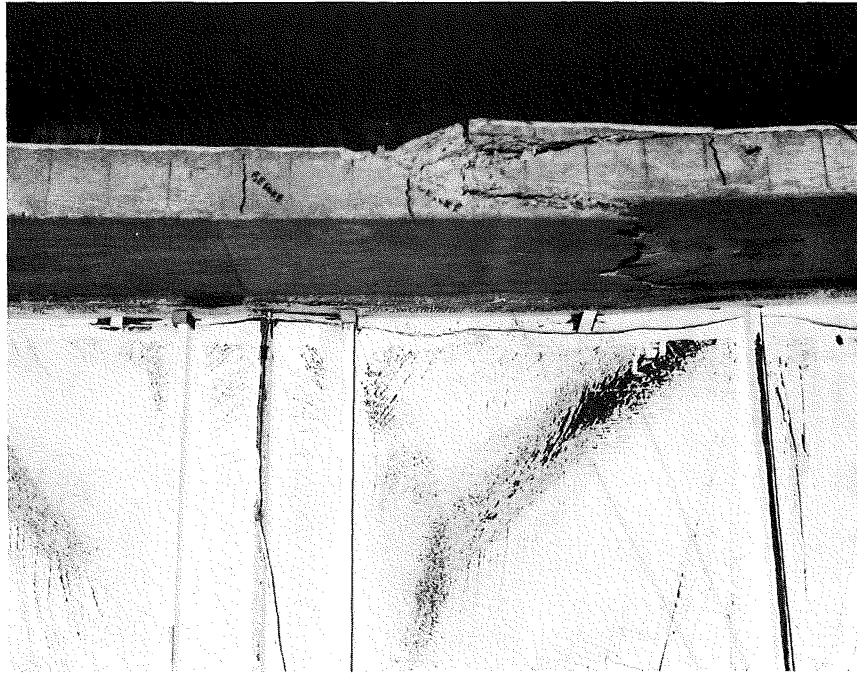
Figure 4.5 is a closeup photograph showing the failed deck and the nodal lines on the web surface. The bottom portion of the deck failed in tension due to bending of the deck. About 2 ft. away, the average deck strain was reduced after the deck failure. The load-strain relationship of the deck at $Z = 225$ in. is depicted in Fig. 4.6.

Fig. 4.5 Crushed Concrete Deck, Test L1 - CB

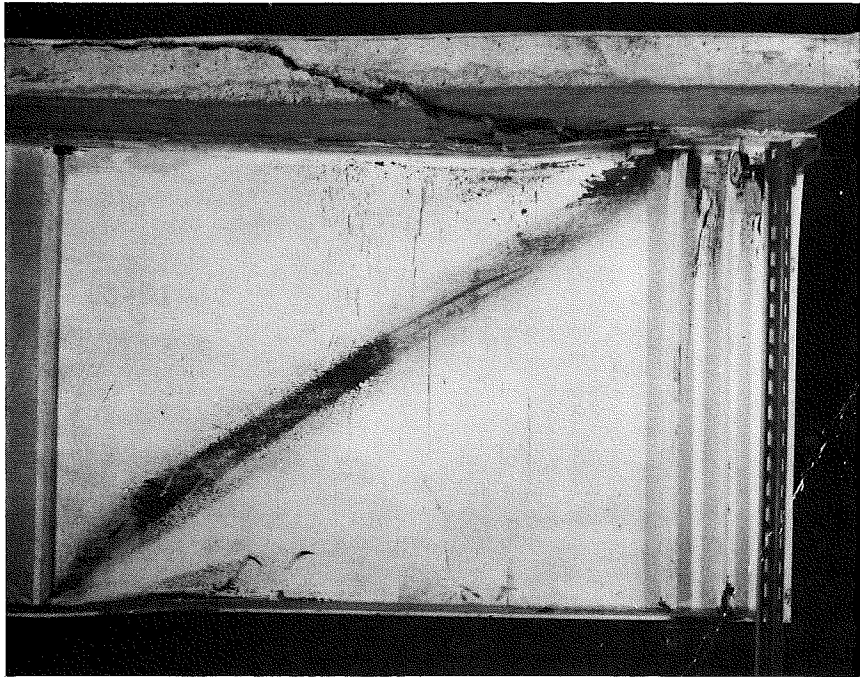
The failed end panel of the north web is shown in Fig. 4.8. The diagonal tension field was signified by the dark band in the web. The concrete deck was pulled down, causing a large crack, and the steel bottom flange was pulled up. Figure 4.9 shows the "kink" at the bottom flange and the general appearance of the composite box girder. The telltale diagonal mark of tension field can be seen in every panel. This is more obvious in Fig. 4.10. On the other side of the composite box girder, in the south web, tension field action also took place. Figure 4.11 shows the deflected web and transverse stiffener at $Z = 115$ in. of the south web.

By examining Fig. 4.8 carefully, it can be seen that the upper portion of the bearing stiffeners were bent. This is clearly shown in Fig. 4.12, a photograph taken after removal of testing apparatus. Figure 4.13 records the yield lines on the surface of the bearing stiffener at the end of the box girder. This type of failure condition is typical of end panels of plate girders when tension field action developed in the end panel. For test L2-CB, the second panel from the west end had a longer panel length with an aspect ratio of 1.2, thus developed tension field action earliest. However, because the flanges were not subjected to high stresses, failure did not take place in this panel. It was the inability of the end bearing stiffeners to resist the tension field components that lead to the failure of the concrete deck.

Fig. 4.8 Failed North Web and Flanges of West End
Panel (L2 - CB)

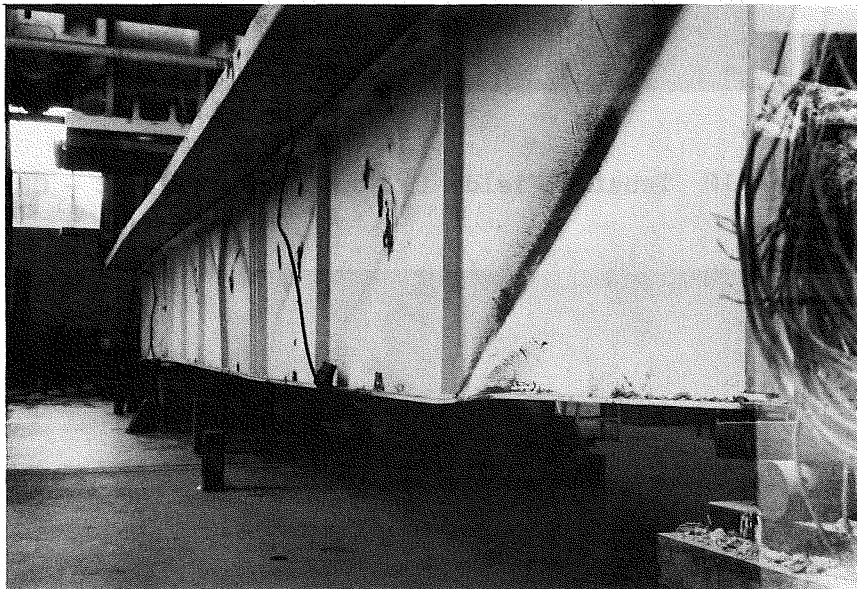
Fig. 4.9 Deflected Steel Bottom Flange
Test 12 - CB

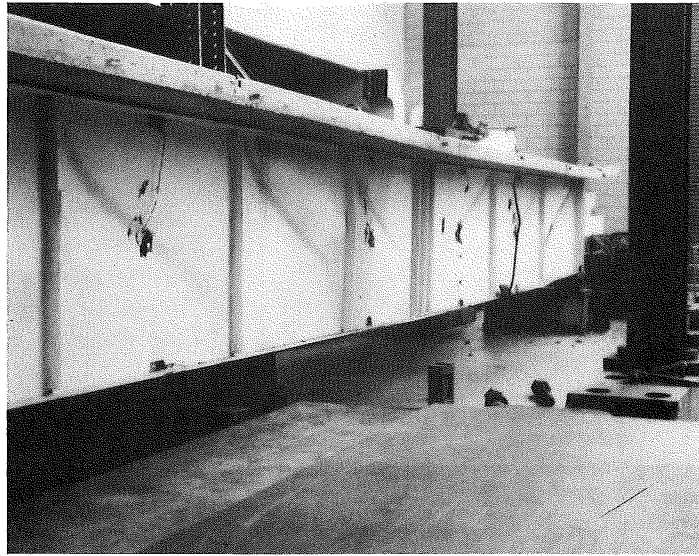
Fig. 4.10 Tension Fields in North Web, Test L2 - CB

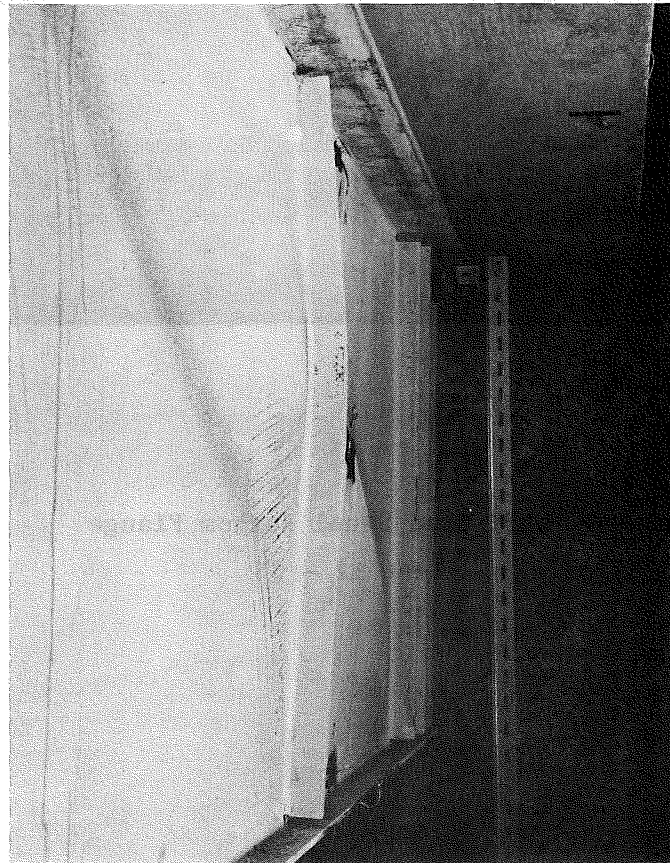
Fig. 4.11 Tension Field and Bent Stiffener, South Web,
Test L2 - CB

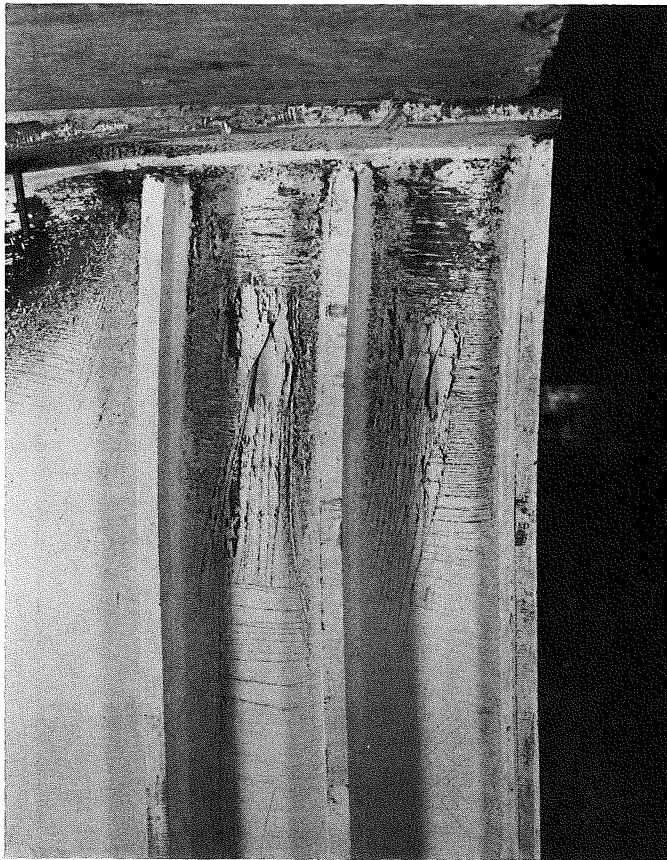
Fig. 4.12 Deformed End Bearing Stiffeners
Test L2 - CB

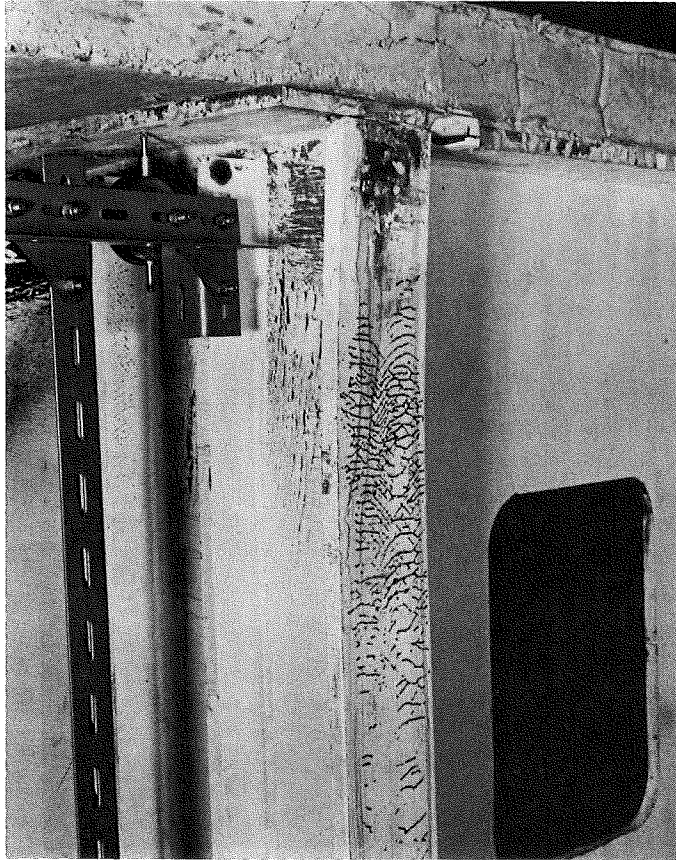
Fig. 4.13 Yield Lines on End Bearing Stiffener
Test L2 - CB

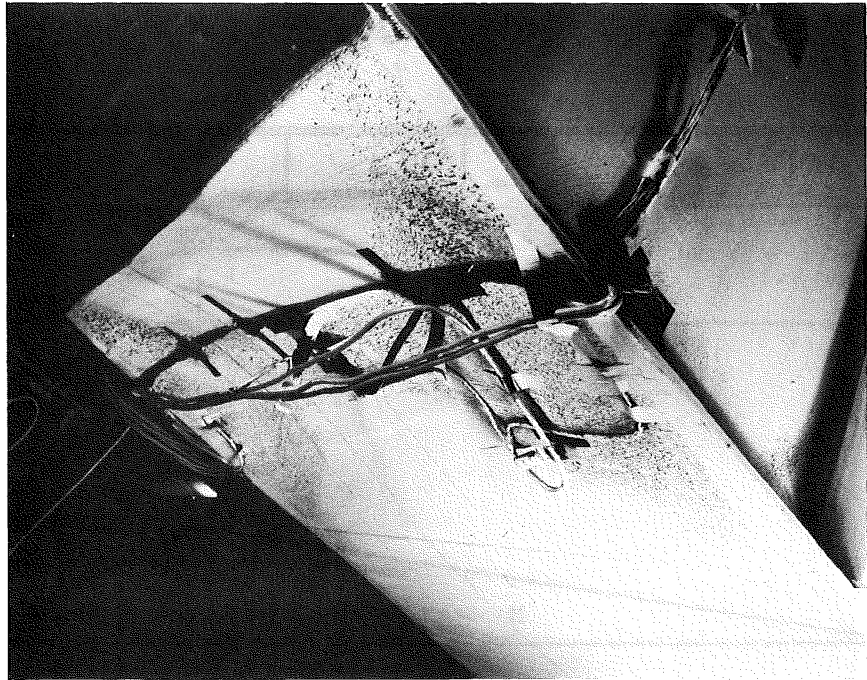
The failed steel bottom flange of Test L1-CD is shown in Fig. 5.2. The photograph shows an inclined view from below the flange. It was located in the second panel from the support C, and was in panel 11 of Fig. 5.1. As the flange buckled (deflected) gradually with the increasing magnitude of the applied load, the deflection of the

Fig. 5.2 Failed Compression Flange, Panel 11, L1-CD

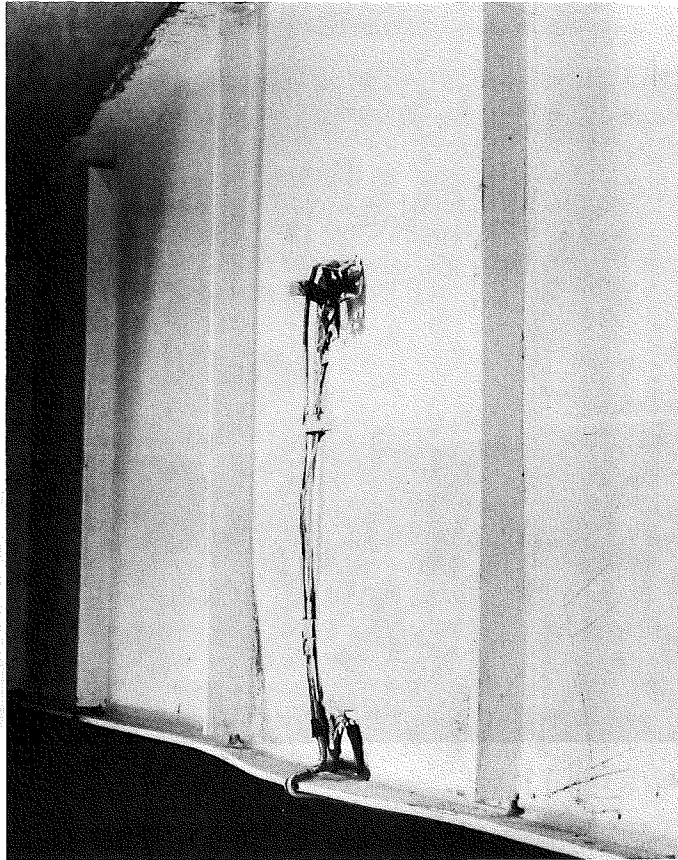
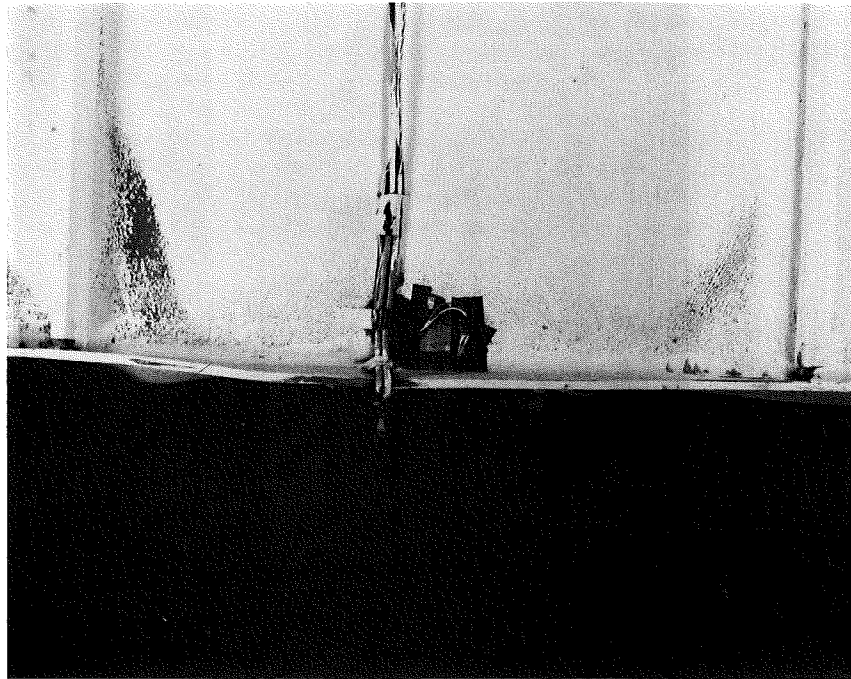
steel flange plate caused bending of the webs. The partially failed south web of the panel is shown in Figs. 5.3 and 5.4. The composite box girder had one side of a panel failed, a second side started to fail, but the box girder had not reached its load carrying capacity. In order to preserve the composite box girder for other tests, (that is, Test L1-CB), the applied load was removed.

Fig. 5.3 Deflected Bottom Flange and South
Web of Panel 11, L1-CD

Fig. 5.4 Yielding of Web at Bottom Flange, Panel 11,
L1-CD

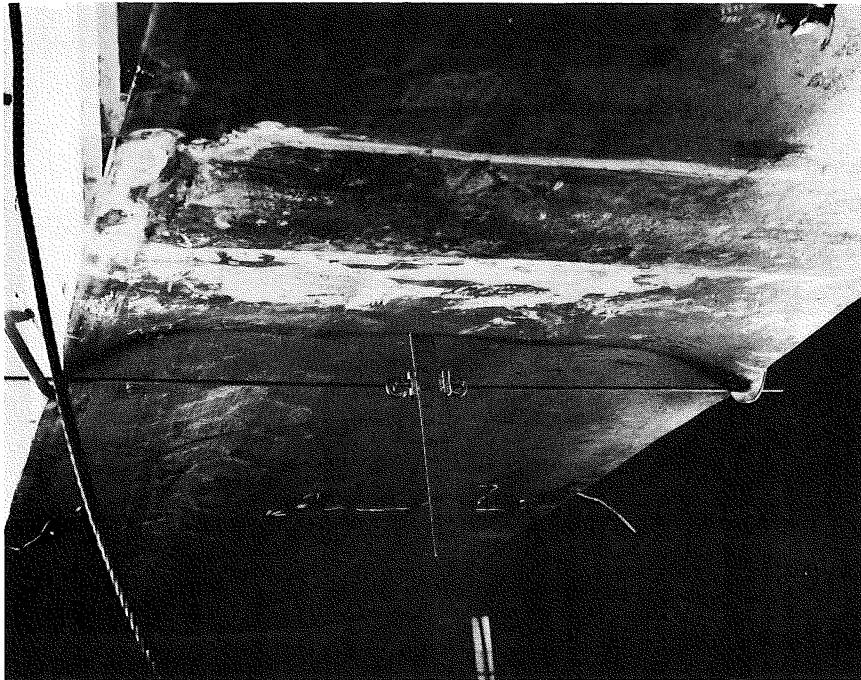
When test L1-CD resumed after testing the single span portion in positive bending and torsion, the box girder sustained a maximum load of 282.5 kips. Failure again was initiated by buckling of the steel bottom flange. Figure 5.7 shows the profile of the bottom compression flange at location of failure. (The whitewash had been brushed away).

The failure was in the first panel from the support, panel 12 (see Fig. 5.1). The compression flange deflected (buckled) gradually as load was increased. The deflection caused the webs to bend. Yielding of the web-to-flange junctions then took place. The webs subsequently failed. The component parts of the box girder panel was

Fig. 5.7 Failed Compression Flange, Panel 12, L1-CD

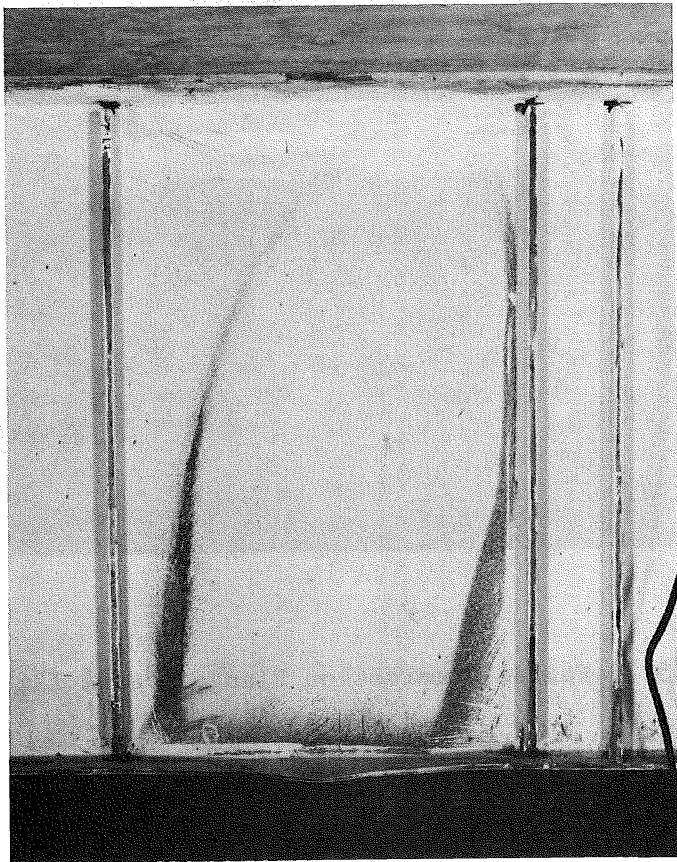
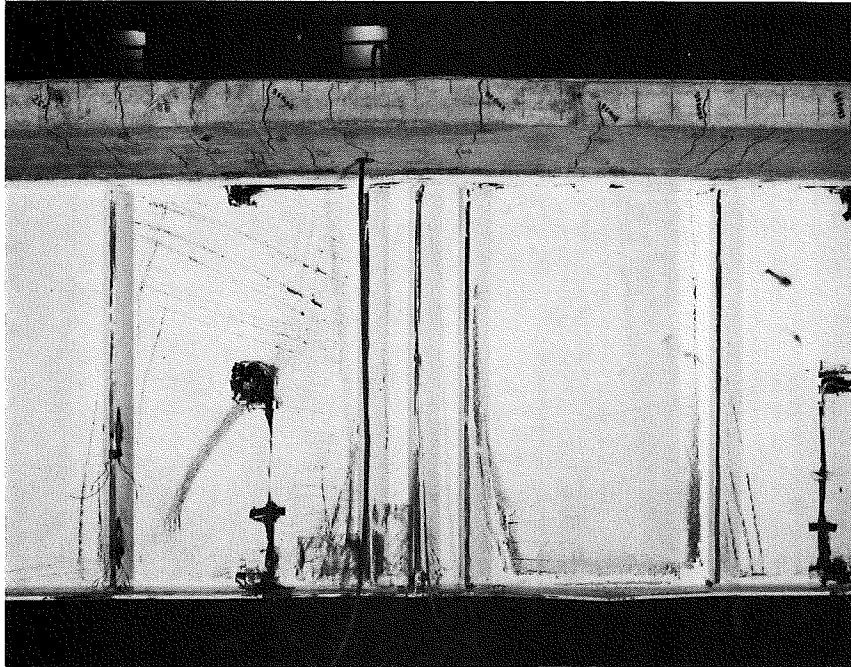
The appearance of the south web and north web after testing are shown in Figs. 5.8 and 5.9, respectively. The failed web panel in Fig. 5.9 is the first to the right of three bearing stiffeners. The locally deflected steel compression flange can be seen clearly. This failure mode was analogous to that of Fig. 4.4 (with the concrete compression flange on top), and is typical of steel plate girders. (4.3)

Fig. 5.8 Failed South Web, Panel 12, L1-CD

Fig. 5.9 Failed North Web of Panel 11 and Tension Field Diagonal in Panel 13, L1-CD

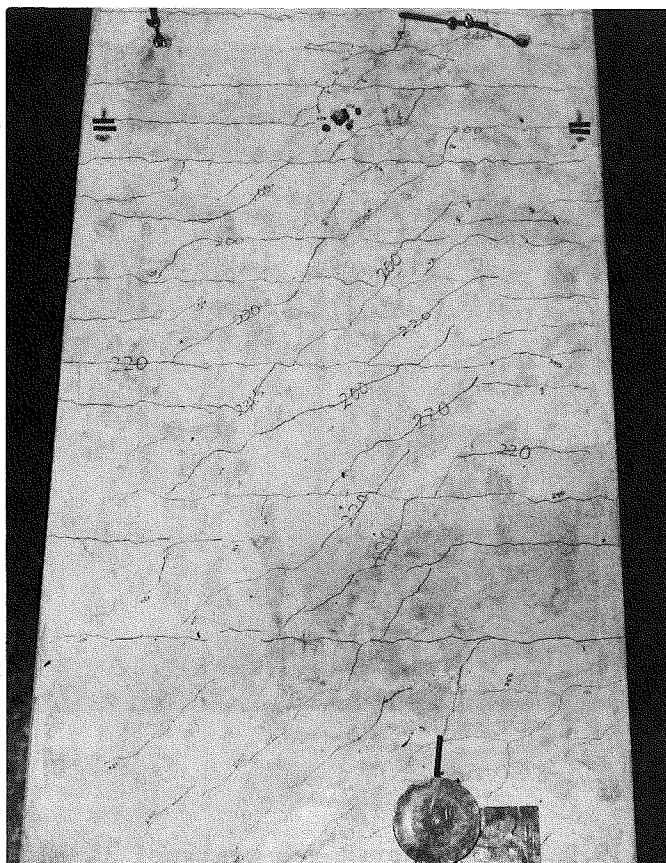
The concrete deck was the tension flange of the composite box girder under negative bending moment. Small cracks transverse to the length of the deck existed when the box girder was under its own weight in the testing position. When the magnitude of the applied load increased, these cracks widened and grew deeper. The widened cracks concentrated primarily over the region of the interior support. Under higher and higher loads, these cracks spread toward the loading end and the centerline of the anchoring span, while diagonal cracks started to appear near the support C. More and more diagonal cracks formed closer and closer to the load point as the applied load got higher and higher. Figure 5.10 shows a bird's eyeview of the crack pattern on the surface of the concrete deck of the overhanging portion. The cracks were marked by black ink and the magnitudes of the applied load were also indicated. The load point is at the lower righthand corner; those two holes for lifting cables were directly over support C.

Fig. 5.10 Concrete Deck after Test L1-CD,
Overhand Span

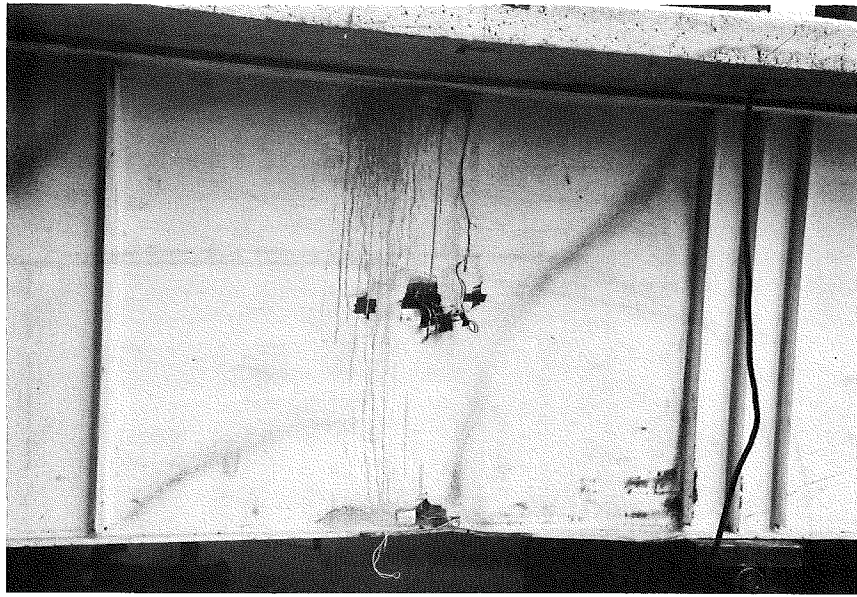
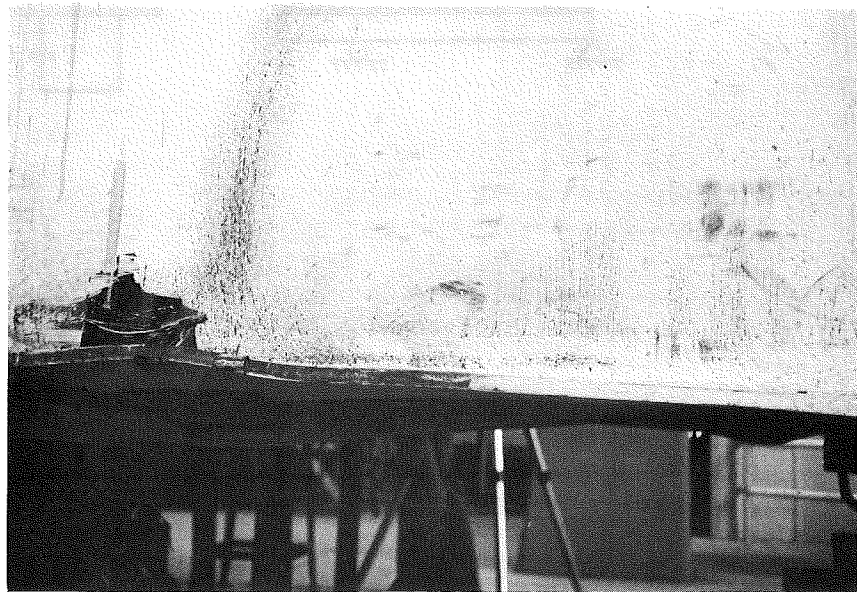
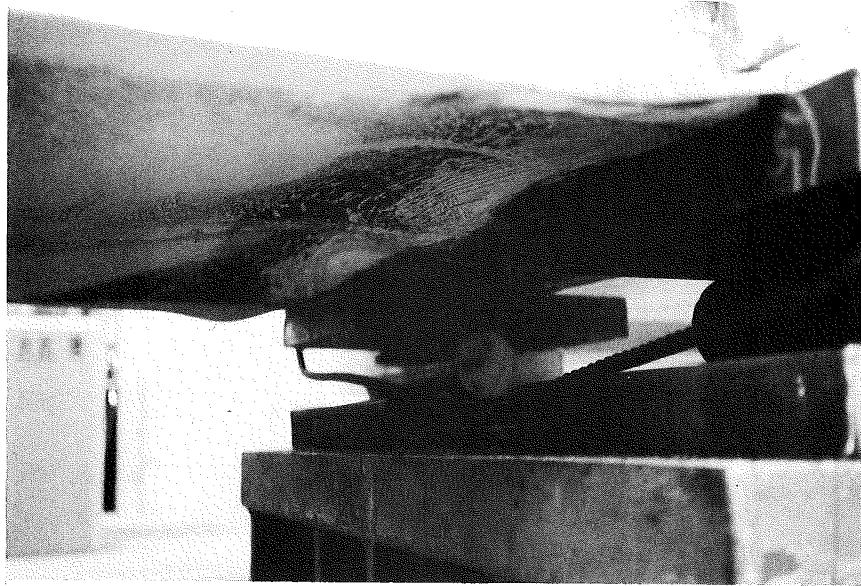
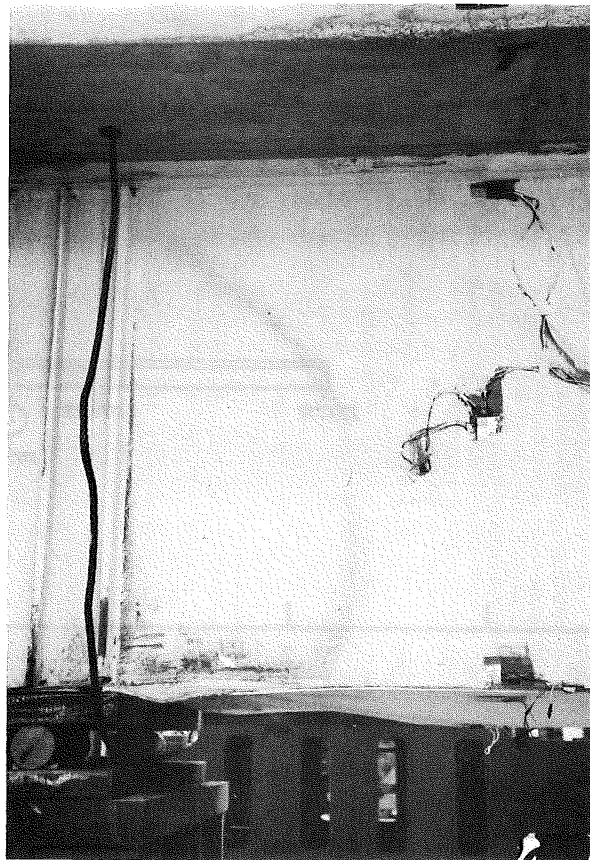
Failure was in panel 8 (see Fig. 5.1), the first panel of the overhanging portion of the composite box girder. The appearance of the failed webs and bottom flange after testing are shown in Figs. 5.16 to 5.19. Figure 5.16 shows that the north web of this panel developed a diagonal tension field and the flange failure caused the tension field troughs to bend toward the flange buckle. A closeup photograph of the buckled flange at the end of the curved trough is shown in Fig. 5.17. The flange buckle spread over a length of about three feet from the support. The buckled, very wavy compression flange after completion of testing is shown in Fig. 5.18. At the south web next to the support the flange buckled, tension field yield band developed, and local yielding occurred directly above the support. These can be seen in Fig. 5.19.

Fig. 5.16 North Web of Failed Box Panel 8, L2-CD

Fig. 5.17 Buckled Bottom Flange and Yielded Web, L2-CD

Fig. 5.18 Buckled Compression Flange at Support Test, L2-CD

Fig. 5.19 Failure at Bottom Flange and South Web, L2-CD

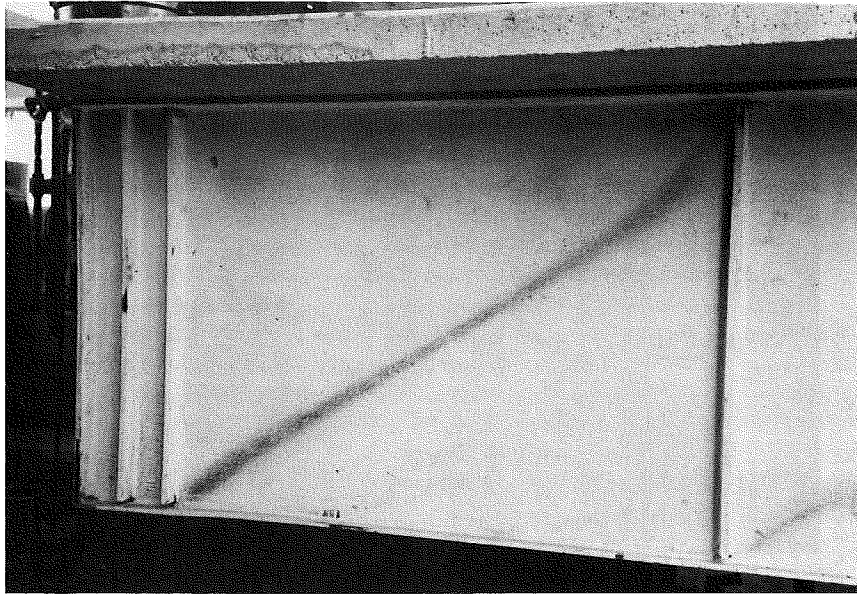
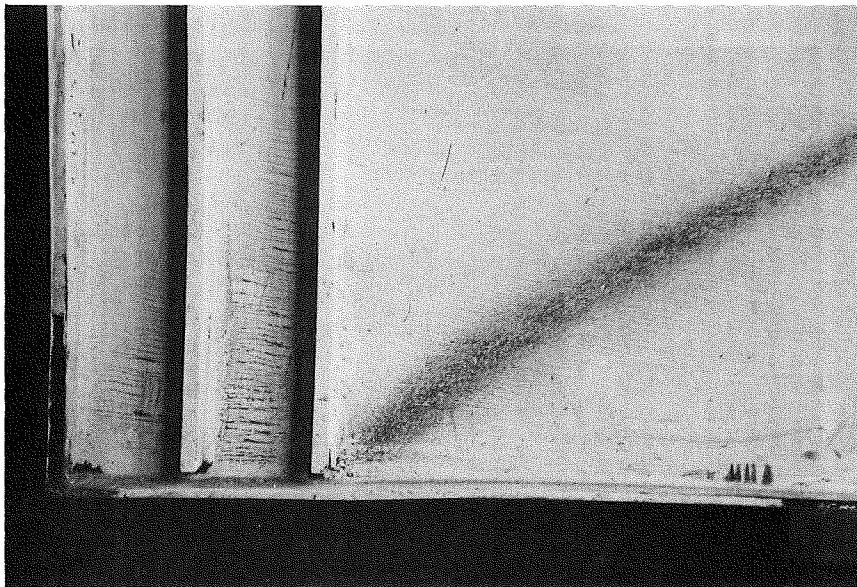
While additional deflections were imposed on the composite box girder, the north web of the end panel near the load point incurred the typical tension field failure at end bearing stiffeners. (4.3) Figure 5.21 is an overall view of the web panel and Fig. 5.22 shows the yielded zone between the stiffeners and the slightly bent flange. Comparison of Figs. 5.21 and 5.22 with Figs. 4.8 and 4.12 reveals the similarity between the failure of the end panels. In the case of a steel flange, the resistance to the vertical component of the tension field force was relatively low; the flange bent. For the Test L2-CB the composite compression flange was fairly rigid against vertical pull; the end bearing plates were bent before the compression flange was cracked.

Fig. 5.21 Tension Field in North Web of End Panel, Test L2-CD

Fig. 5.22 Yielding at Stiffener and Bending of Bottom Flange
End Panel, L2-CD

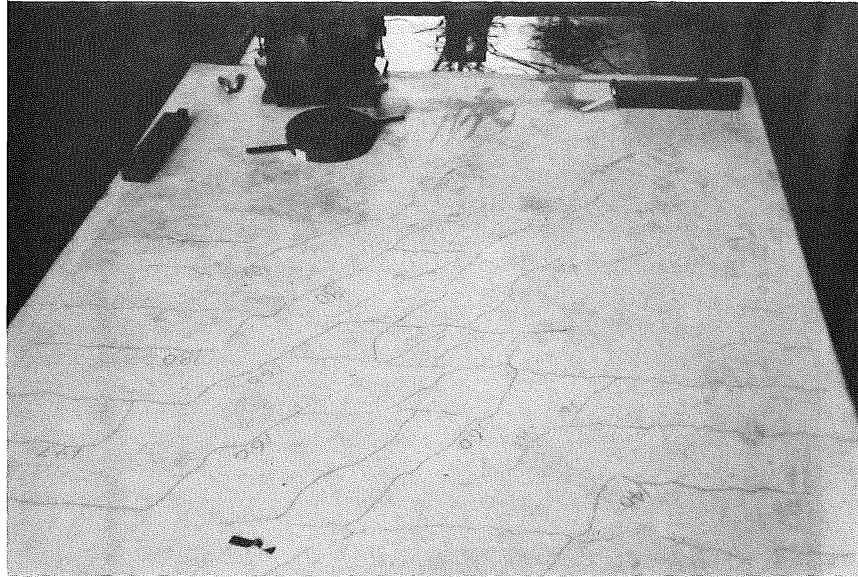
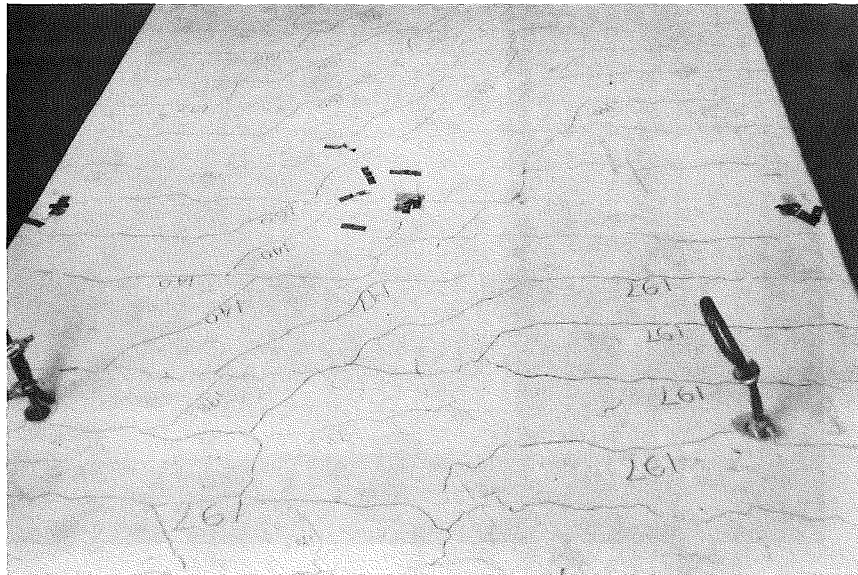
For Test L2-CD, the concrete deck was in tension. The existence of hair cracks before application of loads and the crack patterns during testing were similar to the conditions of Test L1-CD, described in Section 5.1. The transverse and diagonal cracks are shown in Figs. 5.23 and 5.24, two photographs taken after testing and removal of all loads.

Fig. 5.23 Cracks on Concrete Deck Surface over End Panel,
L2-CD

Fig. 5.24 Cracks on Concrete Deck Surface over Panel 8,
L2-CD
