# Laboratory and Field Fatigue Investigation of Cantilevered Signal Support Structures in the City of Philadelphia

# FINAL REPORT

ATLSS Report No. 04-22

October 2004

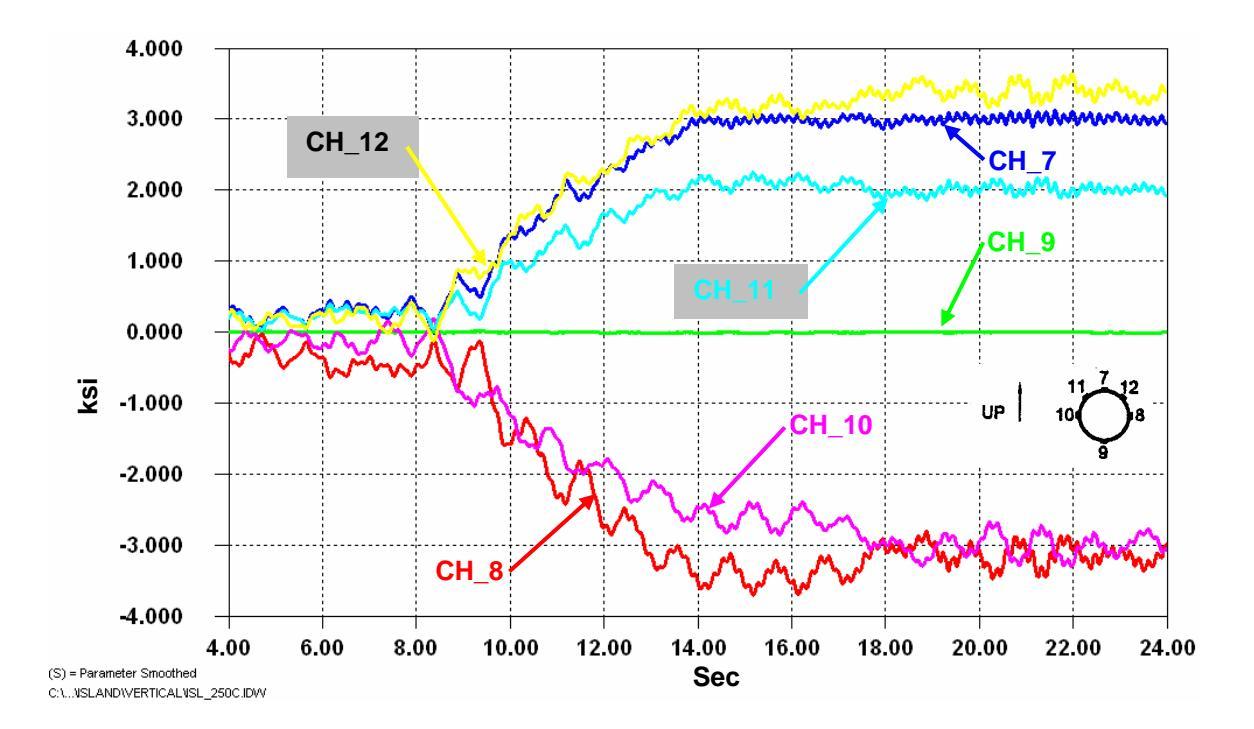
Figure 4.6 presents the response in the <u>mast-arm</u> as the 100 lb load was applied. The response is considerably different than expected and observed in the mast-arm at 84<sup>th</sup> street. Channel CH\_9 indicates nearly no compressive stress is carried through the bottom portion of the mast-arm. However, channels CH\_8 and CH\_10, which are located at the theoretical neutral axis (*for vertical bending*), show that the mast-arm is subjected to a significant compression stress at the mid-depth. All instrumentation was closely checked to verify that the measured behavior was not due to mis-wiring or some other problem. It was found that all instrumentation was working properly and that the measured stresses were correct.

Figure 4.6 - Stresses in mast-arm adjacent to flange plate connection to pole as 100 lb vertical load is applied at tip of mast-arm (Island Ave. and SR 291)

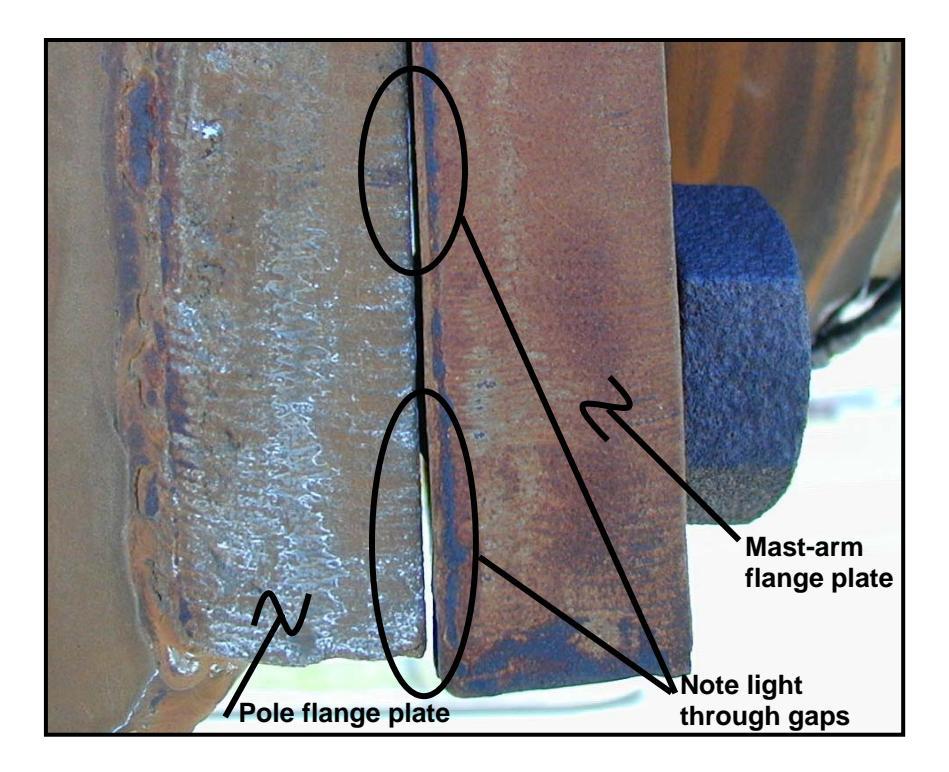
In order to establish the cause of the observed behavior, a close-up inspection was made of the upper mast-arm flange connection. The inspection revealed that the flange plates were not in full contact, especially at the lower portion of the connection. Figure 4.7 is a photograph of this detail and clearly shows the gap between the flange plates. Although all four bolts appear to be tight, the preload was apparently insufficient to close the gap.

It is clear from the photograph that there is no contact between the flange plates at the elevation where the bottom portion of the mast-arm tube is welded to the flange plate. Hence, there is no path for compression stresses in the bottom of the tube to follow into the flange plate.

Figure 4.7 - Photograph of flange plate connection showing gap between plates (Island Avenue and SR 291)

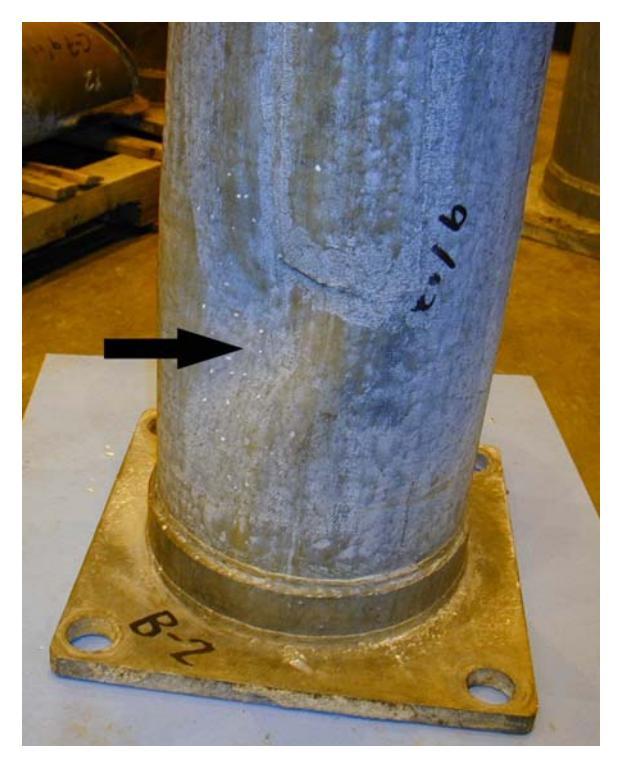
Figure 7. Damage typical to Samples B-2 and B-4

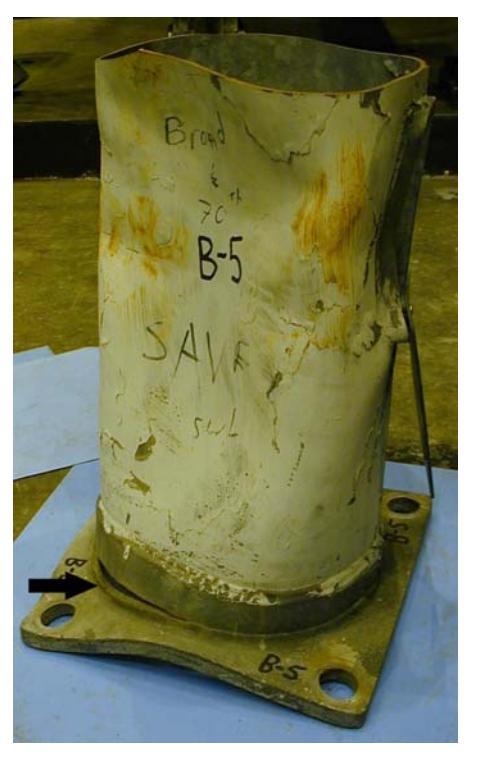
Figure 8. Damage to Sample B-5

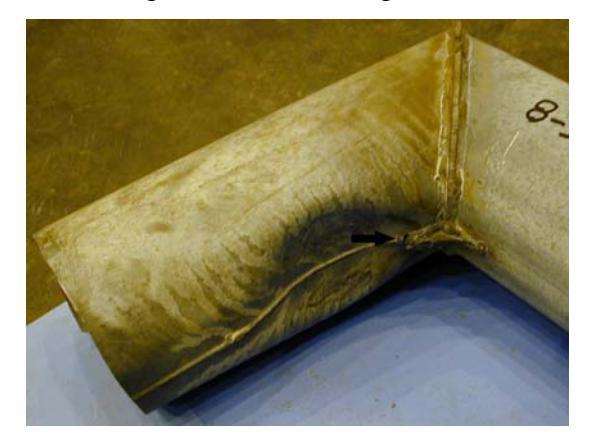
Figure 9. Localized damage to sample C-8

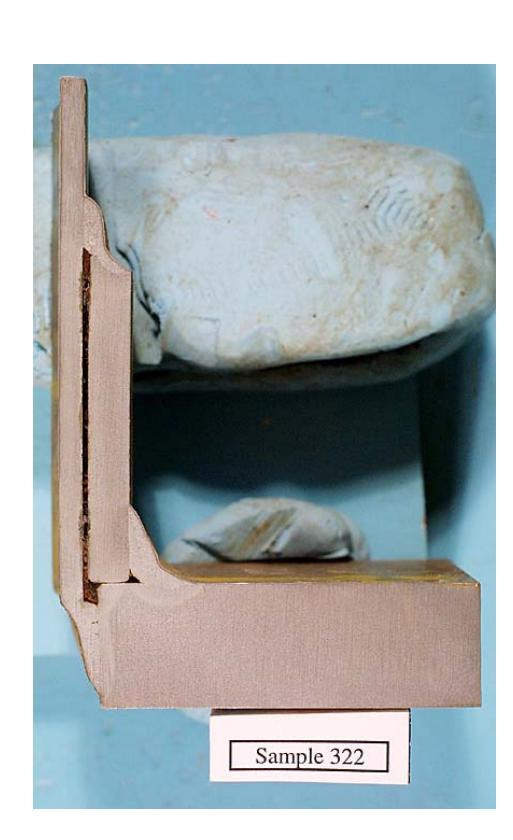
The primary weld defects encountered in the base plate and end plate weld details were as fabricated incomplete fusion and inadequate joint penetration. A typical baseplate section is shown in Figure 20, indicating the three fillet welds, Weld A, Weld B, and Weld C, which make up the baseplate to column connection. (Note that Figure 20 applies equally to the typical end plate section.) The similarity between the end plate and base plate samples is illustrated in Figures 21 and 22.

Figure 21. Inadequate penetration in a baseplate sample (Weld B)

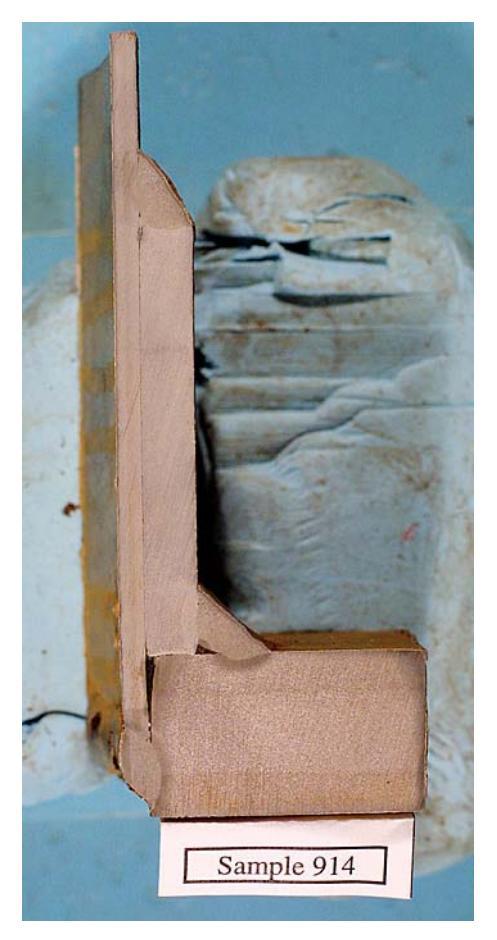
Figure 22. Inadequate penetration in an endplate sample (Weld B)

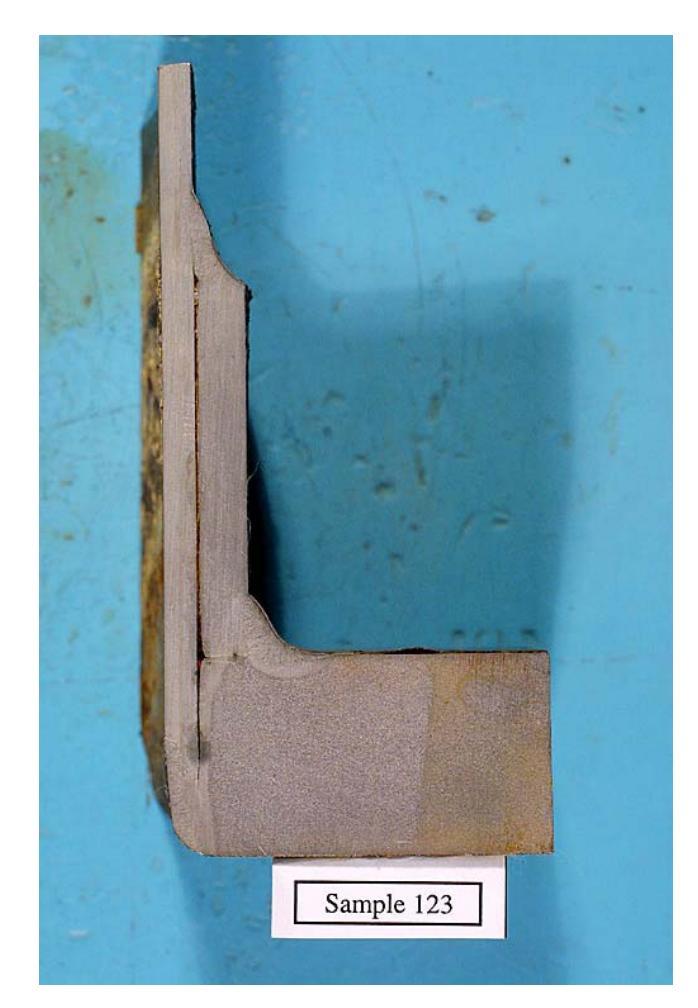
Figure 23. Incomplete fusion weld defect

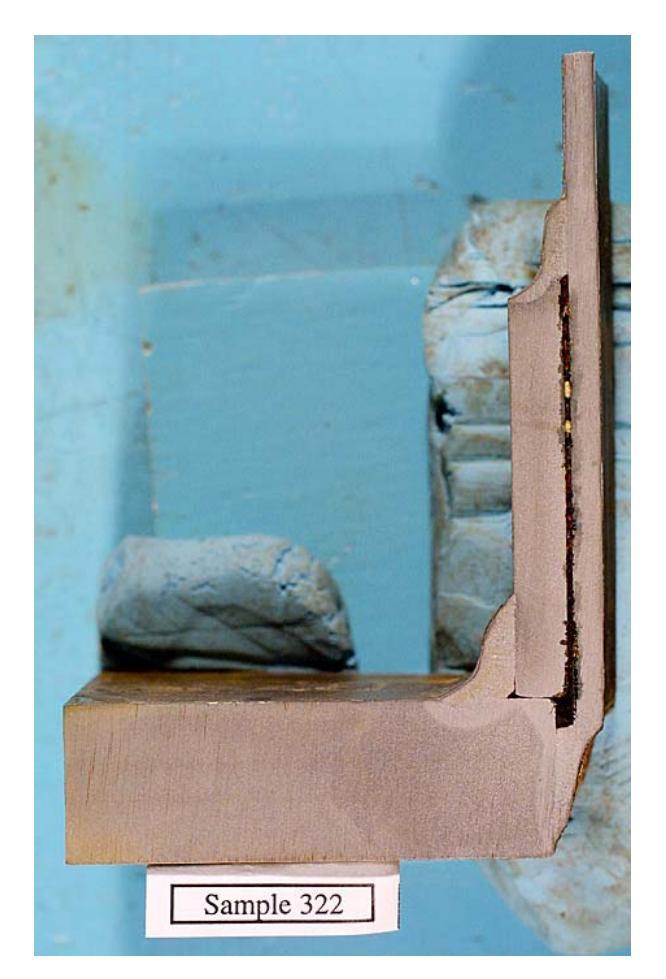
Figure 24. Combination inadequate penetration/incomplete fusion weld defect

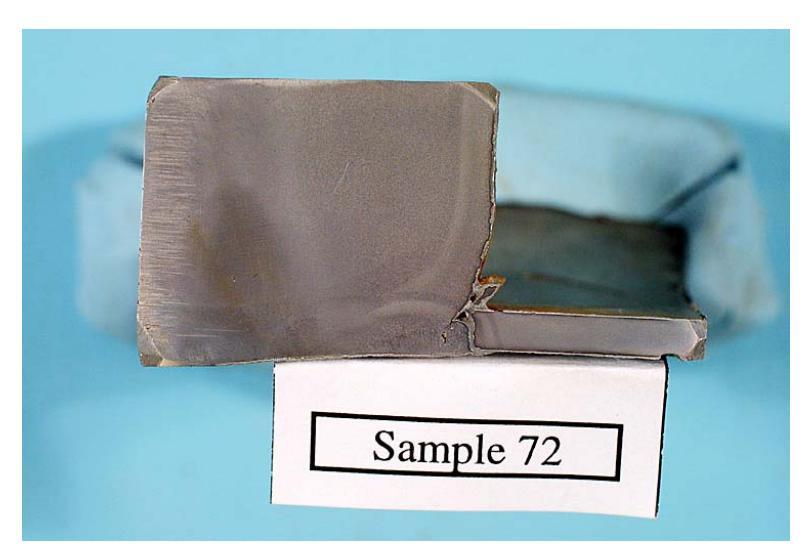
Figure 25. Corner style column to mastarm connection sample. Note zinc finish penetrating through to the outer surface.

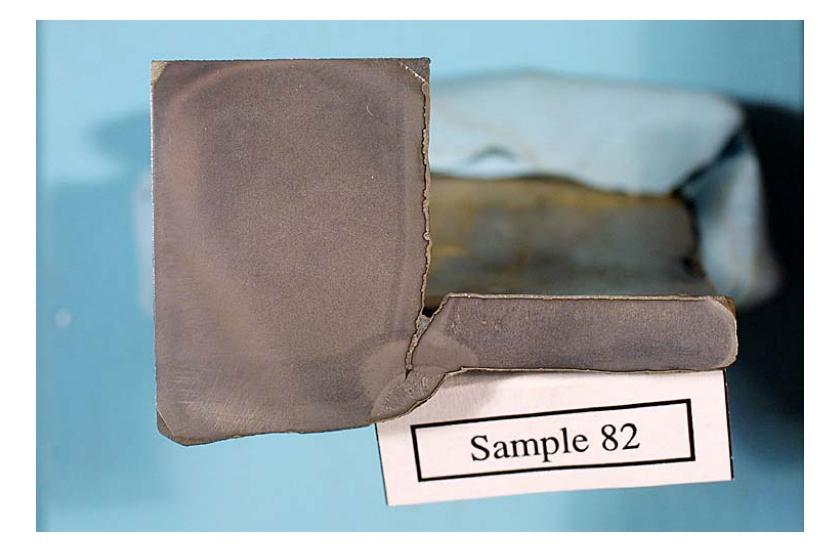
Figure 26. Corner style column to mast-arm connection sample. Note zinc finish inside the large weld metal gap.

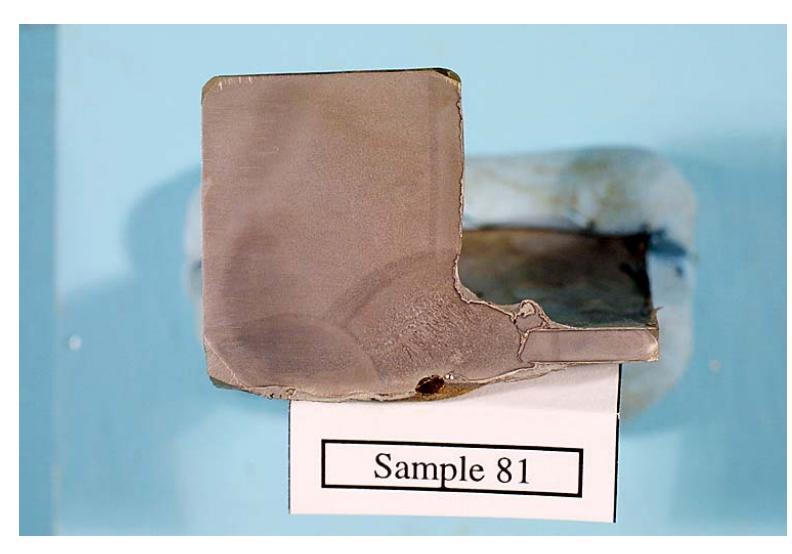
Figure 27. Corner style column to mastarm connection sample, showing the base metal gap filled in with a large amount of weld metal.

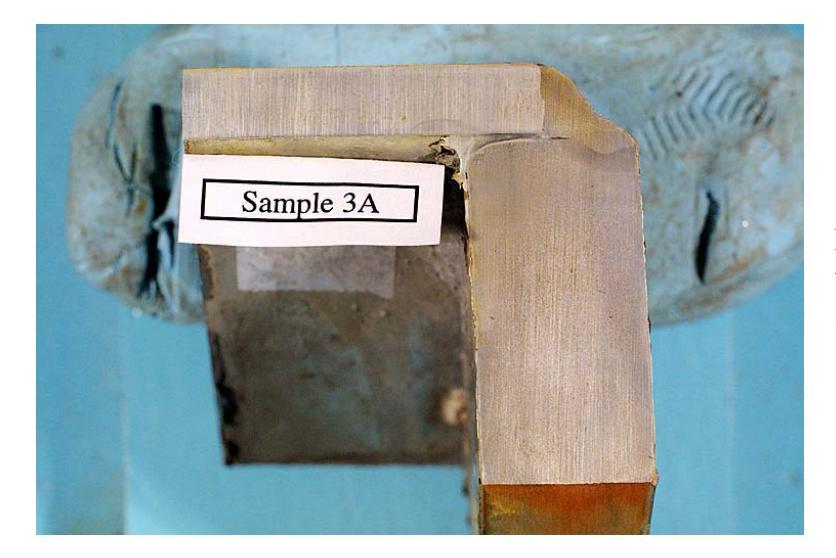
Figure 28. Built-up box sample 3A. Note the gap between base metals tapers into a sharp weld defect.

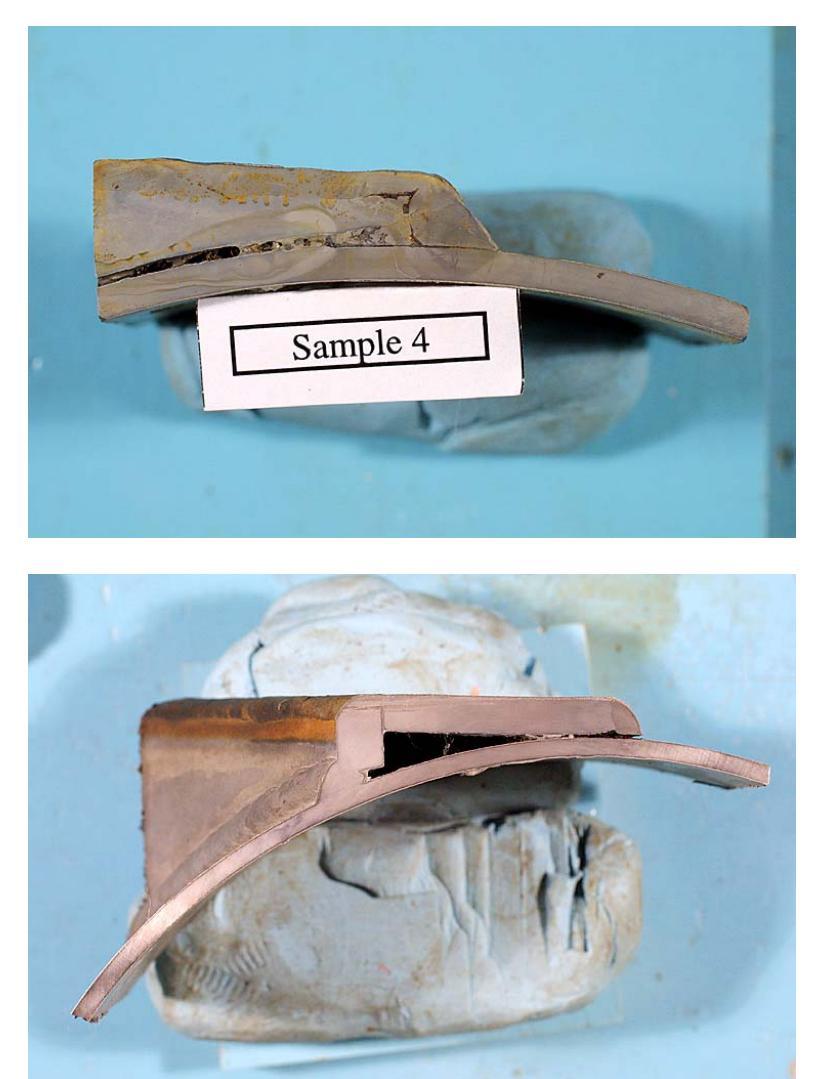
Figure 29. Built-up box sample 4. Note the incomplete fusion weld defect, a common defect fond in the built-up box samples.
