NASA/TM-2016-219188
NESC-RP-13-00860

Carbon Fiber Strand Tensile Failure Dynamic Event Characterization

NASA Engineering and Safety Center Technical Assessment Report	Document #: NESC-RP- 13-00860	Version: 1.0
Title: Carbon Fiber Strand Tensile Failure Dynamic Event Characterization		Page #: 1 of 40

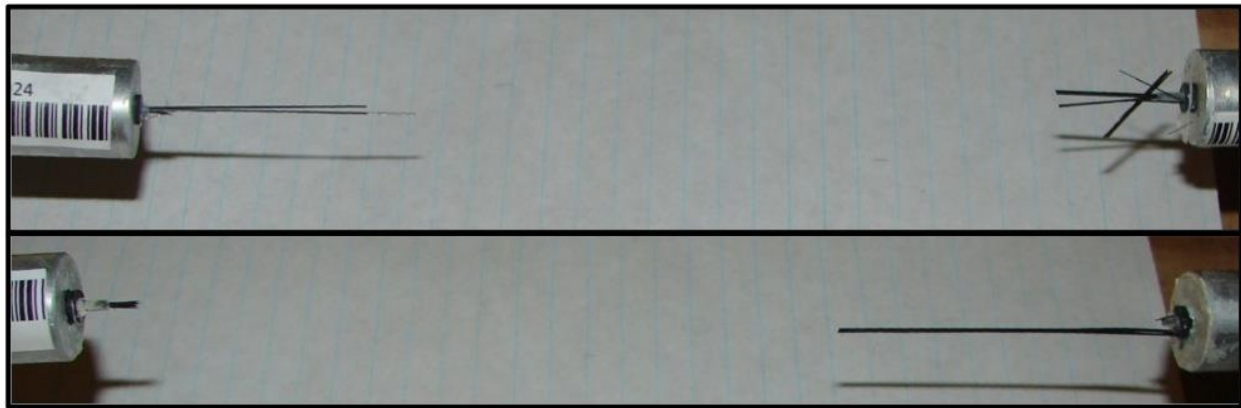
Center: failure (breakage) occurs clearly within the gage section, between the grips. There are no anomalous slippages or other obvious issues that could imply a failure mode not reflective of a nominal failure event. Strand center material is missing after test. A failure occurring primarily in the center of the strand is normally considered a valid failure. Examples of post-test specimens exhibiting center failures are shown in Figure 6.1-1. An example of the video-imaged failure sequence (SN# 8101) is shown in in Figure 6.1-2. Although some initial damage occurs just before failure, the main tension break occurs remote from the initial damage. The main tension break is followed almost immediately by a compressive recoil break near a grip, producing a clean cut across the strand near one of the grips. With the fiber severed in two spots the rest of the strand collapses sending fibrous material toward both grips, which often embeds into the elastomeric material as shown in Figure 6.1-1.

*Figure 6.1-1. Images of Broken Strands after “Center” Failure
(example strands, not part of this study)*

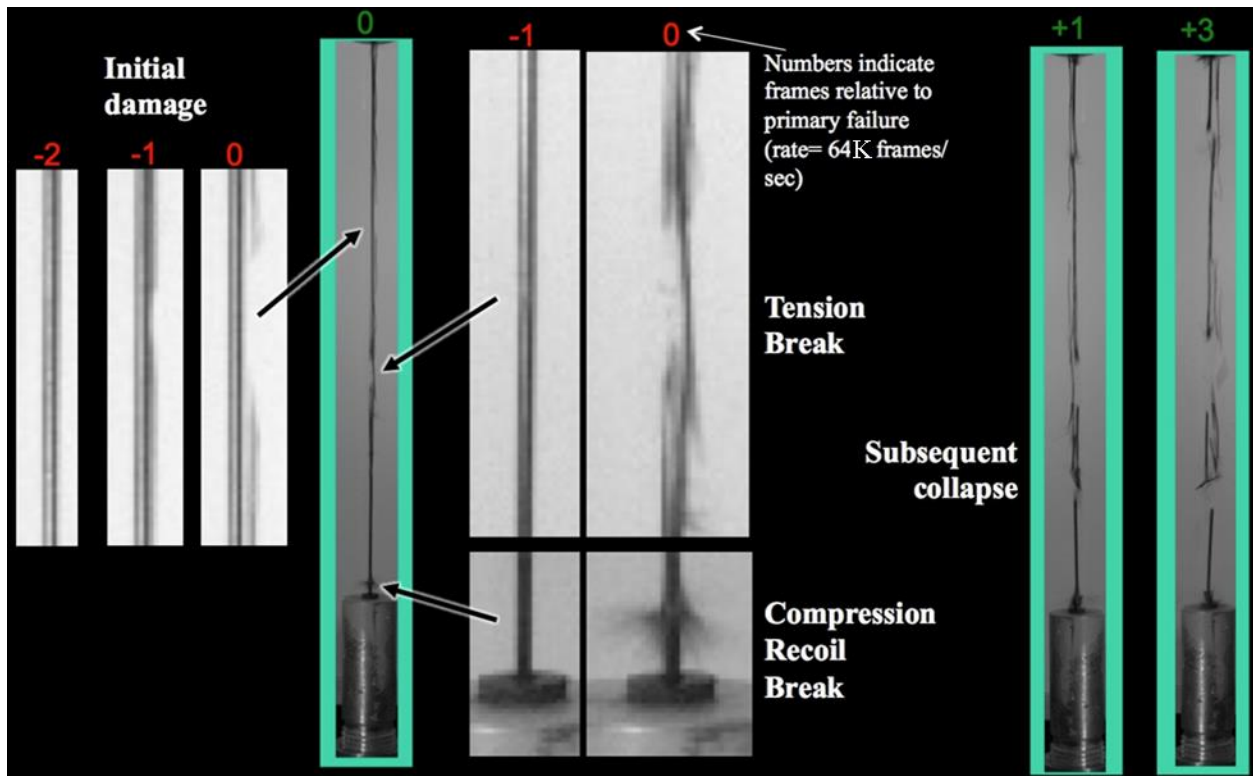
Figure 6.1-2. High-speed Camera Images Showing Sequence of Failures in "Center" Failure Mode (S/N 8101)

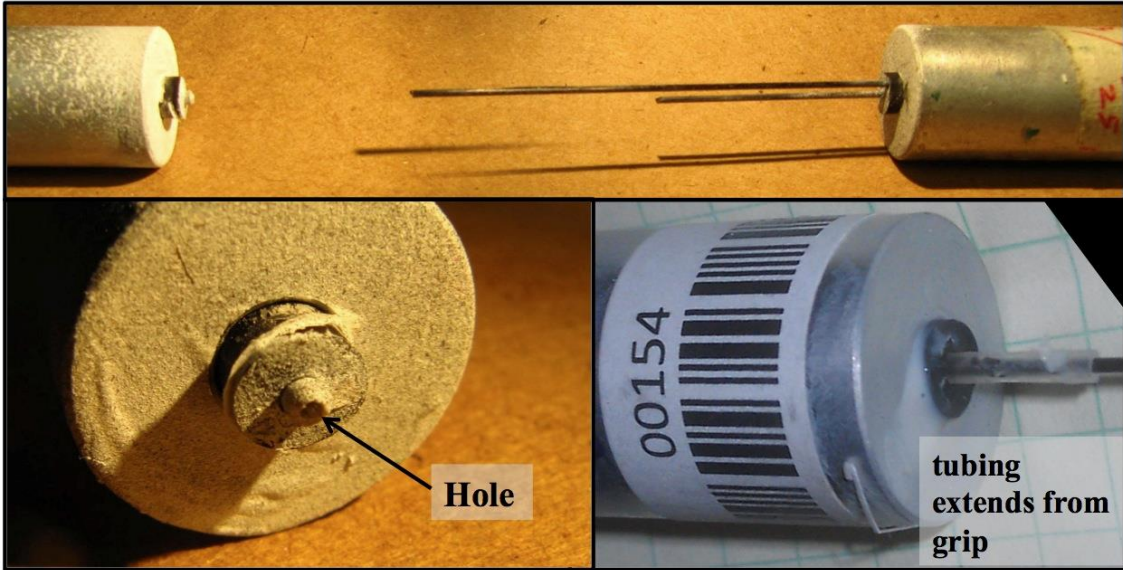
GripF: grip failure; failure of the strand in the grip region (see Figure 6.1-3). These failures could indicate either damage due to gripping or the weakest point of the strand did randomly occur in the grip. Because of the uncertainty in this failure mode, GripF failures are usually considered invalid even if the failure load value is relatively high.

Figure 6.1-3. Images of Broken Strands After “GripF” Failure Mode

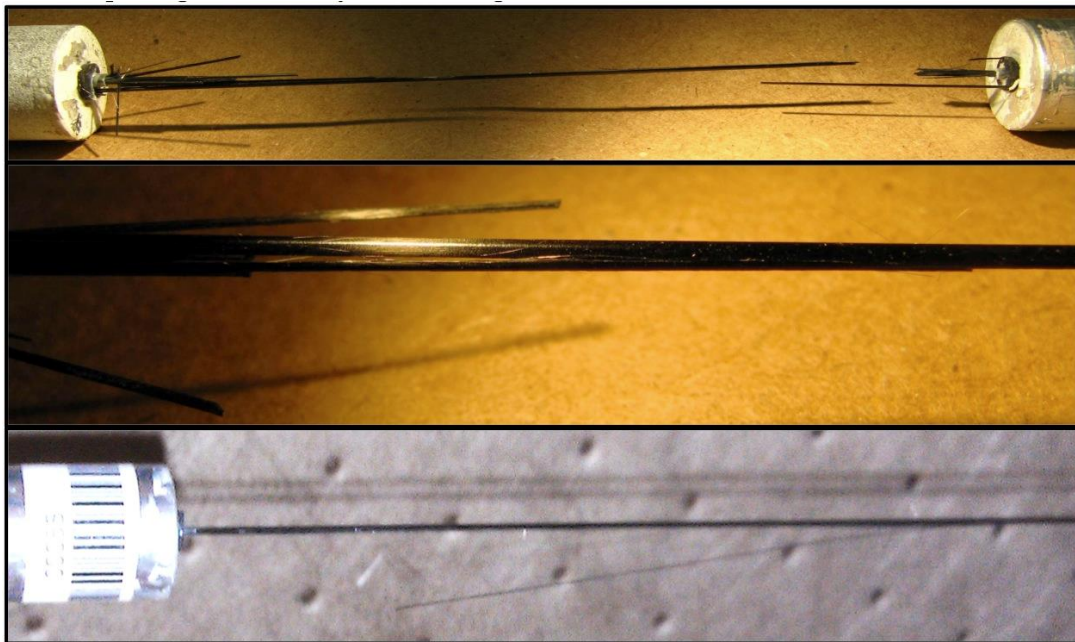
Split: strand splits in the gage region rather than making a sharp, clean break. The specimen tends to remain somewhat intact with long longitudinal splits down its length. A Split is normally considered a valid failure. Images of post-test specimens from “Split” failure mode are shown in Figures 6.1-4 and 6.1-5. Notice that even though the failed specimen looks distinct from a “center” failure, the initiation may be similar with a different progression mechanism, such as a primary tension break occurring within the gage section.

Figure 6.1-4. Images of Broken Strands after “Split” Failure Mode

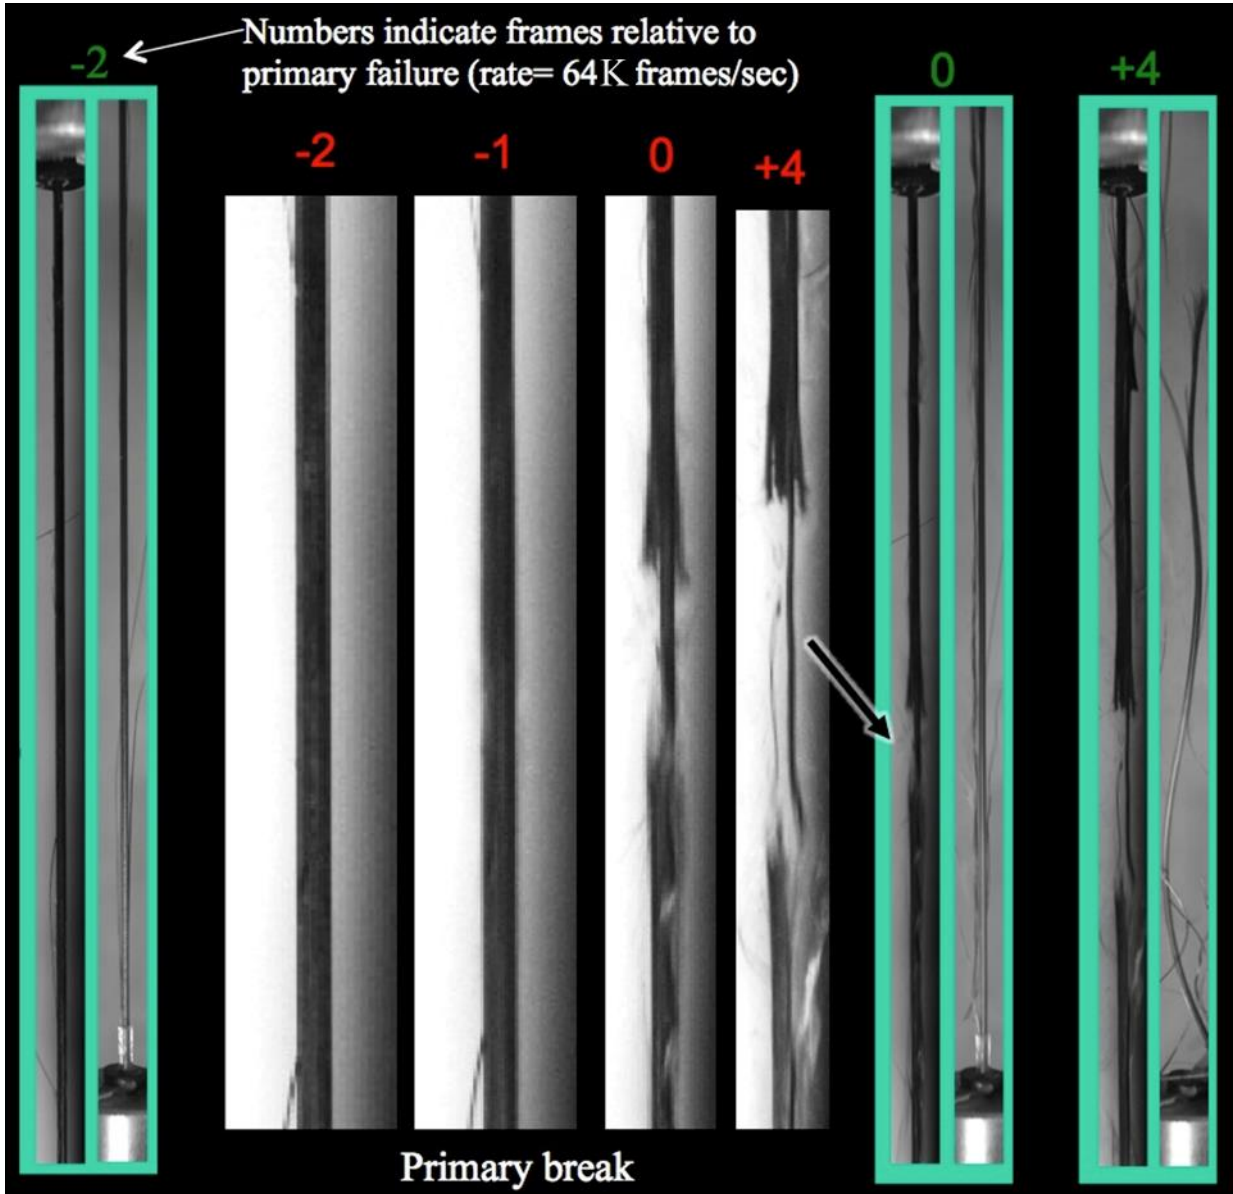
Figure 6.1-5. Failure Sequence from SN 8405 Characterized as “Split”

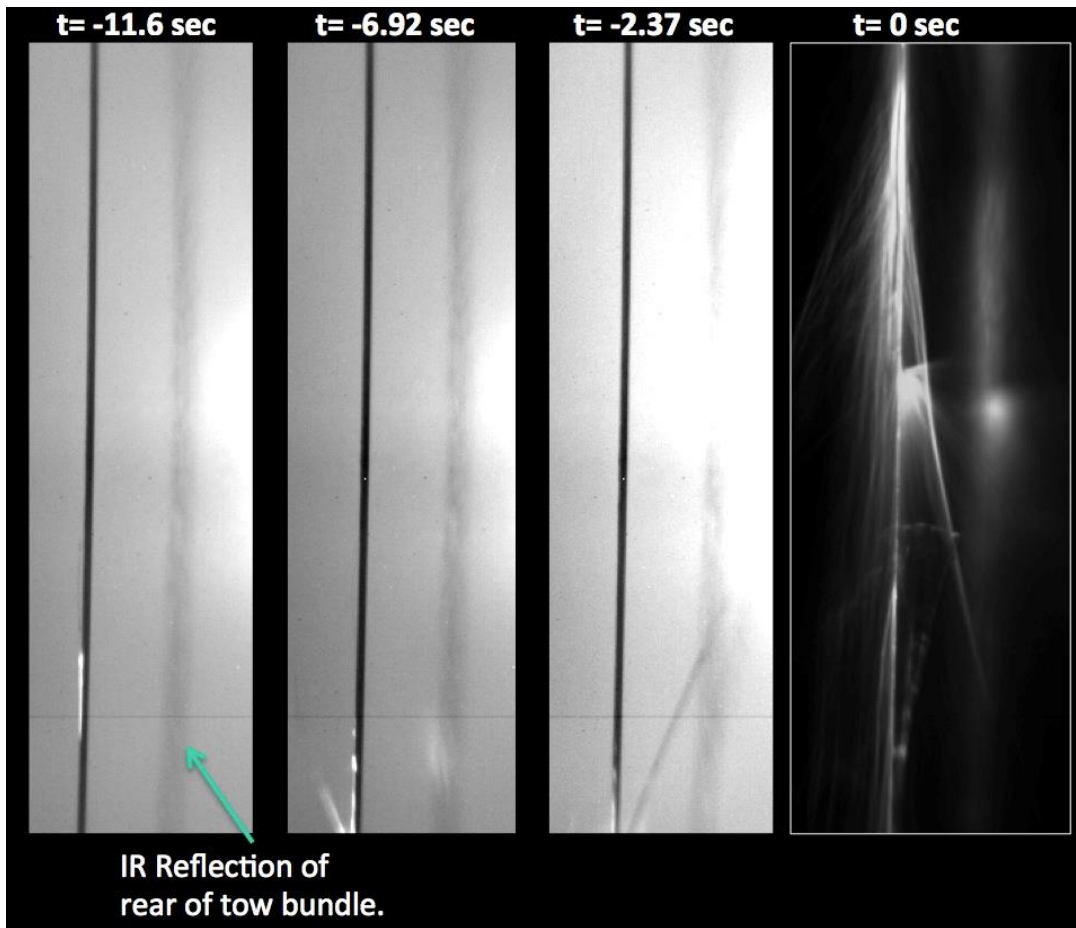
It was found that thermal transients, many quite pronounced, were observed during strand loading, at least some of which appeared to be associated with bundles of fibers failing in tension. It was concluded for this reason that this measurement system may be of value for research into events involved in failure progression. Figure 6.2-3 depicts example thermography showing several high-energy events occurring as much as 11 seconds before final failure of the specimen.

Figure 6.2-3. Example Thermography Images From Specimen S/N 5

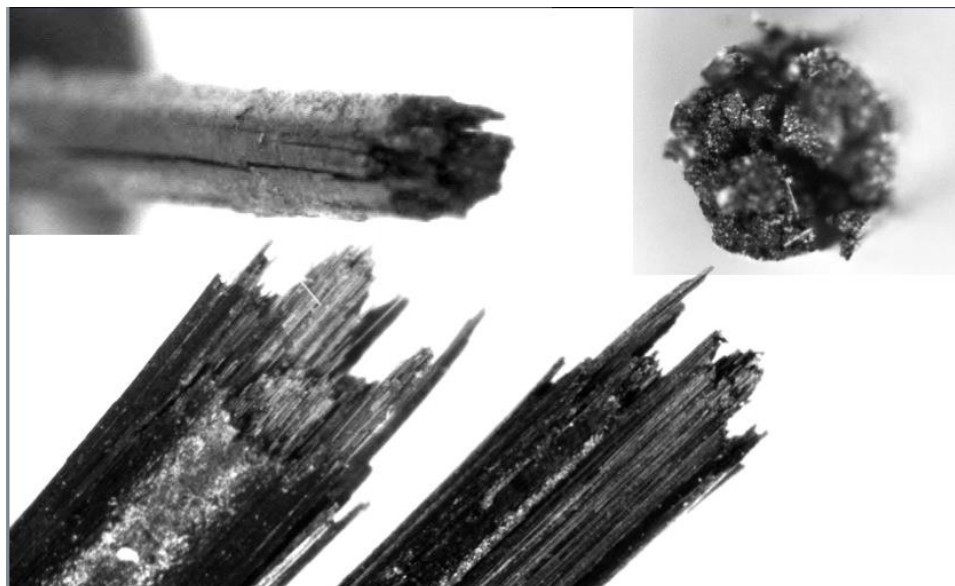
Figure 6.2-5. Fractured Ends of SN 8407 Showing Multiple Axial Splits

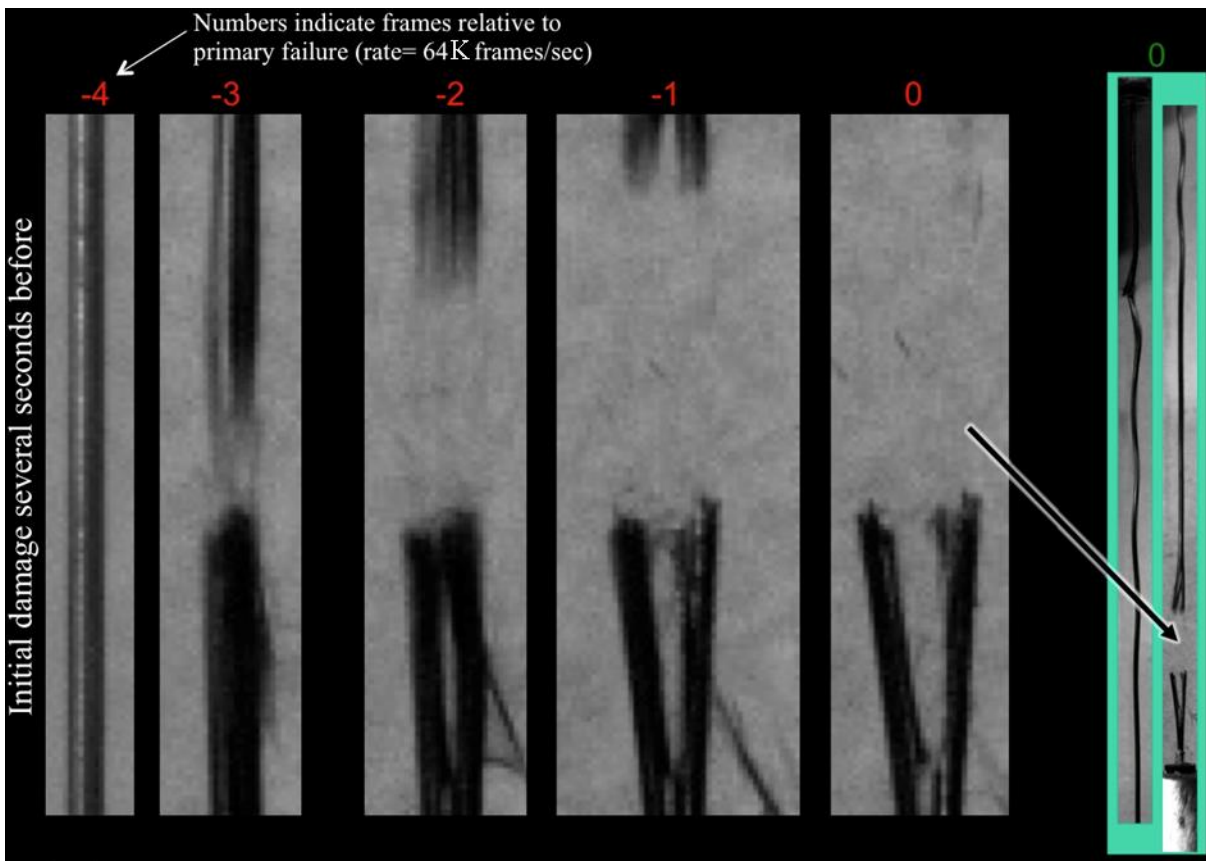
Figure 6.2-6. High-speed Imaging of SN 8407 Showing Dynamic Tension Failure Splitting the Failing Strand Open
