## Schlieren System Enhancements at GRC

### Advanced Schlieren Working Group Meeting November 21 & 22, 2013

RHI/Optical Instrumentation and NDE Branch NASA Glenn Research Center

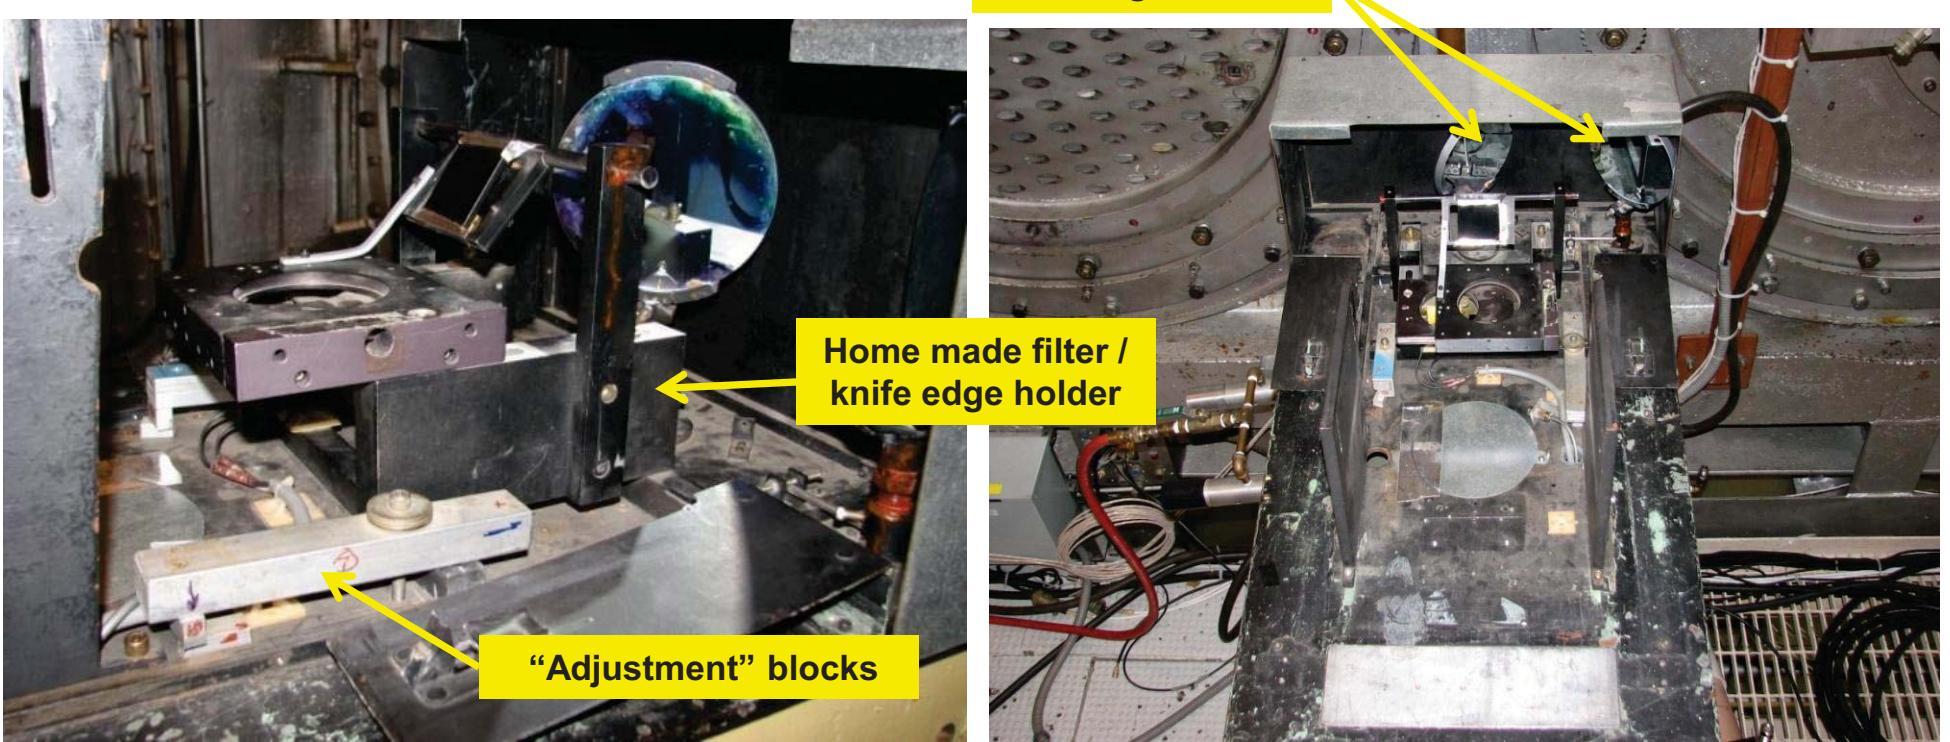
**Original 8x6 Schlieren Receiving Optics**

- The system used "home made" and very antiquated components
- Very hard to adjust
  - No remote adjustment capability on knife edge
- No provisions for adjustable camera mounts
  - Cameras installed as needed and attached to fixed plate
- The system was extremely difficult to set-up and very sensitive to vibration

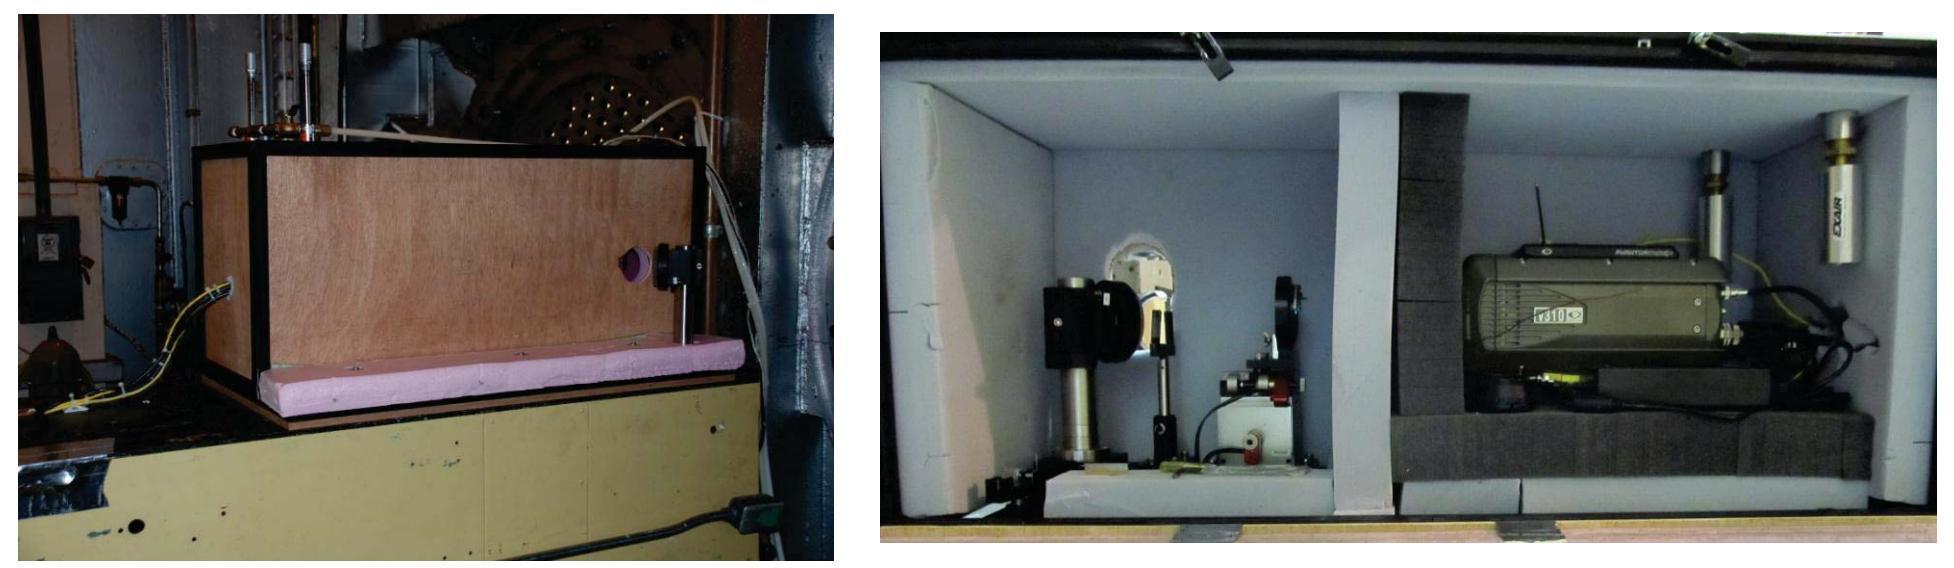
**Receiving Optics Enclosed in an Environmental Enclosure**

- System is located in the balance chamber.....tough environment for optics.
  - 200 deg F in temperature
  - ~3 psia
- Enclosed receiving optics station in an insulated environmental box with cooling to protect the high speed camera and associated optics
- Worked well for all of the tests to date.
  - Even at highest temp conditions, box conditions have been kept under 90 degrees F.
- Definite plans are to improve box <u>or at least make it look better! (but it has worked!!)</u>

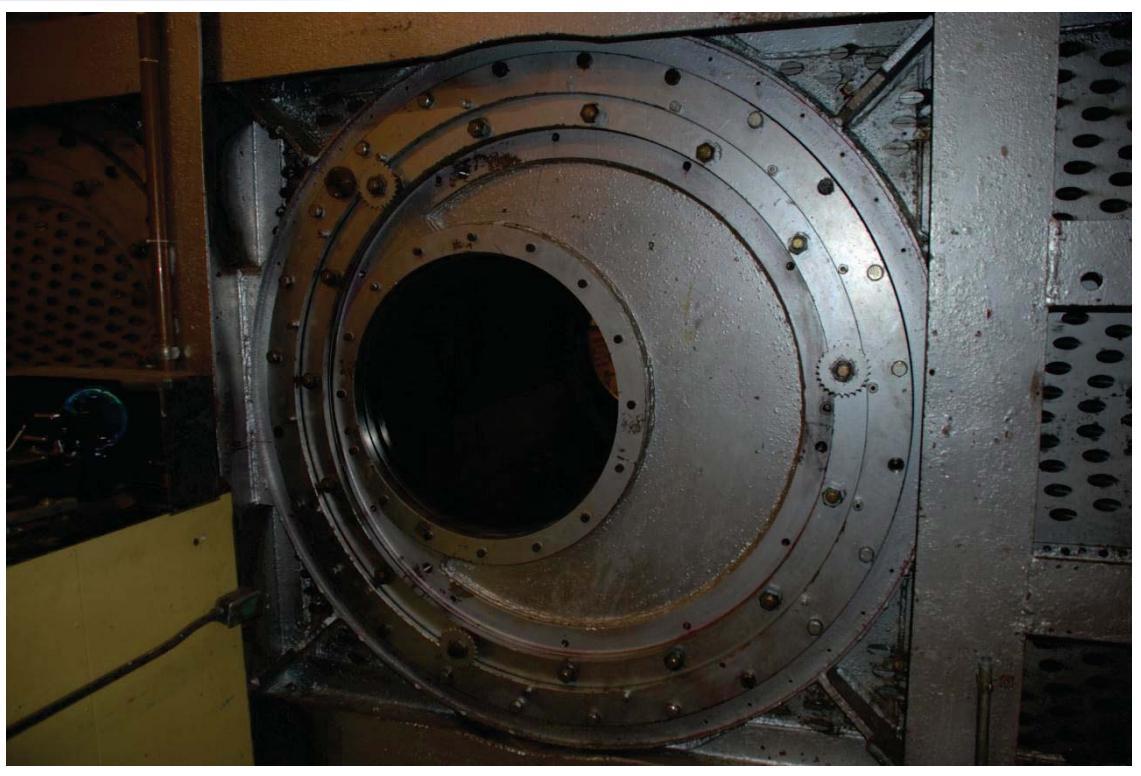
Schlieren Window at 8x6 Wind Tunnel

- The existing windows (4 total) have developed numerous nicks and flaws in them due to years of usage and wear.
- The existing windows were installed into the frames using lead seals using a very laborious process.....The windows had not been replaced in several decades.
  - Two windows had become damaged to a point where they were not usable.
- Frames were becoming difficult to align and get flush due to wear and previous installation processes.

- Design a new seal and have window frames remachined to remove old seal and incorporate new "epoxy based" seal design.
- Re-surface & polish frames to make flat again so they are flush to the inside of the tunnel when installed.
- Design, fabricate and/or procure
  - · Fixtures required for the re-machining
  - Surface table and fixtures required for the window installation
- Identify sealant material that will have low viscosity for application but cure to have minimal deflection, 100 mil thick, no more than 2 mil at tunnel test conditions, 250 deg F, 81 psi load.

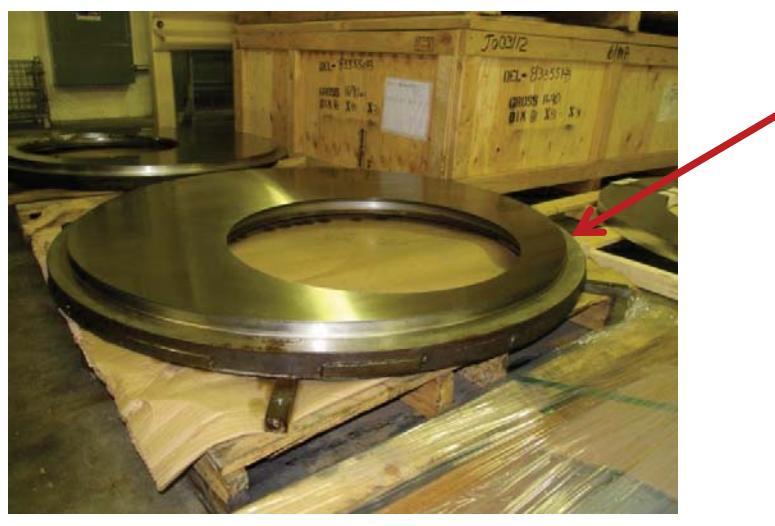
**Existing Window Frame After Being Resurfaced**

# • Window frames were successfully machined for the new seal design and resurfaced (2011)

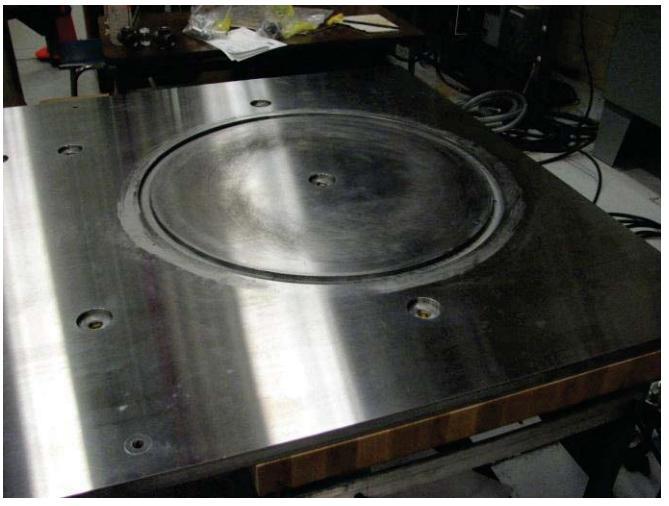
**Steel Schlieren Window Installation Table**

- Steel table not providing stable, flat surface as required.
  Determined it was deflecting
- Belzona material was not of low enough viscosity for our application

- Able to recreate first attempt scenario using the steel table
- At fab shop utilized granite table for mock up of installation, verified granite table would work for installation
- Determined it would be better to caste seal in place around window once installed in frame

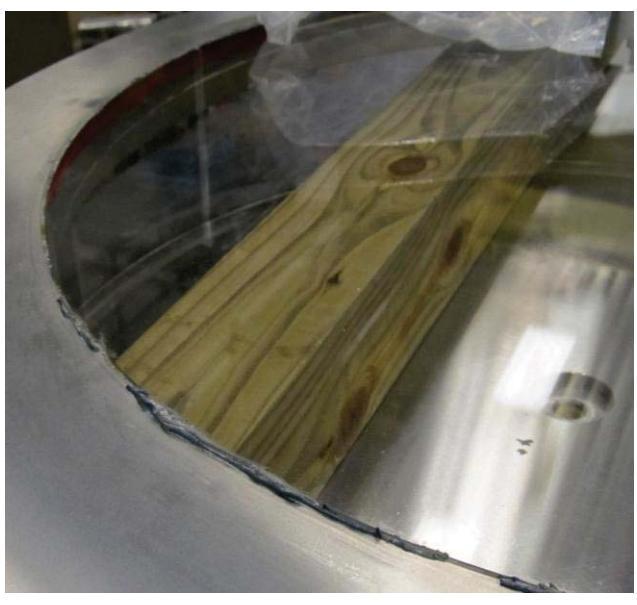
First Window Installation Attempt

- Material did not flow evenly as required, excess material in some areas voids in others.
- Window was not flush, protruded into the flow side by 3 mils causing forward facing step. Exceeds our requirements of ~1 mil, (2 mils allowable at most).

- Install frame on granite surface table
- Install window into frame and center using dowel pins
- Pour sealant material into area between window and frame
- Vacuum was again applied through holes in table to hold frame & window in place during cure
- New granite surface table (~June 2012)

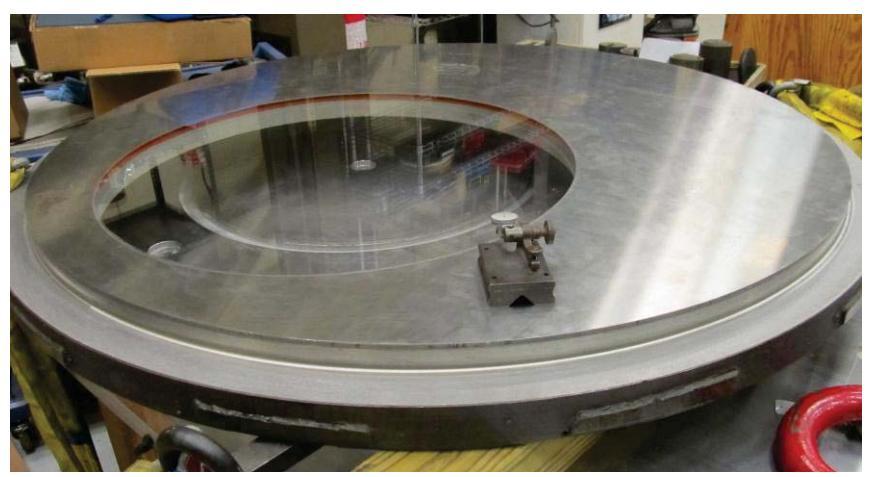
- Completed two "test" installations on plexiglass windows to validate the process (Dec-Jan 2013)
  - Cotronics material 4461S
  - Master Bond EP42HT-2
  - Both with in +/-1 mil tolerance
- First window successfully installed into frame March 2013
  - Master Bond EP42HT-2
  - With in +/- ½ mil of being flush
- Second window successfully installed in July 2013
- Two new windows have been completed
  - Design, fixtures, materials and procedure on-hand for follow on installations
- Lessons learned
  - For next time will use 20 to 50 mil gap for seal instead of 100 mils
  - Others lessons to be documented....

First window successfully installed using revised procedure March 2013

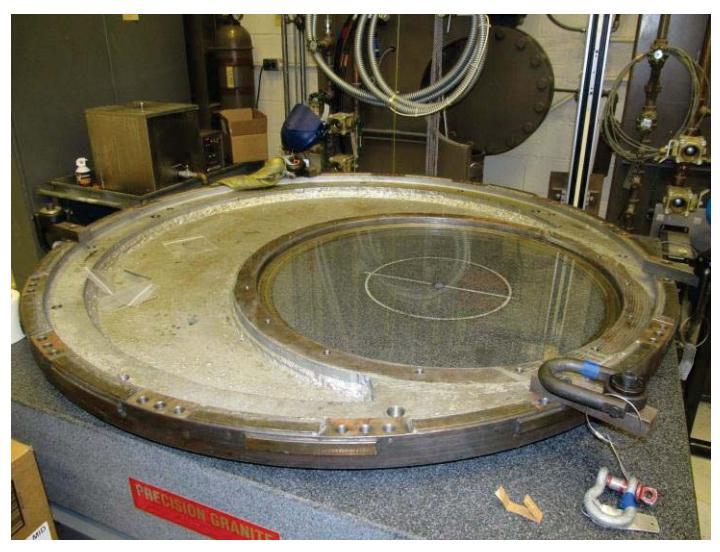
Second window in process of being installed into frame July 2013

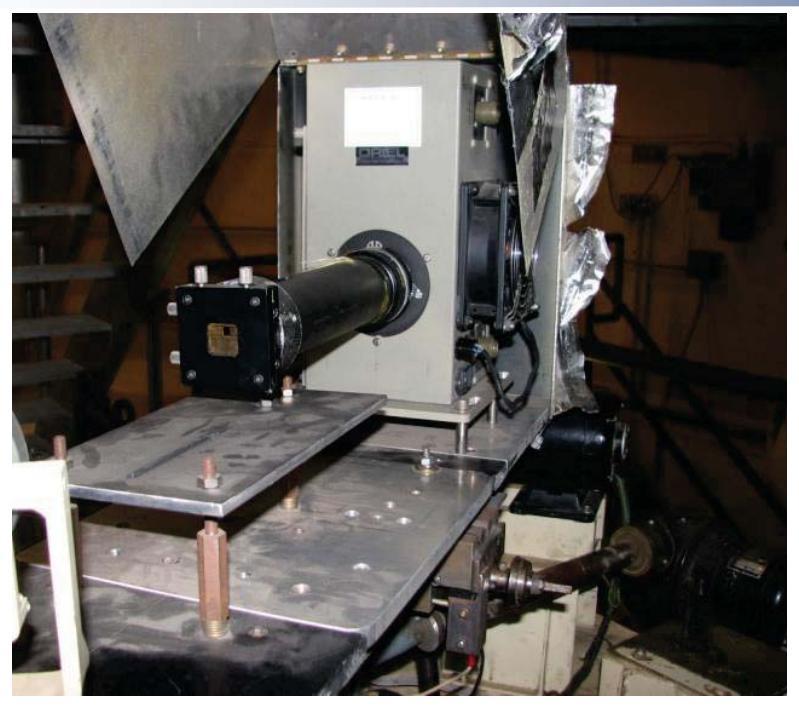
Existing 150W Xenon Light Source

- Replaced 150W Xenon Light Source
  - Required large 48V, 6A power supply, needed to be co-located in test chamber with light source
  - Bulbs & 150W Xenon light source parts very expensive to replace.
- Implemented new LED technology
  - Provides ample lighting, relatively inexpensive
  - Requires relatively low power (700ma @ 3.2V)
- Used monochromatic light (505nm) to take advantage of new knife edge technologies.
- Evaluated several NASA built and commercial LED light sources
- Installed NASA built LED units in 8x6 and used for two Boeing Sonic Boom Test (2012-13)
