NASA Contractor Report 181780

Manufacturing Development of Pultruded Composite Panels

LOCKHEED AERONAUTICAL SYSTEMS COMPANY
BURBANK, CALIFORNIA 91520

PREPARED FOR
LANGLEY RESEARCH CENTER
UNDER CONTRACT NAS1-15069
APRIL 1989

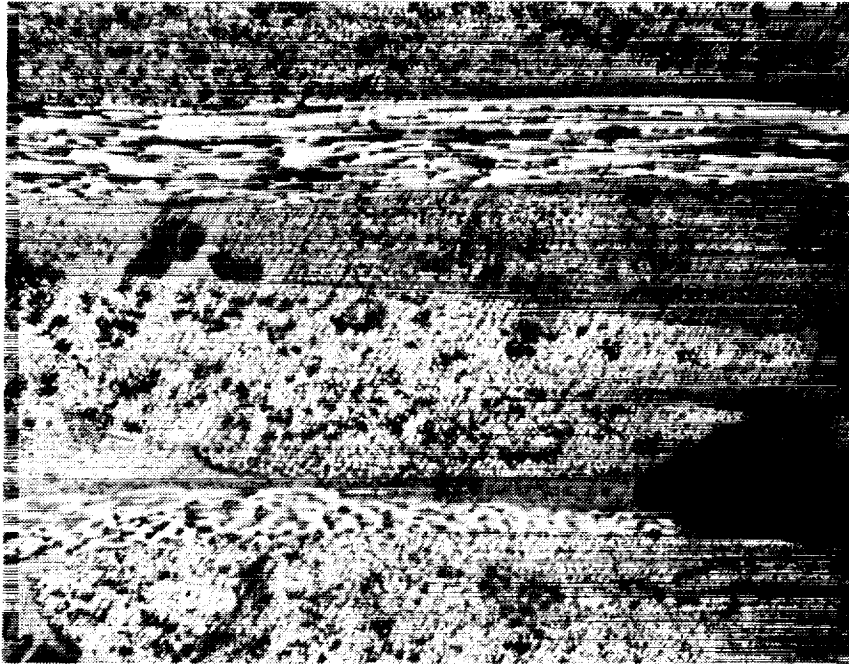
Figure 7. Micrograph of pultruded plate

The cured plate was sent to Lockheed for examination. Ultrasonic inspection indicated a highly porous part. This result was confirmed by photomicrographs of a typical section of the plate as shown in Figure 7. The causes of the porosity were deemed due to the unfilled die problem and improper wet-out of the fabric in the dip tank. These problems had to be

resolved before another plate was pulled. Fabric was ordered woven to a 12-inch width with a leno edge (two twisted glass warp yarns) to hold the warp yarns in place. A larger dip tank was needed plus means to heat the resin to reduce its viscosity to ensure thorough wetting of the fabric.

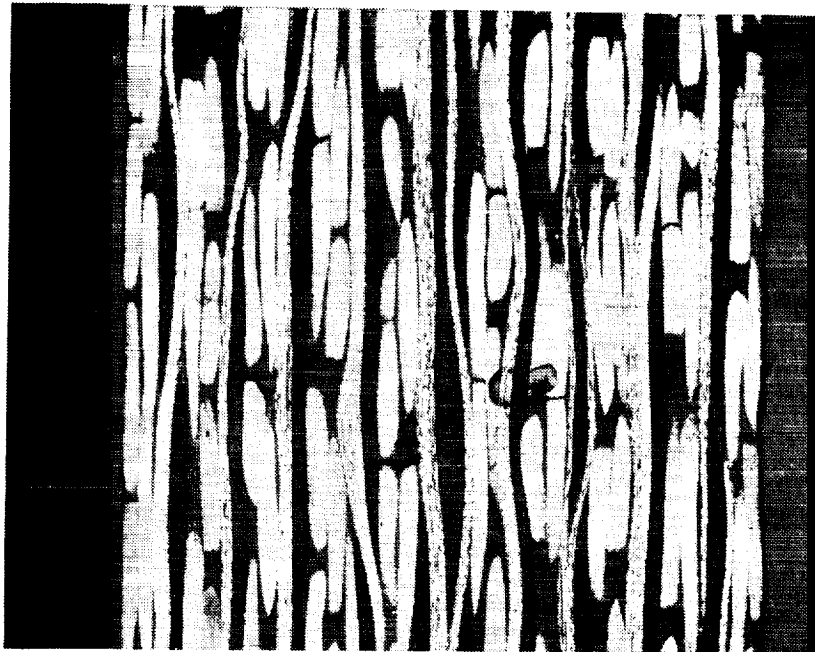
Figure 9. Photomicrograph of a "good" area of the plank

The 17-ft plate was postcured at 400°F for 4 hours then C-scanned. Numerous indications of delaminations and porosity were found, however, the first 5 feet appeared to be free of voids. Photomicrographs of both "good" and "bad" areas indicate problems throughout the laminate. Figure 9 shows a section of a "good" area while Figure 10 is from a "bad" area. Microcracking is apparent in both photos. Severe fabric distortion is seen on Figure 10.

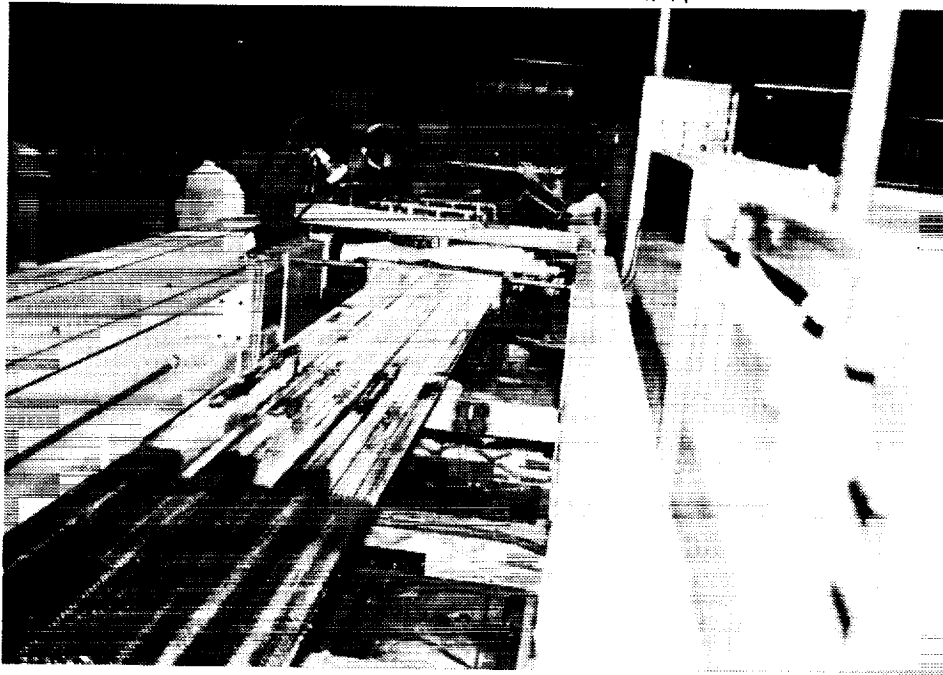
Figure 19. Pultruded plank showing sloughing (white resin) condition. The black area in the foreground is fabric used for start-up. The dark areas show where A-scans were made

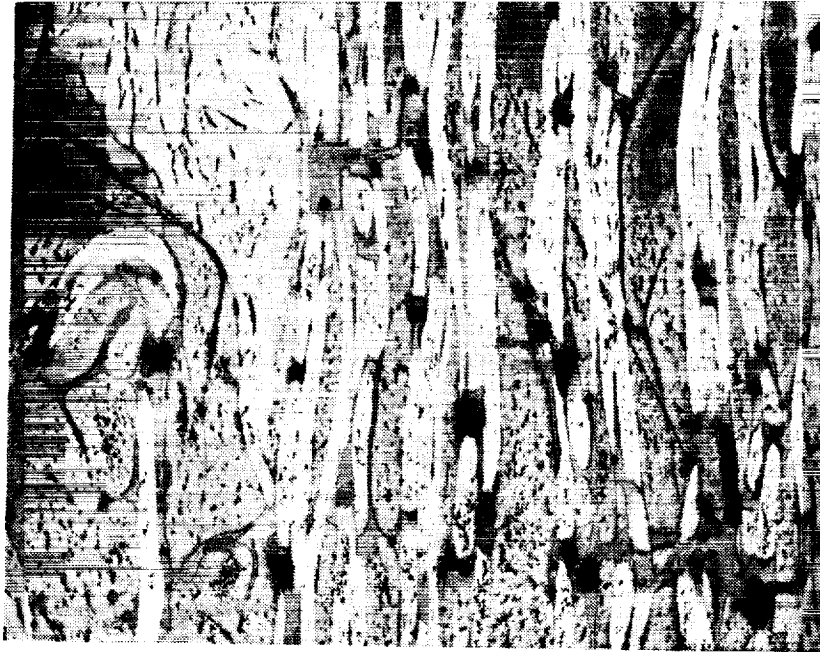
Figure 21. - Photomicrograph through skin area directly under a stiffener

Figures 21 and 22 show typical porosity found in the panel. Most of the voids occur between tows but these are indications of porosity in some of the tows. Resin content measurements were made in the skin and blade areas. The skin areas had resin contents of 36 to 39 percent while the blades were between 30 and 32 percent. This result suggests that additional plies should be included in the skin.

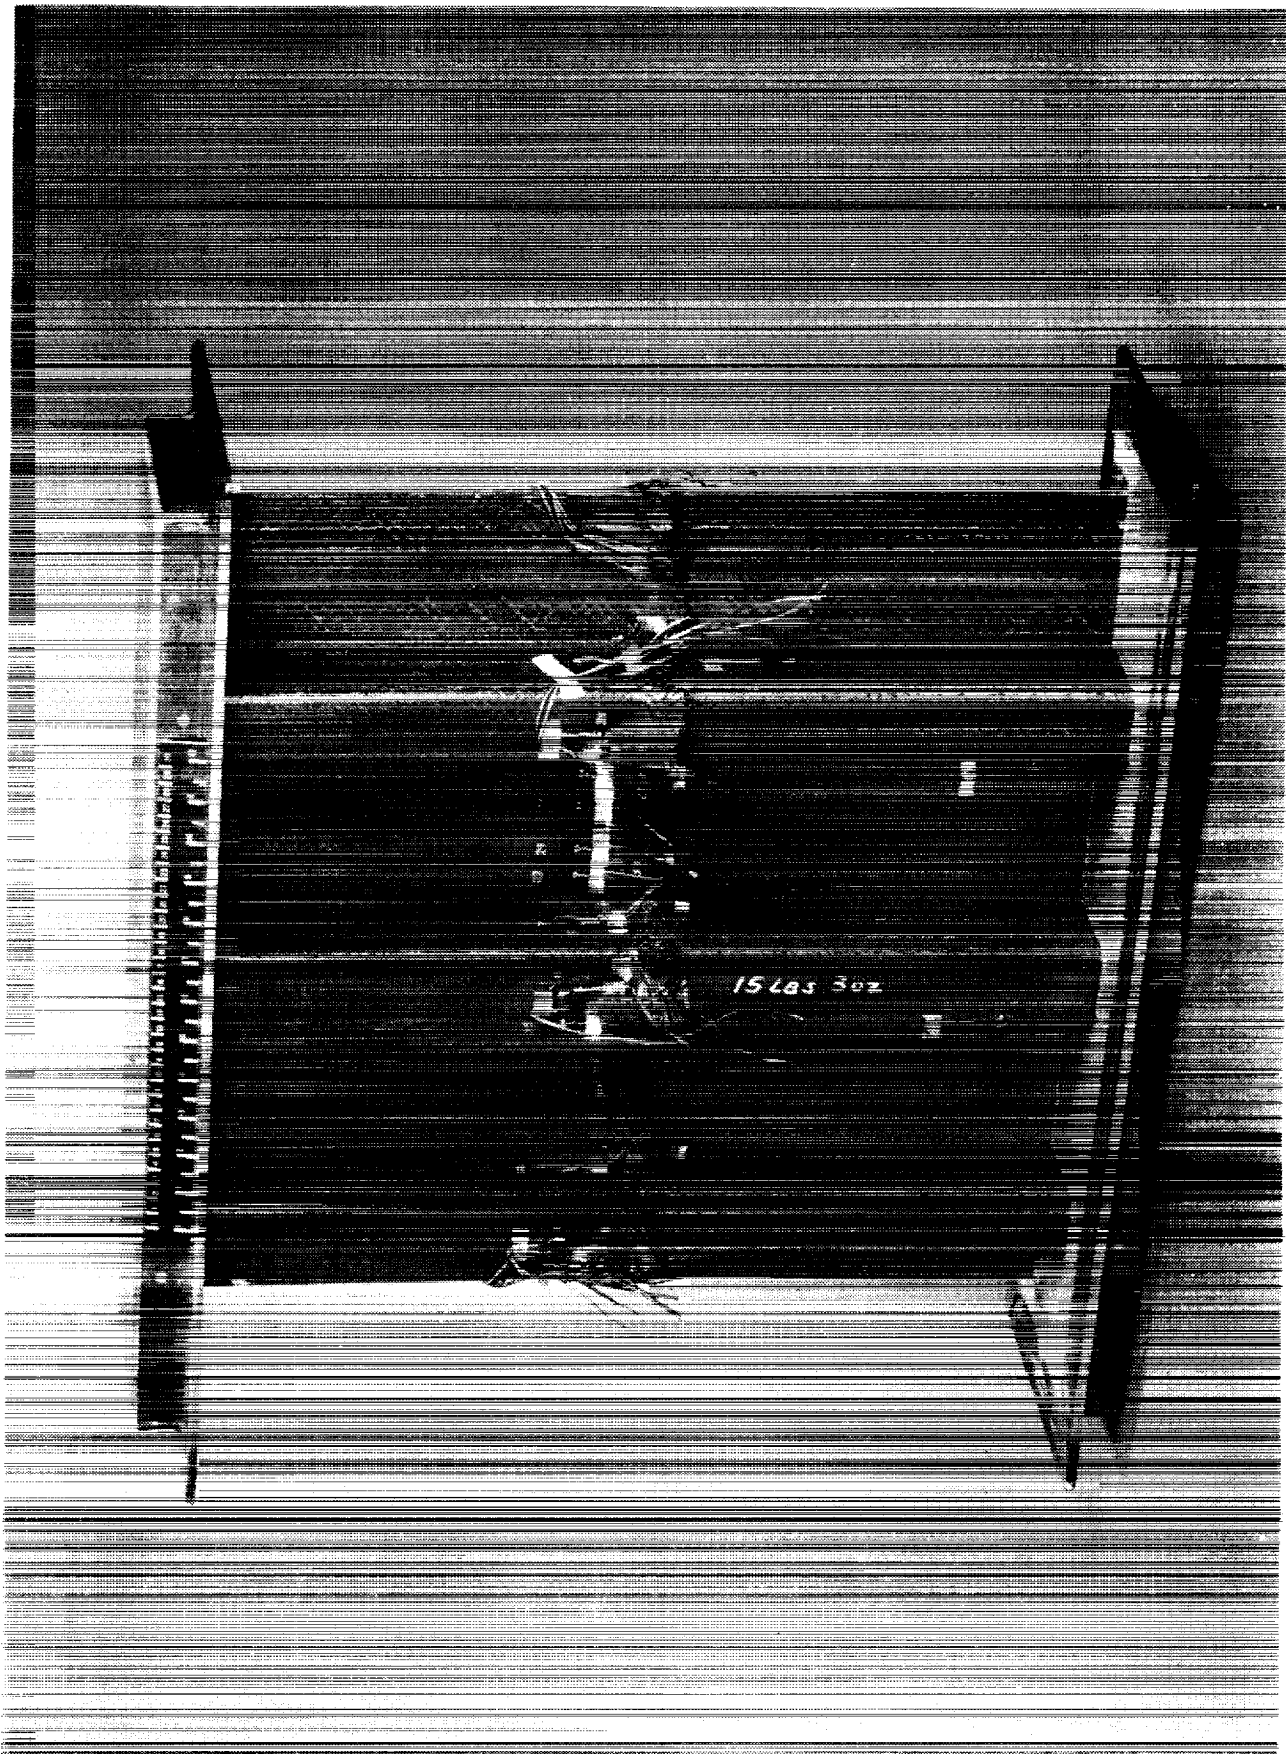
Figure 30. - Typical compression specimen after failure

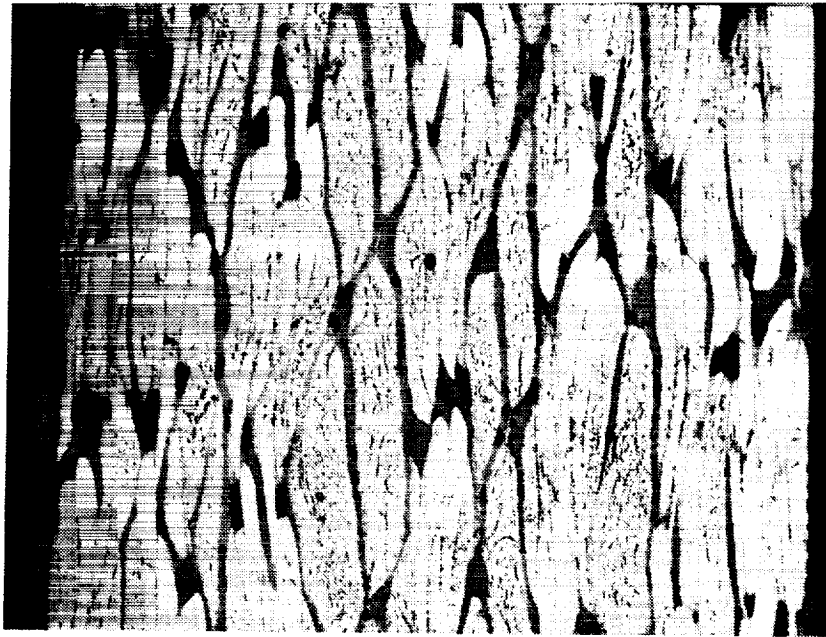
Figure 38. 9310 "puddle method" wet layup 10x magnification

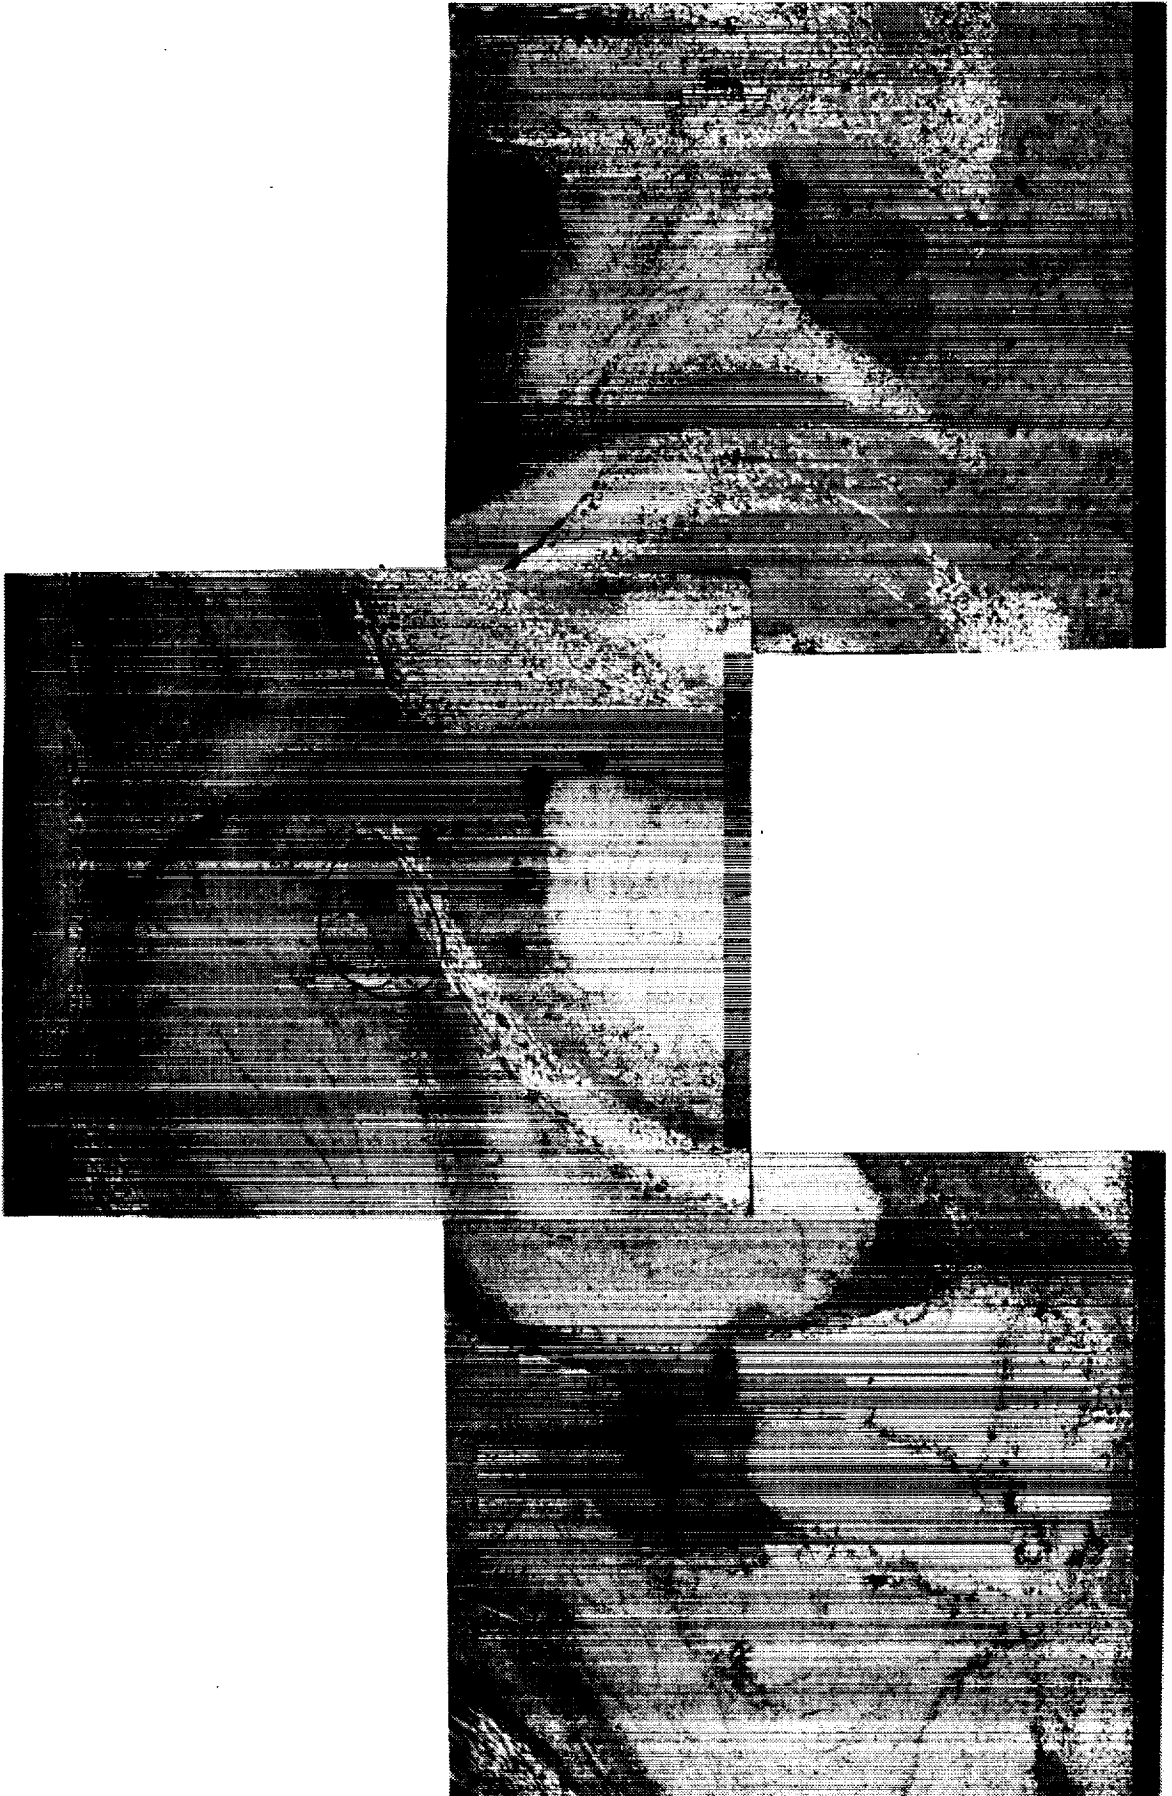
Figure 49. - Photomicrographs showing void locations near polyester stitching yarns and clay filler particles

After analyzing the photomicrographs of the second pultrusion trials, it was noted that a lot of the residual porosity was "attached" to the polyester stitching yarns and the clay filler particles as described by the photomicrographs in Figure 55.

The voids near the Dacron stitching yarn and the clay filler particles could have several causes. Both the Dacron and the clay (Kaoline) are hydrophillic. They could have absorbed small amounts of water which would evaporate during the pultrusion process. Pre-drying both the clay and the pultrusion fabric would eliminate this problem. In addition, the Dacron or a sizing used with the Dacron could be degrading just enough to cause the porosity seen in Figure 53. A solution to this problem would be to use carbon stitching thread. When this program was initiated, the vendor (Hi-Tech/Hexel) was questioned about using a carbon stitching yarn. At that time, the a carbon yarn was a developmental product and could not be delivered during this program. Today, however, the carbon stitching yarns could replace the Dacron.
