NASA Contractor Report 178246

Test Results for Composite Specimens and Elements Containing Joints and Cutouts

P. T. Sumida, R. C. Madan, and A. V. Hawley

August 1988

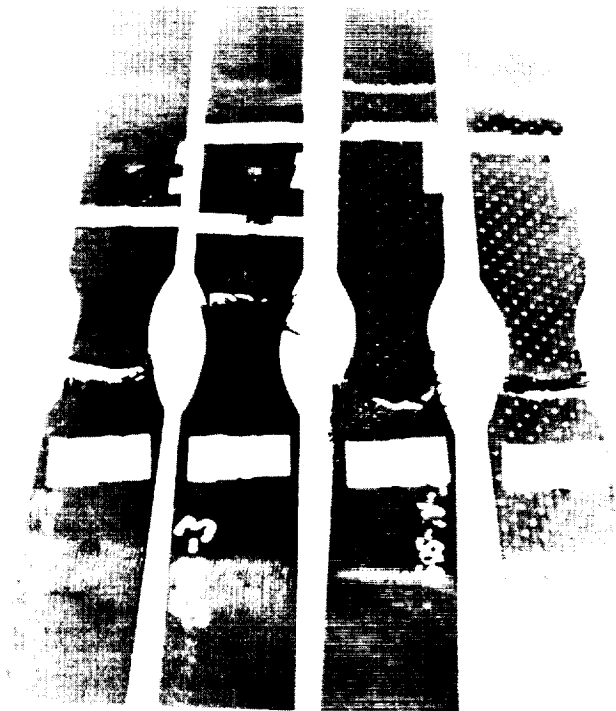
Figure 5-3. Failures of the Dogboned UNT Specimens

Two sets of unnotched tension specimens were fabricated and tested. The original specimens were “dog-boned” in an attempt to avoid failures at the grips of the test machine. None of these specimens, however, actually failed at the minimum cross section (Figure 5-3). The redesigned specimens were simply 7.50-inch by 1.12-inch strips with no dogbone or doublers. It was observed that there was only a slight increase in the ultimate tension strength of lay-ups No. 2, 3, and 4. Lay-up No. 1, however, showed a substantial increase in strength of just over 37 percent. In an attempt to reconcile this discrepancy, specimens from both sets were inspected for thickness, ply count, and ply orientation, but no anomalies were discovered.

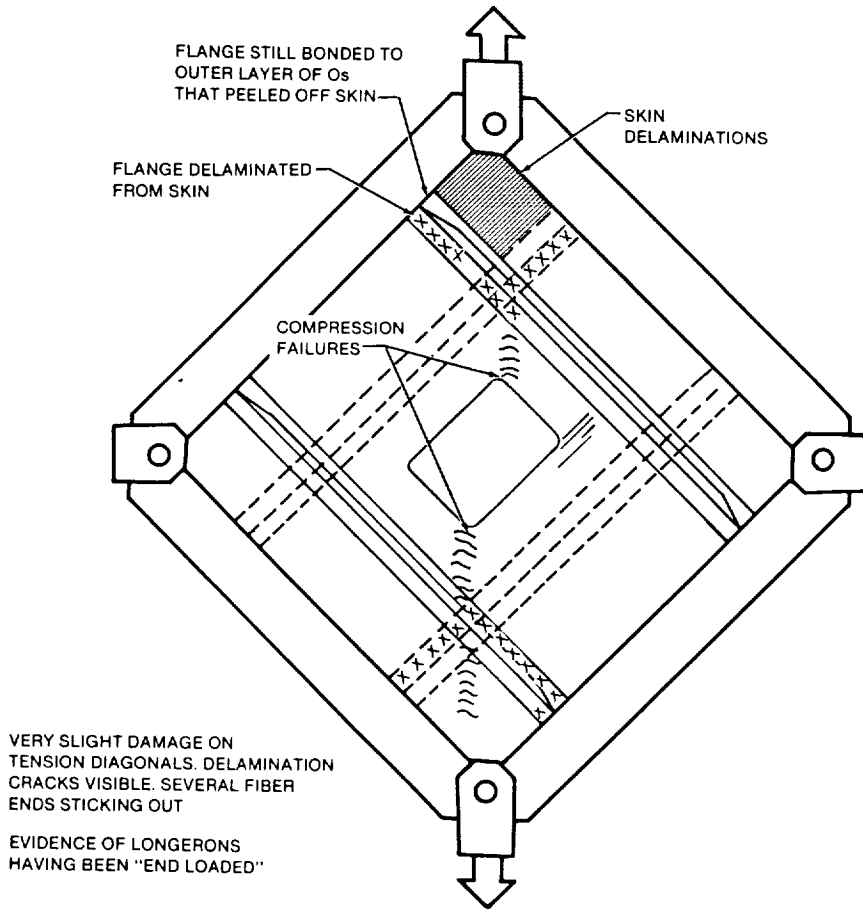
Figure 5-26. Failure Locations for -501 Shear Cutout Panel

As noted in Figure 5-26, there was also some very slight damage observed on the tension diagonals, as well as some slight brooming at the ends of the stiffeners, indicating that they had been end-loaded by the thick steel doublers bonded to the periphery of the panel. The loads carried by the latter, however, are not considered to have been significant.

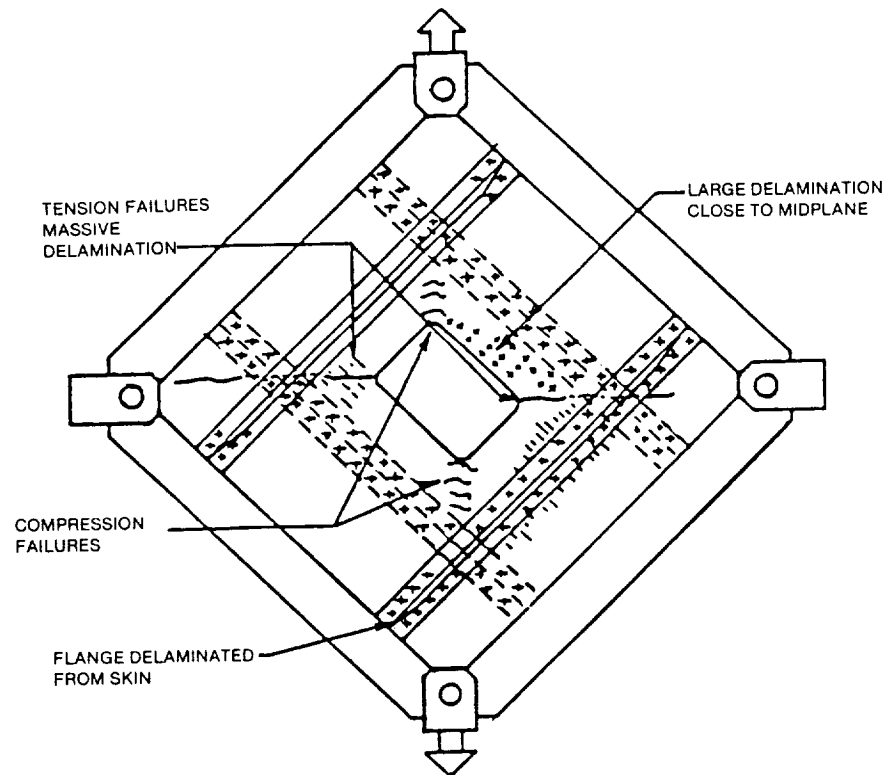
Figure 5-28. Failure Locations for -503 Shear Cutout Panel

Figure 5-28 is a sketch of the softened panel (-503) after failure. Strain gage data taken at the bottom corner indicate roughly linear behavior to about 60 kips. At 70 kips, measured strains at the bottom corner began to drop off rapidly with increasing load (down from $-11,629 \mu\text{in./in.}$ at 70 kips to $-5,360 \mu\text{in./in.}$ at 80 kips). Visual examination revealed very localized delaminations in both compression corners. These delaminations occurred on the side of the panel with the photoelastic film only a few layers from the outside surface. They were also located very close to the points of tangency of the corner radii to the straight sides. The load was then increased to 100 kips. Unlike the -501 (baseline) panel, very little growth of the delaminations was detected as the loads were increased to panel failure, which occurred at 121,110 pounds.

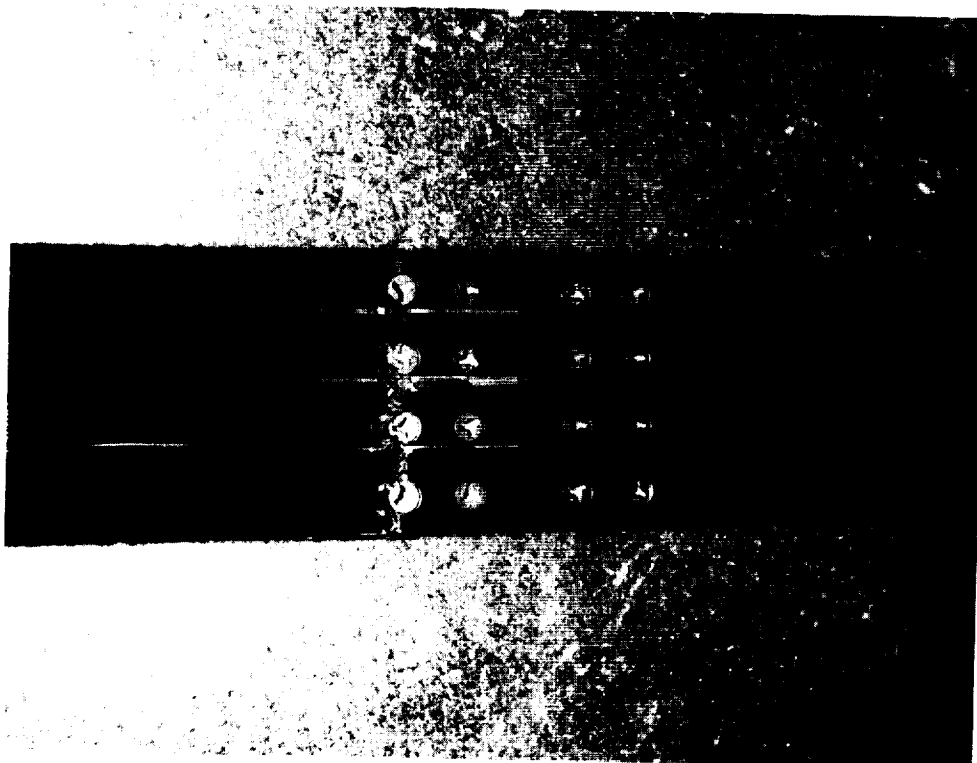
Figure 5-33. Failed Baseline Transverse Skin Splice Specimen

Figure 5-33 shows the failed baseline transverse skin splice specimen. The failure mode was net-section tension through the countersunk skin at one of the outermost rows of fasteners. Fastener rotation and bearing damage was minimal at the other three rows. This was typical of the two specimens assembled without sealant. The failed -1 specimen (assembled with sealant) appeared quite different, however. The ultimate failure apparently was partially tension through the outermost row of fasteners, and partially a combination of fastener failure and fastener pull-through. In addition, all four rows of fasteners exhibited significant fastener rotation with the accompanying bearing damage.

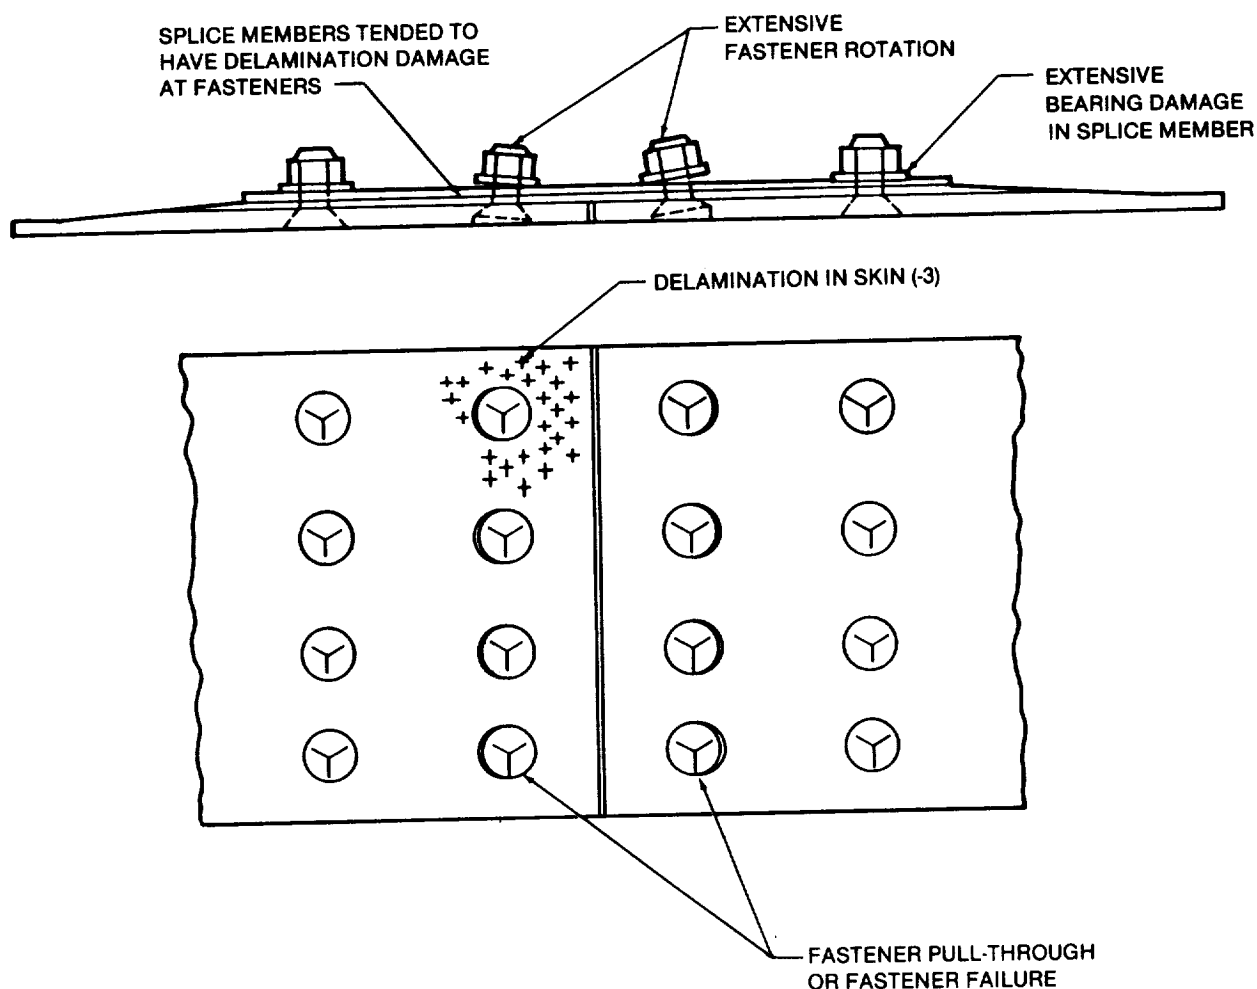
Figure 5-34. Failure Mode for Tailored Transverse Skin Splice Specimens

The presence of the sealant (for the -1 specimen) significantly reduced the strength of the tailored transverse splice specimen. The failure mode, for the most part, appears very similar to that of the -2 and -3 specimens (i.e., extensive bearing damage in the splice member at the outside rows of fasteners with the ultimate failure occurring at one of the inside rows due to fastener failure). Fastener failure for the specimens tested without sealant always occurred at the fastener head, through the tri-wing recess. Fastener failures for the -1 specimen, however, occurred at the opposite end near the first thread.

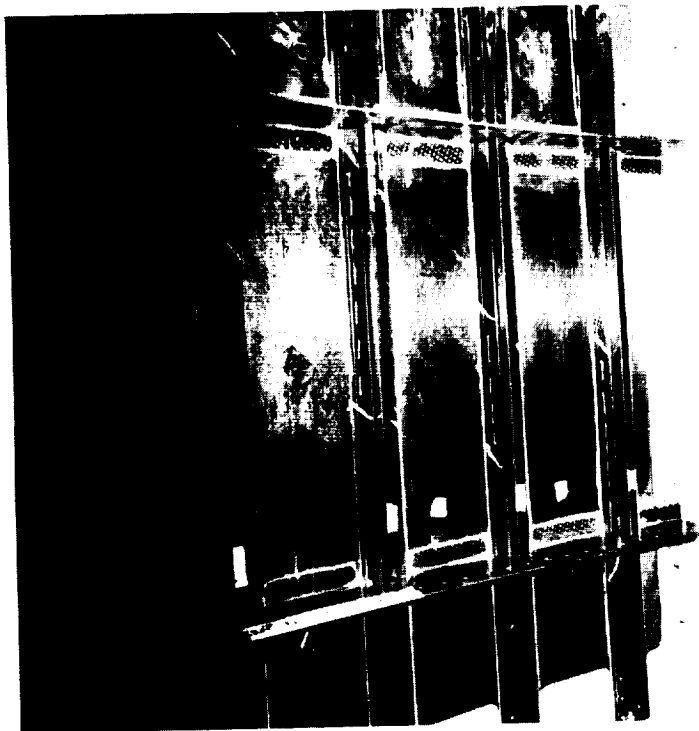
Figure 5-44. Areas of Delamination of Transverse Skin Splice Panel (from NDI)

delamination. The marked areas in Figure 5-44 show that the skin and longerons were separated over a considerable portion of the stiffener length (especially the third longeron from the left).

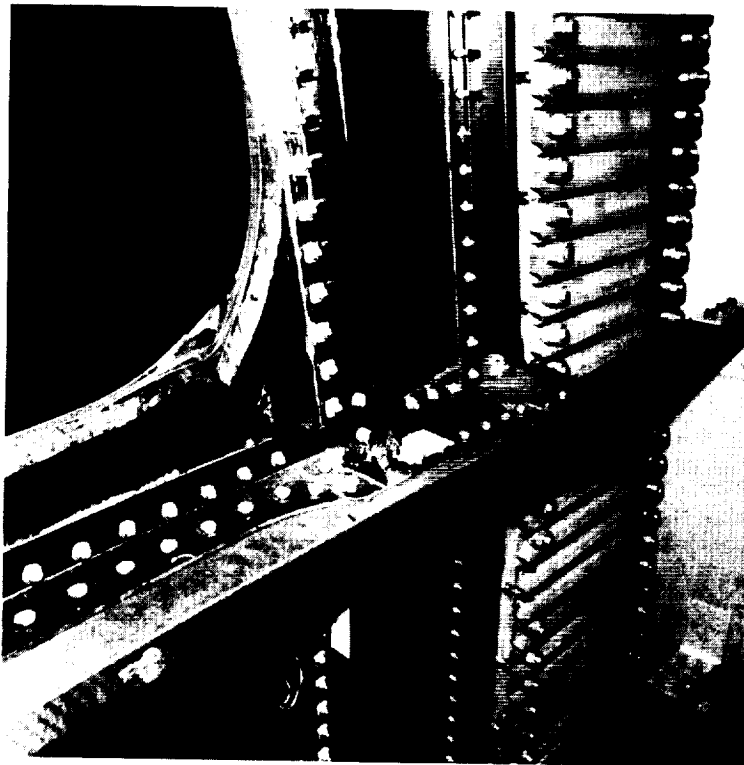
Figure 5-48. Group D Window Belt Panel — Failure of Skin, Longerons, and Frame

Figure 5-48 is a closeup of the right-hand side of the panel. The collapse of this side of the specimen was more centered about the middle frame. The videotapes indicate that the skin failures (through the cutouts) and the longeron failures preceded the failure of the frame. The frame failure is better seen in Figure 5-49, which is a bottom view of the same area. Local failures also occurred at the upper left and upper right corners of the panel. As these areas were not visible in the videotapes, the relative timing of these failures is unknown. Nondestructive examination of the failed panel revealed skin damage as outlined in Figure 5-50. (The light area around the cutout is the photoelastic film.)
