CR-168037
R82AEB2A3

NASA-CR-168037
19850026886

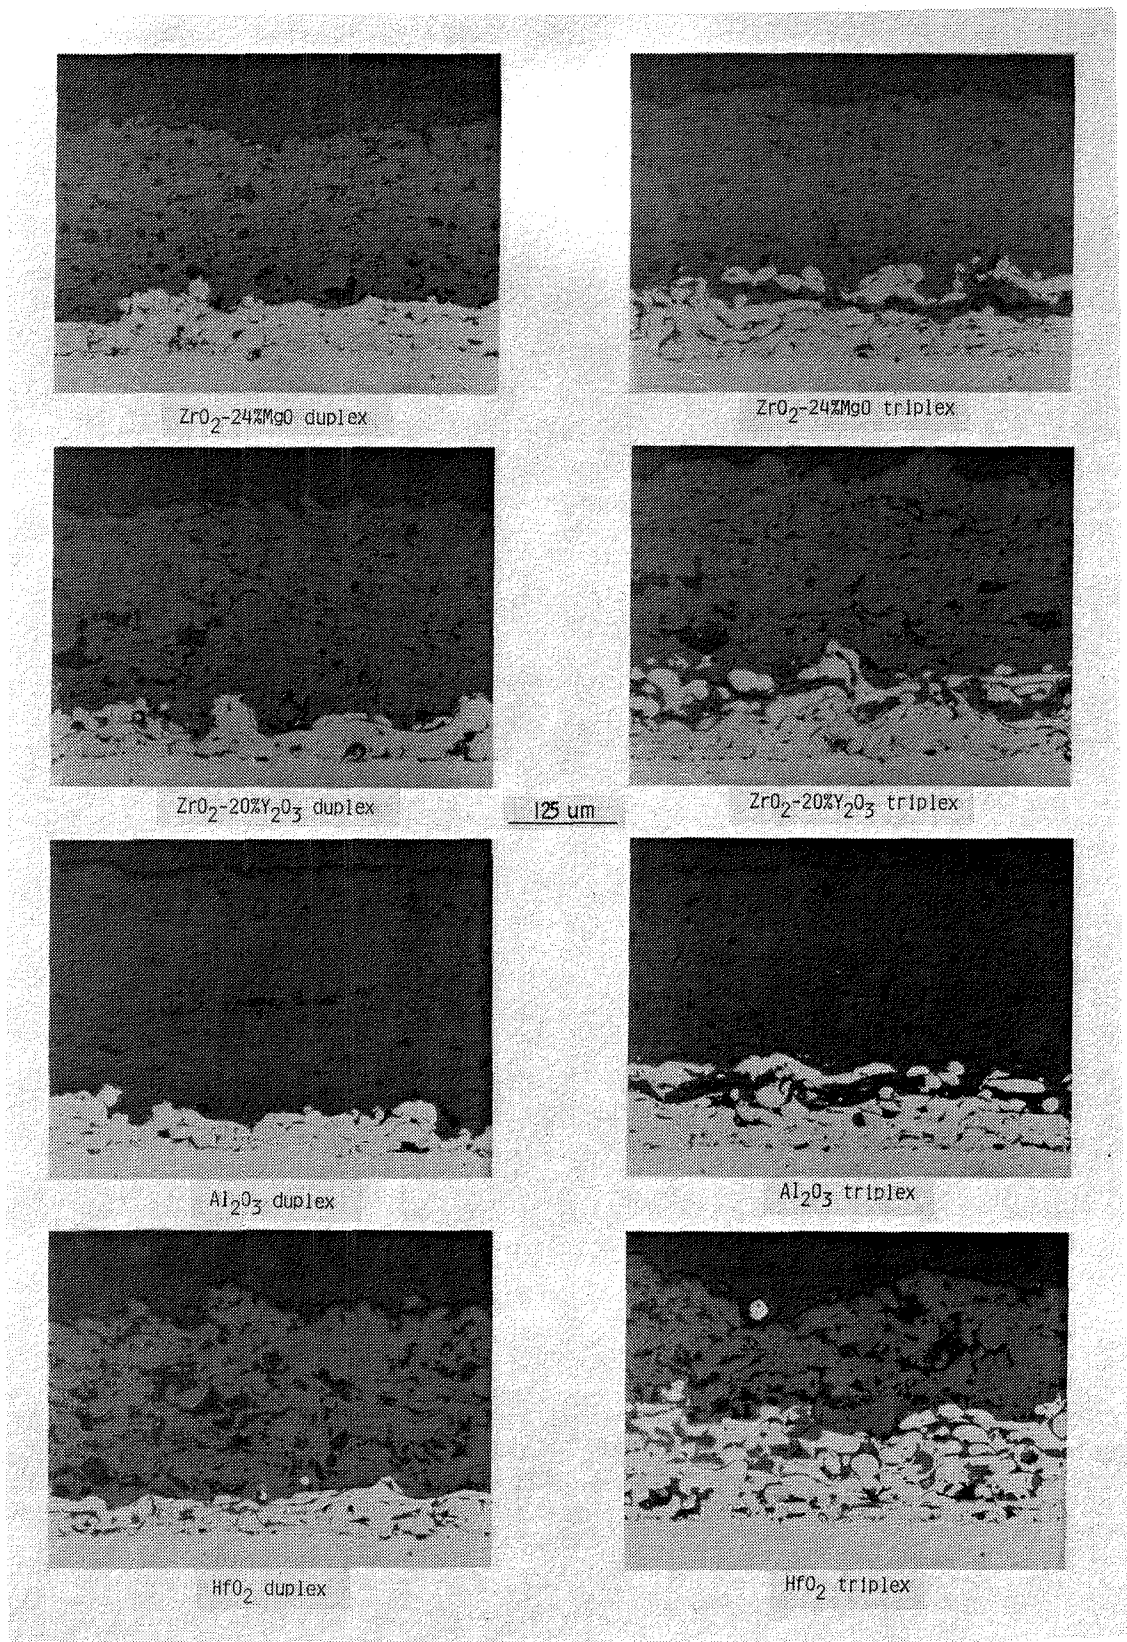
Figure 1. Typical Microstructures of Candidate Coating Systems.

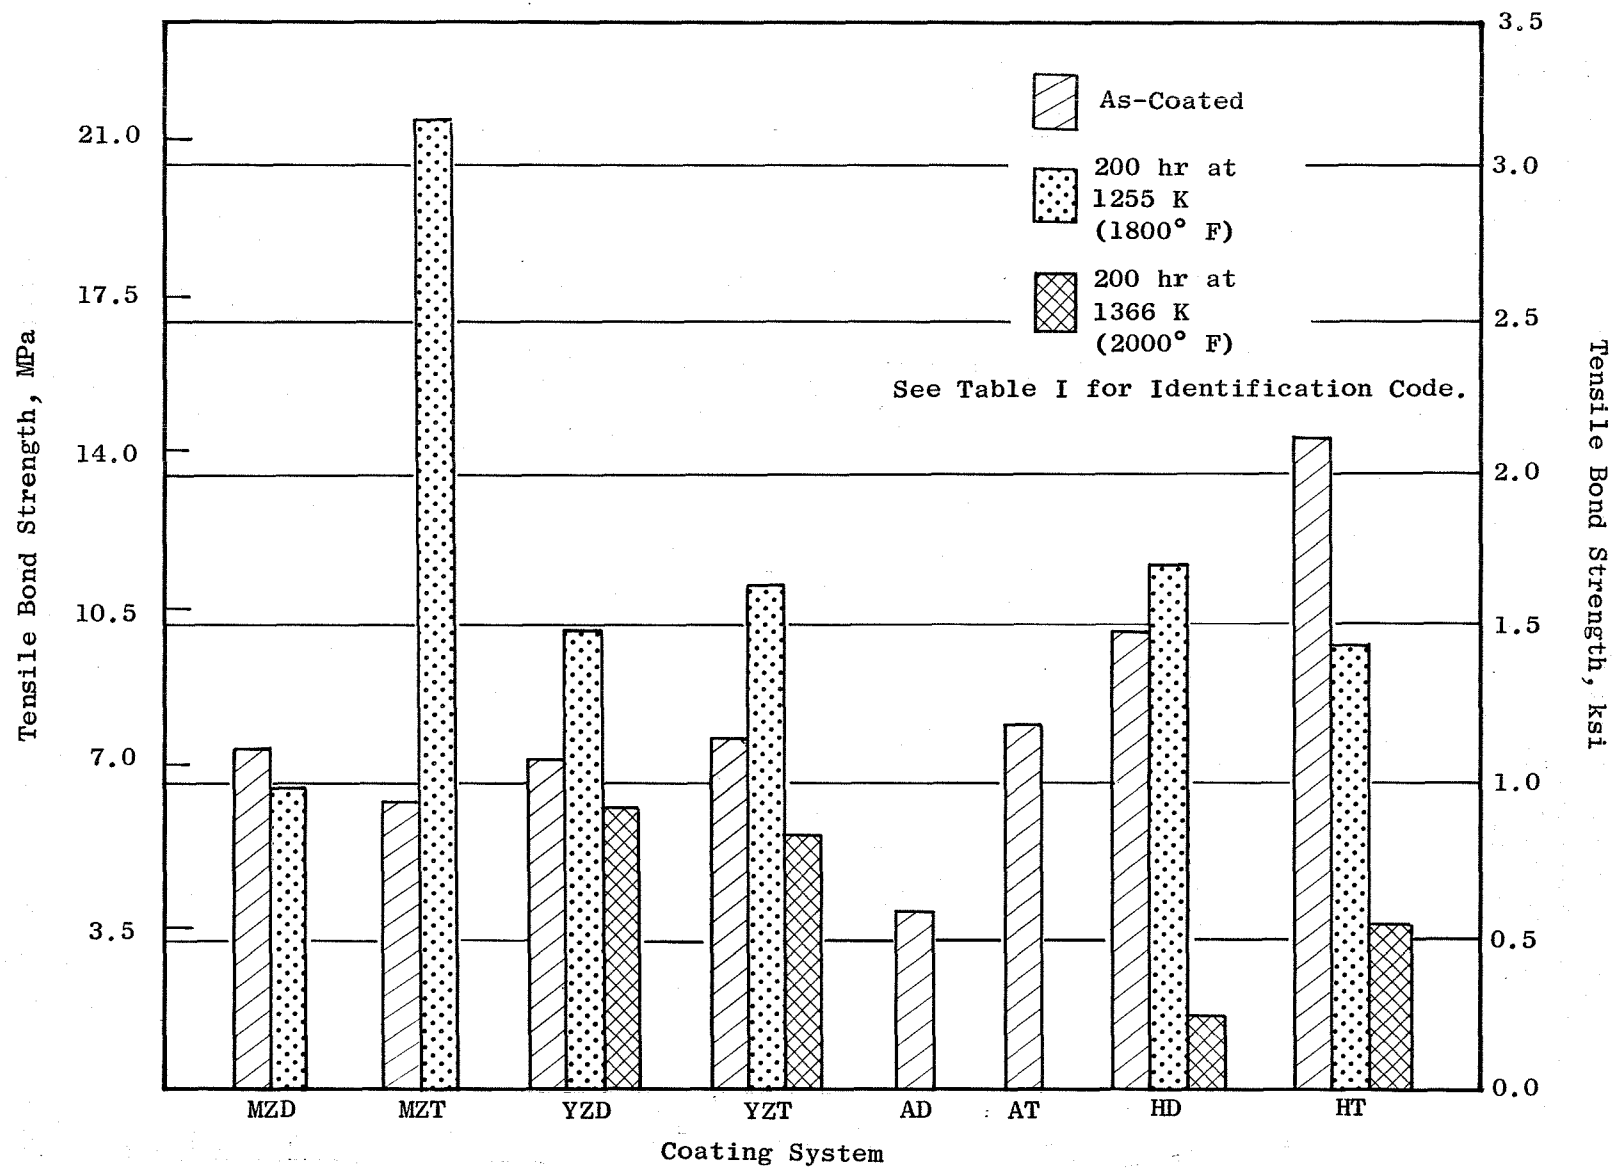
Figure 2. Tensile Bond Strengths in the As-Coated Condition and After 1255 K (1800° F)/200-Hour and 1366 K (2000° F)/200-Hour Exposures (Average of Three Specimens).

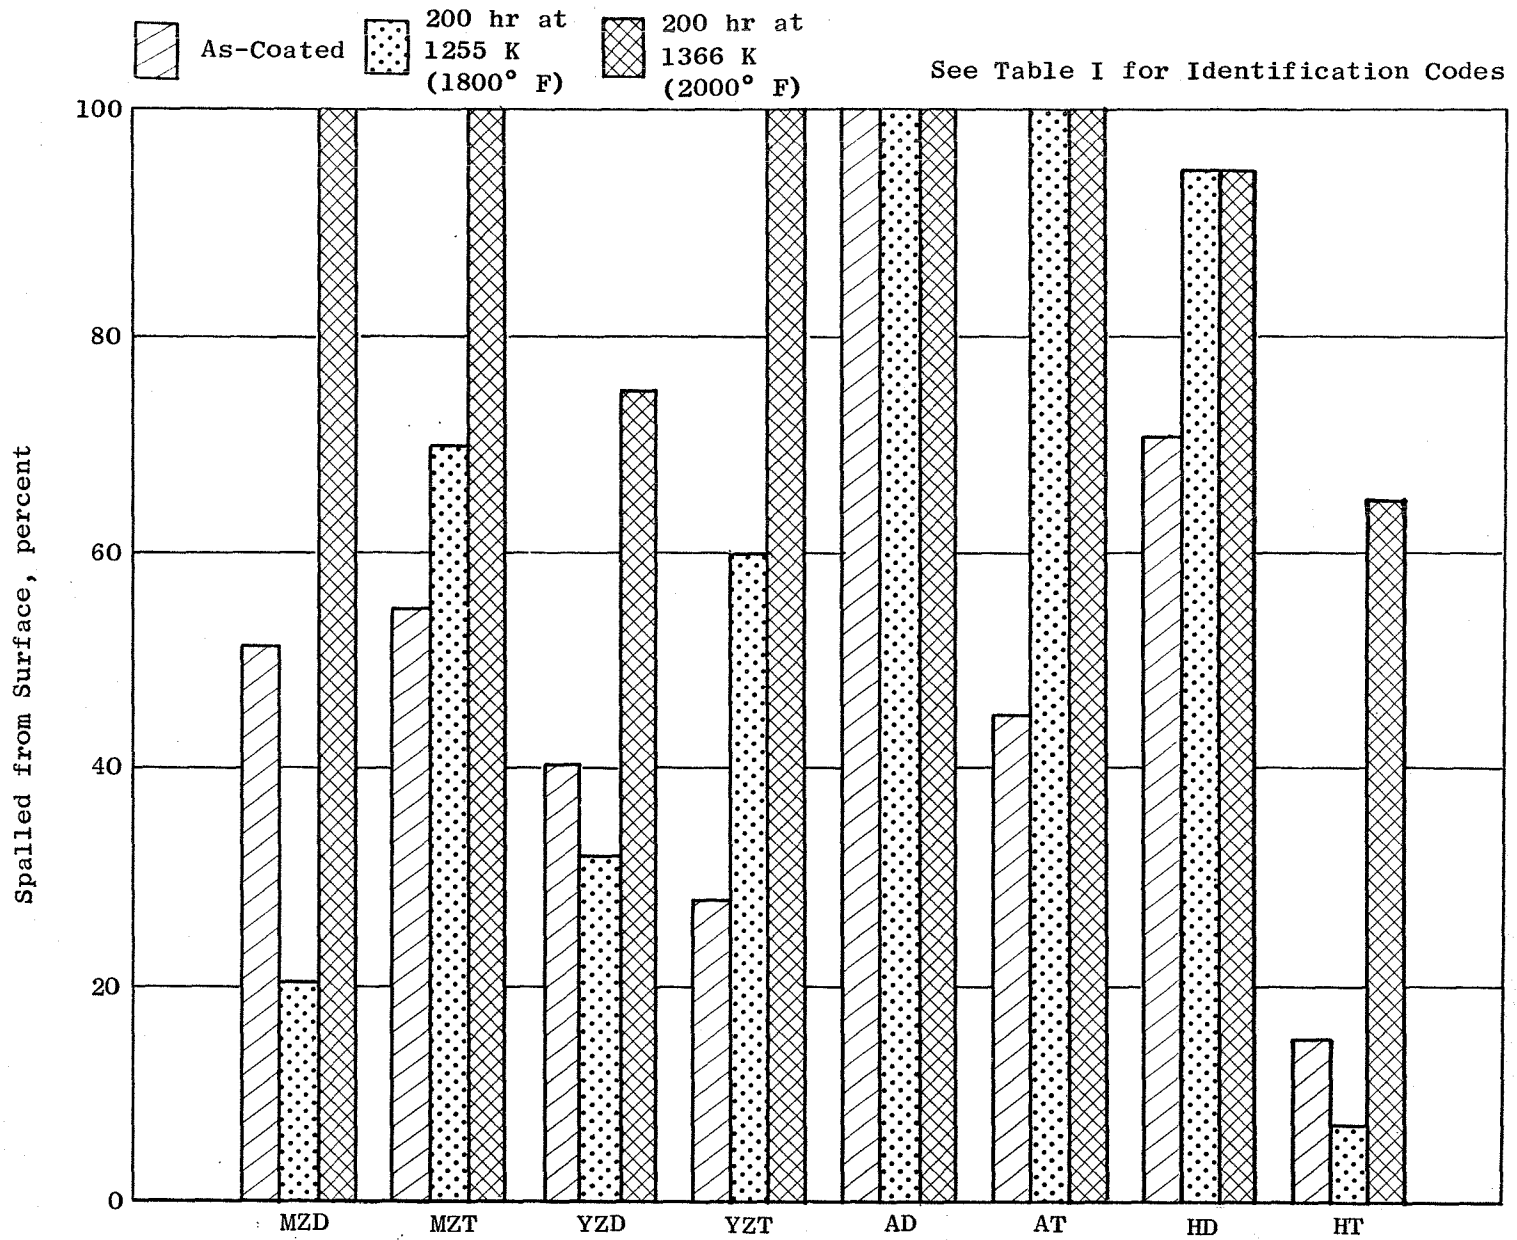
Figure 3. Bend Test Results Showing Extent of Coating Spallation in the As-Coated Condition and After 1255 K (1800° F)/200-Hour and 1366 K (2000° F)/200-Hour Exposures (Average of Three Exposures).

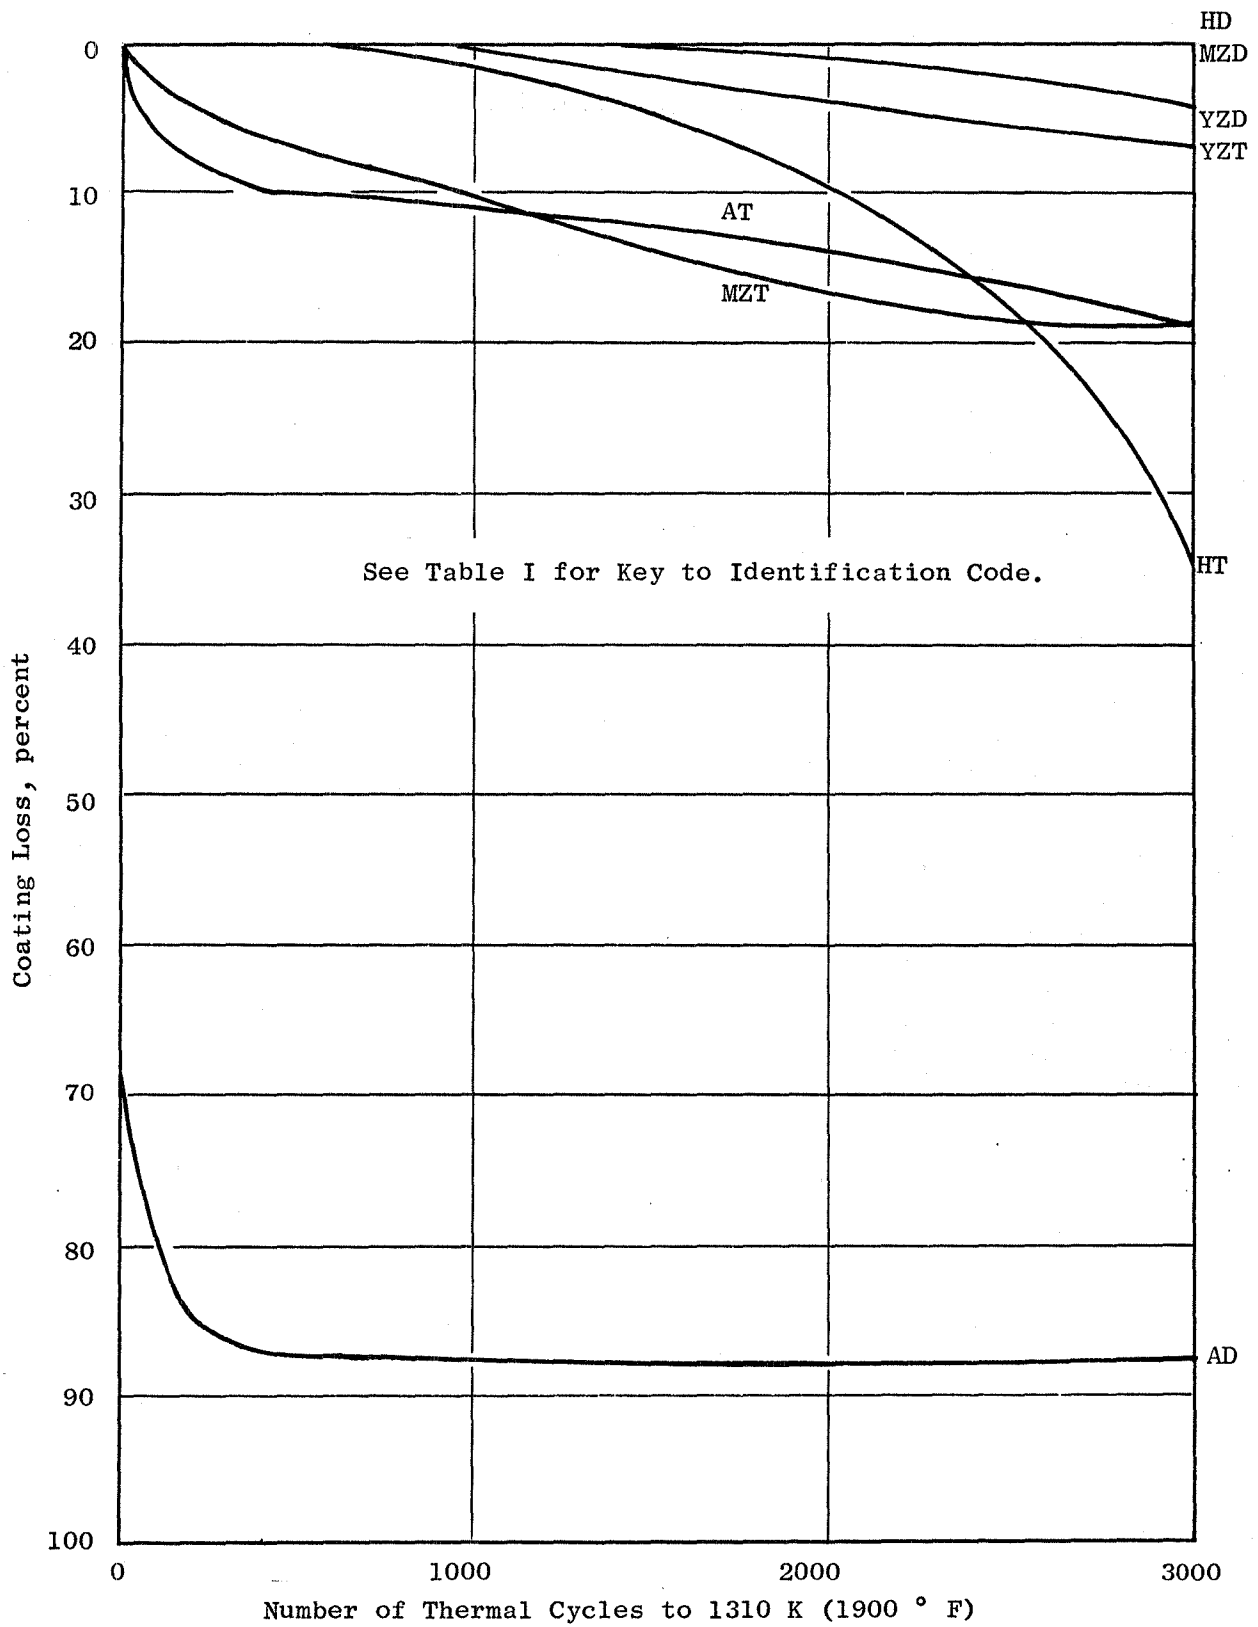
Figure 7. Thermal Cycle Test Results.

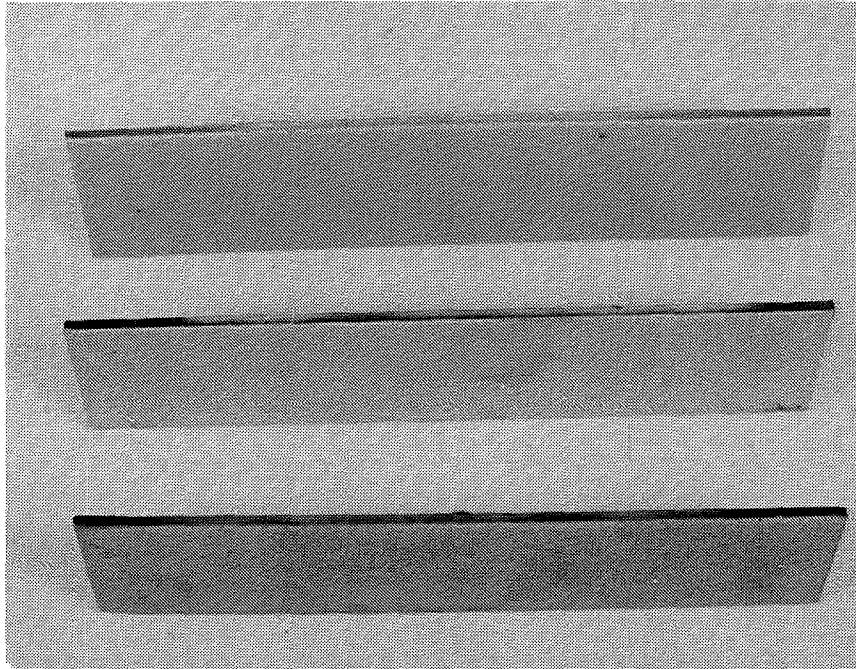
(1) See Table I for key to identification code.

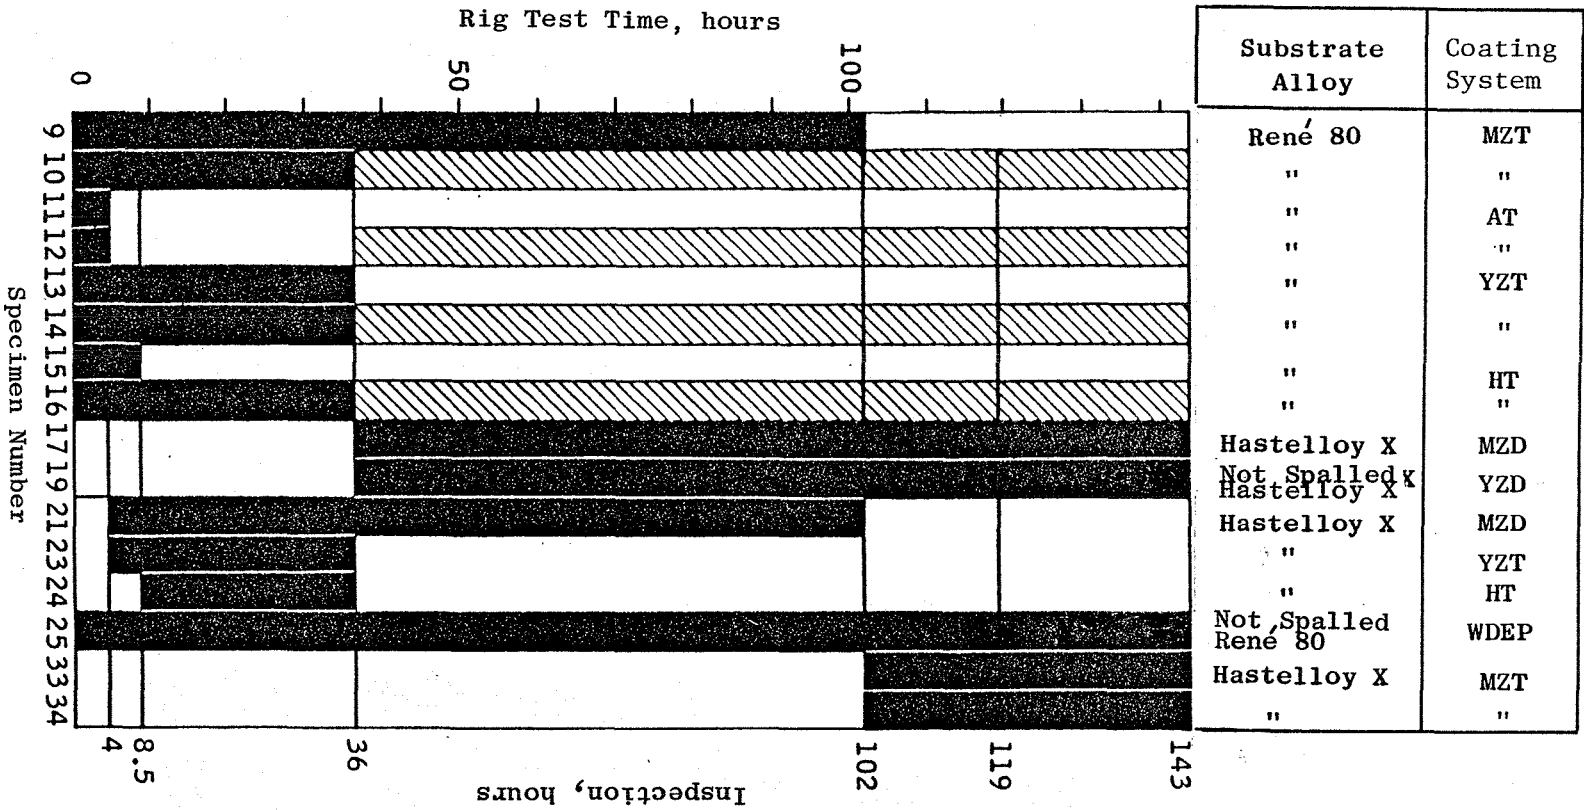
See Table I for Identification Code.

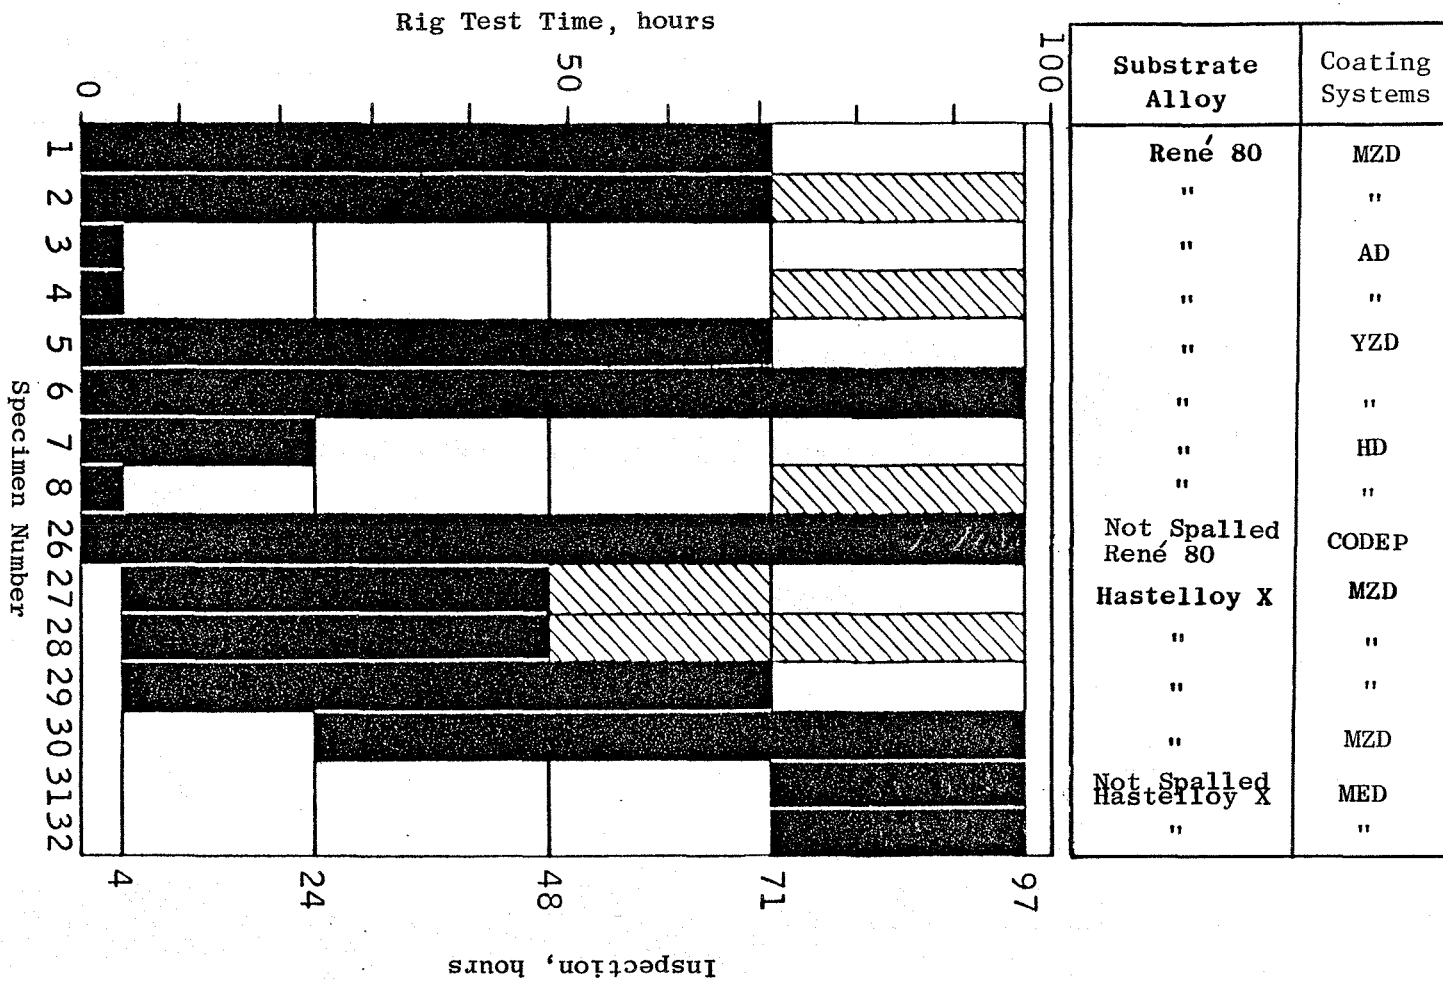
See Table I for Identification Code.

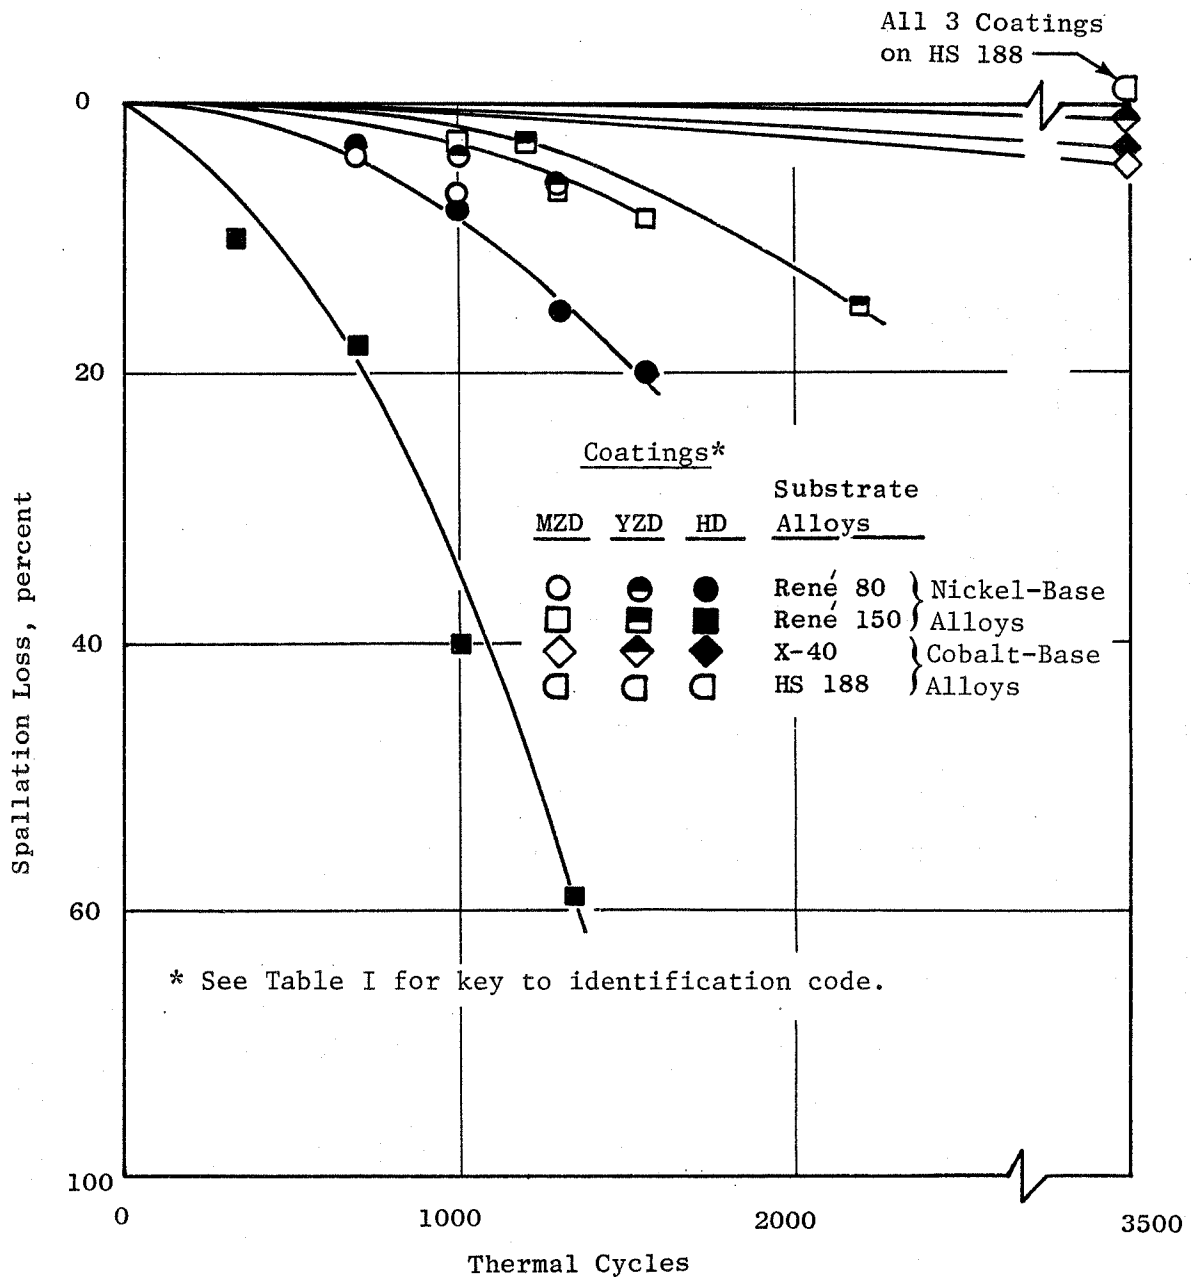
Figure 11. Thermal Cycle Test Results.

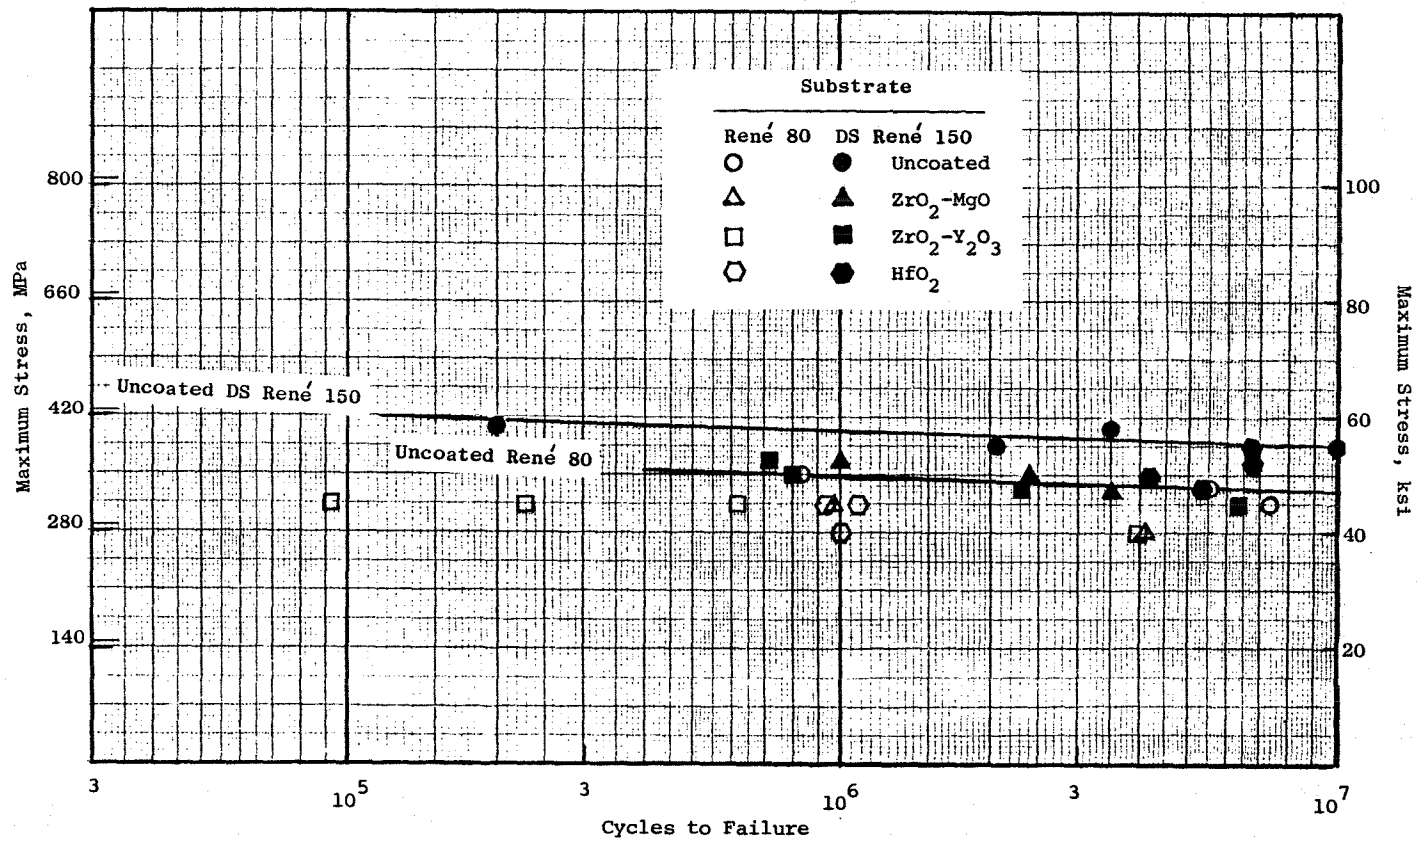
Figure 14. High Cycle Fatigue Test Results on Uncoated 1255 K (1800° F) and Thermal-Barrier-Coated 1280 K (1850° F) Specimens.

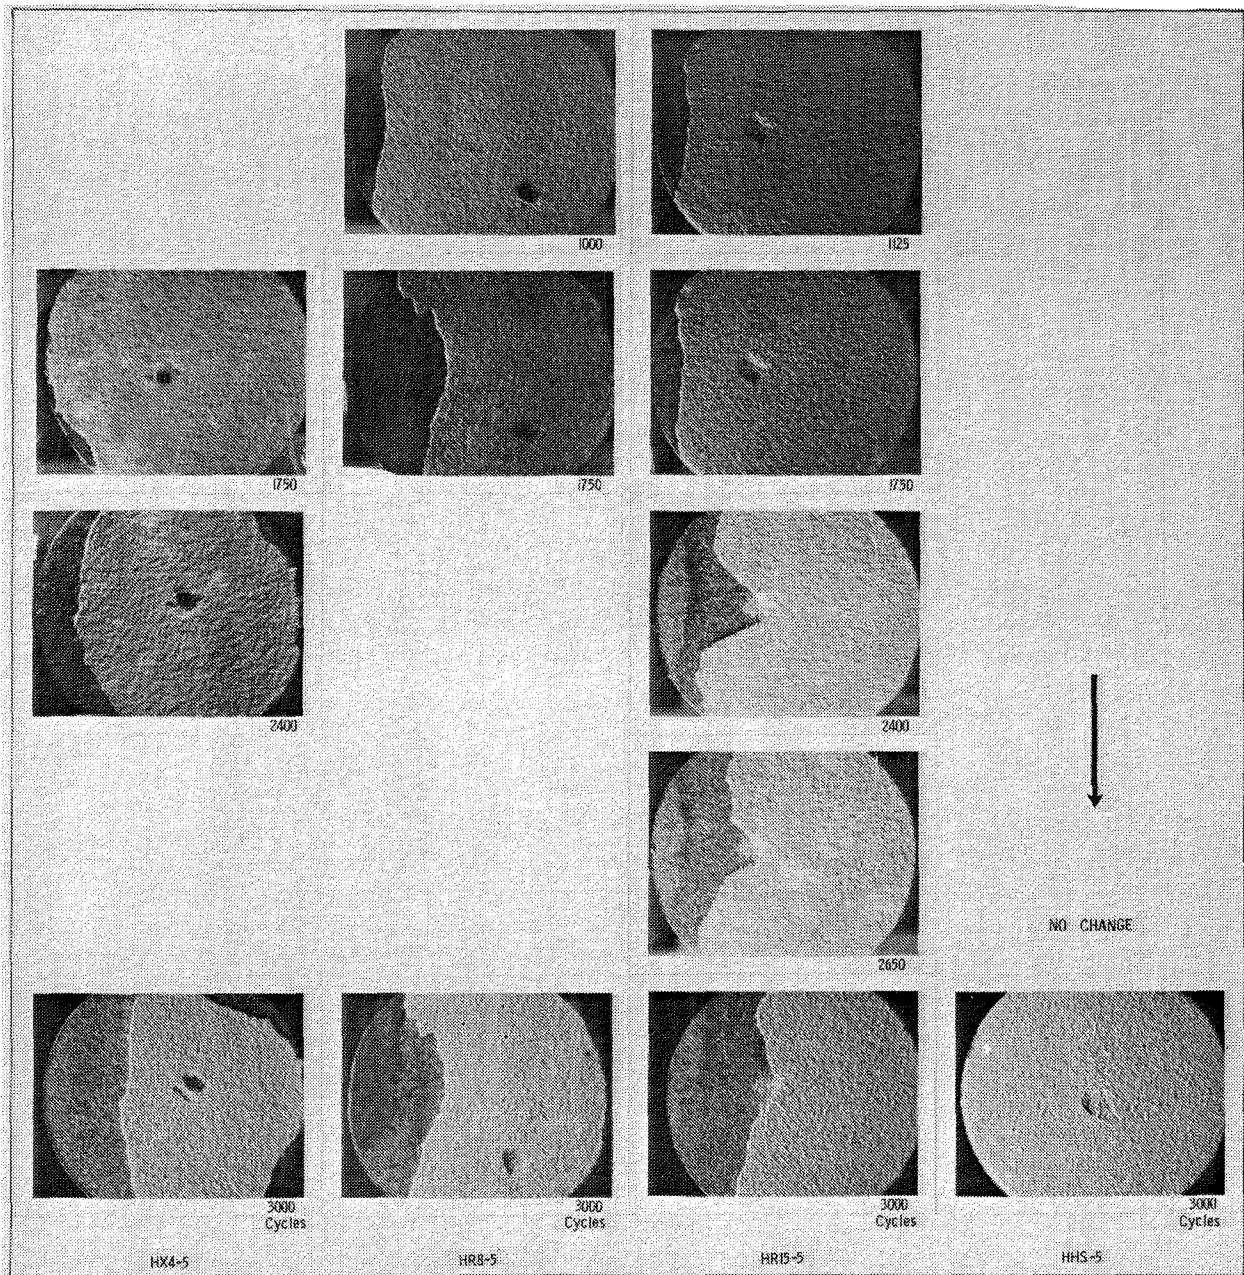
Figure 16. Results of Thermal Cycle Testing of HfO₂ TBC with Ballistic Impact Damage (20° Impact Angle).

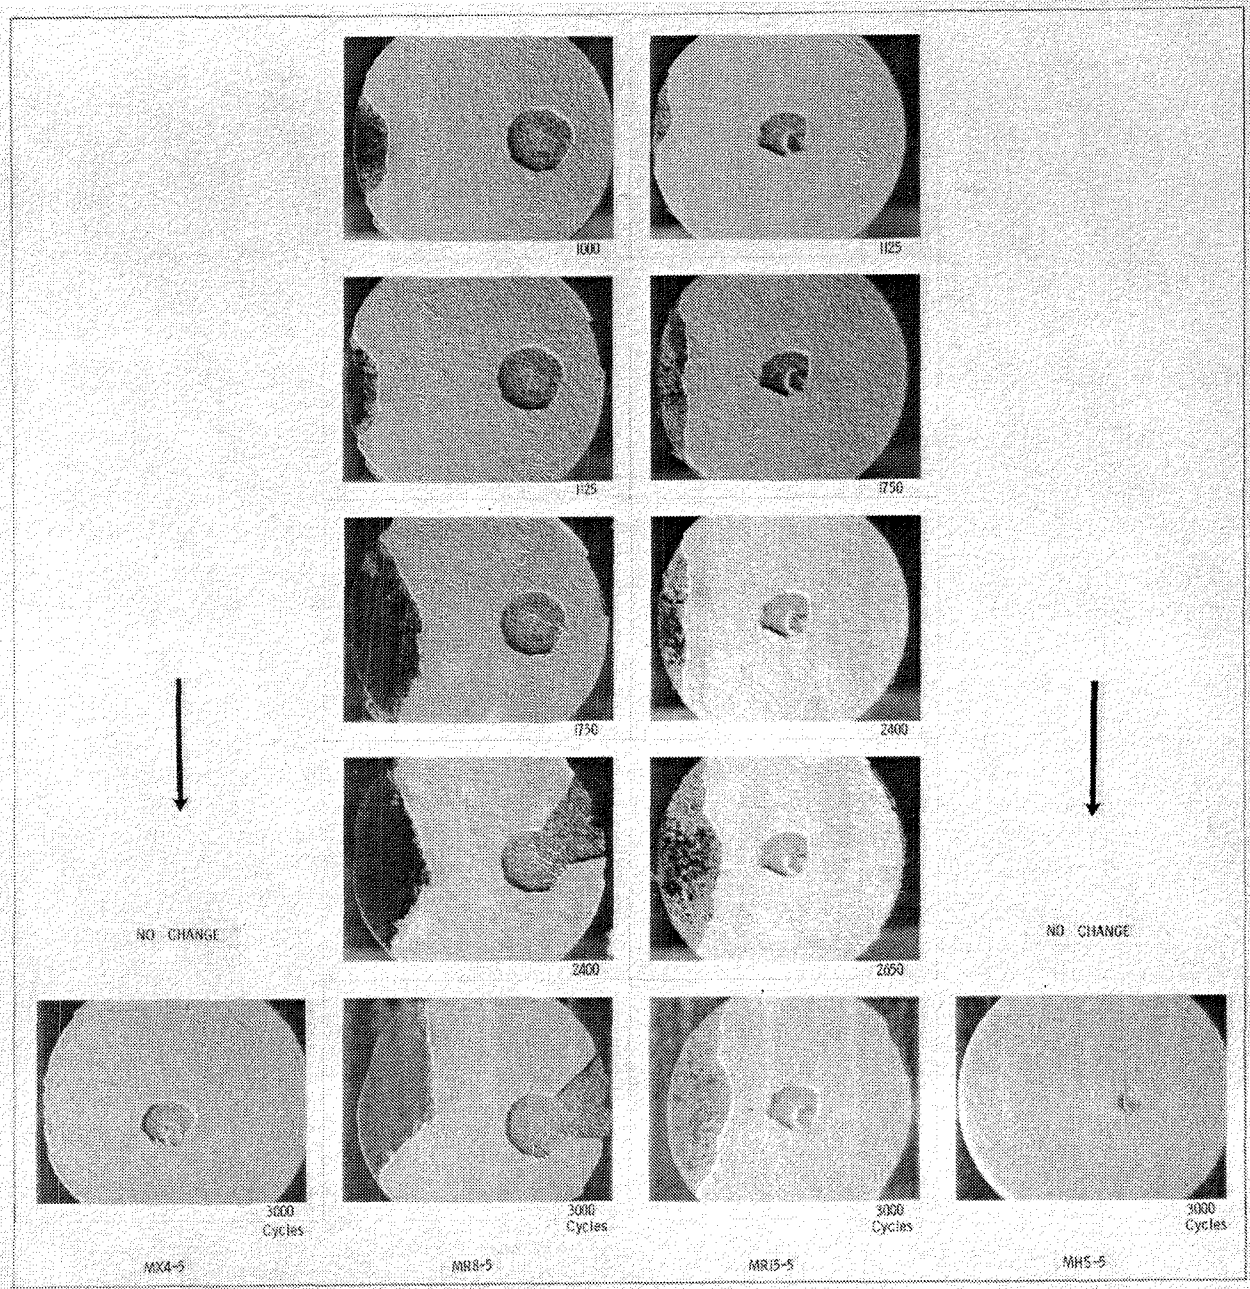
Figure 17. Results of Thermal Cycle Testing of $ZrO_2-24\%MgO$ TBC with Ballistic Impact Damage (20° Impact Angle).

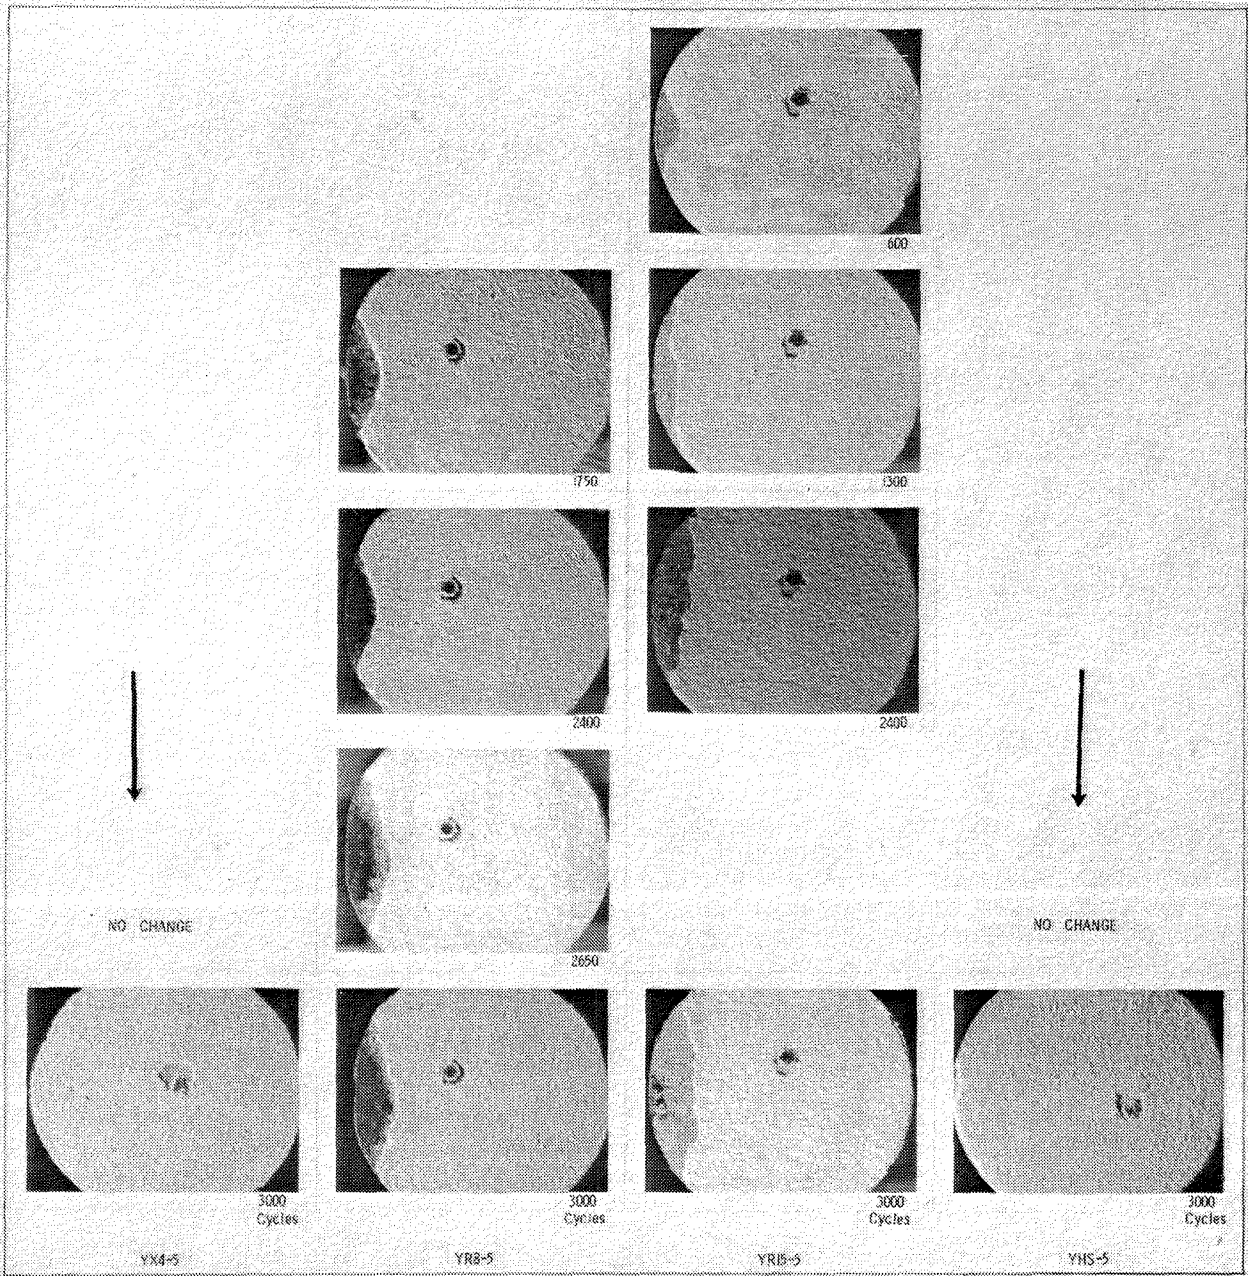
Figure 18. Results of Thermal Cycle Testing of $ZrO_2-20\%Y_2O_3$ TBC with Ballistic Impact Damage (20° Impact Angle).

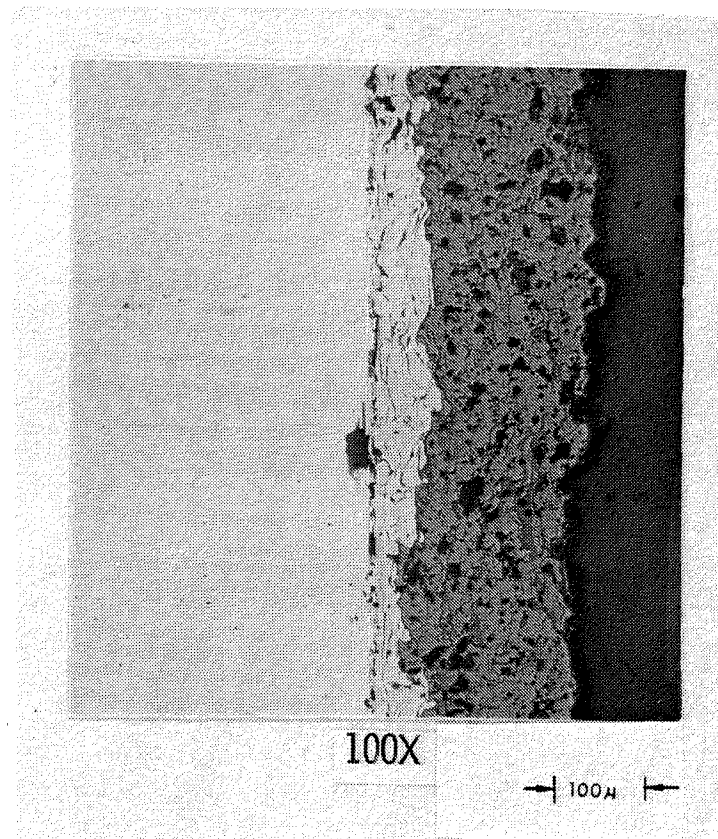
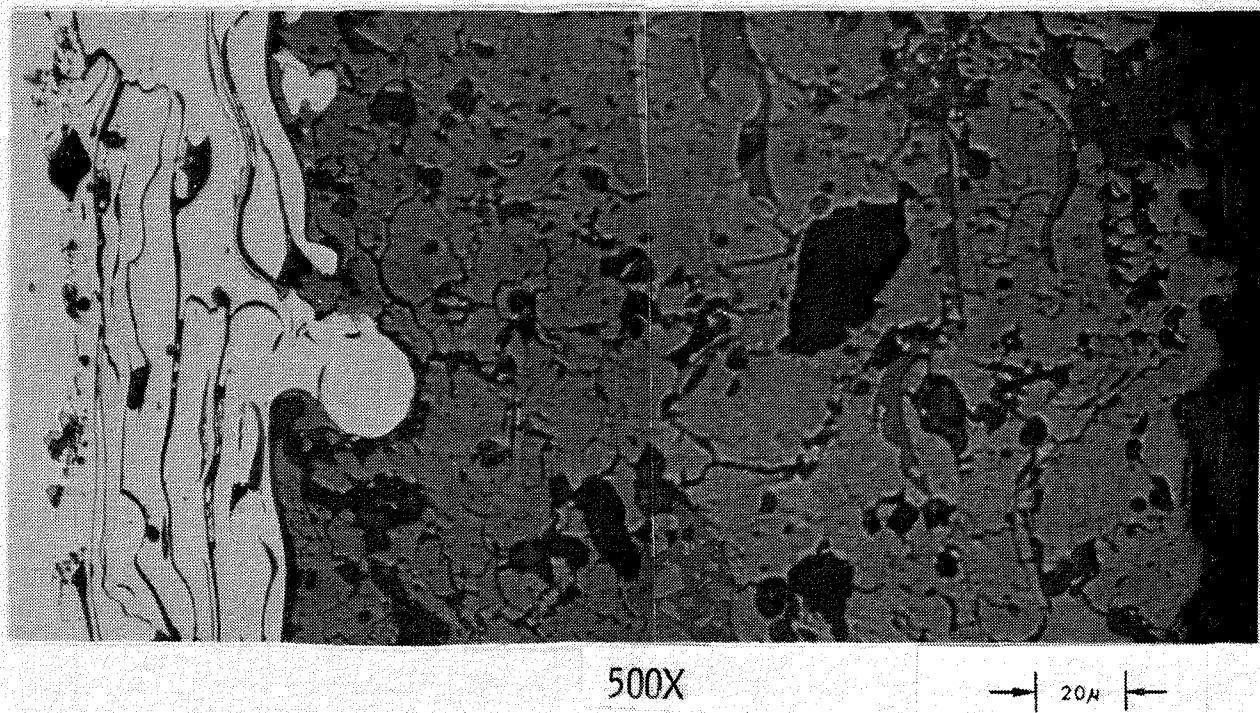
Figure 22. Microstructure of $ZrO_2-8\%Y_2O_3$ TBC.

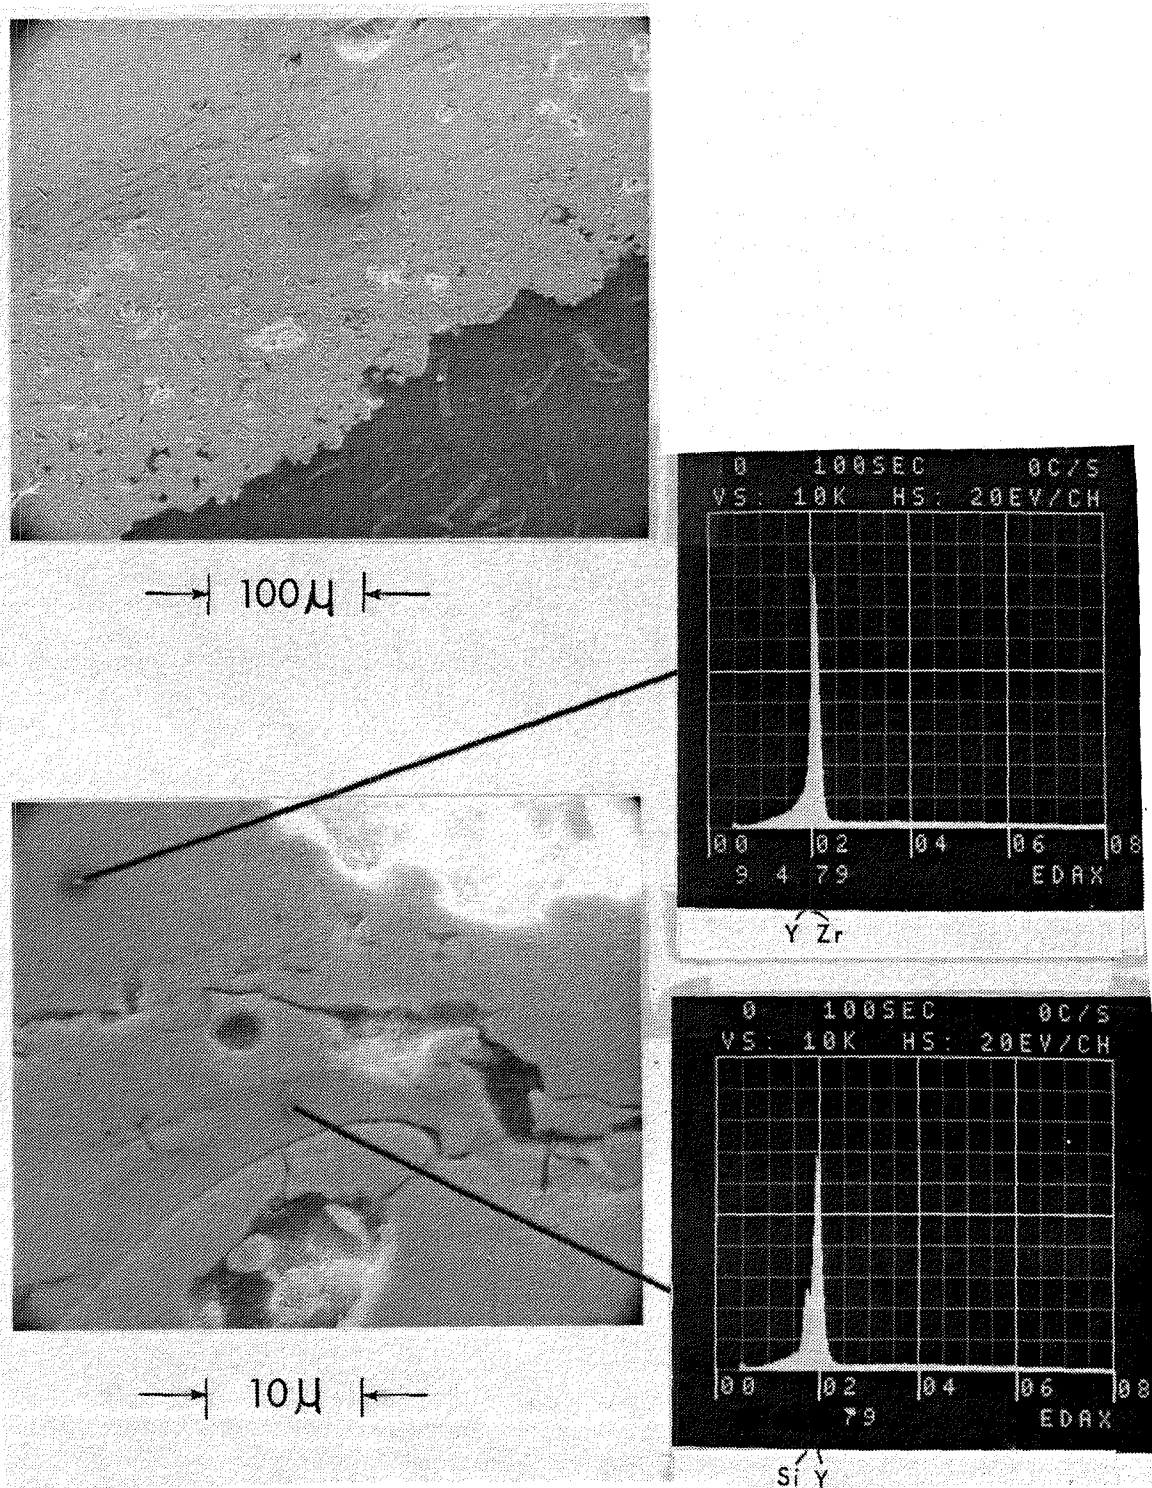
Figure 23. Scanning Electron Micrograph and EDAX Results on $ZrO_2-8\%Y_2O_3$ TBC.

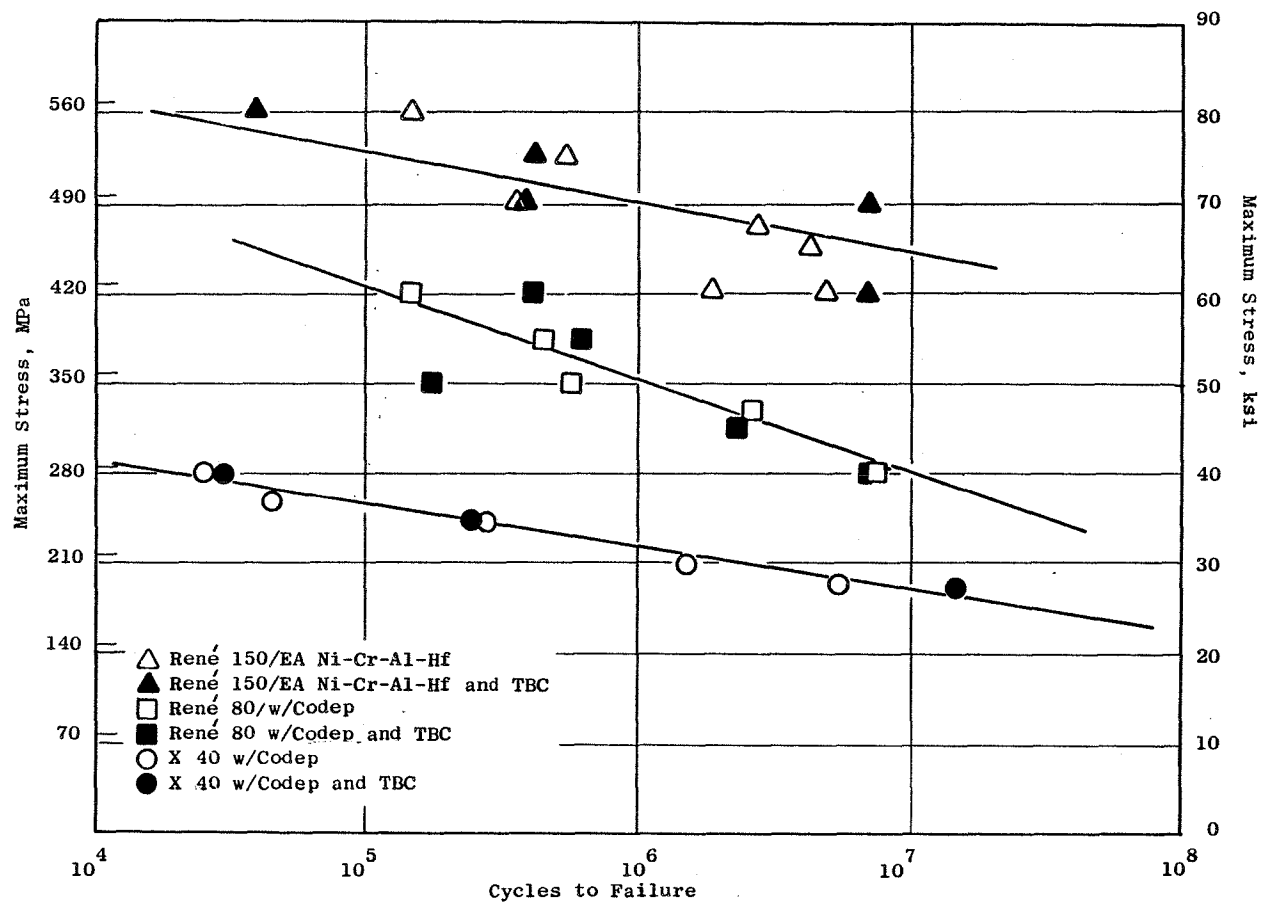
Figure 24. Results of 1255 K (1800° F), High Cycle Fatigue Testing Comparing Specimens With and Without Thermal Barrier Coating.
