CR-168037
R82AEB2A3

NASA-CR-168037
19850026886

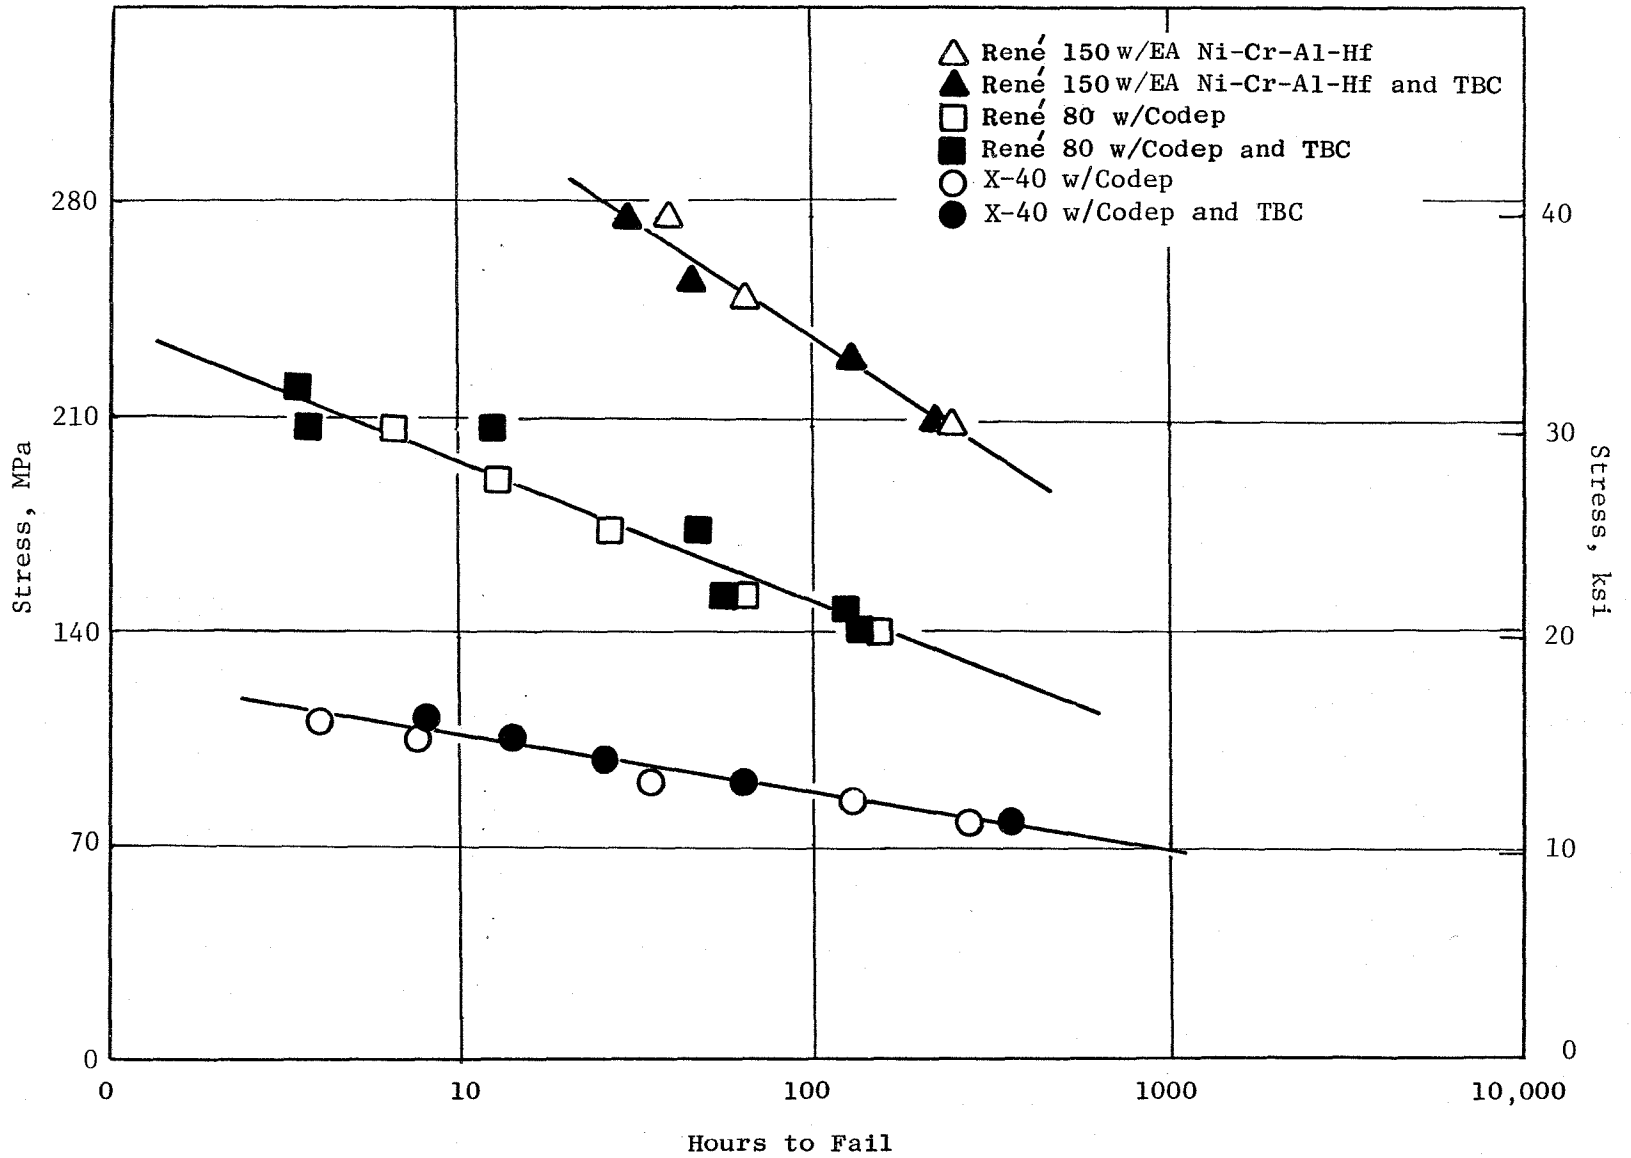
Figure 26. Results of 1255 K (1800° F), Stress Rupture Testing Comparing Specimens With and Without Thermal Barrier Coating.

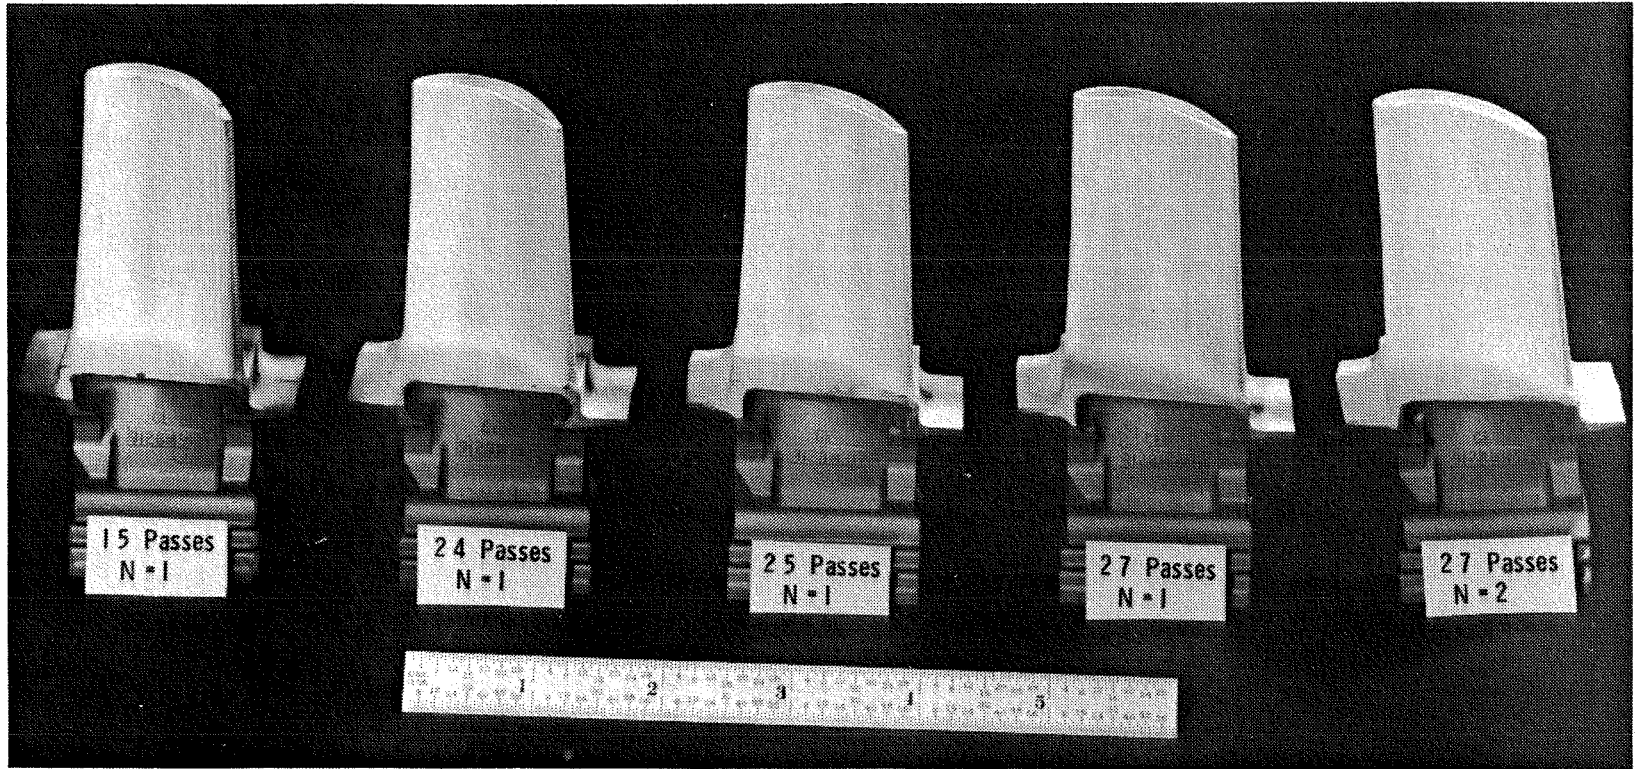
Figure 27. CF6-50, Stage 1 Blades With Increasing Number of Coating Passes of $ZrO_2-20\%Y_2O_3$ Ceramic Layers.

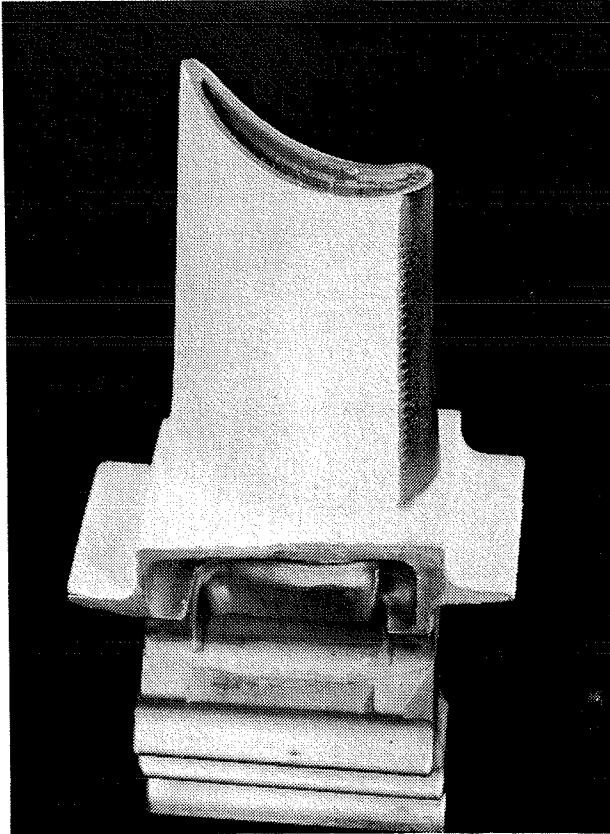
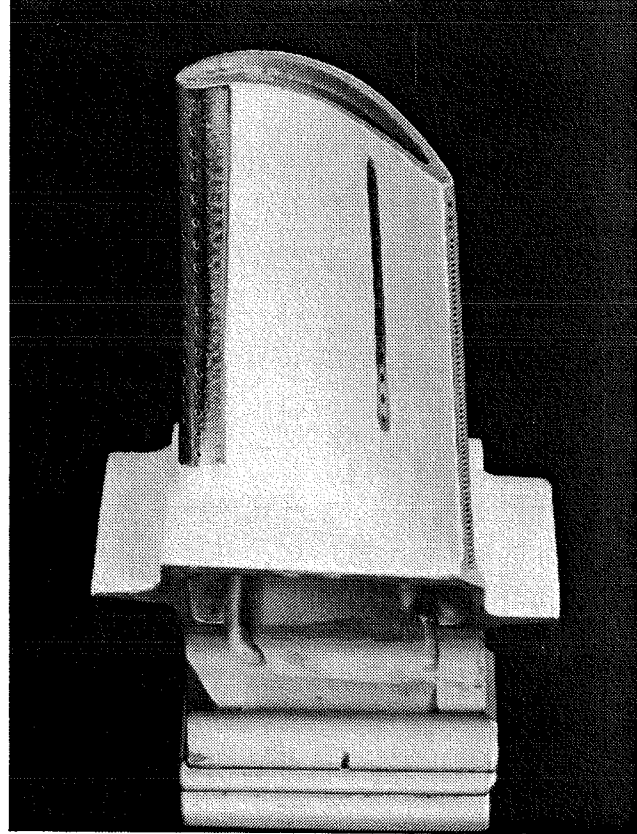
Figure 29. CF6-50 HPT, Stage 1 Blade (DS René 150) With Ni-Cr-Al-Y/ZrO₂-20%Y₂O₃ Duplex TBC Over EA Ni-Cr-Al-Hf Coating.

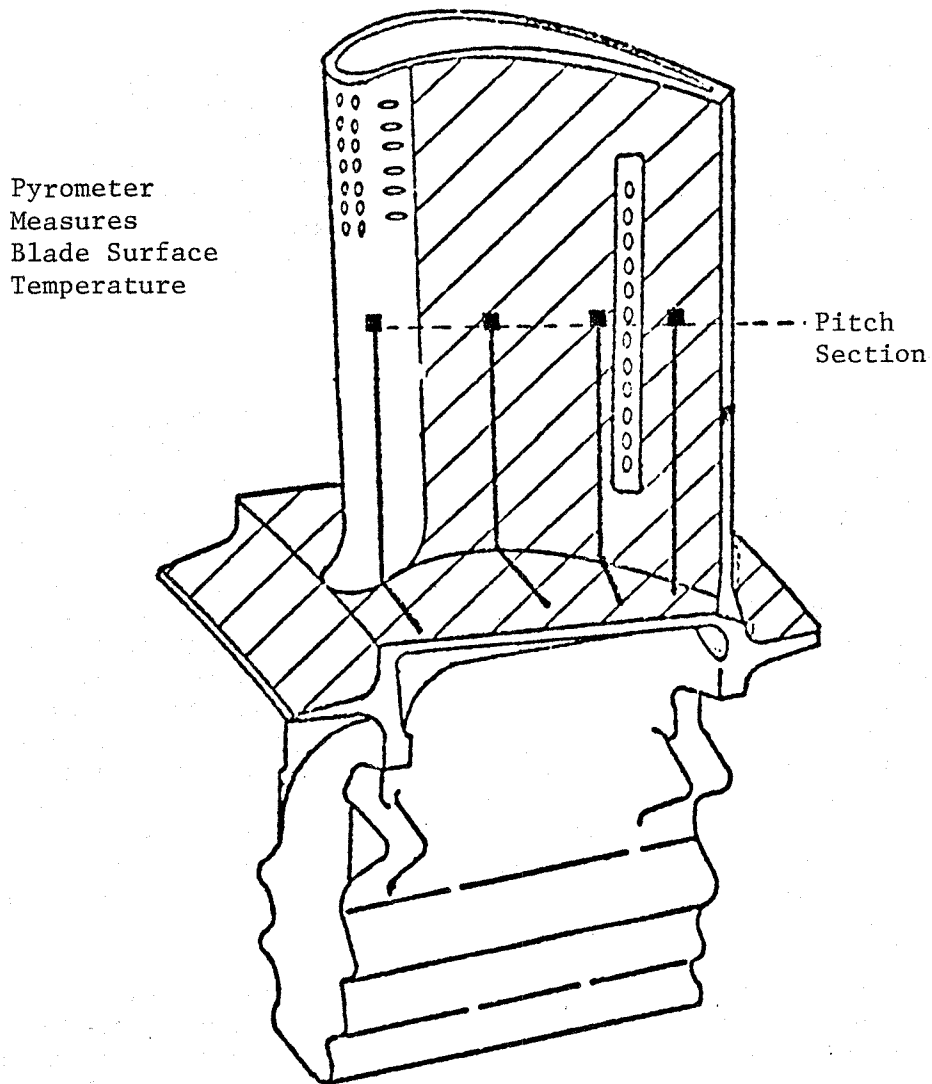
Blade Instrumentation
For Rig Test

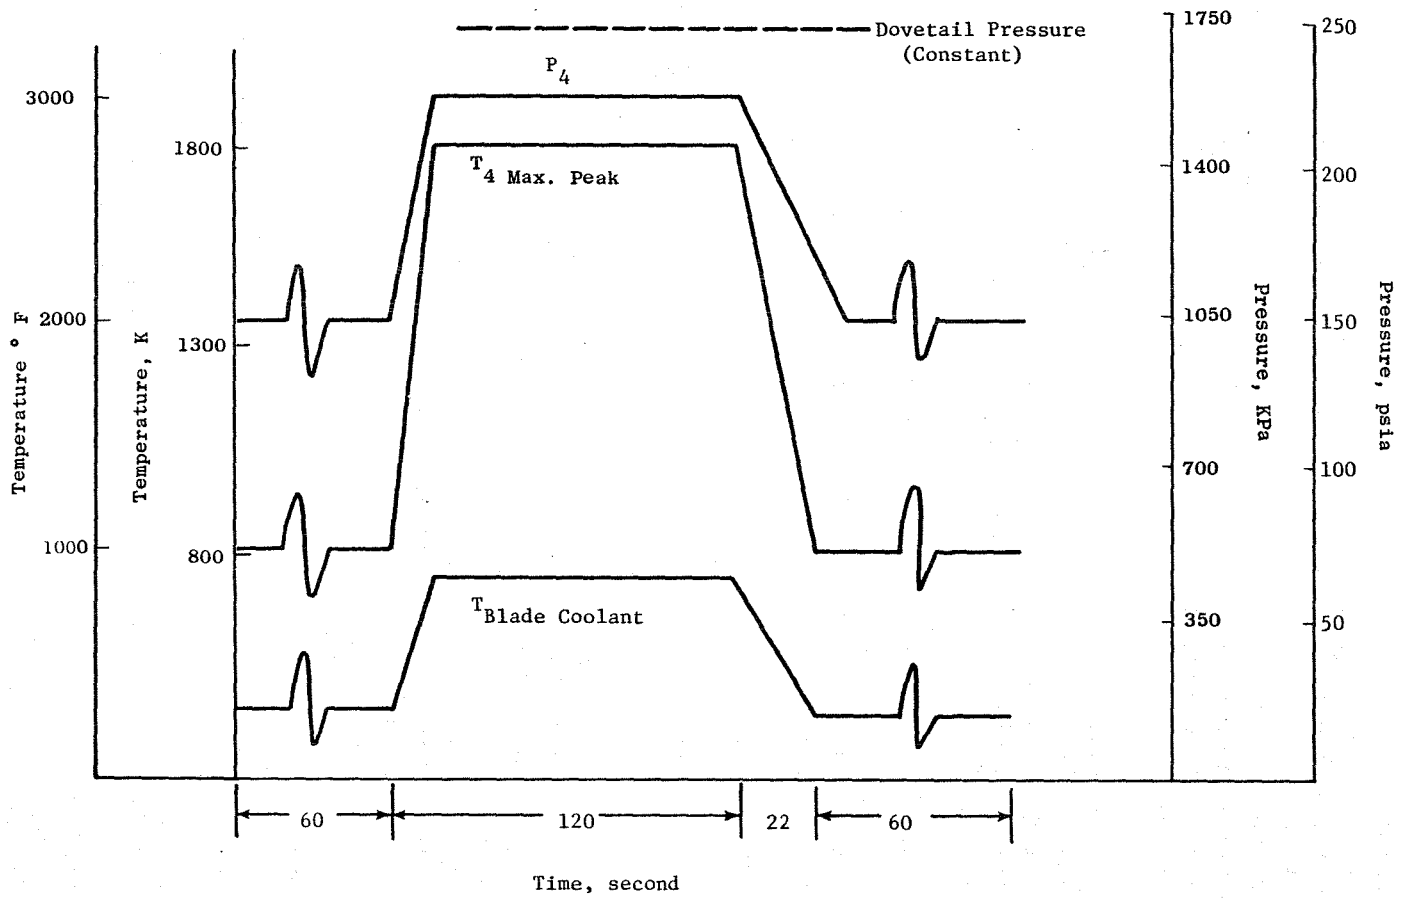
Figure 35. Planned Cyclic Conditions for Cascade Rig Test of Thermal-Barrier-Coated Blades.

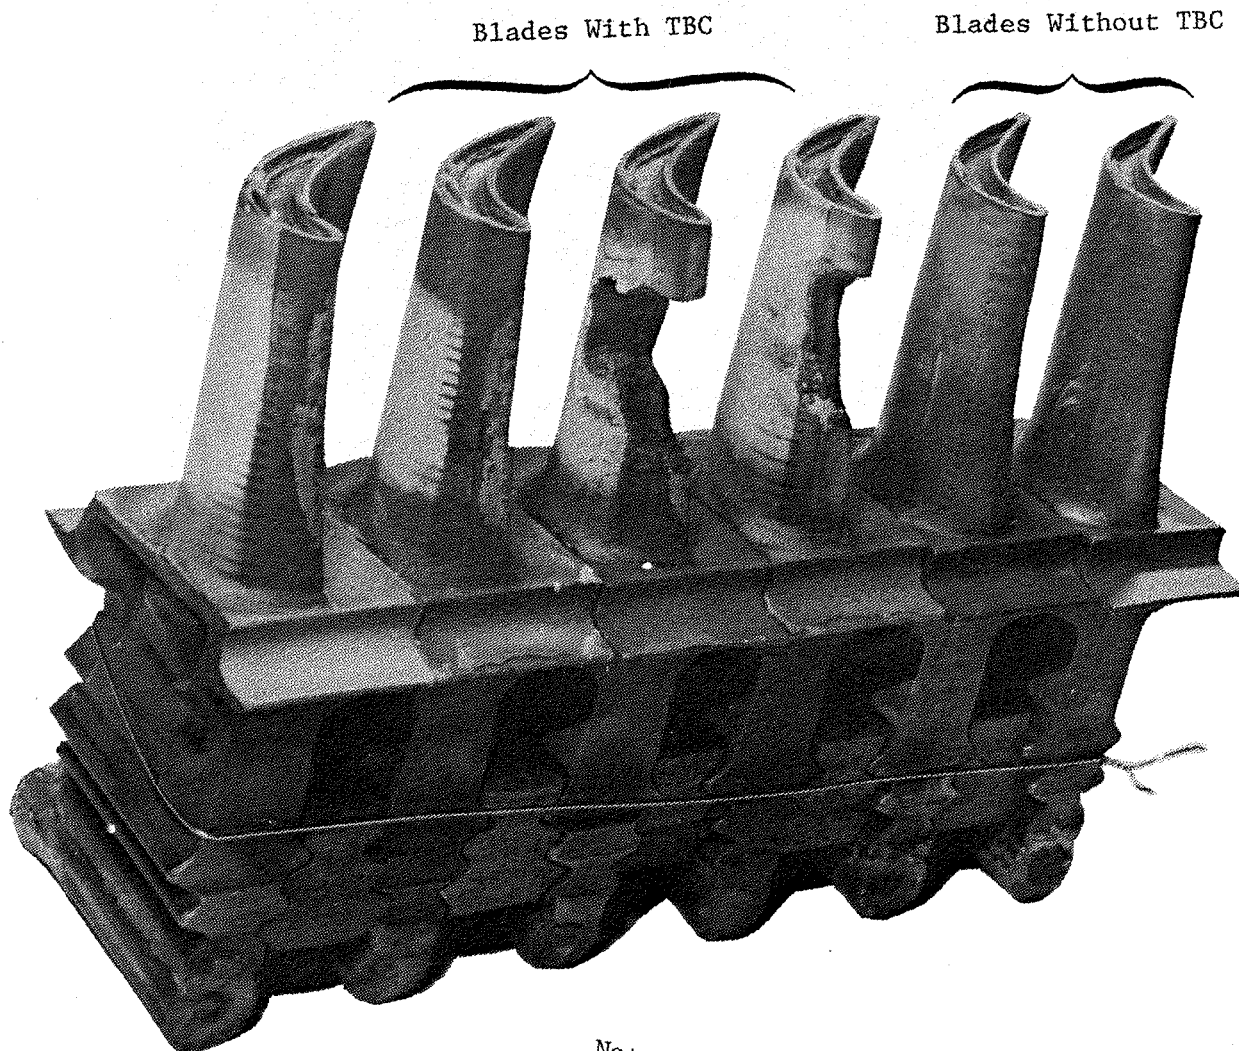
Note: The leading edge burnout was caused by a negative backflow margin.

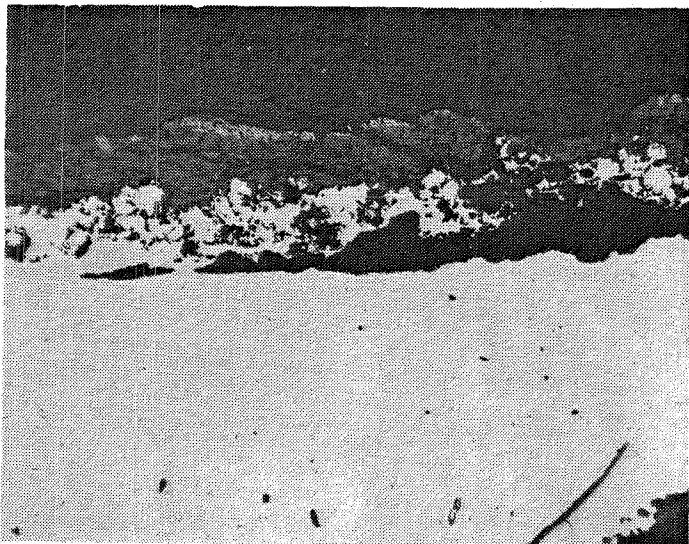
(a) Near Leading Edge in the Damaged Region 200μ

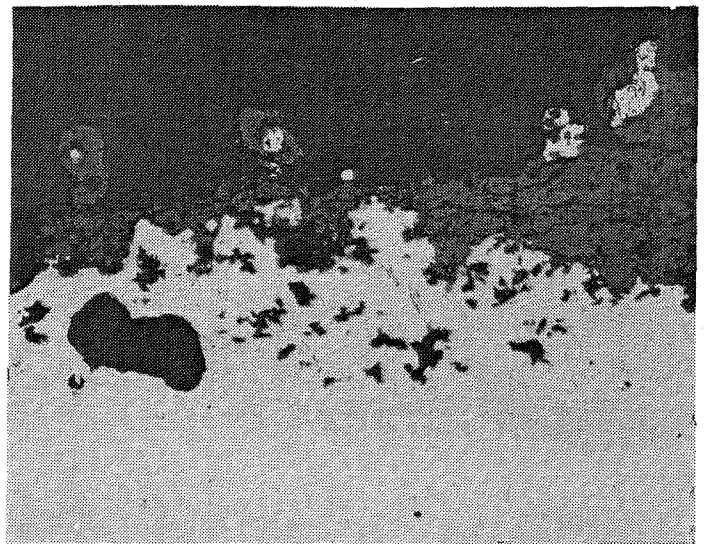
(b) Near Leading Edge in the Damaged Region 100μ

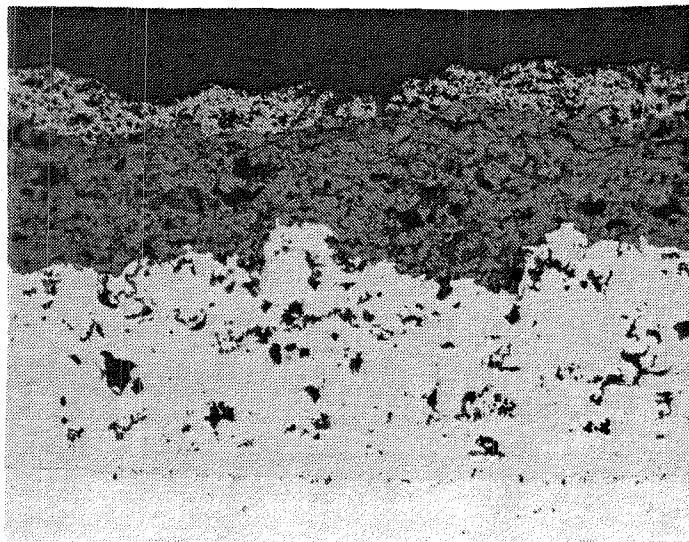
(c) Tip Region, Pressure Side 100μ

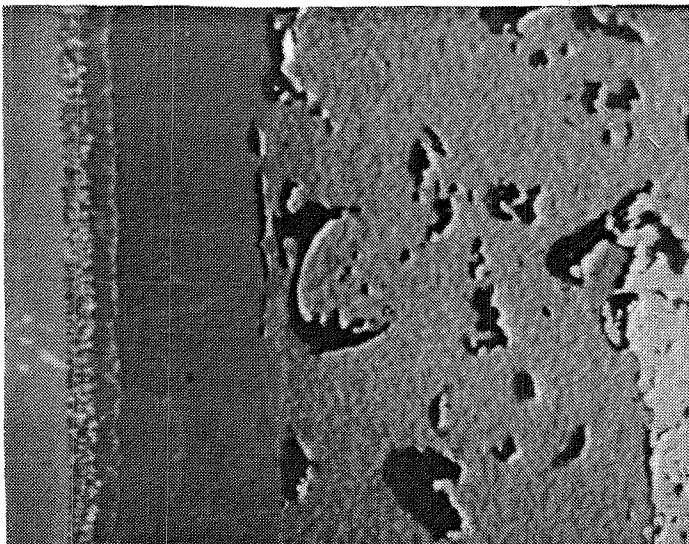
(a) Secondary Electron Image 20 μ

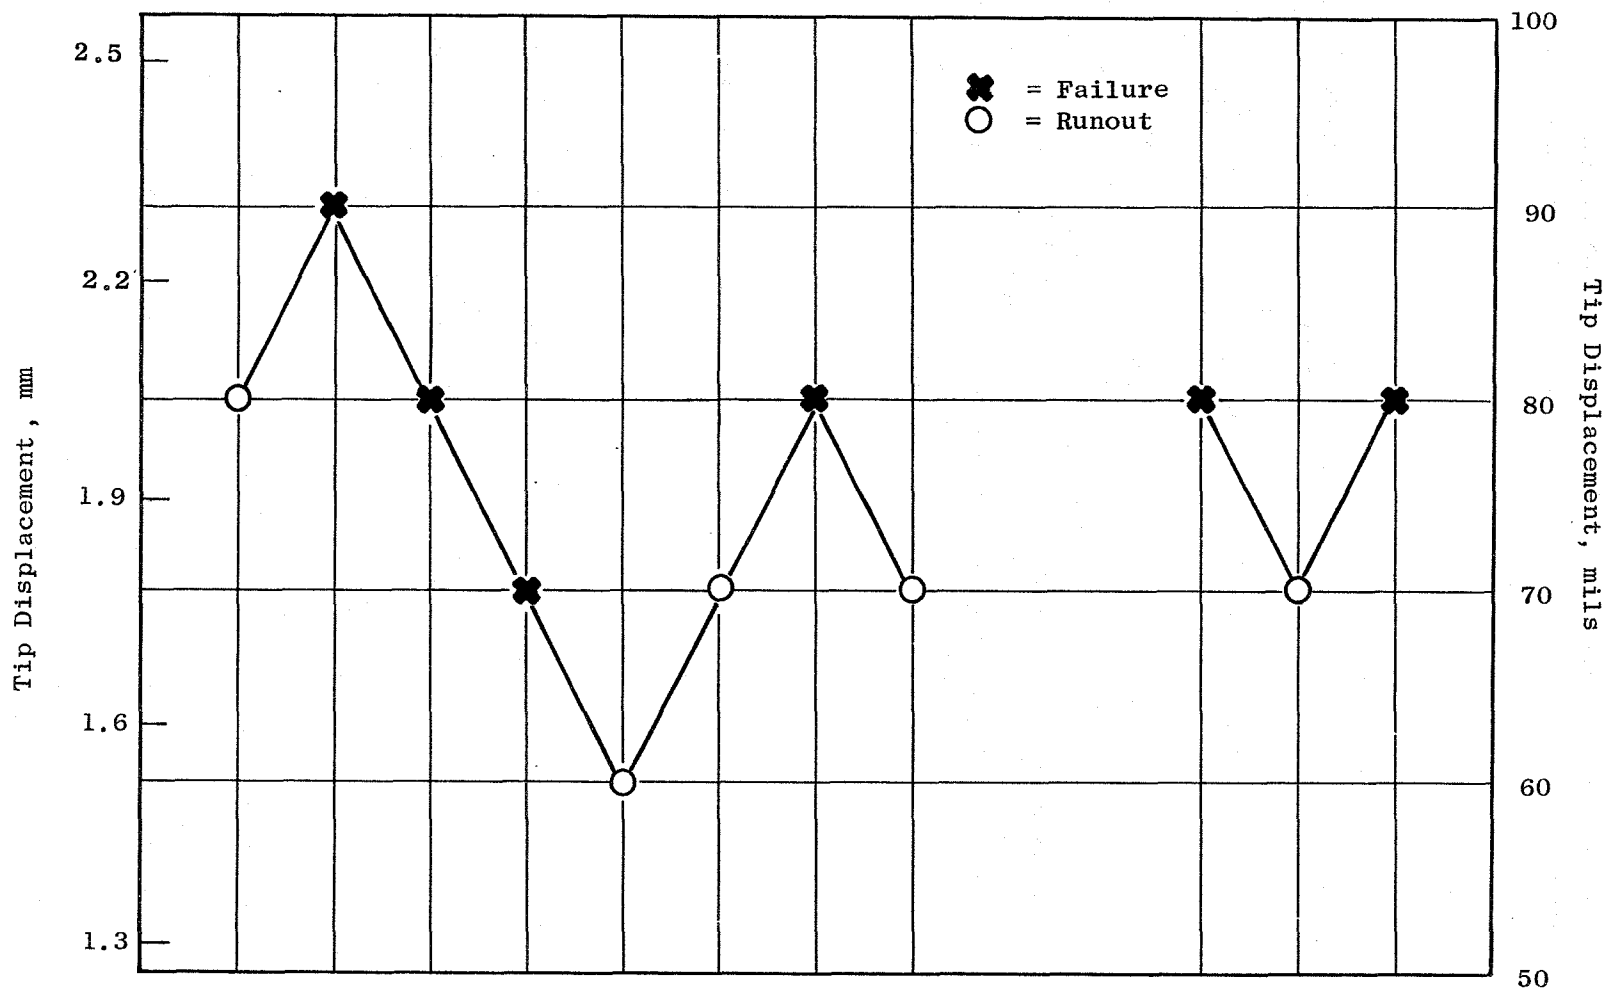
Figure 41. Component High Cycle Fatigue Test Results of Thermal-Barrier-Coated Blades at 1200 K (1700° F).

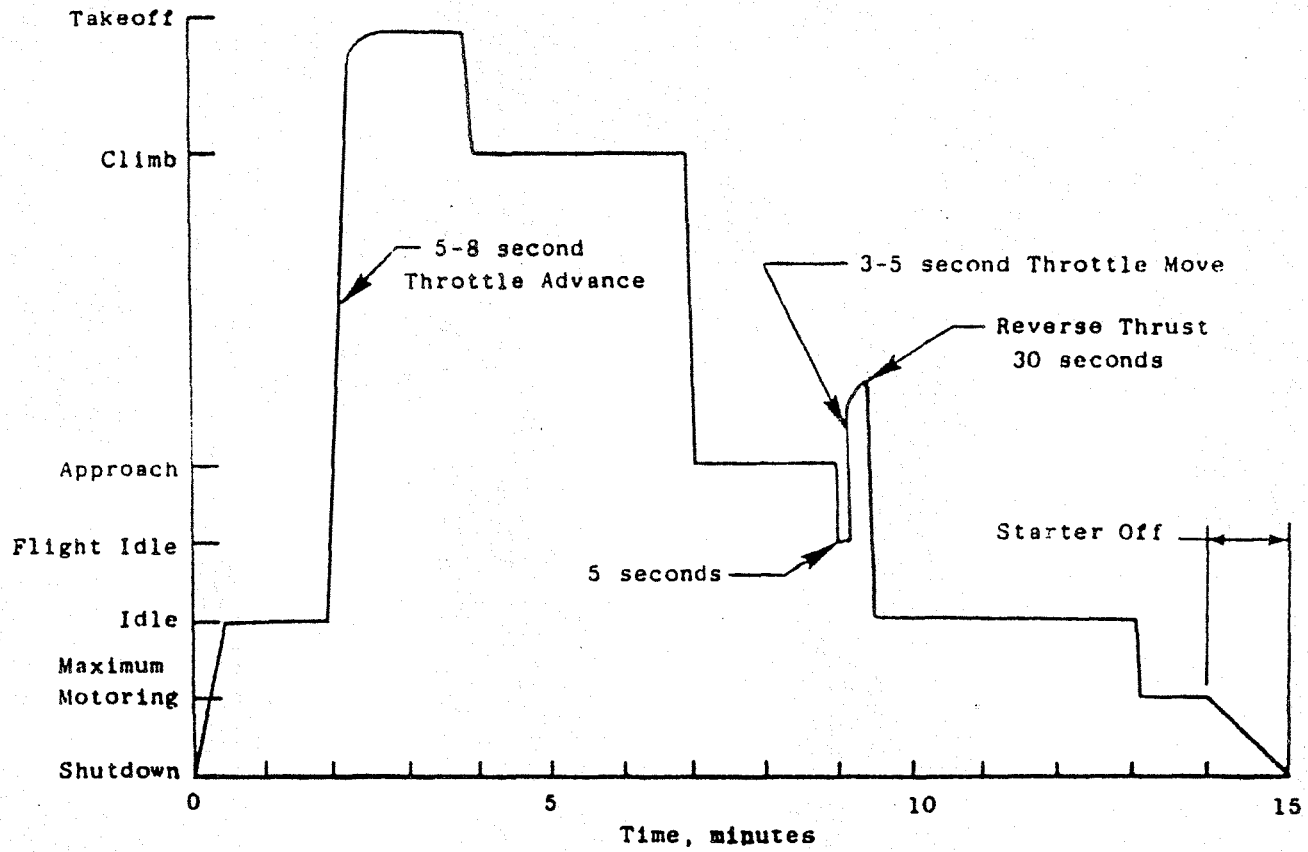
Figure 43. CF6-50 Engine Output Versus Time for Endurance Testing "C" Cycle.

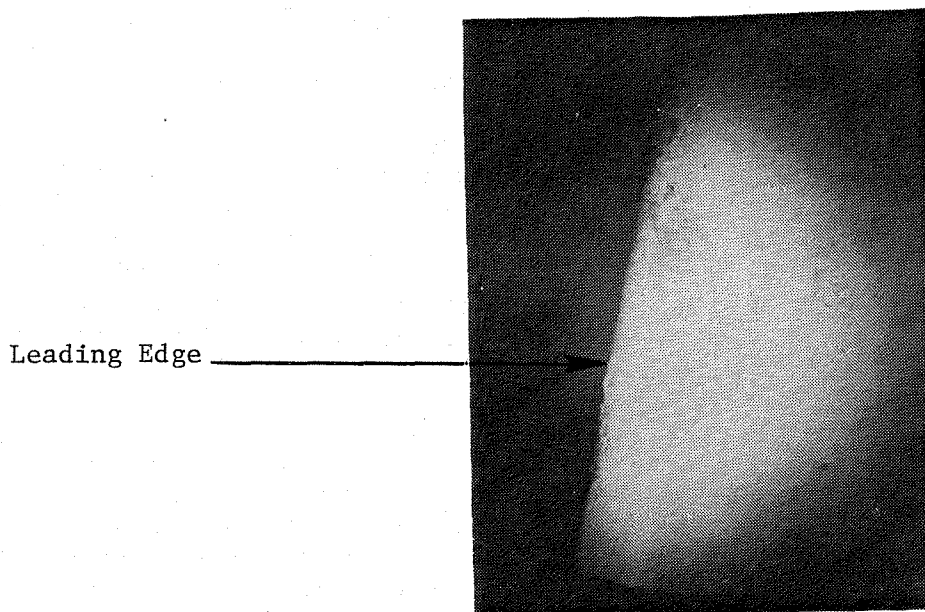
Figure 45. Borescope Photograph Showing Extent of Damage to Leading Edge of Thermal-Barrier-Coated Blade After 476 "C" Cycles.

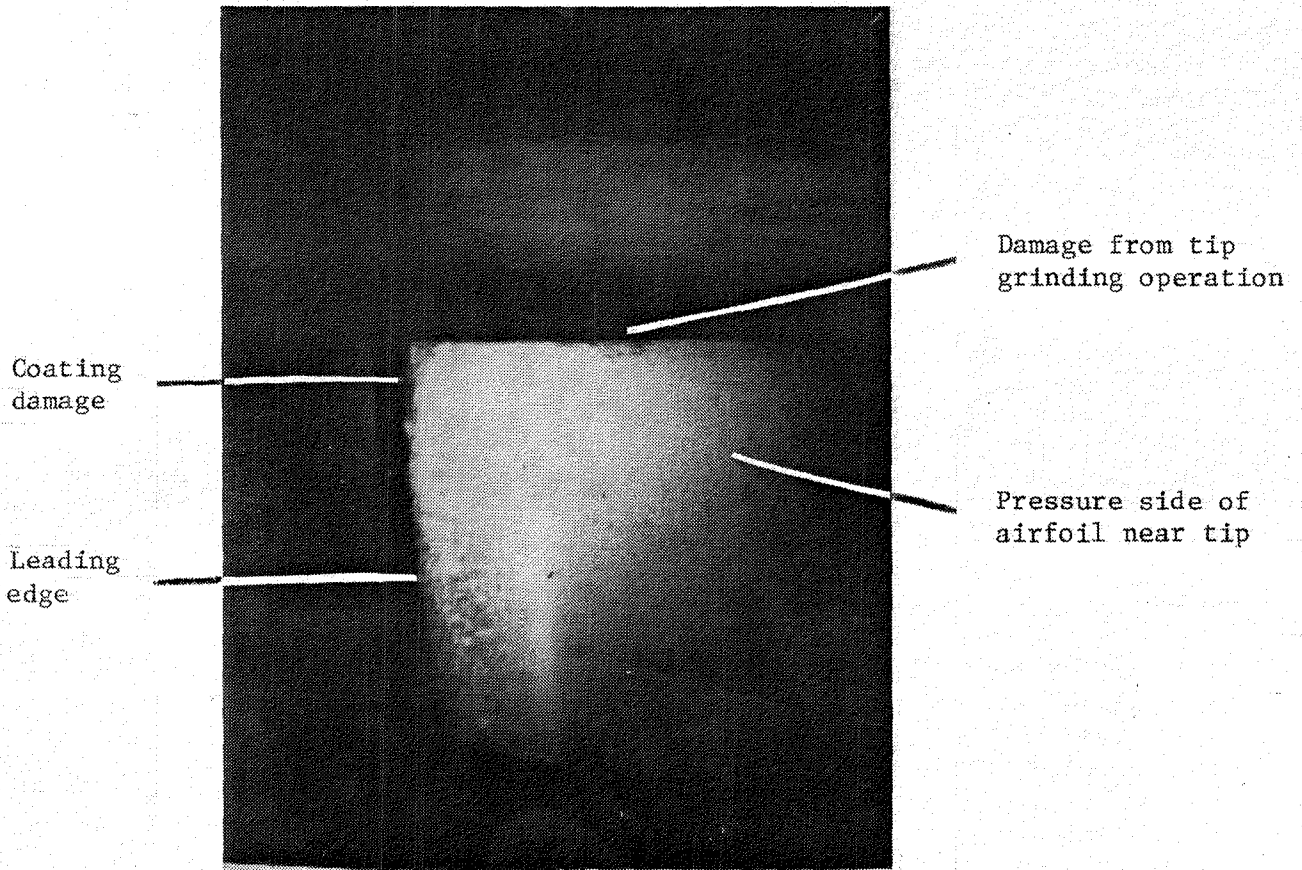
Figure 46. Borescope Photograph of Coating Damage After 27 Hours of Engine Checkout (Blade A2139).

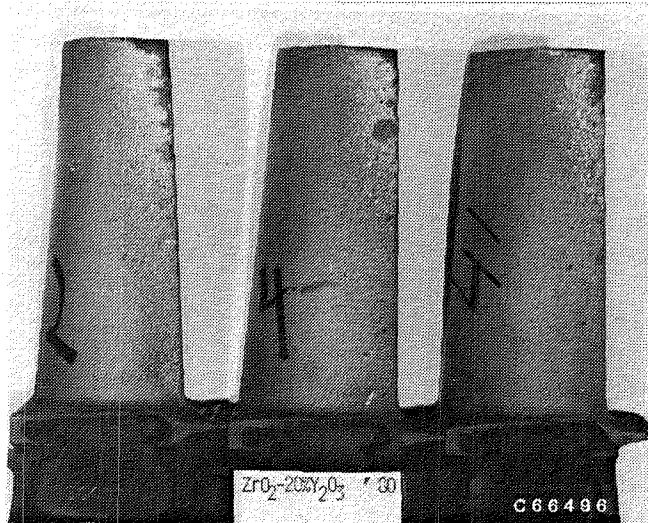
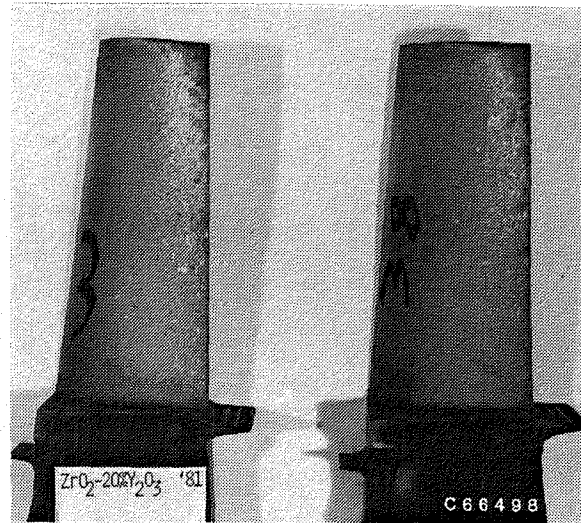
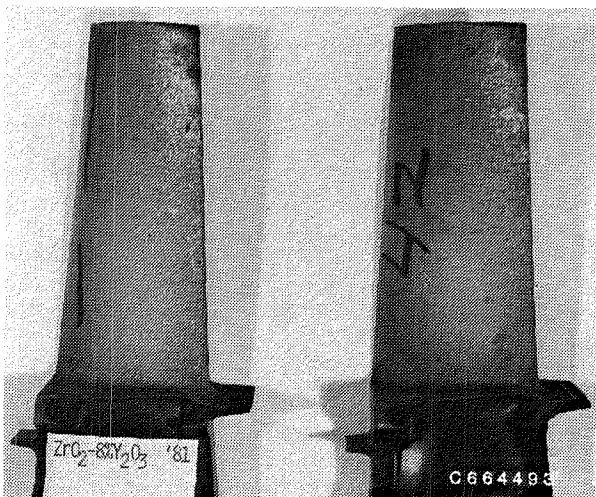
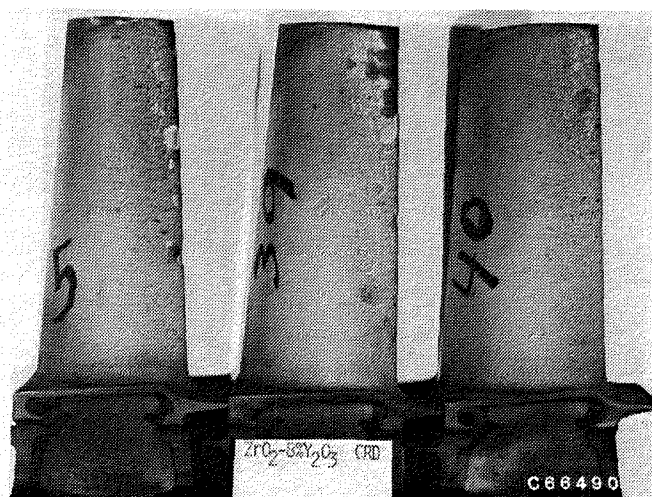
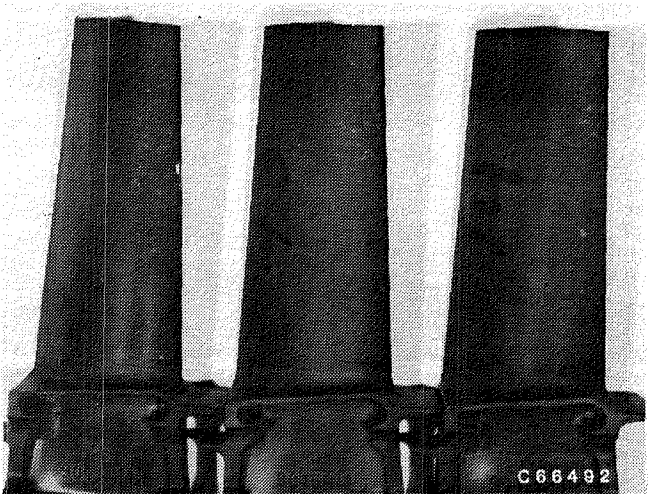
Note: Vacuum-Plasma-Sprayed
 Ni-22Cr-10Al-1Y/ZrO₂-
 Y₂O₃ as Indicated

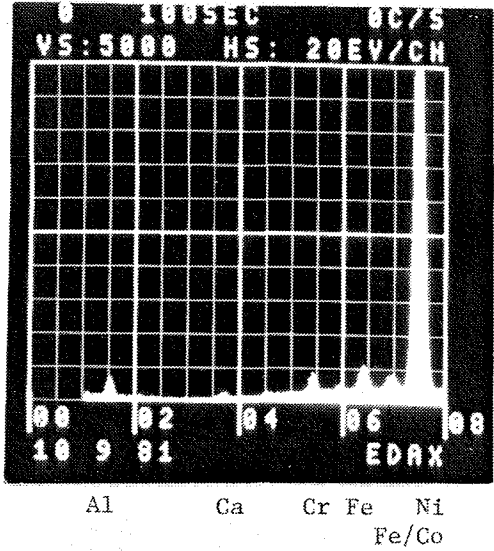
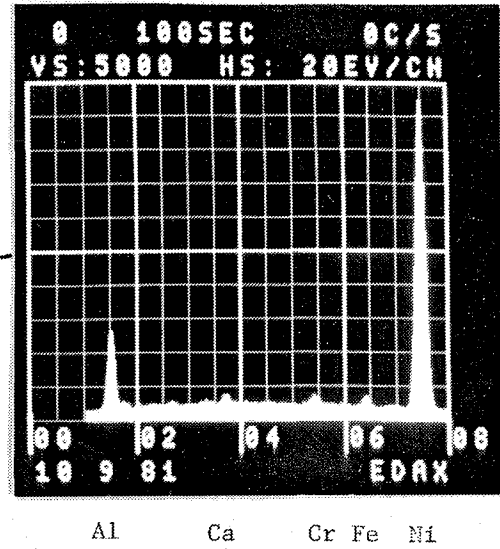
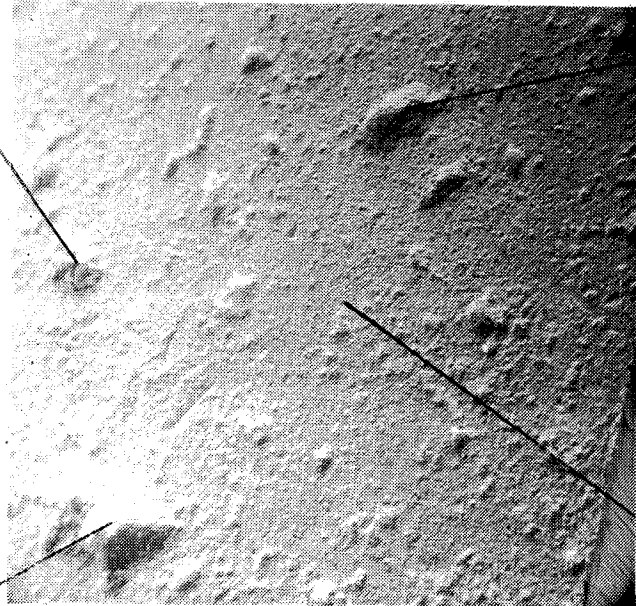
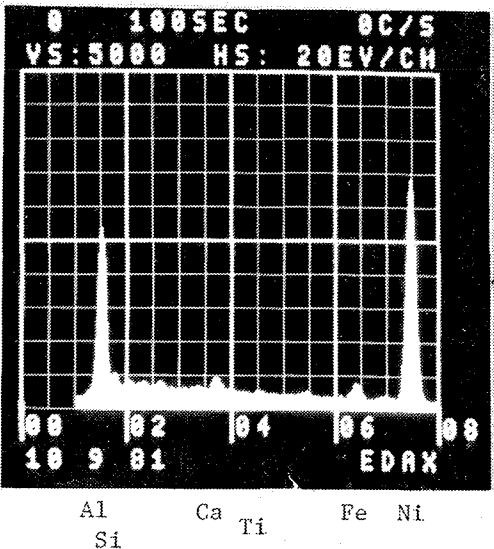
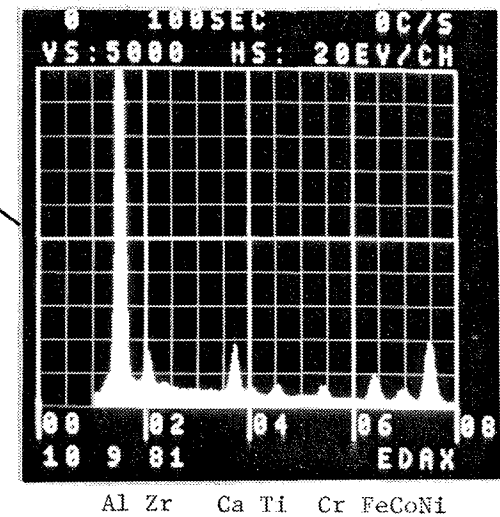
Figure 48. Chemical Analysis by EDAX of the Greenish Deposits on the Leading Edge, Suction Side of an Engine-Tested, Stage 2 Blade.

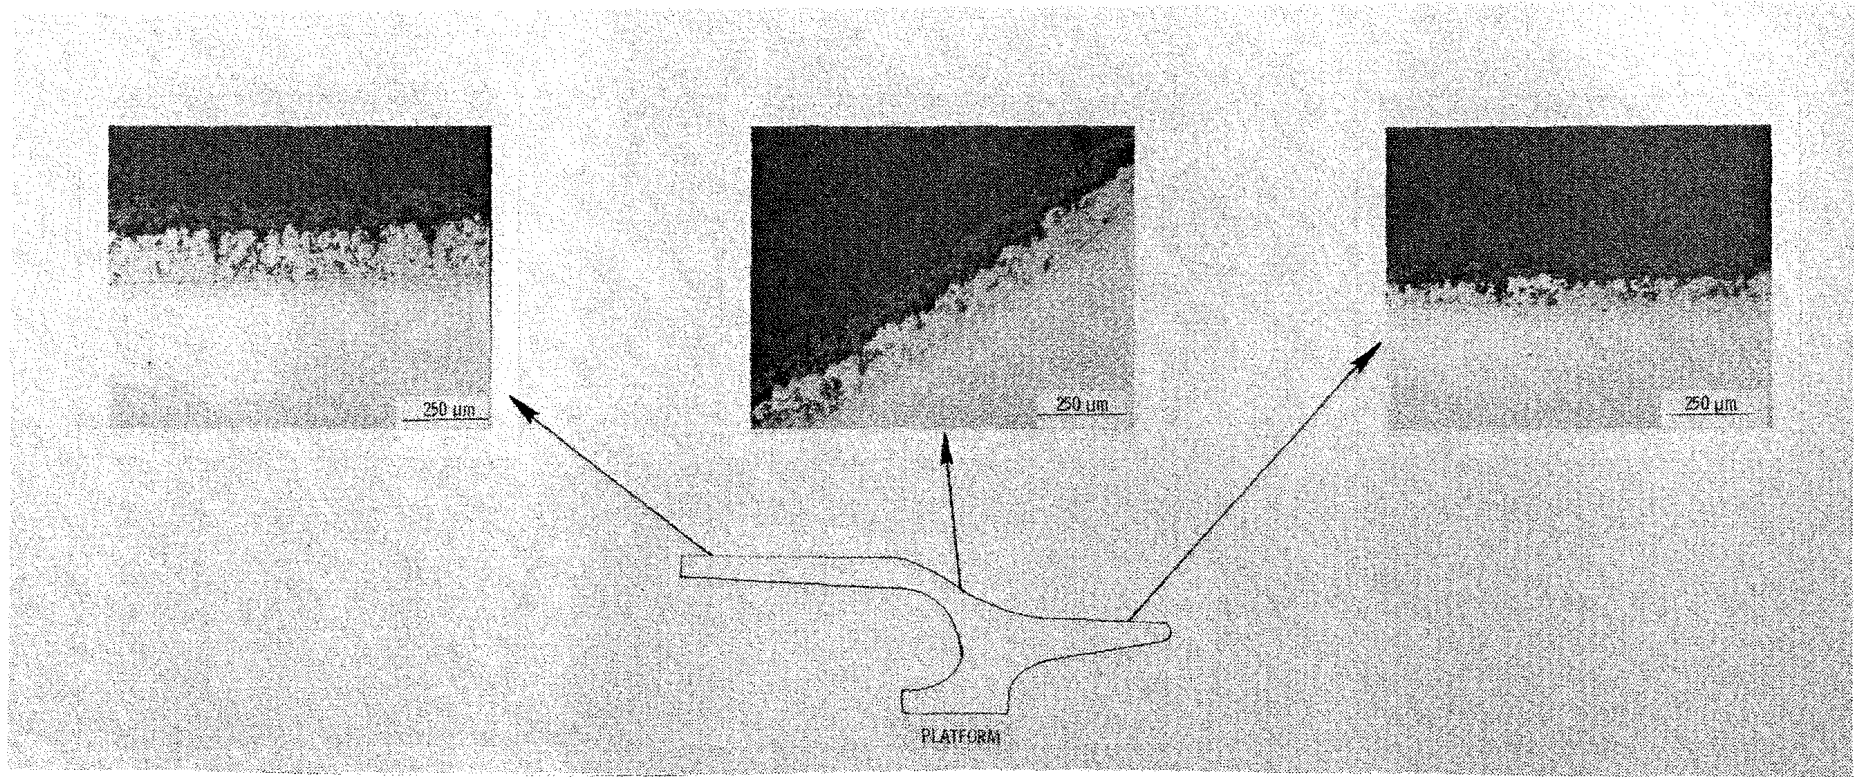
Figure 5ld. Photomicrographs of Engine-Tested (1000 "C" Cycles) CF6-50 Stage 2 Blade With TBC (Ni-22Cr-10Al-1Y/ZrO₂-8%Y₂O₃ Duplex), Platform (Blade No. 39, Table XV).

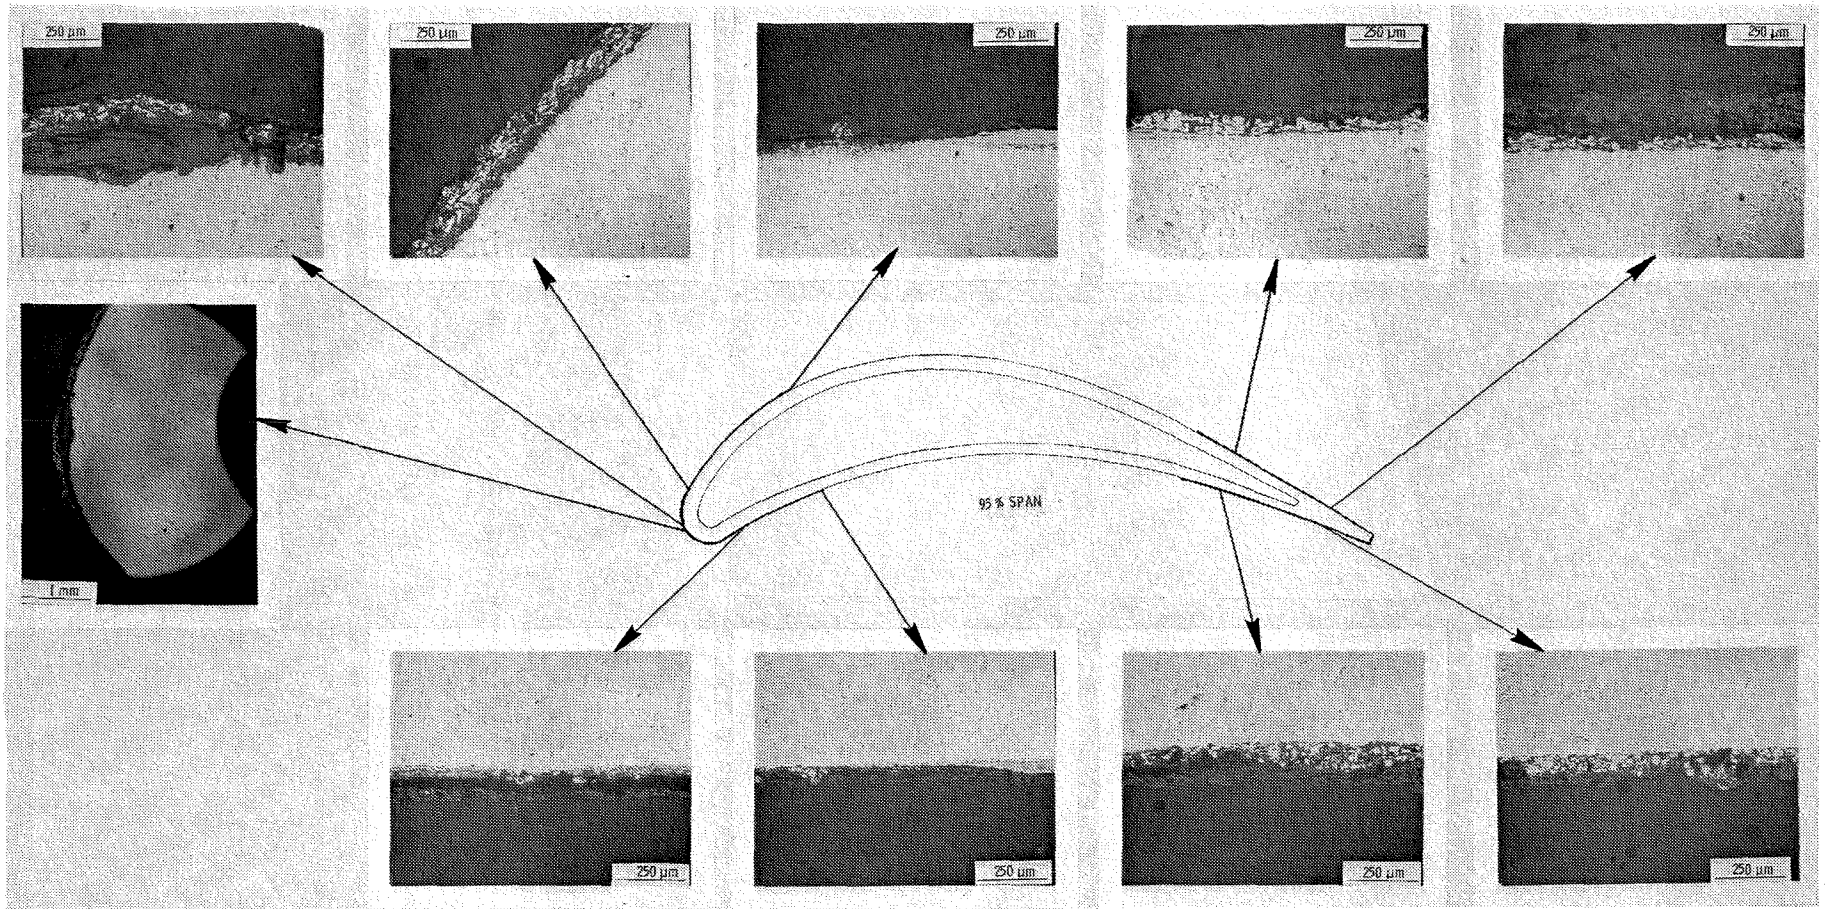
Figure 57a. Photomicrographs of Engine-Tested (1000 "C" Cycles), CF6-50, Stage 2 Vane With TBC (Ni-22Cr-10Al-1Y/ZrO₂-20%Y₂O₃ Duplex); 95% Span.
