DOE/NASA/1005-1
NASA TM-83407

Test Results and Description of a 1-kW Free-Piston Stirling Engine with a Dashpot Load

Jeffrey Schreiber
National Aeronautics and Space Administration
Lewis Research Center

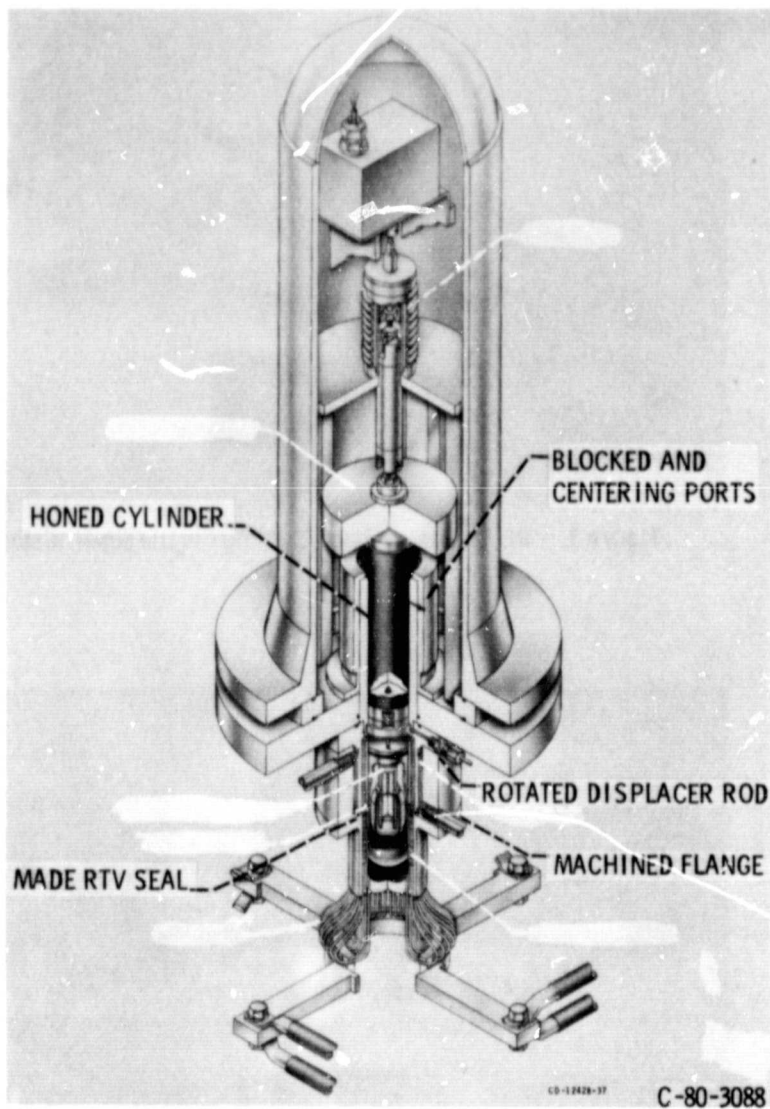
From past experience in the assembly of the RE-1000, it was known that at some point in the stack up of the heat exchangers, some amount of misalignment existed. Careful inspection and measurements taken showed that the problem originated at the mounting flange of the heater head. At this point the centerline of the heater head deflected at a slight angle from the centerline of the cooler assembly. The flange at which this misalignment originated is indicated in Figure 5.

Figure 5. - RE-1000 free-piston Stirling Engine problem areas corrected.

The first step taken to refurbish the engine was to remachine the mounting flange of the heater head to insure a truer stack up of the heat exchanger assembly. Prior to this remachining process, the displacer would very lightly rub on the cylinder wall. The rub was light enough that the engine would still run smoothly. The effect of the rub, however, was to cause some amount of damping to the displacer motion.

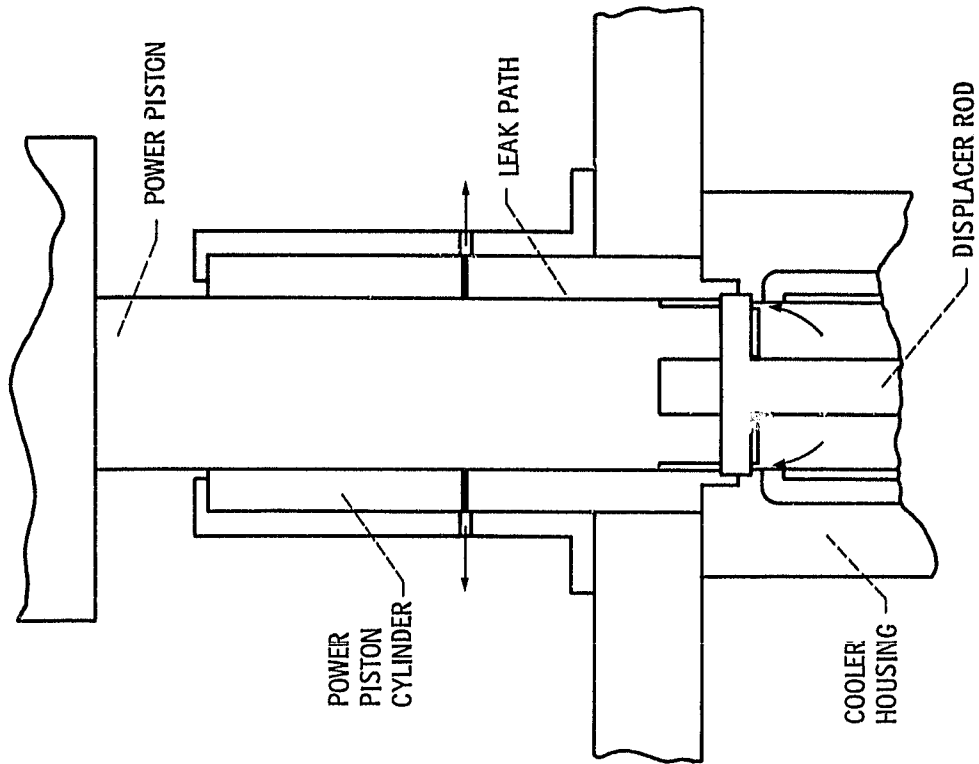
A pressure decay half-life pressure test was then performed to check the level of leakage past the power piston. This test is performed by clamping the power piston at some desired position. The pressure vessel of the engine is removed so as to expose the back side of the power piston to atmosphere. The working space is then pressurized with helium to a pressure of 1200kPa. The amount of time for the pressure in the working space to decay to 600kPa is measured. For the engine to be able to run as designed, the half life of the pressure should be about 15 seconds or more. The half-life tests showed the measured time to be approximately 2 seconds. At some time during earlier tests the half life was measured to be 15 seconds. Since the gas leaking out of the working space travels out the annular gap between the piston and cylinder to the centering ports and then out through the centering ports, it was theorized that honing away the high spots that surrounded the centering ports allowed the leak rate to increase. Figure 9 showed the leak path being investigated during the half life tests.

To see if the leak rate could be slowed without rechroming the cylinder wall to minimize the gap between the piston and cylinder, 2 of the 4 centering ports drilled through the cylinder wall were plugged with epoxy. Half-life pressure tests were run to see if this lessened the leak rate, but the half life was still about 2 seconds. This indicated that even with 2 of the 4 centering ports blocked, the major restriction to leakage was the piston to cylinder wall clearance, and therefore the piston to cylinder clearance must be reduced to control the leak rate.

Figure 9. - Power piston leak path of RE-1000 engine.

Based on the results of these leak tests it was determined that the radial clearance between the power piston and the cylinder should be reduced. Since the cylinder had recently been honed and was therefore known to be round and true, it was thought that the best solution would be to recoat the power piston and grind it to provide 0.020 mm diametral clearance instead of the original value of 0.036 mm. The displacer bore was honed and the displacer rod was recoated with chrome oxide at this same time to bring all of the close tolerance parts back to the original level of quality. The power piston,

however, was coated with a fluorocarbon-based, low-friction substance. This coating was applied and ground to size such that it provided the 0.020 mm diametral clearance desired.

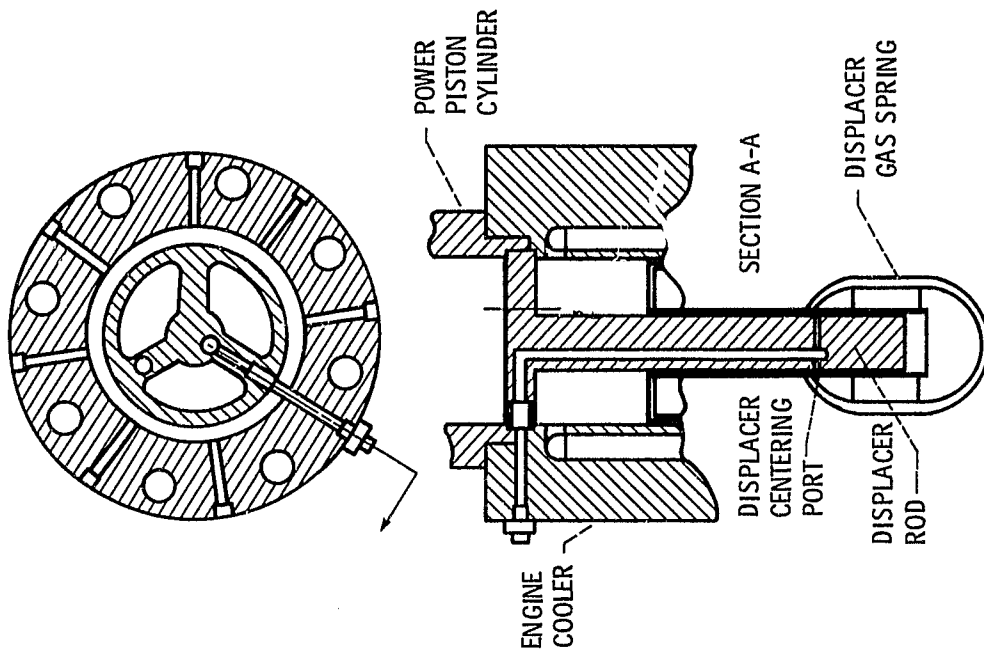
It was found that the centering ports in the displacer were rotated 60° from the centering ports on the displacer rod. Although the circumferential groove in the displacer bore allows for this condition, it was felt that if the ports were aligned so as to not need the circumferential groove, a stronger centering system would exist. Because of provisions in the engine for some future instrumentation, it was possible to assemble the engine in a configuration which would permit the centering ports to be aligned.

Figure 8. - Displacer rod mounting and communication ports for RE-1000 engine.

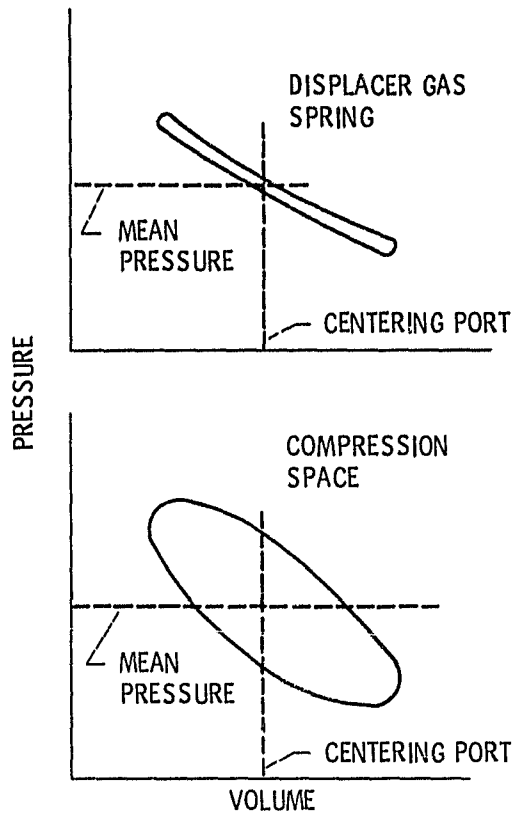
It is interesting to note that the design of the centering ports for the displacer is less critical than the design of the centering ports for the power piston. In the case of the displacer gas spring, the centering ports will flow enough gas to make up for any leakage into or out of the gas spring. If the gas spring pressure had no hysteresis there would be very little flow through the displacer centering port system and therefore very little power loss. The power piston centering port system, however, will yield large losses if too much gas is allowed to flow. Since there is a much larger P-V diagram in the compression space, the working gas will try to flow to the buffer space or bounce space when the piston is on the expansion part of the cycle. Similarly, the gas from the bounce space will try to flow into the working space on the compression part of the cycle. P-V diagrams are shown in Figure 10.

Figure 10. - RE-1000 engine centering port pressure drop for displacer gas spring and compression space.

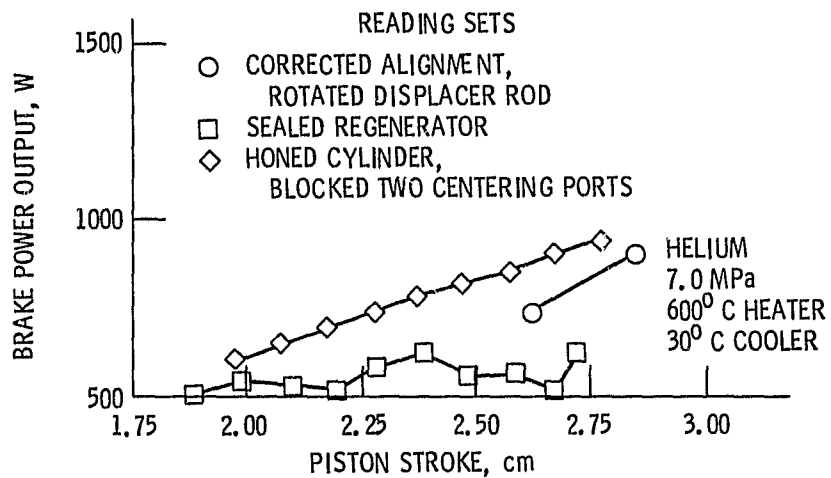
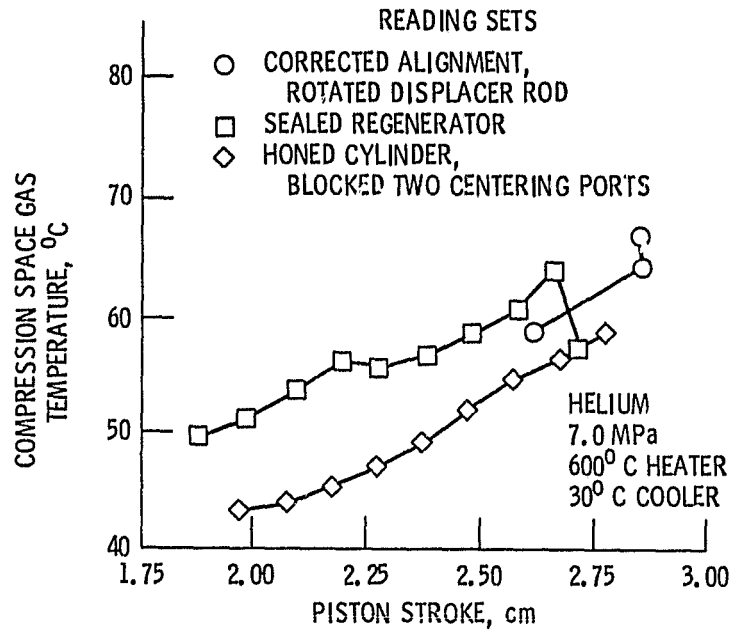
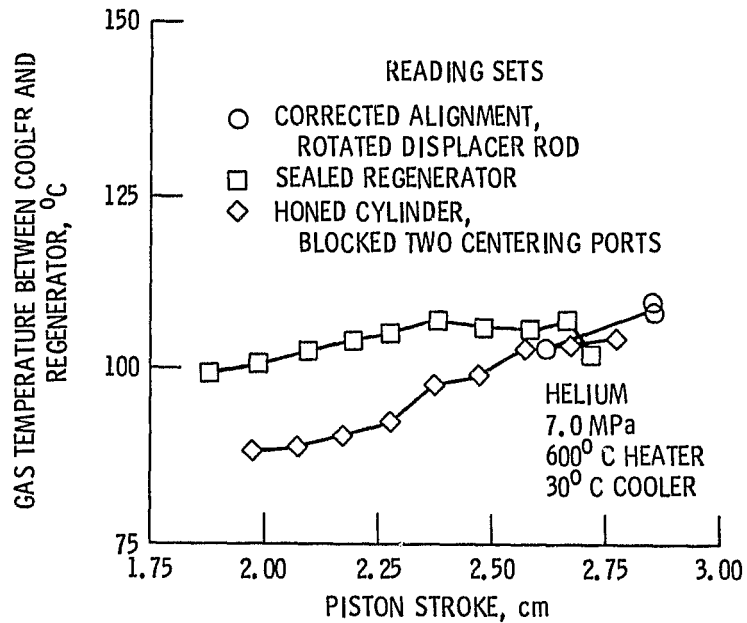
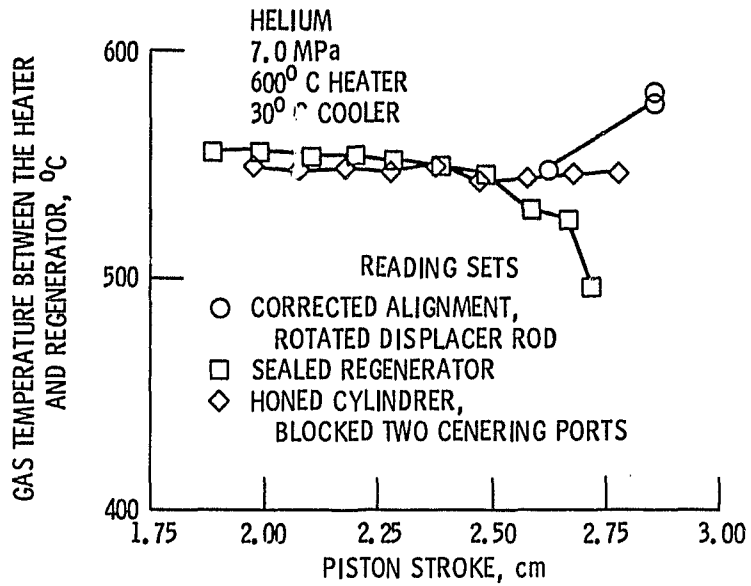
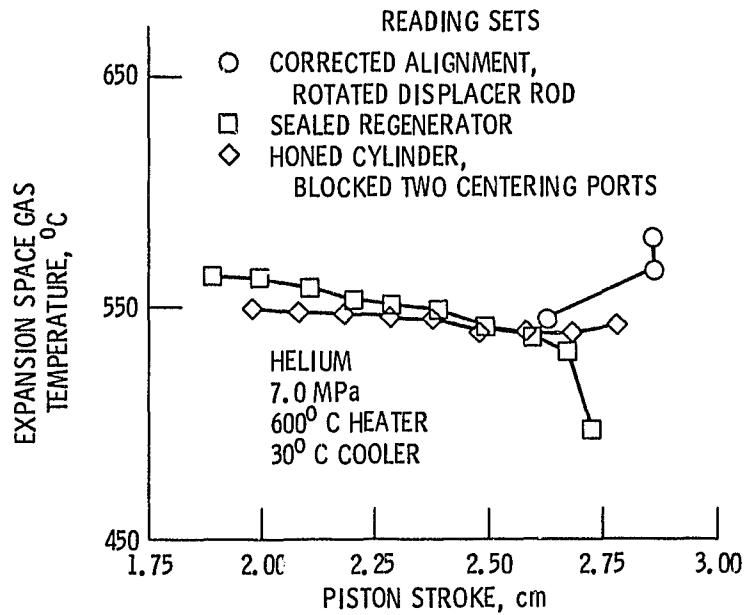
Figures 11 to 15 show the changes to the engine gas temperatures and the brake power output resulting from these modifications. Shown are the results after correcting the alignment of the heat exchangers and rotating the displacer rod, the results after sealing the regenerator with RTV, and the results after honing the cylinder and eliminating 2 of the 4 power piston centering ports.

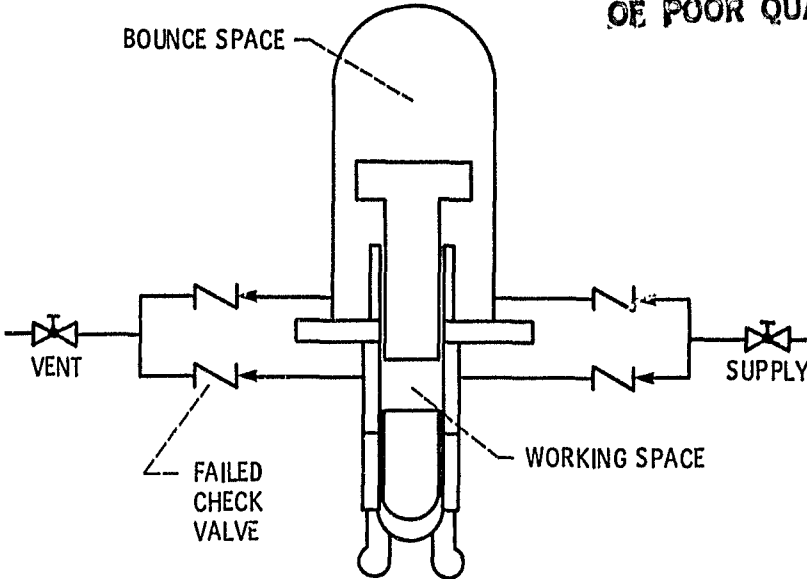
differential pressure transducers were removed. A valve known as the short circuit valve was removed. The short circuit valve existed to connect the working space to the bounce space when charging the engine or venting the engine. Check valves to allow gas from a supply system to be introduced to the working space and to allow gas to be vented from the working space were removed. With these two check valves removed, the engine would be brought up to full operating pressure after operation has started by slowly bleeding gas into the bounce space and letting the piston centering ports equalize the mean pressure across the power piston. These valves are shown schematically in Figure 16.

Subsequent tests showed that the Validyne differential pressure transducer and the short circuit valve had no effect on engine performance. It was found that the working space venting check valve was not sealing properly although it is not known exactly when this valve began to fail. The method used at LeRC to check piston leakage would not show a leak problem in that check valve.

Figure 16. - Supply and vent check valve system.

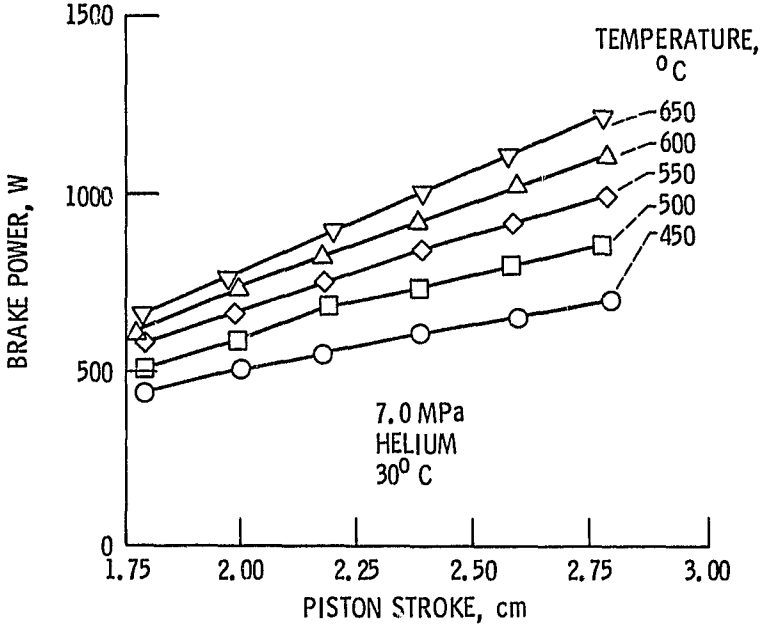
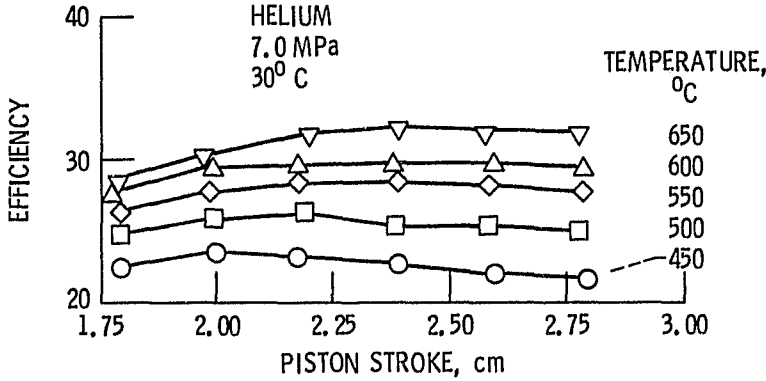
Subsequent tests showed the power level to be able to go well above 1200W brake power and efficiency levels above 32 percent as calculated by the following equation:

Curves of brake power output and efficiency are shown in Figures 17 and 18. These tests were run with the cooling water inlet temperature set at 30° C and with helium at 7.0 MPa as the working gas.
