NASA Technical Memorandum 84554

William E. Howell and J. Anderson Plumer

October 1982

EFFECTS OF SIMULATED LIGHTNING ON COMPOSITE AND METALLIC JOINTS

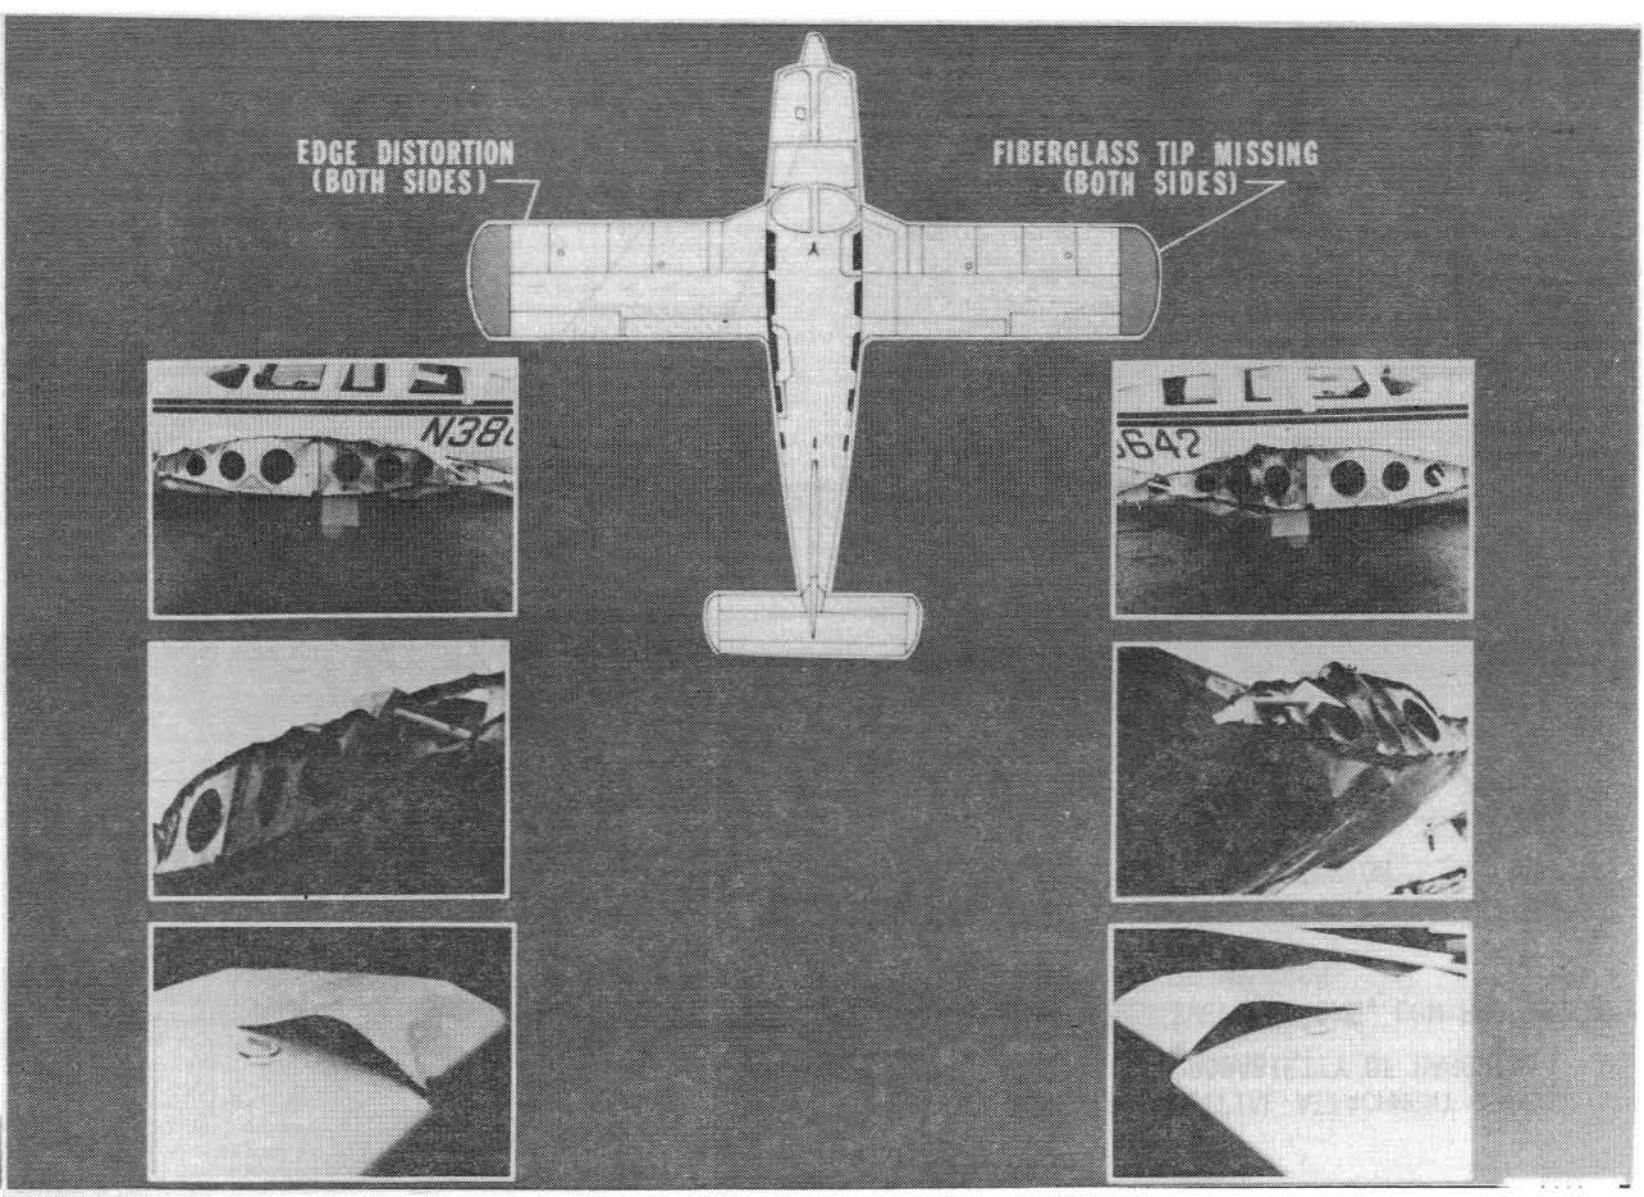
The results of a strike on a general aviation aircraft is shown in figure 1 and indicates the need to ensure electrical safety in all aircraft designs and fabrication methods. The lightweight fiberglass wing tips on the aircraft in figure 1 represent a general class of wing tip construction used on single and light twin engine aircraft. Navigation lights are mounted on these dielectric wing tips. As indicated by the damage shown in figure 1, adequate paths for the current associated with the lightning strike were not

Figure 1. - Lightning damage to a general aviation aircraft.

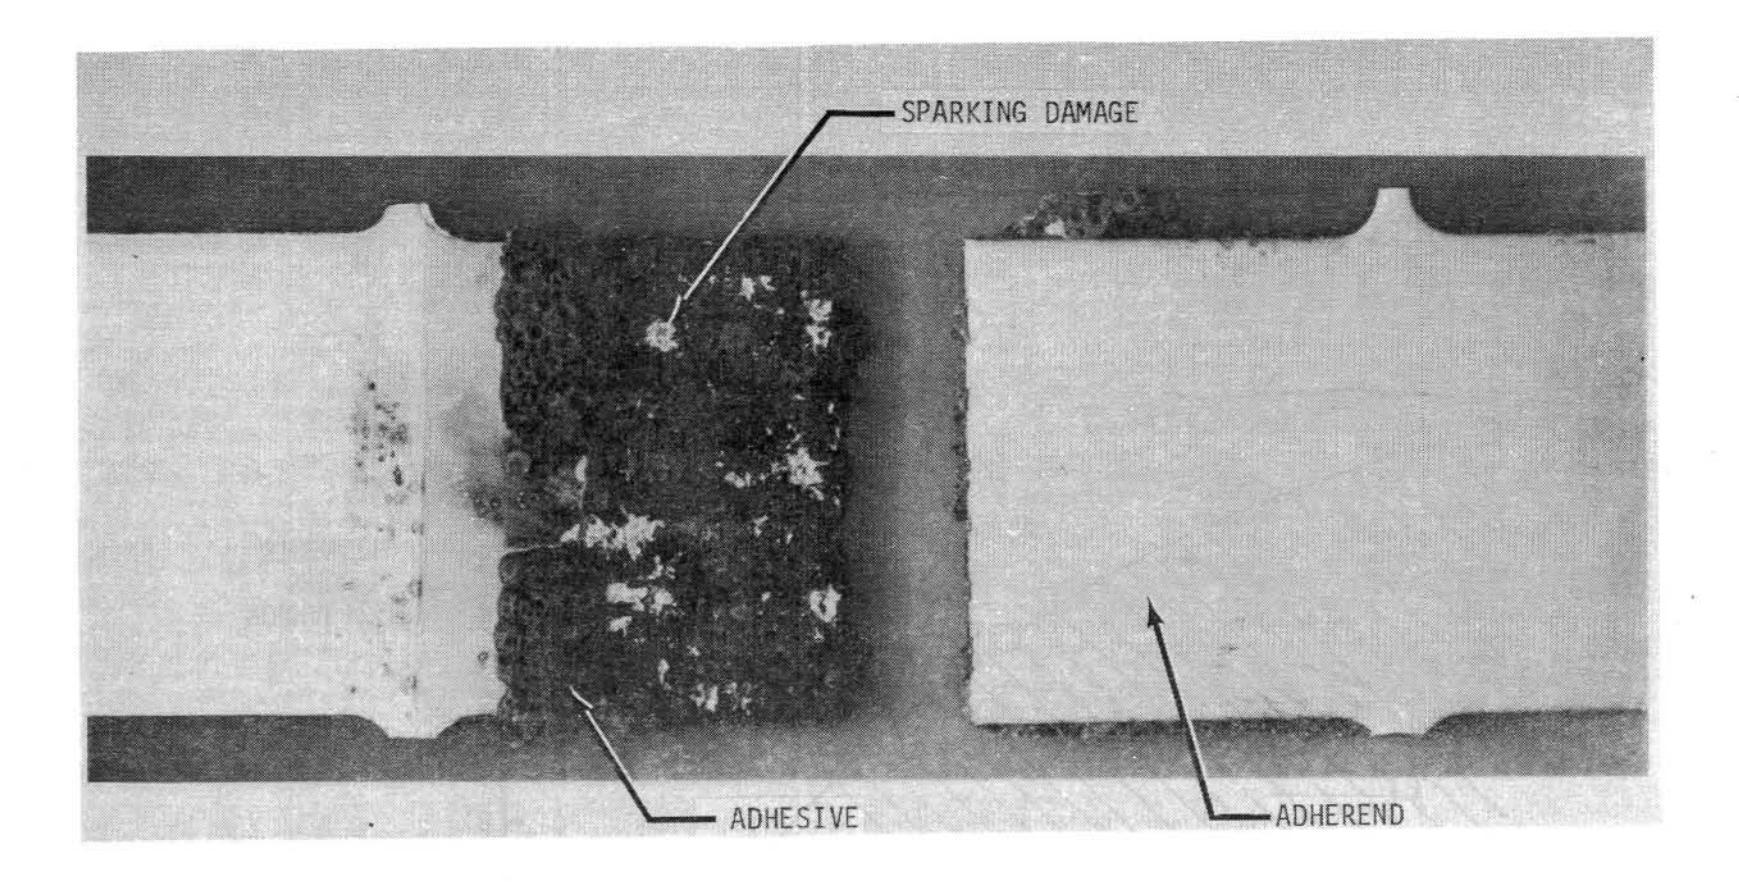
<u>Aluminum adherends</u>. - Test results for the first set of specimens (the ones not deburred and with bondline thickness not controlled) are presented in figure 9. Tests were conducted at current levels of 2, 10, 20, and 100 kA/ in.² (0.31, 1.55, 3.10, and 15.50 kA/cm²). Tensile tests conducted on specimens exposed to no current and to 2 kA/in.² (0.31 kA/cm²) showed no shear strength degradation for all the adhesives tested. A current density of 2 kA/ in.² (0.31 kA/cm²) represents the normally expected lightning threat. Some of the adhesive systems tested experienced no damage at current densities as high as 24 kA/in.² (3.72 kA/cm²). Other adhesives were significantly degraded at a current density of 10 kA/in.² (1.55 kA/cm²). Damage was caused by sparking through the adhesive as shown in figure 10. All specimens tested at a current density of 100 kA/in.² (15.50 kA/cm²) were totally destroyed. With the facing burs, most of the joints were electrically conductive. Even so, the specimens experienced external sparking, from the end of one adherend to the surface of the other adherend, at all current levels.

Figure 10. - A failed aluminum single-lap bonded joint specimen.

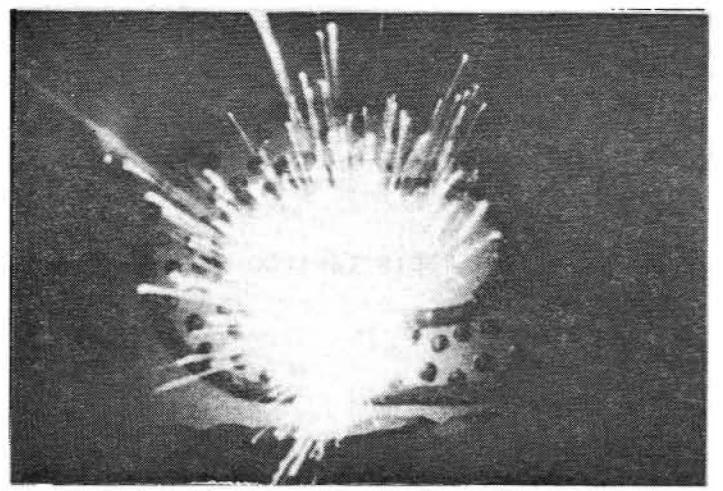
(a) Sparking at Panel-to-splice rivet (Staggered row of rivets design)

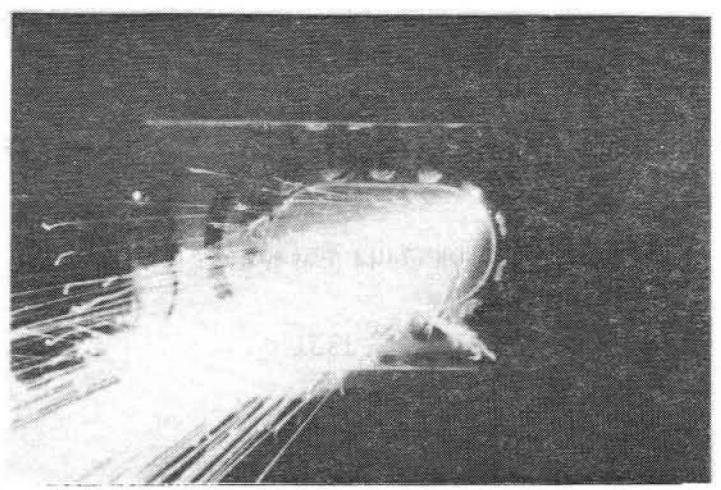
(b) Sparking at panel-to-skin interface (Bonded splice-to-skin design)

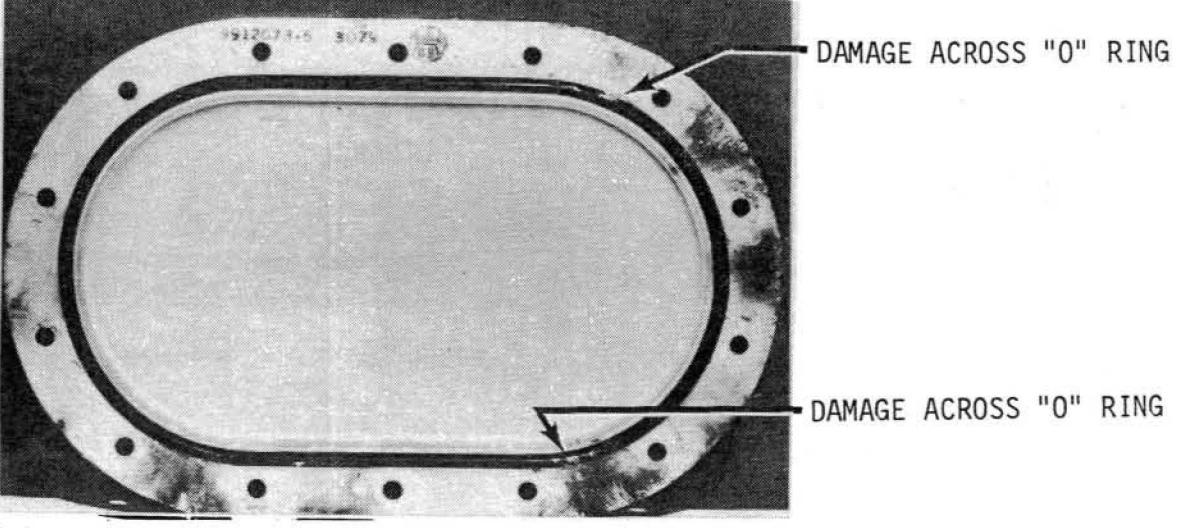
<u>Aluminum skins</u>. - The sparking threshold determined for these specimens is shown in figure 14. As indicated in the figure, there is considerable scatter in the sparking threshold of similar specimens. Safety dictates, however, that the minimum observed sparking current values be of primary importance. For the rivet patterns tested, no sparking through the fuel tank sealant occurred below approximately 40 kA. For the limited number of tests performed, 40 kA was the minimum sparking current observed. More tests are required to statistically determine the minimum sparking threshold. Except for the single row of rivets, which did not exhibit sparking throughout the range of test currents, the rivet pattern did not significantly affect the sparking threshold. Figure 15 shows the location of sparking and damage in aluminum access/inspection panels. For the test configuration with the splice bonded to the skin, a strike or restrike with a current level higher than 40 kA could cause sparking past the "0" ring seal which would destroy the fuel tank integrity (fig. 15(c)).

(c) Sparking damage of bonded splice-to-skin panel

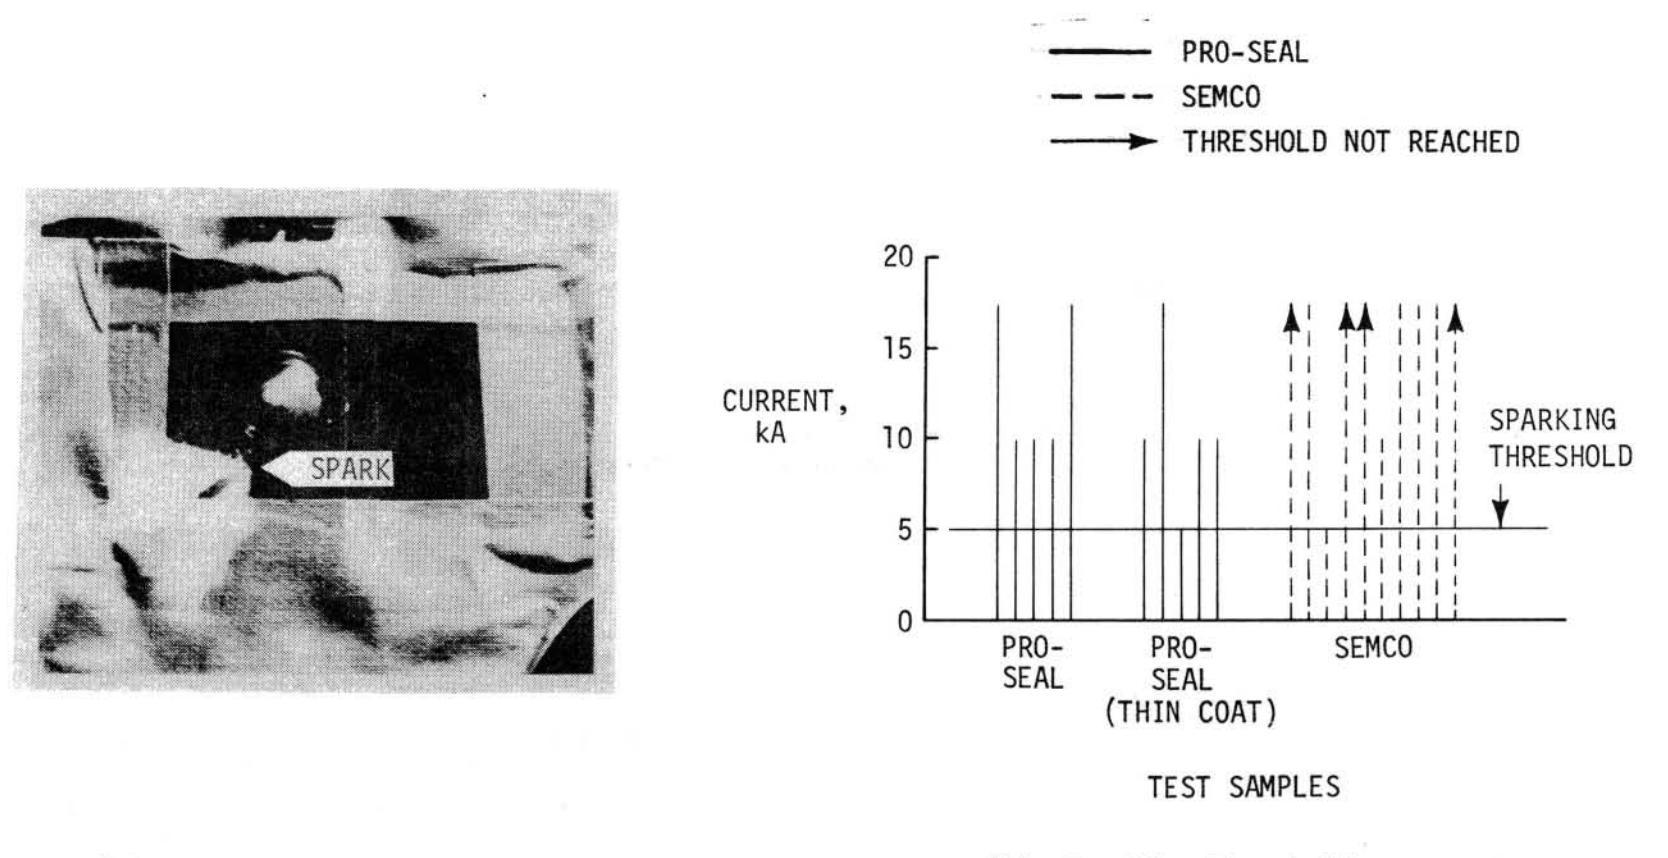
<u>Graphite/epoxy skins</u>. - Tests were conducted to determine the threshold for sparking through the fuel tank sealant on the fuel side of dome nut fasteners (fig. 16(a)). Figure 16(b) is a plot showing sparking threshold for the fasteners and fuel tank sealants evaluated. Figure 16(b) indicates that there is considerable scatter in the data. Some specimens sparked at 5 kA whereas other specimens did not spark at the highest test current of 17 kA. For the configuration tested, an individual dome nut fastener, treated with fuel tank sealant conducted up to 5 kA of current without sparking. Although two different sealants were evaluated, it is beyond the scope of this paper to dicuss the relative merits thereof.

(a) Spark on fuel side.

Figure 16. - Sparking and sparking threshold for access/inspection panel dome nut on graphite/epoxy structure.

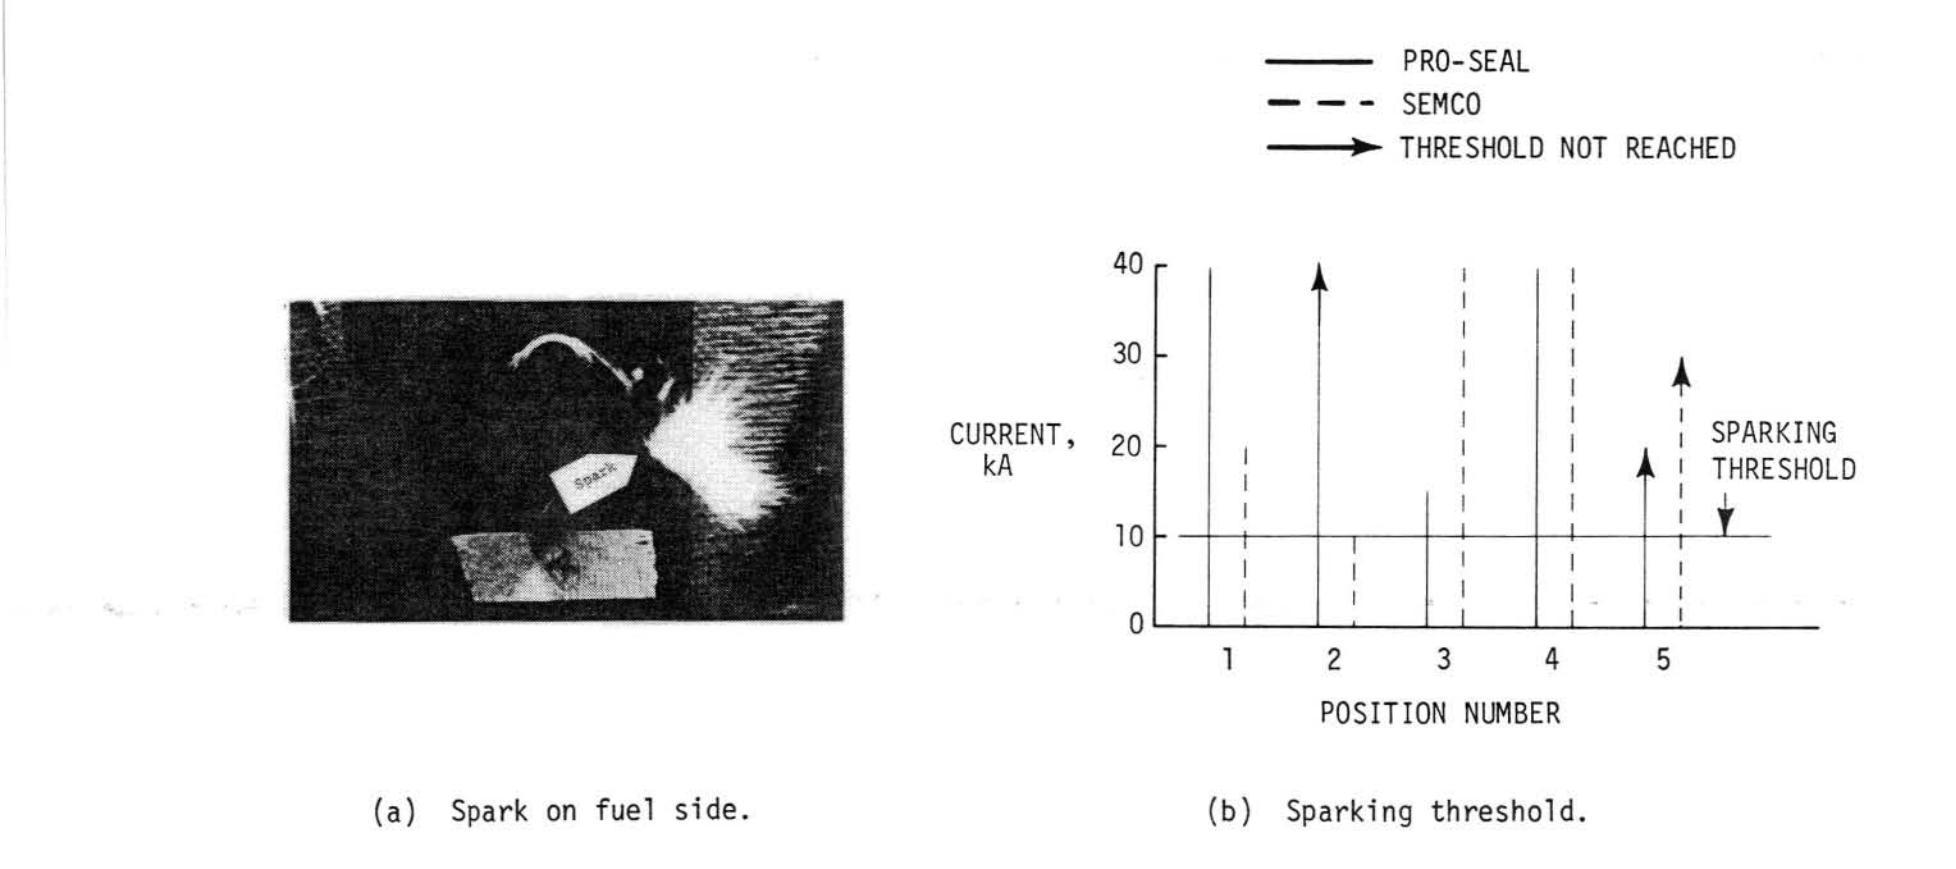
The threshold for sparking through the fuel tank sealant on the metal fuel feed-through elbows was determined. Sparking through the fuel tank sealant at one of the test specimens is shown in figure 17(a) and the sparking data are presented in figure 17(b). There is considerable scatter in the data ranging from a low sparking current of 10 kA to a high current of 40 kA at which one specimen did not spark. The minimum sparking threshold observed was 10 kA.

Figure 17. - Sparking and sparking threshold for metal fuel feed-through elbows on graphite/epoxy structure.
