**NASA Contractor Report 166002**

# **Flight Service Evaluation of Composite Components on the Bell Helicopter Model 206L: Design, Fabrication, and Testing**

**Bell Helicopter Textron Inc.  
Fort Worth, Texas**

**Contract NAS1-15279  
November 1982**

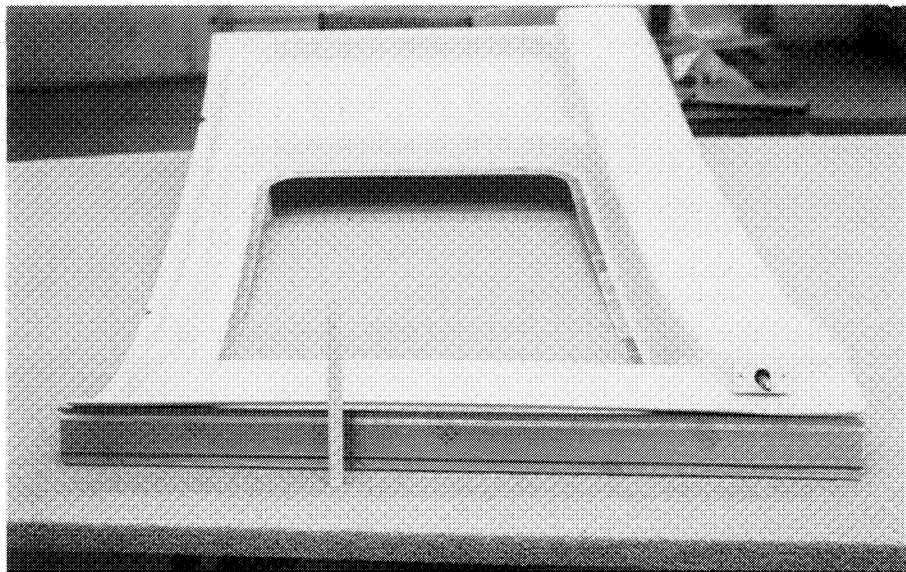
b. Bow of edge.

Figure 15. Litter door bow caused by flexibility of fixture.

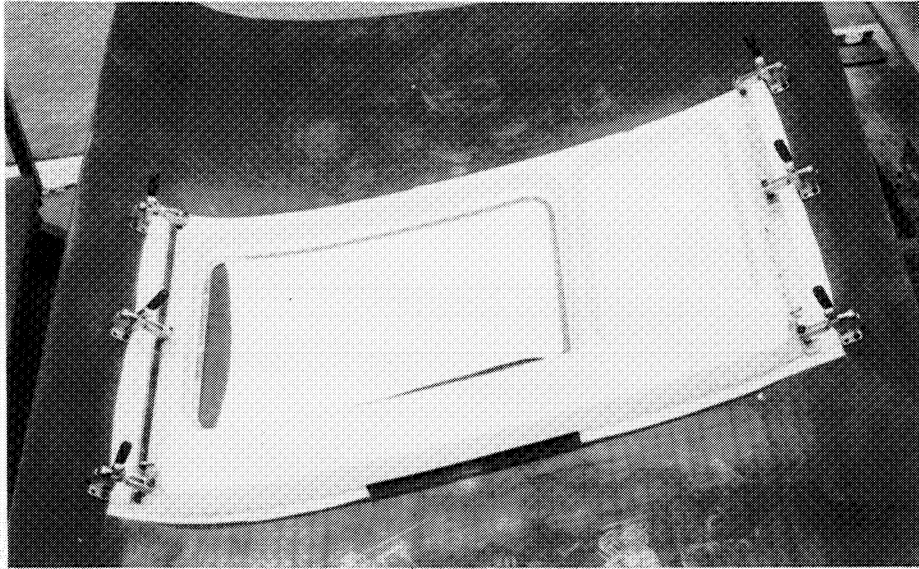
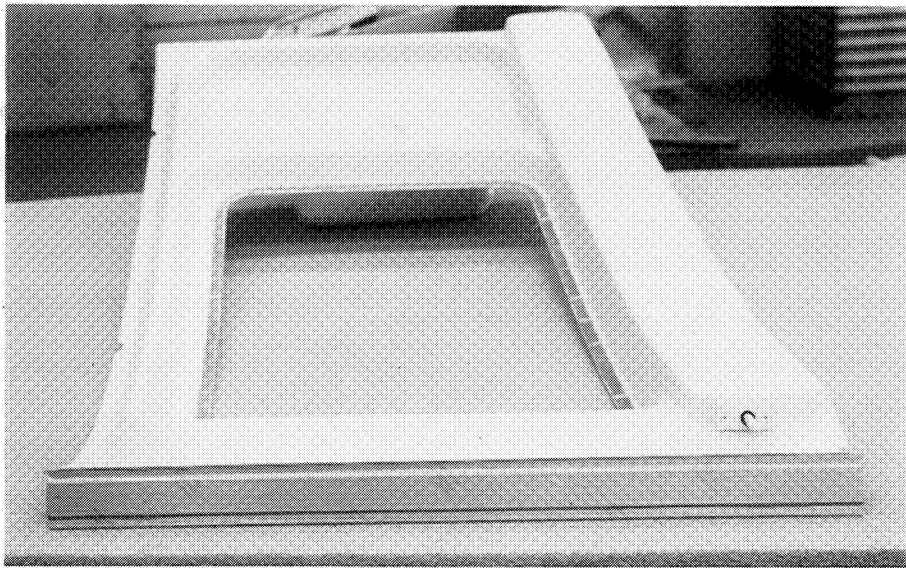
Figure 16. <sup>16</sup> Straightening of bow in composite litter door.

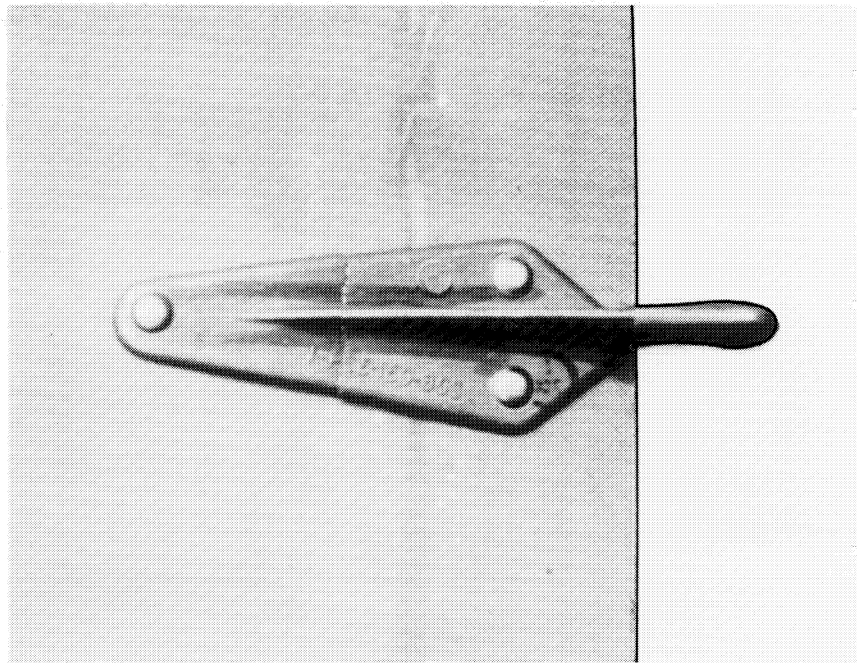
For the pressure test, the door was tested in the fixture shown in Figure 22a. The door was attached to the jig by two hinges and latches. Pressure was applied by means of water bags. Failure occurred at 0.794 psi, or a total of 695 pounds in the metal hinges, as shown in Figure 22b. This is technically a margin of safety of 13.4 percent, but is based on a metallic hinge failure, not a failure of the composite material.

*12 T. + 5 H!* b. Static test failure of hinge

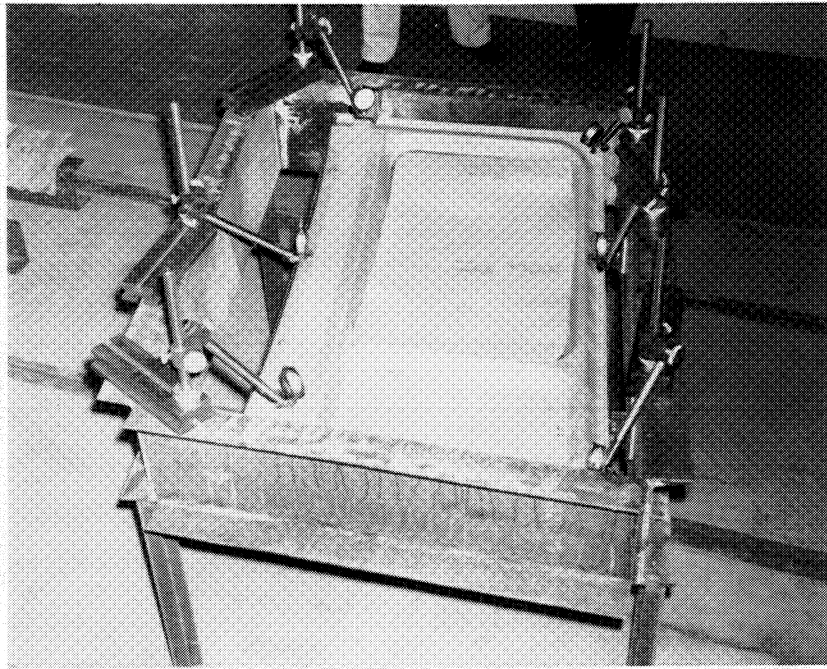
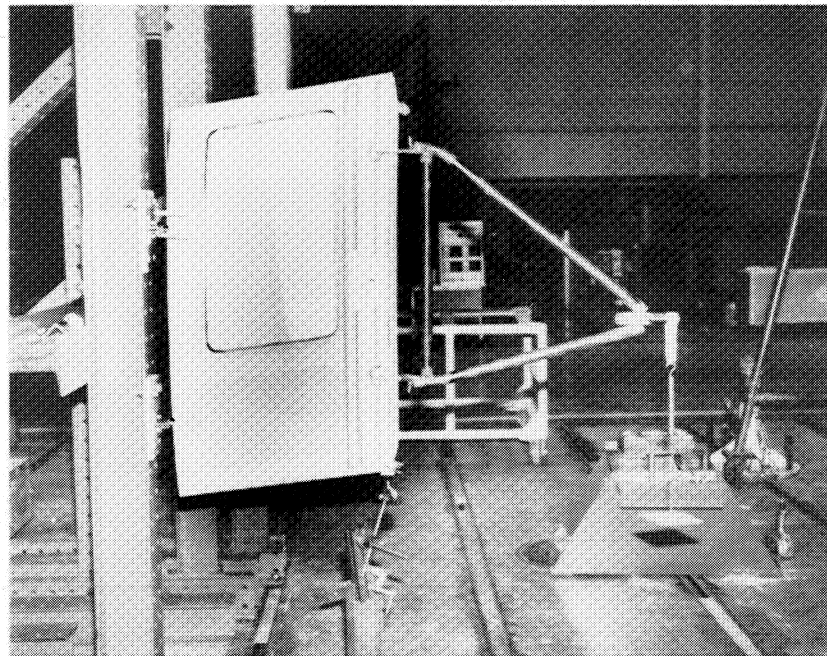
Failure occurred at 0.55 psi pressure (634 pound), 152 pounds at the upper hinge and 390 pounds at the lower hinge. This is between 95 and 99 percent of the required strength if the failure were in the composite material. However, failure was caused by the hinge pin slipping out of the latch, not by failure of the composite material, and for this failure the knockdown factor is not applicable. On this basis the strength of the door was certified by the FAA.

The cantilever test setup is shown in Figure 24b. At 415 pounds of load the door hinges rotated excessively to the point where it was not possible to load any higher in this manner. Since a failing load test was required, the load application point was moved directly to the litter door hinges. This reduces the cantilever moment, but eliminates the rotation of the hinges. Failure occurred at 833 pounds when loaded in this manner, and the failure occurred by compression buckling at the lower forward corner.

Figure 24. Static tests of composite litter door.

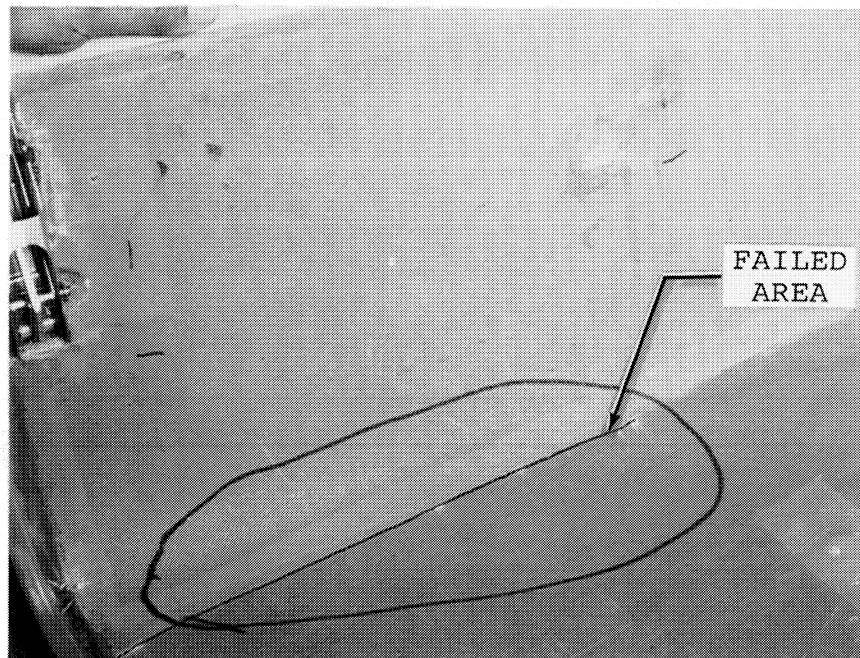
Two fairings were tested to failure. The first one failed at 1.51 psi at the inner corner splice, as shown in Figure 27. The second fairing failed at 1.94 psi, but was not a composite failure. At 1.94 psi the right-hand aft latch slipped, causing some local, noncatastrophic failures of the surrounding structure.

Subsequent examination of the test parts revealed a possible knife cut in the failed area of the first specimen and the probability of a faulty latch on the second specimen. (The much higher load that five subsequent fairings withstood supports this theory. This is discussed in Section 6.2.6).

Figure 27. Forward fairing failure.

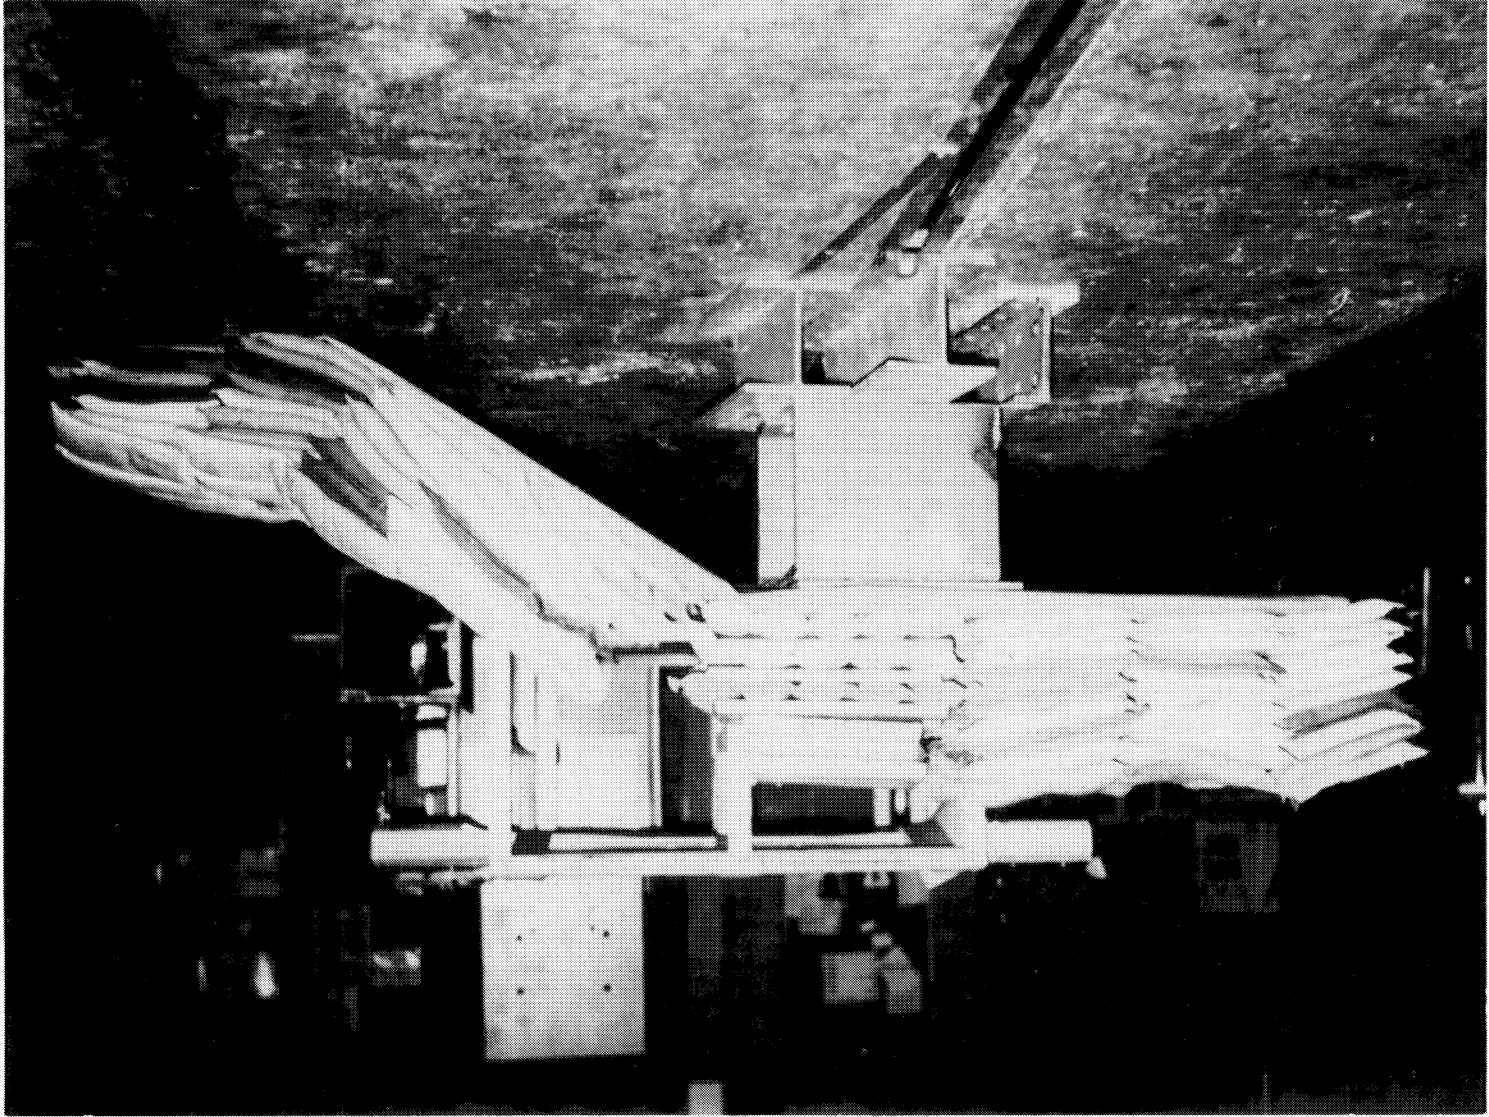
Examination of the failed area revealed two facts: first, that the area had been overheated and was probably partially disbanded before the test was started. Second, that the overheated area was sufficiently localized for the fin to be used for the aerodynamic test.

Figure 32. Fin static test failure - aerodynamic loading.

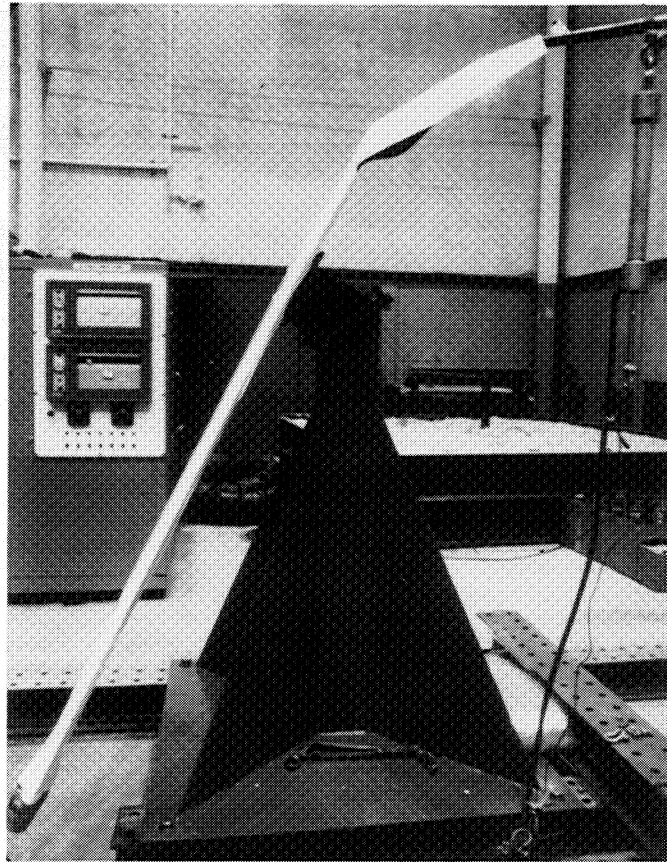
Figure 33. Fin static test failure - tail down landing.
