NAPC-PE-23 NASA-CR-165388

ROTOR FRAGMENT PROTECTION PROGRAM: STATISTICS ON AIRCRAFT GAS TURBINE ENGINE ROTOR FAILURES THAT OCCURRED IN U. S. COMMERCIAL AVIATION DURING 1978

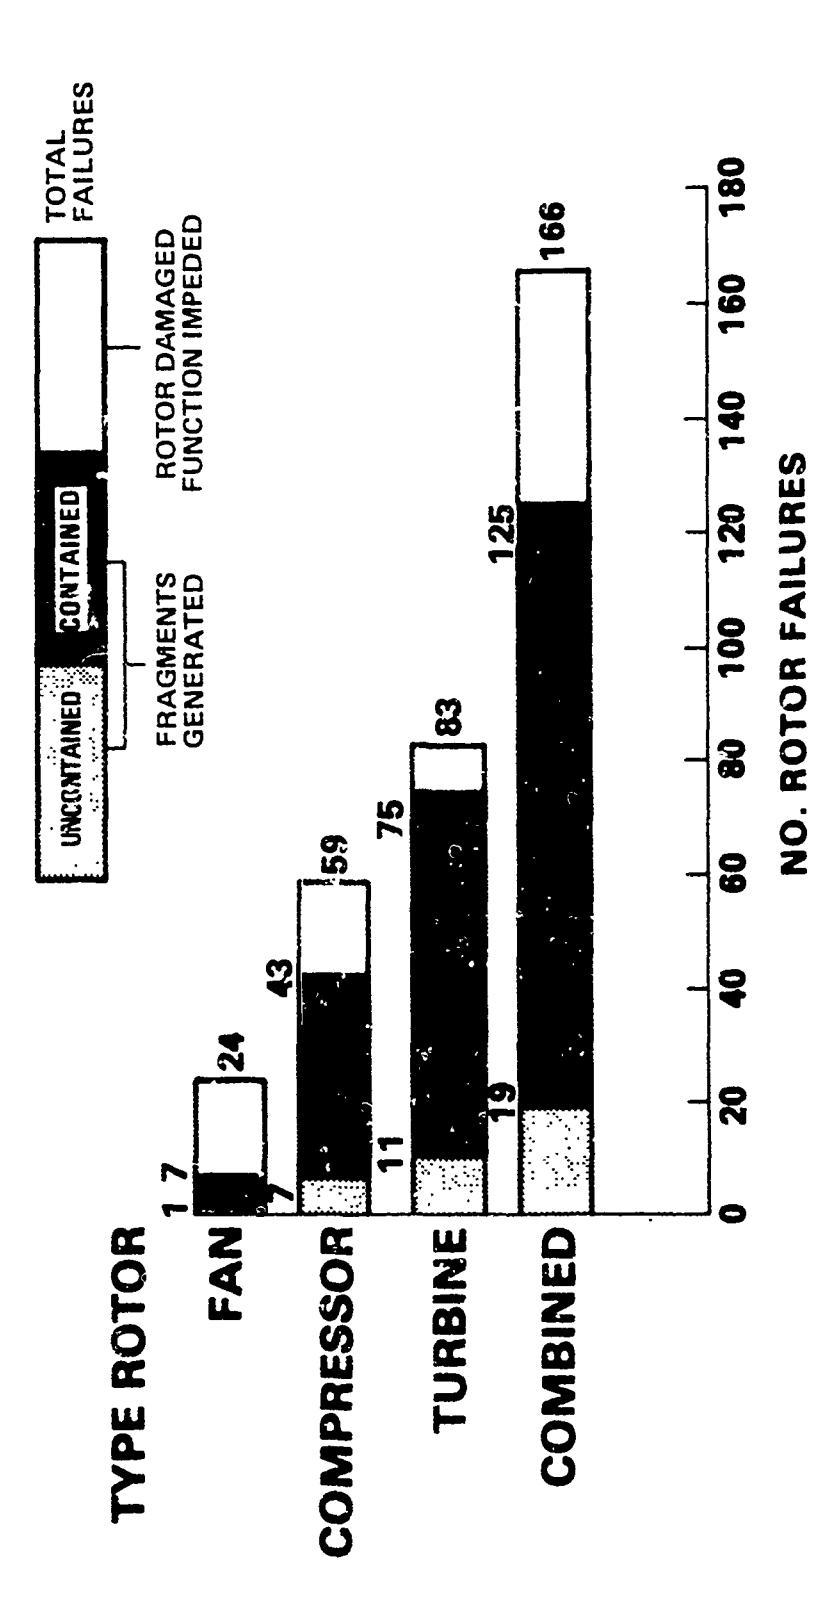
a. Figure 1 shows that 166 rotor failures occurred in 1978. These rotor failures accounted for approximately 8.4% of the 1971 shutdowns experienced by the gas turbine powered U. S. commercial aircraft fleet during 1978.

Rotor fragments were generated in 125 of the failures experienced and, of these, 19 (15.2% of the fragment producing failures) were uncontained. This represents an uncontained failure rate of 3.6 per million gas turbine engine powered aircraft flight hours, or 1.1 per million engine operation hours. Approximately 6.8 million and 21.4 million aircraft flight and engine operating hours, respectively, were logged by the U. S. commercial aviation fleet in 1978. のないないでのないないでものできたとうないないできたがないないできたのできたので、ころうないないので

IN U.S. COMMERCIAL AVIATION 1978 **INCIDENCE OF ROTOR FAILURE**

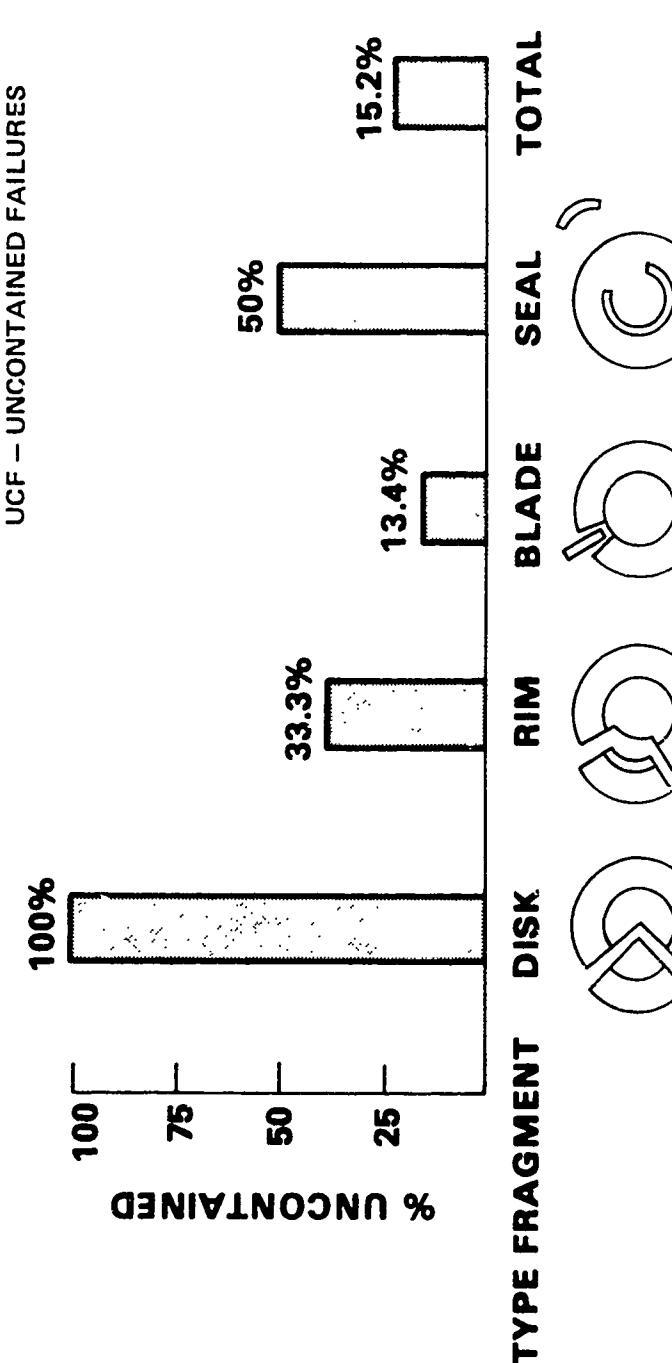
b. Figure 2 shows the distribution of rotor failures that produced fragments according to the engine component involved -- fan, compressor, turbine; the types of fragments that were generated; and the percentage of uncontained failures according to the type fragment generated. These data indicate that:

(1) The incidence of turbine rotor fragment producing failures was approximately two times greater than that of compressor rotor fragment producing failures; these corresponded to 60% and 34.4%, respectively, of the total number of rotor failures. Fan rotor failures accounted for 5.6% cf the fragment producing failures experienced.

(2) Blade fragments were generated in 95.2% of the rotor failures; 13.4% of these were uncontained. The remaining rotor fragments failures (4.8%) produced disk, rim and seal fragments, of which 100%, 33.3% and 50%, respectively were uncontained.

COMPONENT AND FRAGMENT TYPE DISTRIBUTIONS FOR CONTAINED AND UNCONTAINED **ROTOR FAILURES(1) - 1978**

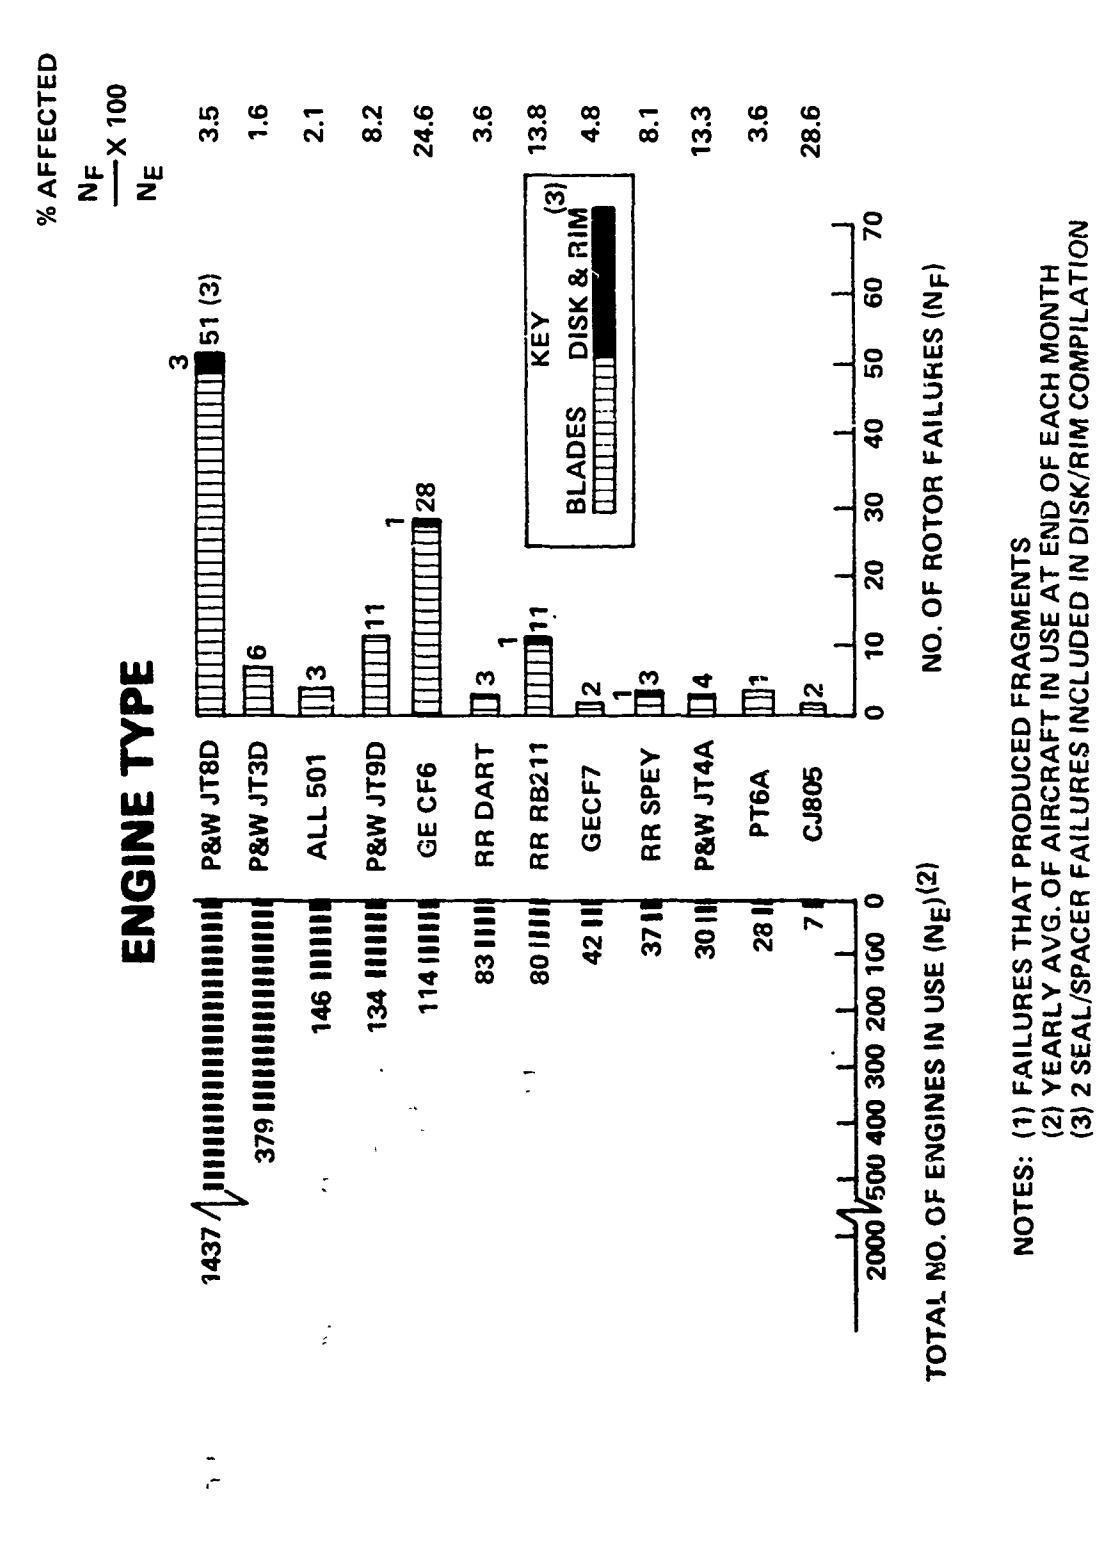
c. Figure 3 shows the rotor failure distribution among the types of engines that were affected, and the total number of that type engine in use.

THE INCIDENCE OF ROTOR FAILURE⁽¹⁾ IN U.S. **COMMERCIAL AVIATION ACCORDING TO** ENGINE TYPE AFFECTED - 1978

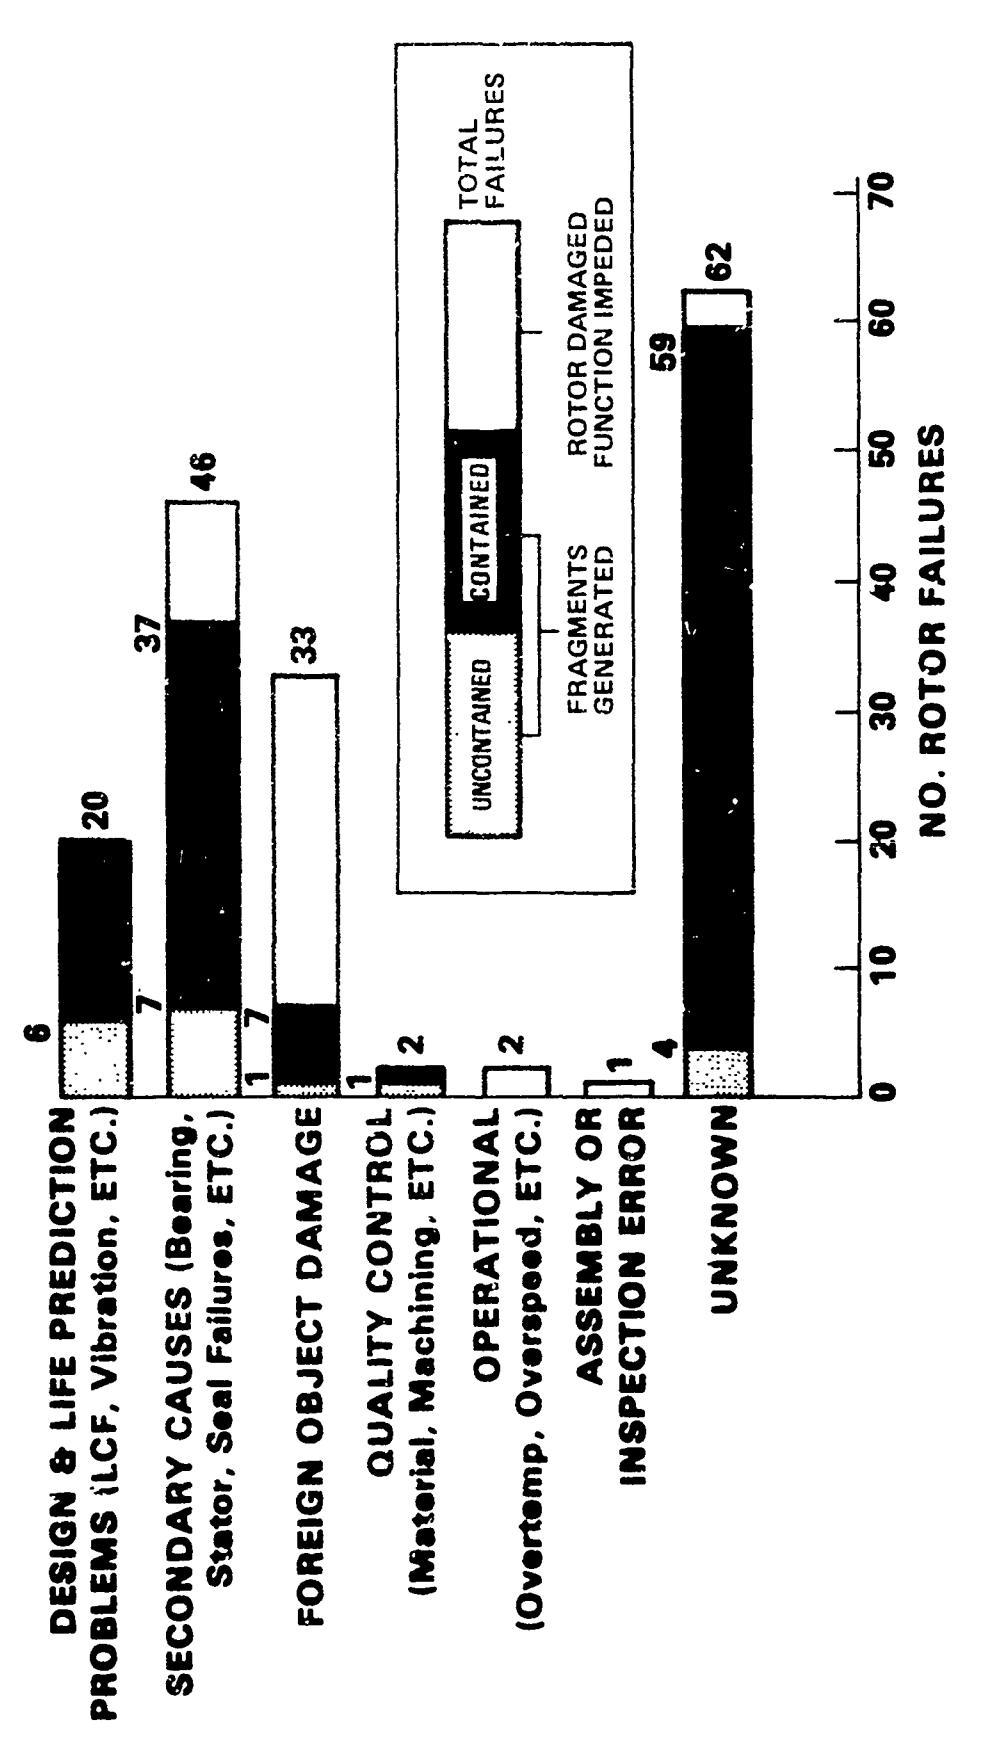
d. Figure 4 shows what caused the rotor failures to occur. Of the known causes of failure (1), the dominant causal factors were: (1) Secondary Causes (44.2%); (2) Foreign Object Damage (FOD) (31.7%), and (3) Design and Life Prediction Problems (19.2%).

- 1978 **ROTOR FAILURE CAUSE CATEGORIES**

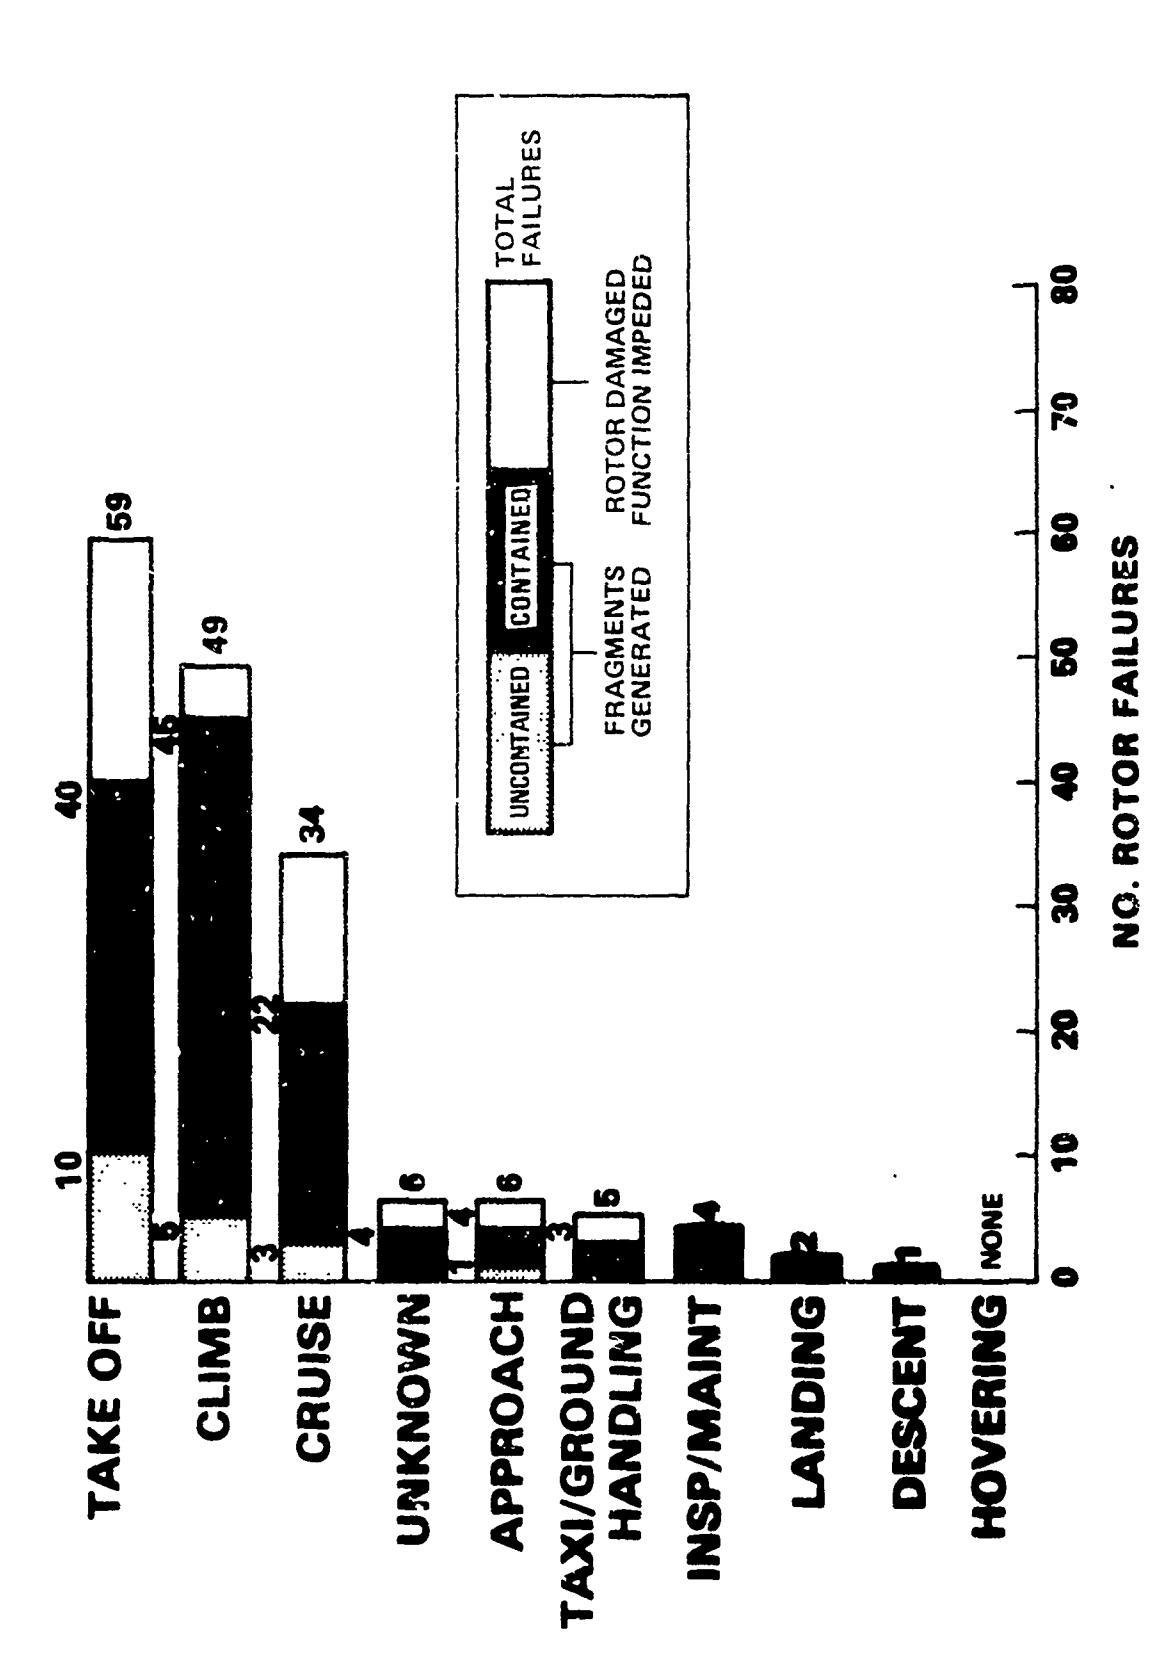
FIGURE 5

e. Figure 5 indicates the flight conditions that existed when the various rotor failures occurred. Approximately 65% of the 166 rotor failures occurred during the takeoff and climb stages of flight. Approximately 68% of the rotor fragment producing failures, and 79% of the uncontained rotor failures, occurred during these same stages of flight. The highest percentage of uncontained rotor failures (53%) were experienced during takeoff.

1978 FLIGHT CONDITION AT ROTOR FAILURE

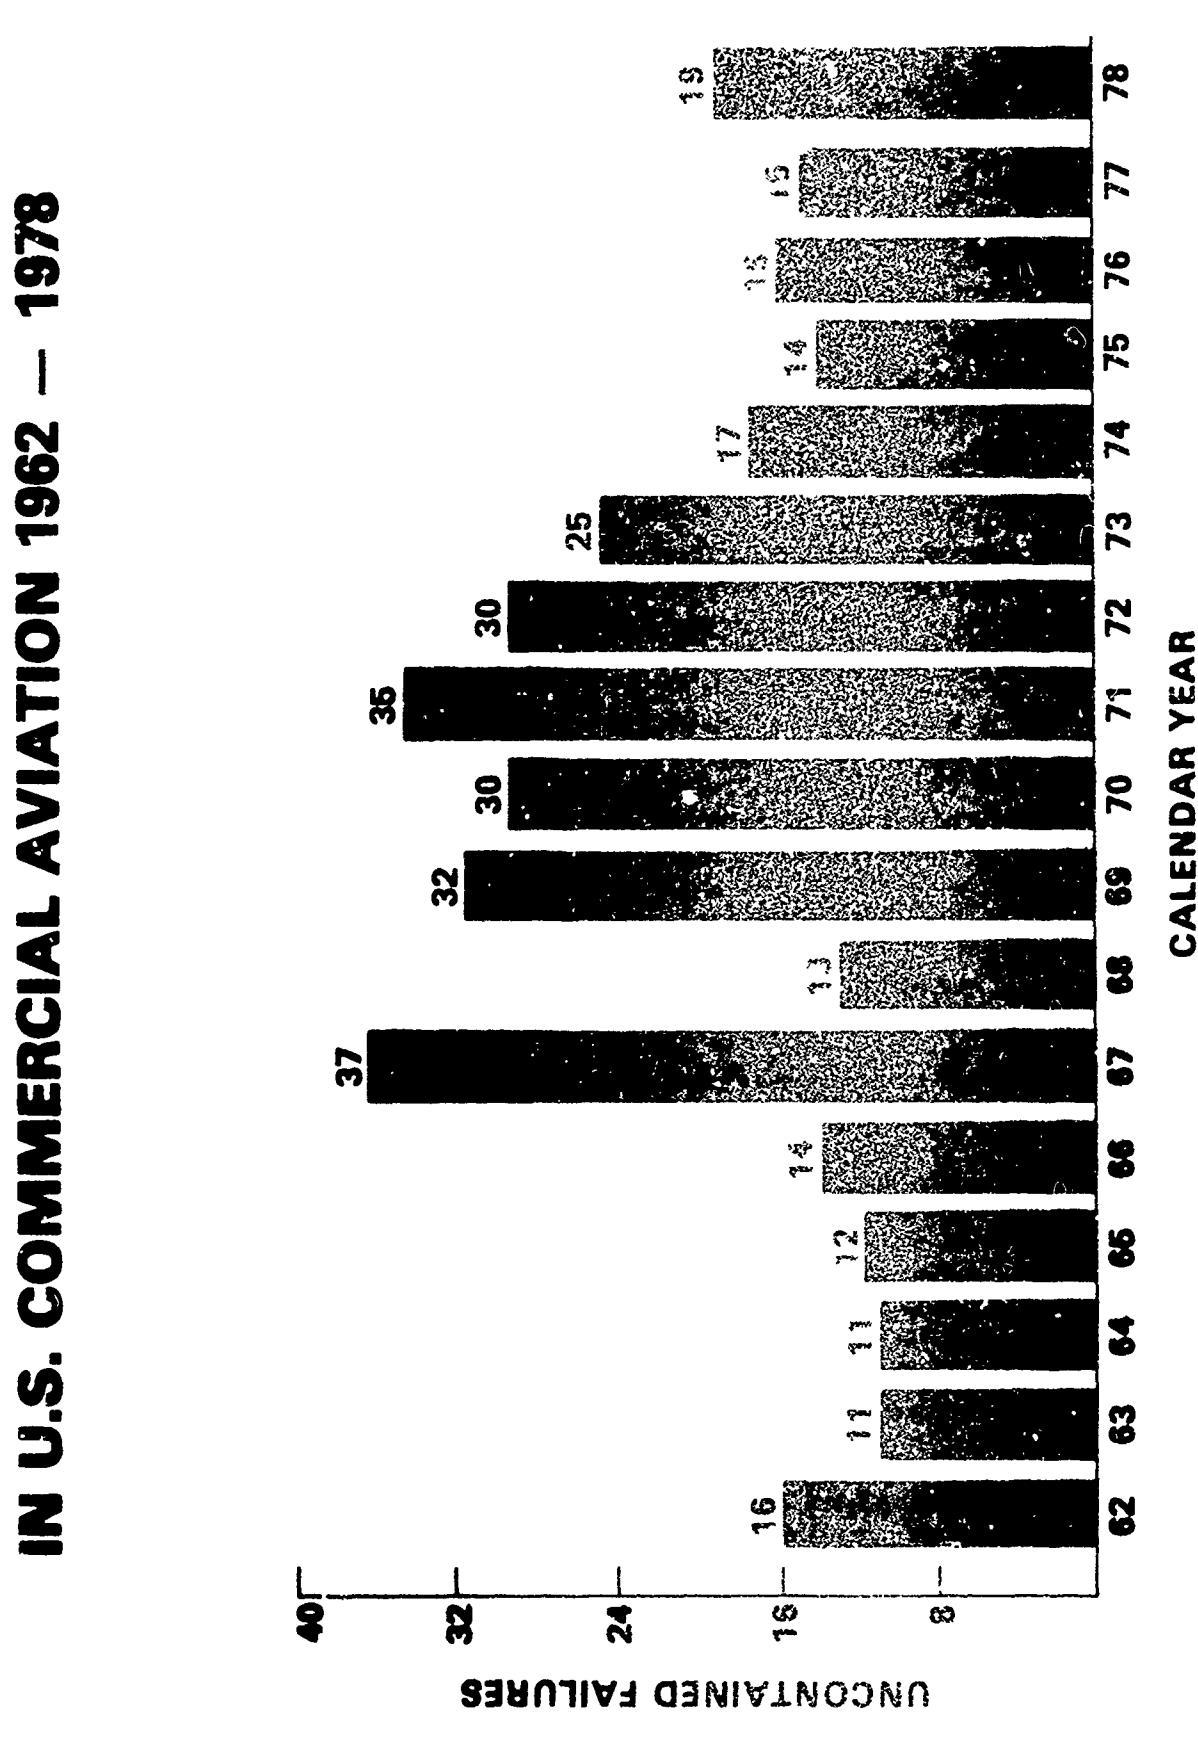
FIGURE 7

g. Notice 7 shows the annual incidence of uncontained rotor failures in commercial aviation for the years 1962 and 1978. During 1978, the incidence of uncontained rotor failure increased by four over the previous year, 1977. Over the past five years, 1974 through 1978, an average of 16.2 uncontained rotor failures per year have occurred. During this same time period, the rate of uncontained rotor failures has remained relatively constant at an average of approximately one per million engine operating hours.

THE MICIDENCE OF UNCONTAINED ROTOR FAILURES
