High Temperature Solar Receiver
Final Report
for the period
7 June 1979 - 7 April 1981

(NASA-CR-164332) HIGH TEMPERATURE SOLAR
RECEIVER Final Report, 7 Jun. 1979 - 7 Apr.
1981 (Sanders Associates, Inc.) 37 p
HC A03/MF A01

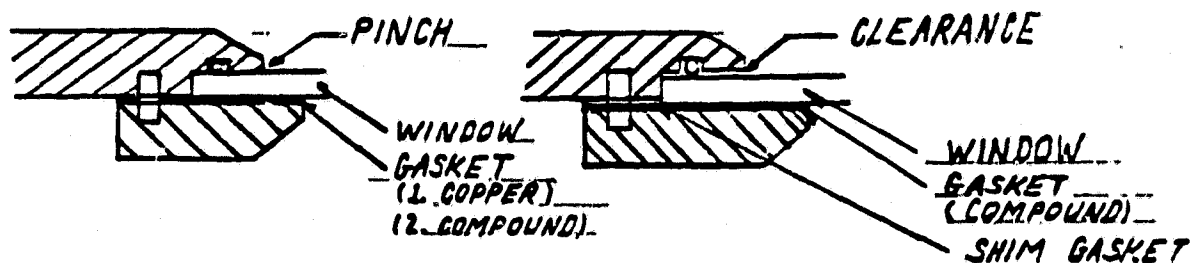
The progression of window retention configurations tested during Nov-Dec 80 are shown below.

The window problems encountered during the above test sequences were the product of initially insufficient clearances being provided for thermal distortion and insufficient shielding of the window retainer flange from spilled solar flux.

A number of windows have broken during the test sequence. Inspection of the failed parts and mounting flanges indicate the window failures were caused by interferences and stress concentrations related to flange design or tracking errors.

5. 8 Dec 80. Ran successful 50% solar test. The clean window performed very well and did not cloud up or get dirty during the test.
6. 10 Dec 80. Attempted 100% solar test. Window survived for 4 minutes and 30 seconds. Crack then propogated from 2 to 9 o'clock. Numerous small and incomplete cracks developed in upper fragment of window. Window did not burst. Slewed off sun and discontinued test. Inspection showed the window retainer flange had "coned" inward and forced window down against the lip of the window support flange. Increased deformation caused the window to

1. Used extreme caution during reassembly to remove all foreign objects from the window mounting surface. Cleaned flanges and buffed copper window gasket.
2. Reduced flange preload and torqued retainer flange bolts evenly to 10 inch-pounds.
3. This fault went uncorrected as it had not yet been detected. Failure was noted on 25 Nov 80 and was subsequently corrected.
4. Used gentle preheat rate of about 50 F/minute.
5. Inspected both the fractured window and its replacement. The windows exhibit numerous bubble inclusions but do not have surface blemishes.

fracture. On 11 Dec 80 the window retention scheme was modified to allow additional clearance for the window retainer flange to distort. The retainer flange was shimmed .032" by use of a double gasket. The window is held off the support flange lip by an uncompressed c-ring.
