O A L S BULLETIN 11

AN ASSESSMENT OF THE IMPACT OF  
WATER IMPOUNDMENT AND DIVERSION STRUCTURES  
ON VEGETATION IN SOUTHERN ARIZONA

OFFICE OF ARID LANDS STUDIES  
University of Arizona  
Tucson, Arizona

December 1975

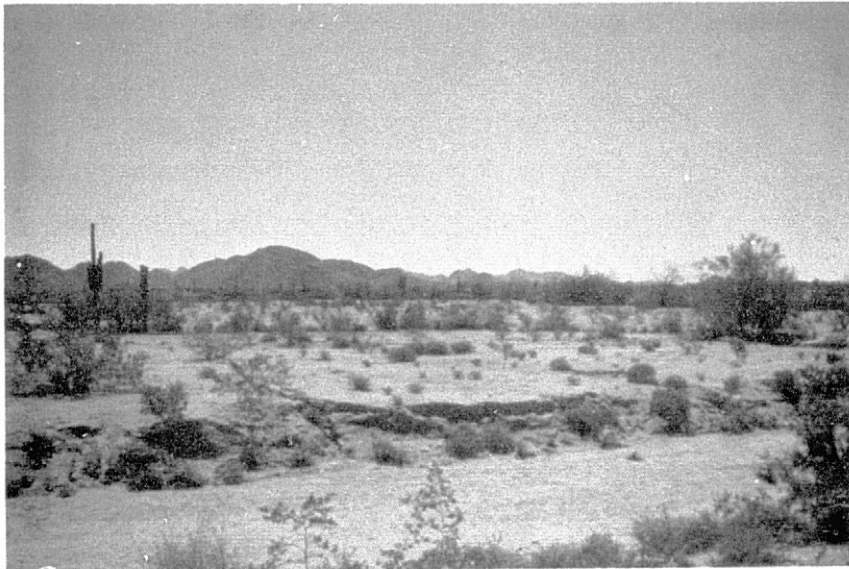
Figure 4. Ground truth photograph of upstream vegetation (Structure #1).

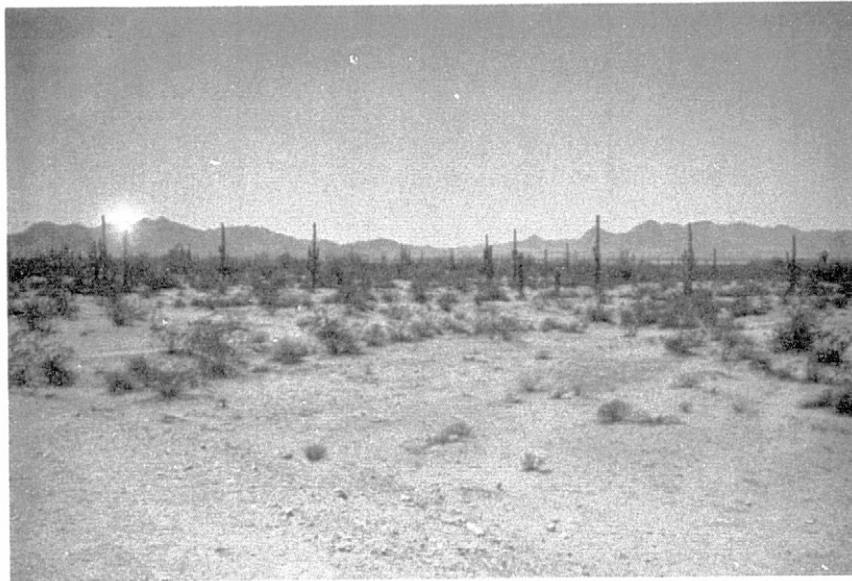
The vigor of the vegetation immediately downslope from the structure was lower than that of upslope vegetation and vegetation further downslope. However, the affected area extends only about 100 yards downslope from the structure. Creosote bush appears to suffer the greatest loss of vigor.

Figure 5. Ground truth photo of downstream vegetation (Structure #1).

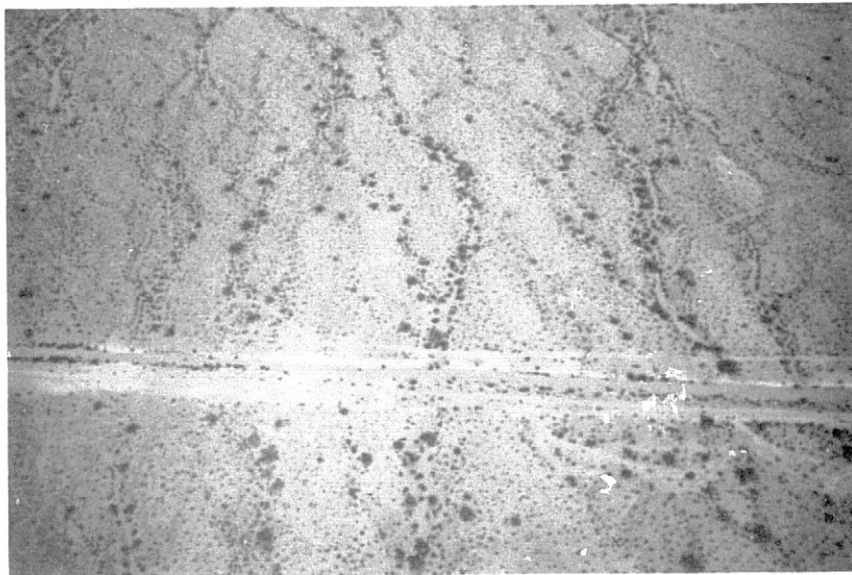
Figure 6. Infrared photo of the diversion structure and adjacent upstream and downstream areas (Structure #1).

Although its affect on vegetation has been minimal, the diversion structure has caused a major wash to exist which parallels the structure, just upstream from it. The new wash, which is approximately 15 feet wide, prevents water from accumulating behind the structure, preventing the occurrence of more luxuriant plant growth upstream.

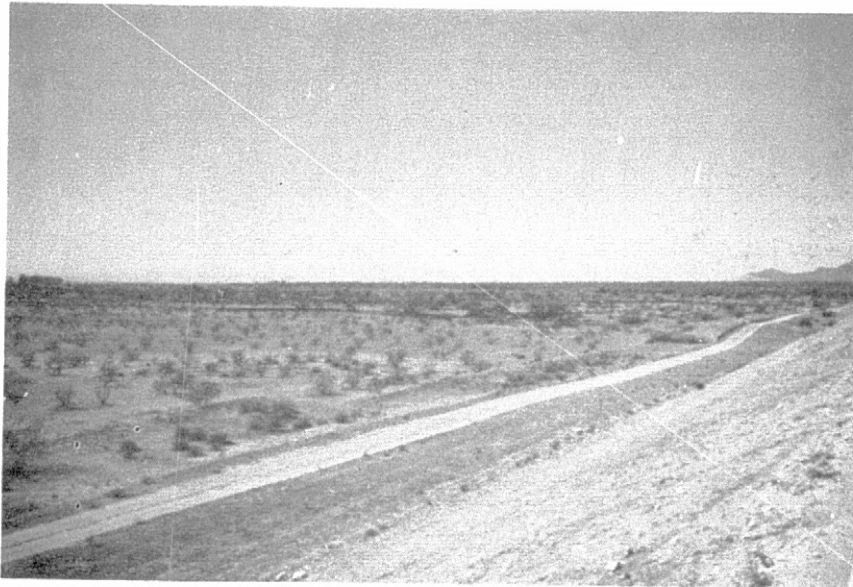
On downslope interfluves, foothill paloverde is less dense and vigorous

Figure 7. Ground truth photo of downslope vegetation (Structure #3).

than on upslope interfluves, while creosote bush and triangle-leaf bursage are little-affected. Wash vegetation, in general, is also much less dense and vigorous downstream.

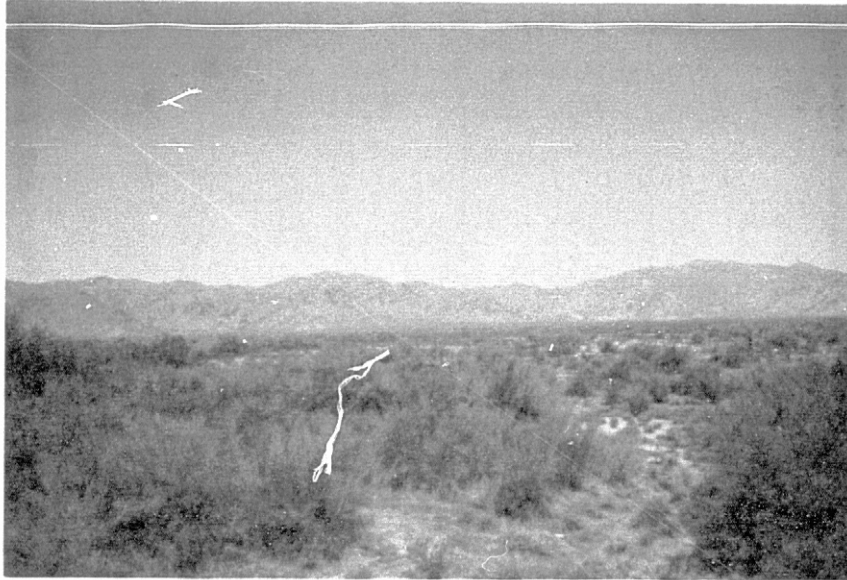
Figure 8. Ground truth photo of upslope vegetation (Structure #3).

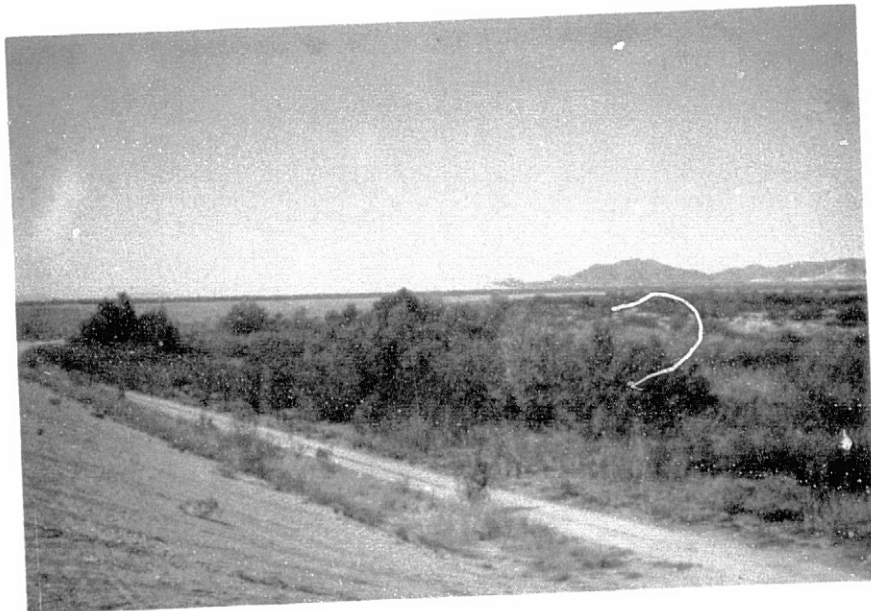
Upslope and adjacent to the structure (corresponding to the area of standing water) exists a very vigorous vegetation type consisting of tamarisk, seep-willow, and desert broom (shown in Figure 10). Further upslope, the interfluvial vegetation consists of the Creosote Bush/Triangle-Leaf Bursage type with occasional foothill paloverde. Riparian vegetation is primarily foothill paloverde, blue paloverde, and ironwood. Downslope, interfluvial vegetation consists of the Creosote Bush/Triangle-Leaf Bursage type with occasional foothill paloverde. Downslope, riparian vegetation is the Foothill Paloverde/Ironwood type.

Figure 10. Vegetation upslope and adjacent to the structure (#4).

Associated with the riparian vegetation upstream is a high cover and density. Cover and density of downslope vegetation is quite low in comparison. Figures 10, 11, 12, and 13 (ground truth and infrared low-altitude photographs of the upslope and downslope areas) illustrate the upslope/downslope vegetation cover and density difference.

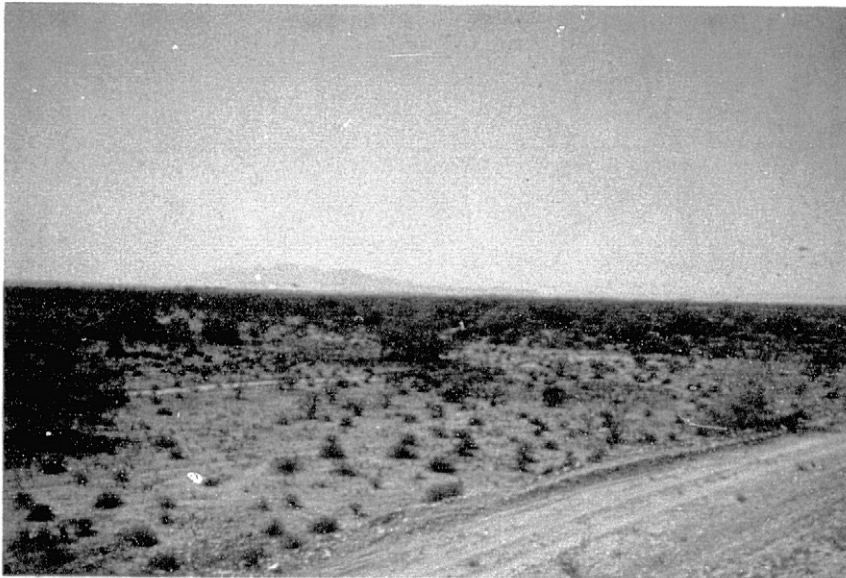
Upslope interfluvial and riparian vegetation is much more vigorous than downslope vegetation. The riparian areas have a very marked difference: upslope riparian vegetation is very vigorous while downslope riparian vegetation is almost dead. Ironwood seems to be the most unfavorably affected plant downslope.

Figure 11. Ground truth photo of downstream vegetation (Structure #4).

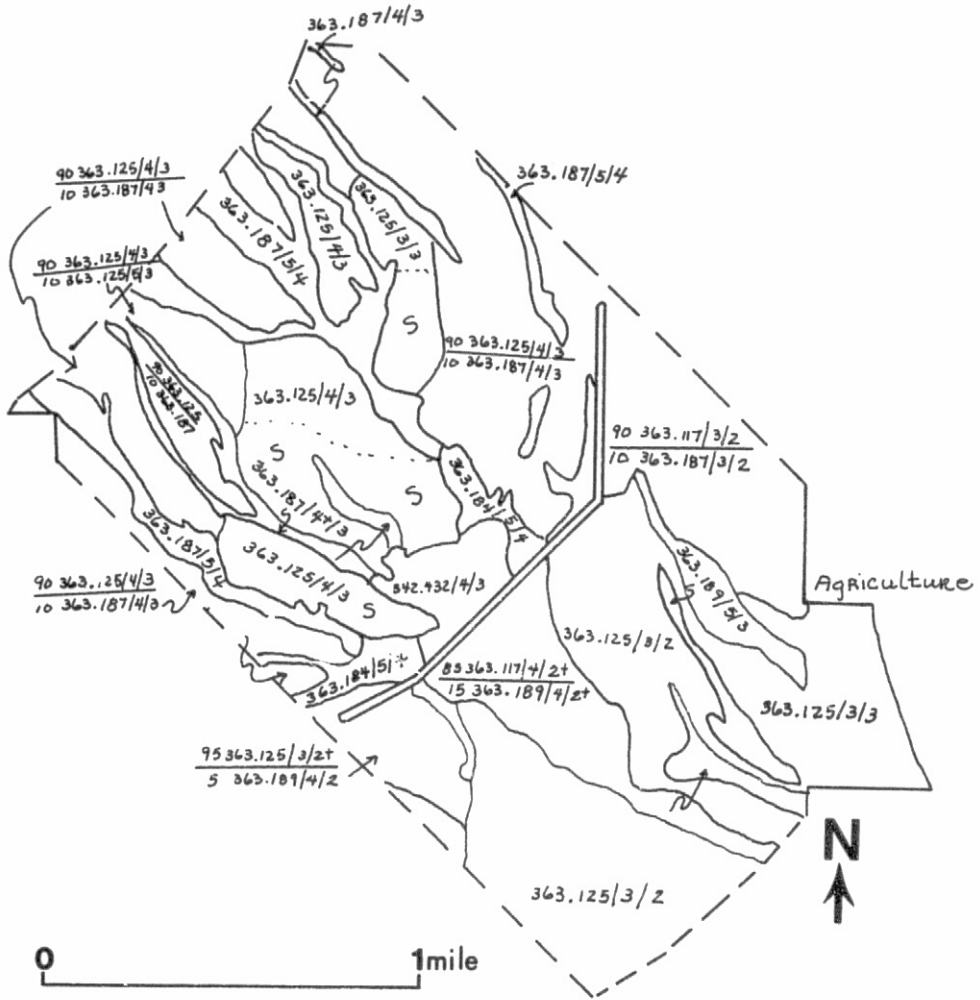
As can be seen from Figure 14 (the vegetation map for this site) vegetation patterns upstream and downstream of the structure remain unaltered.

Figure 14. Vegetation map for White Tanks No. 2 (Structure #4).

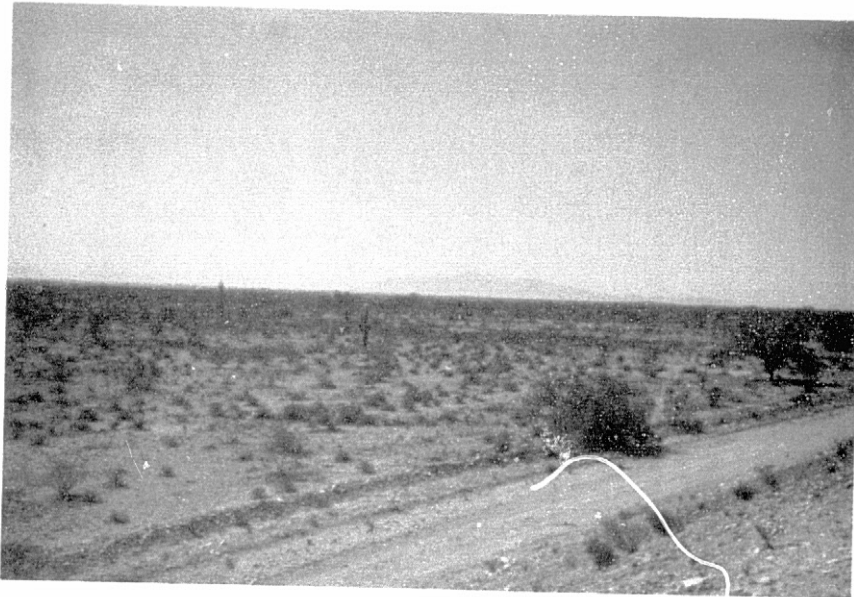
Interfluve vegetation is the Triangle-leaf Bursage/Creosote Bush type with cholla, as is shown in Figure 17.

Figure 17. Downslope interfluvial vegetation. The Triangle-leaf Bursage/  
Creosote Bush type with cholla (Structure #5).

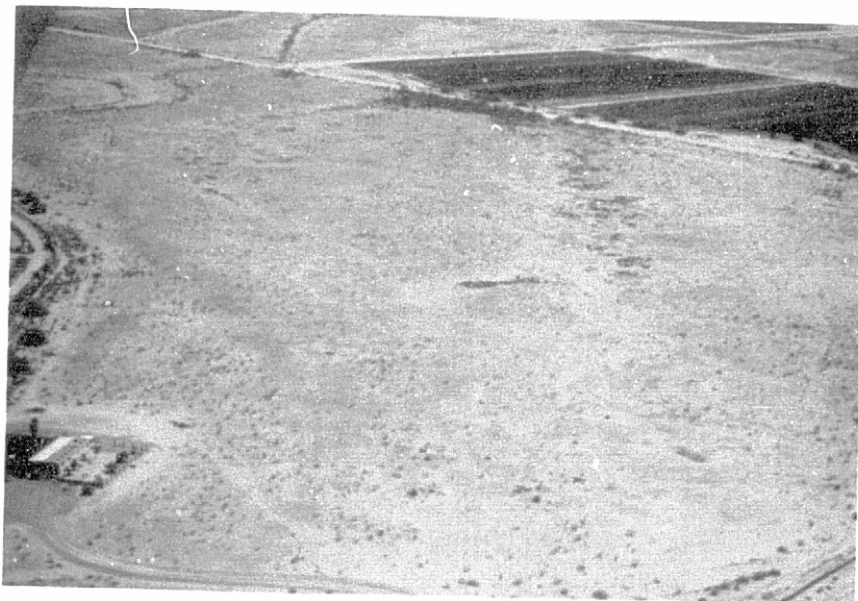
Figure 18. Infrared low-altitude photo of downstream vegetation (Structure #5).

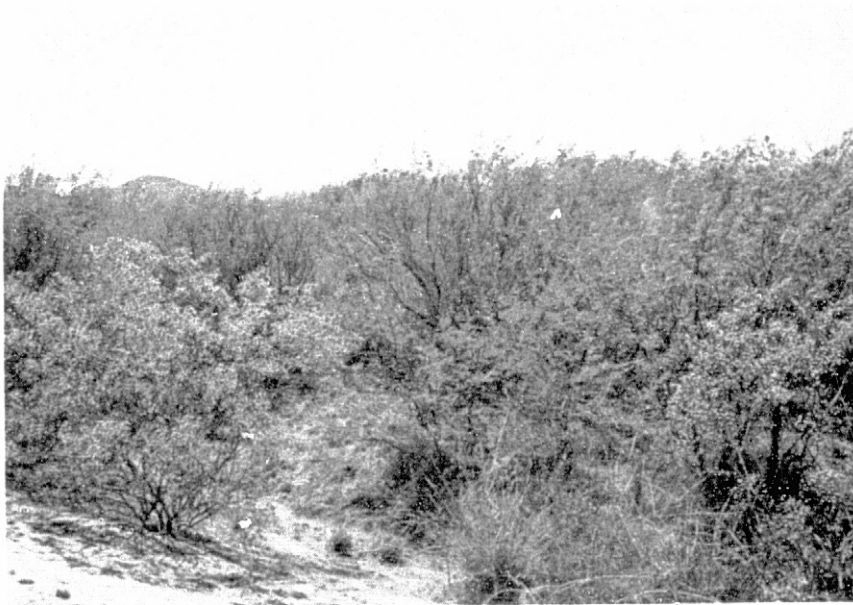
Diversion structures at the upper end of the series have a higher vegetation cover upslope from the structures than do diversion structures at the lower end of the series. Figure 23 is a ground truth photo of one of the upstream structures and associated vegetation.

Figure 23. Ground truth photo of an upstream structure and associated vegetation (#7).

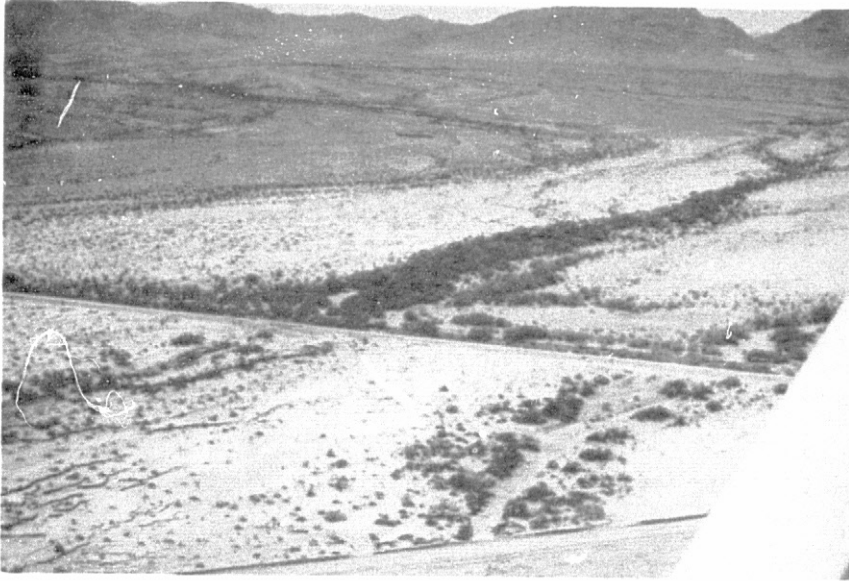
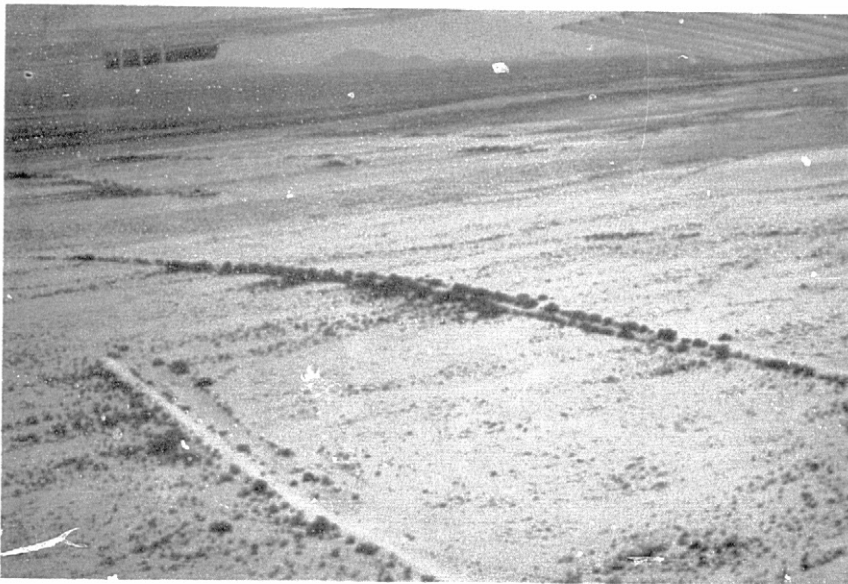
Figure 24 is an aerial view of the same structure. Figure 25, an aerial view of two diversion structures further downstream, when compared to Figure 24, illustrates the reduced impact on vegetation of structures furthest downstream in the series.

Figure 24. Infrared aerial photo of an upstream structure (#7).

Figure 25. Infrared aerial photo of two downstream diversion structures (#7).

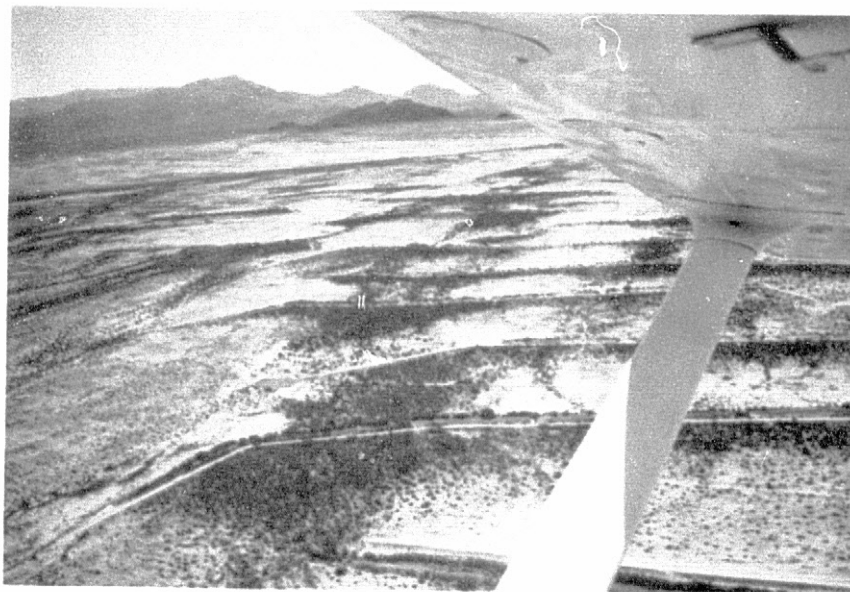
Figure 32, a low-altitude color infrared oblique photograph of the structures, shows a high vegetation density upslope from each structure and lower density downslope. Upslope vegetation adjacent to the diversions consists of the Mesquite/Snakeweed type of relatively high cover (30-40%) and vigor.

Figure 32. Low-altitude infrared oblique photo of the diversion structure network (Structure #9).

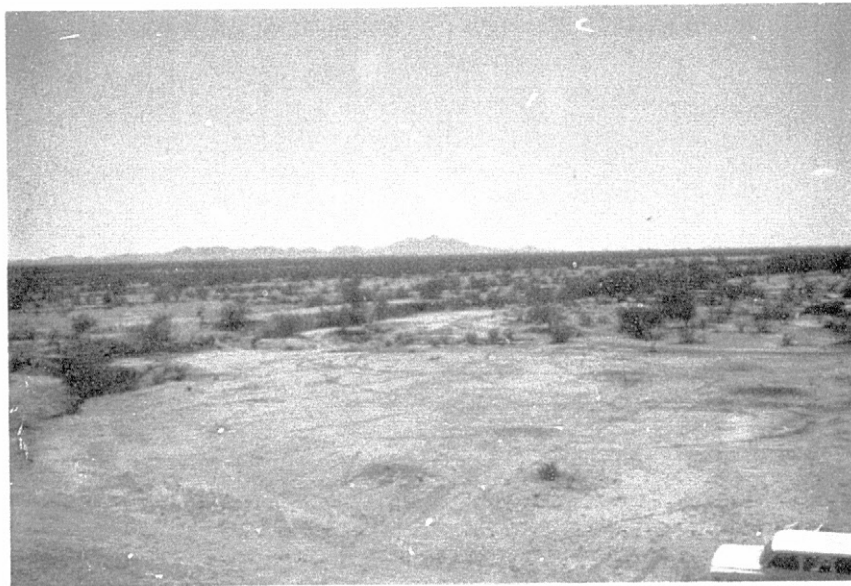
Figure 39. Ground truth photo illustrating erosion downstream from "flow-through" points (Structure #12).

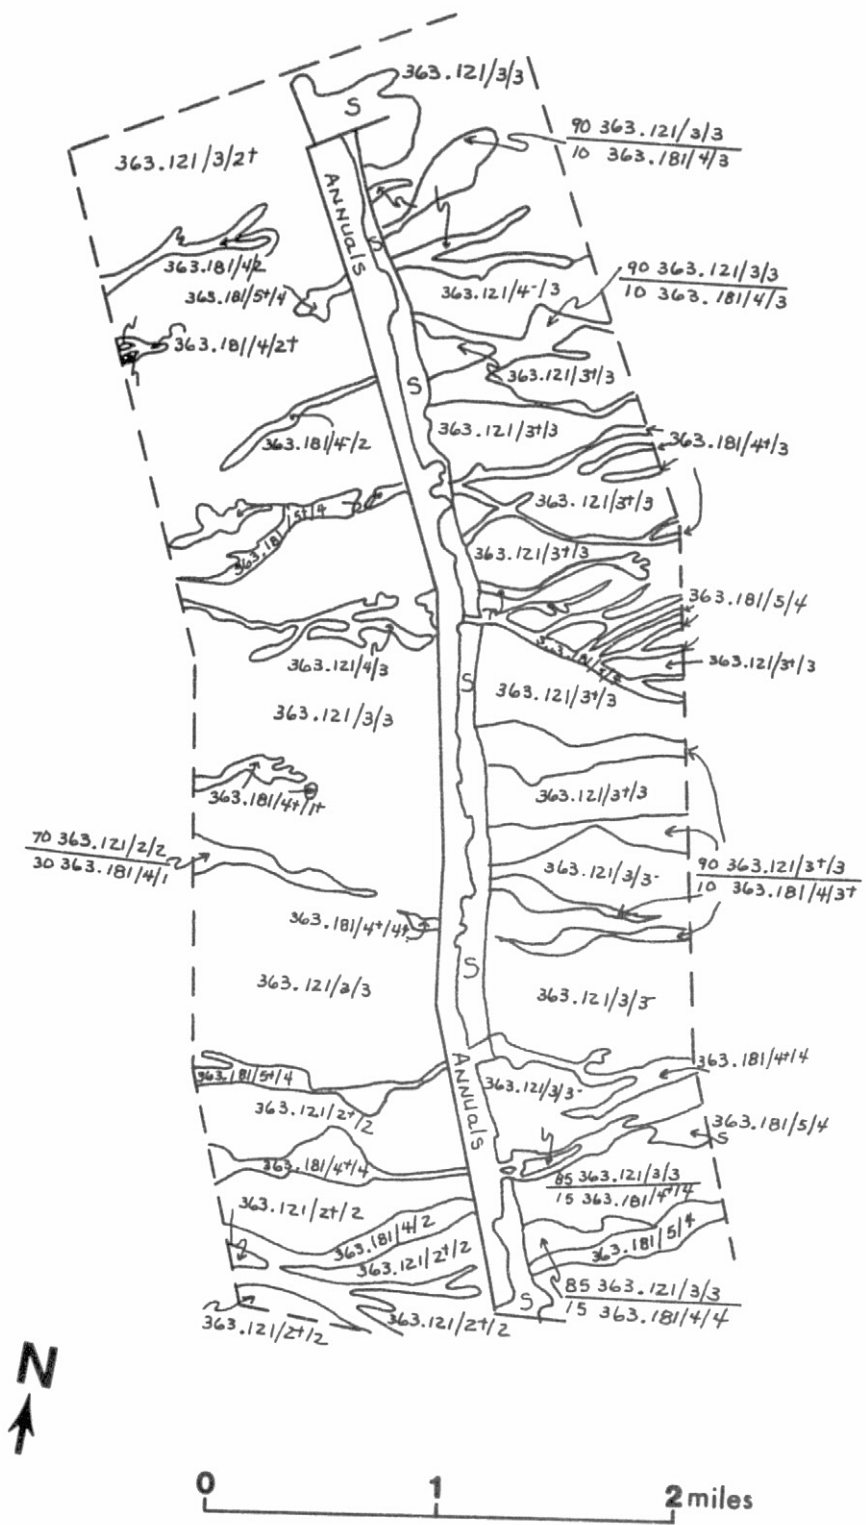
Vegetation patterns upslope and downslope of the structure are shown in Figure 42, the vegetation map for the site. As can be seen from the map, riparian vegetation patterns seem to be unaltered where there are flow-through points (shown as cross hatches on the diversion structure in the

Figure 42. Vegetation map for Vineyard Road Dam (#13).

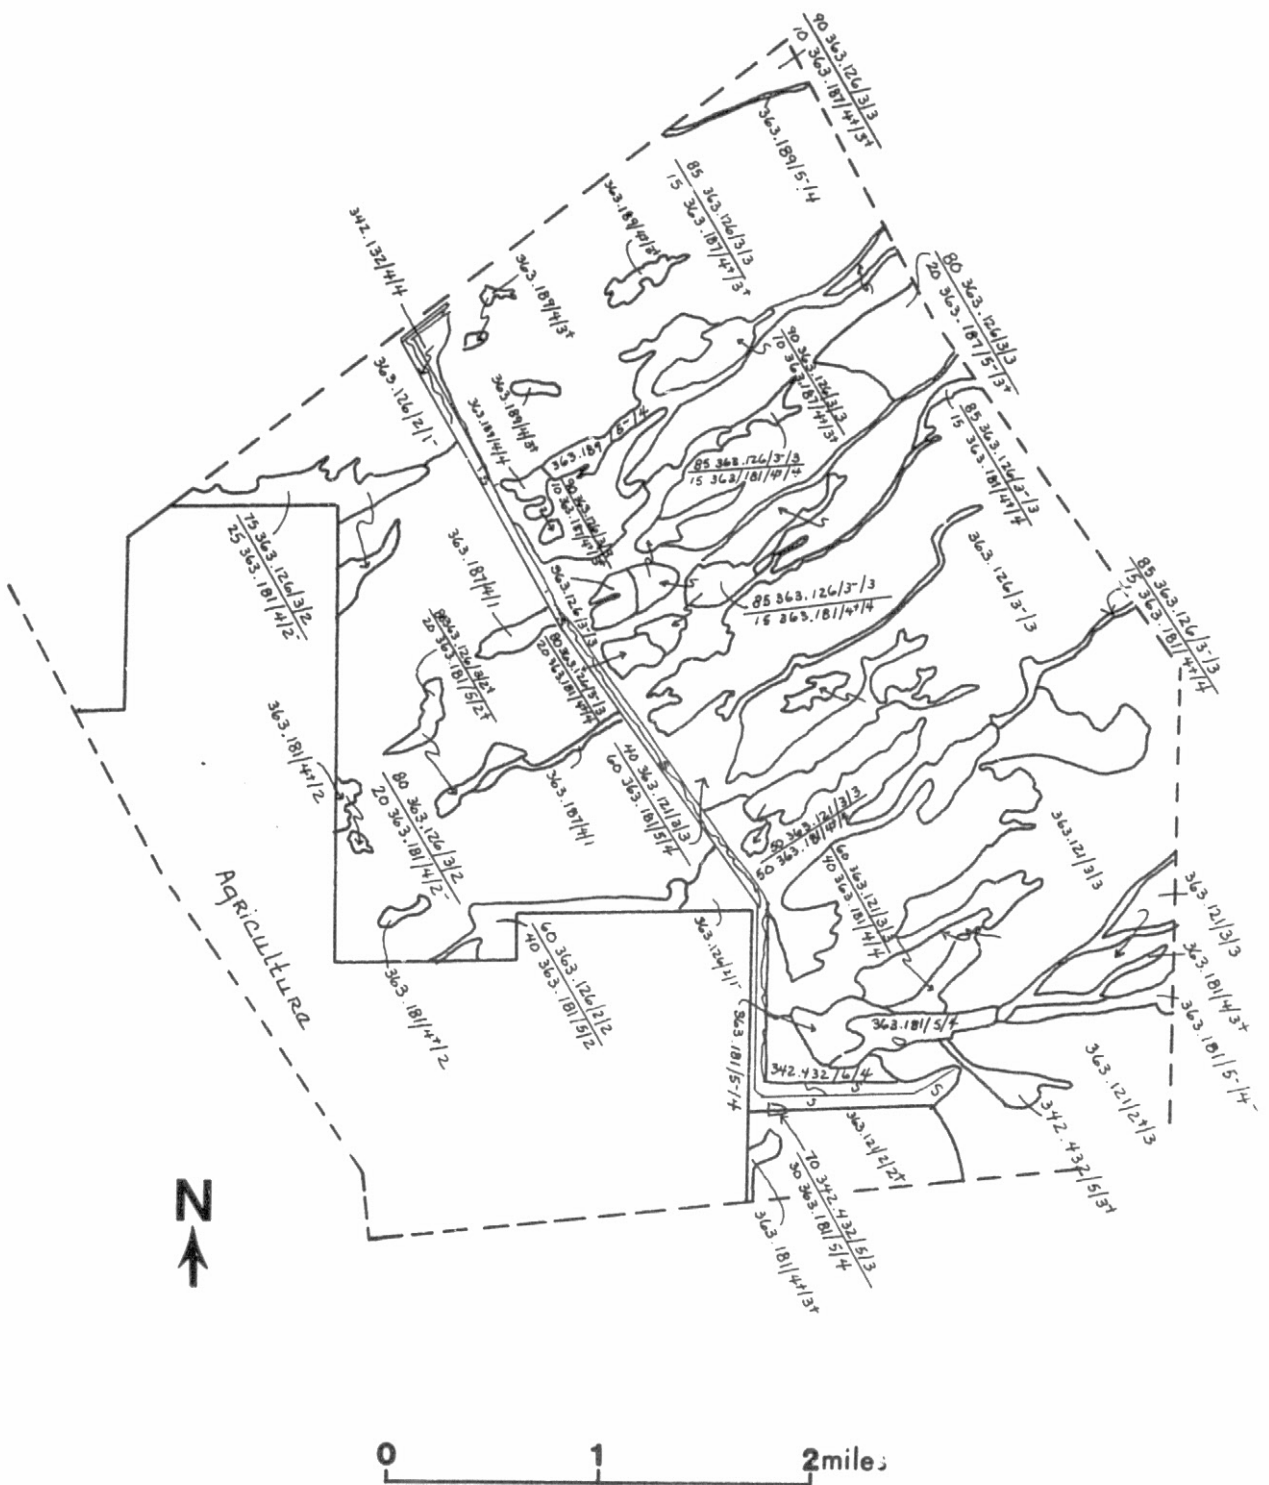
Figure 49, the vegetation map of the site, shows the difference in upslope and downslope vegetation patterns. Upslope, riparian patterns are quite spread out, suggesting that water "backs up" behind the structure. Downslope, riparian

patterns are much more narrow, the vegetation being restricted to wash edges. It should be noted that the Magma Dam has only one flow-through point. Wash vegetation immediately downstream from this point is similar in vigor and cover to wash vegetation upslope.

Figure 49. Vegetation map for Magma Dam (#15).

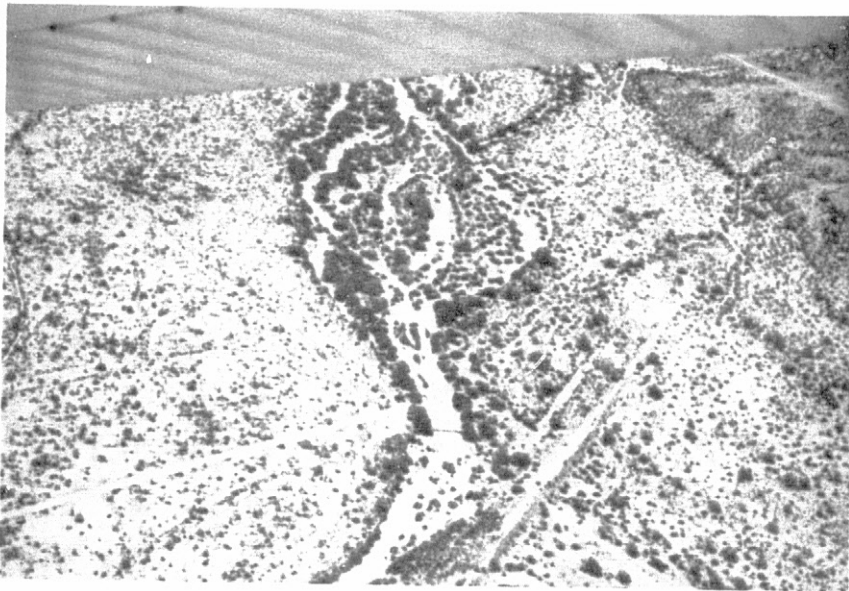
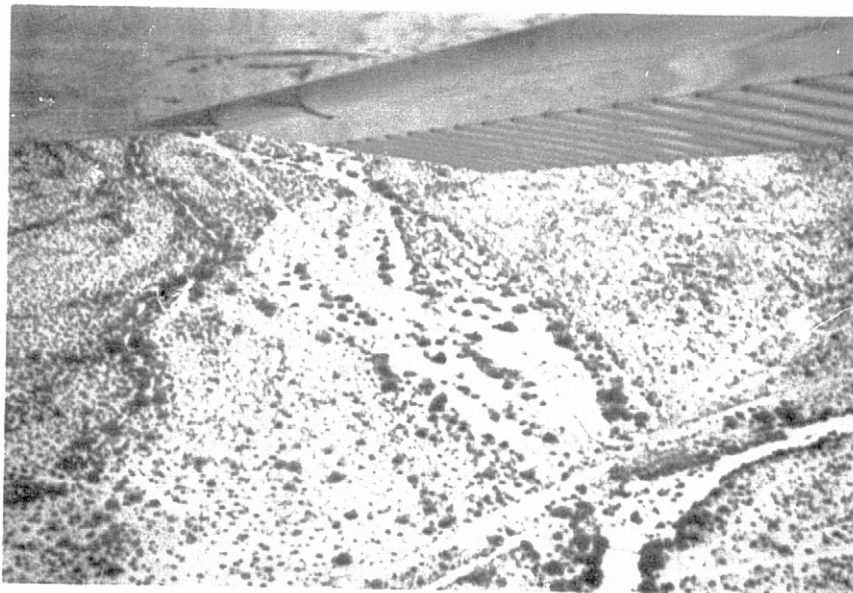
Species composition of downstream vegetation is the same as that upstream with the exception of triangle-leaf bursage, which is absent downstream. Figures 50 and 51 (aerial photos of upstream and downstream vegetation, respectively) illustrate the difference in vigor and cover of upslope and downslope vegetation. Downstream riparian vegetation appears to be more affected by the reduced waterflow than does interfluve vegetation. Downslope, interfluve vegetation is similar to that upslope with respect to cover and vigor. Vigor and cover of downstream riparian vegetation, however, is very much reduced.

Figure 50. Infrared low-altitude photo of upslope vegetation (Structure #16).

Figure 51. Infrared low-altitude photo of downslope vegetation (Structure #16).

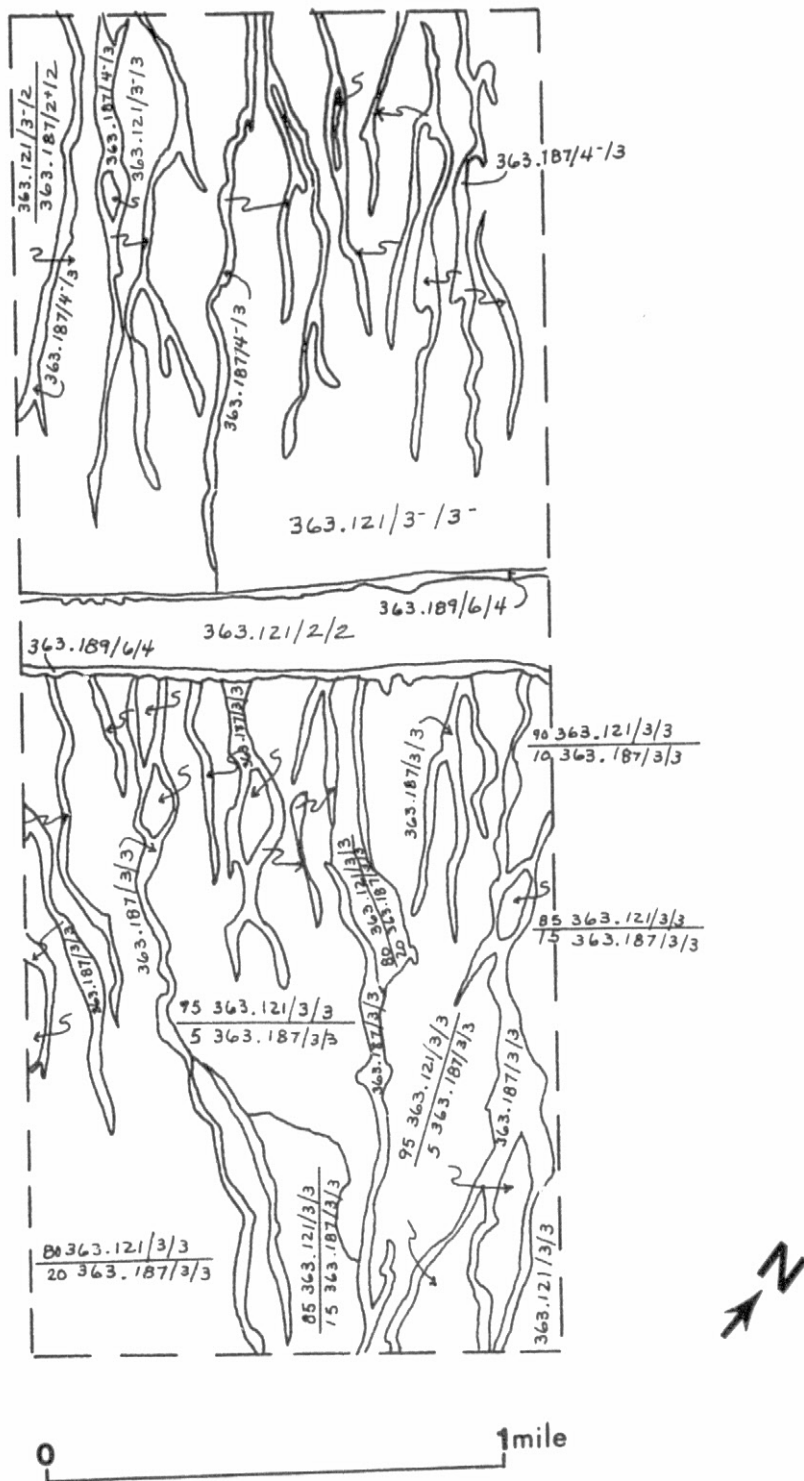
Overall vegetation patterns are relatively undisturbed by the structures. Figure 55, the vegetation map of the site, shows the main effect of the structure: an increase in vegetation cover and vigor up slope, and an interruption of riparian vegetation patterns for a short distance downslope.

Figure 55. Vegetation map for West Sacaton Mountain Site (#18A).
