**NASA TECHNICAL
MEMORANDUM**

NASA TM X- 62,471

**FIRE SAFETY EVALUATION OF AIRCRAFT LAVATORY AND
CARGO COMPARTMENTS**

August 1975

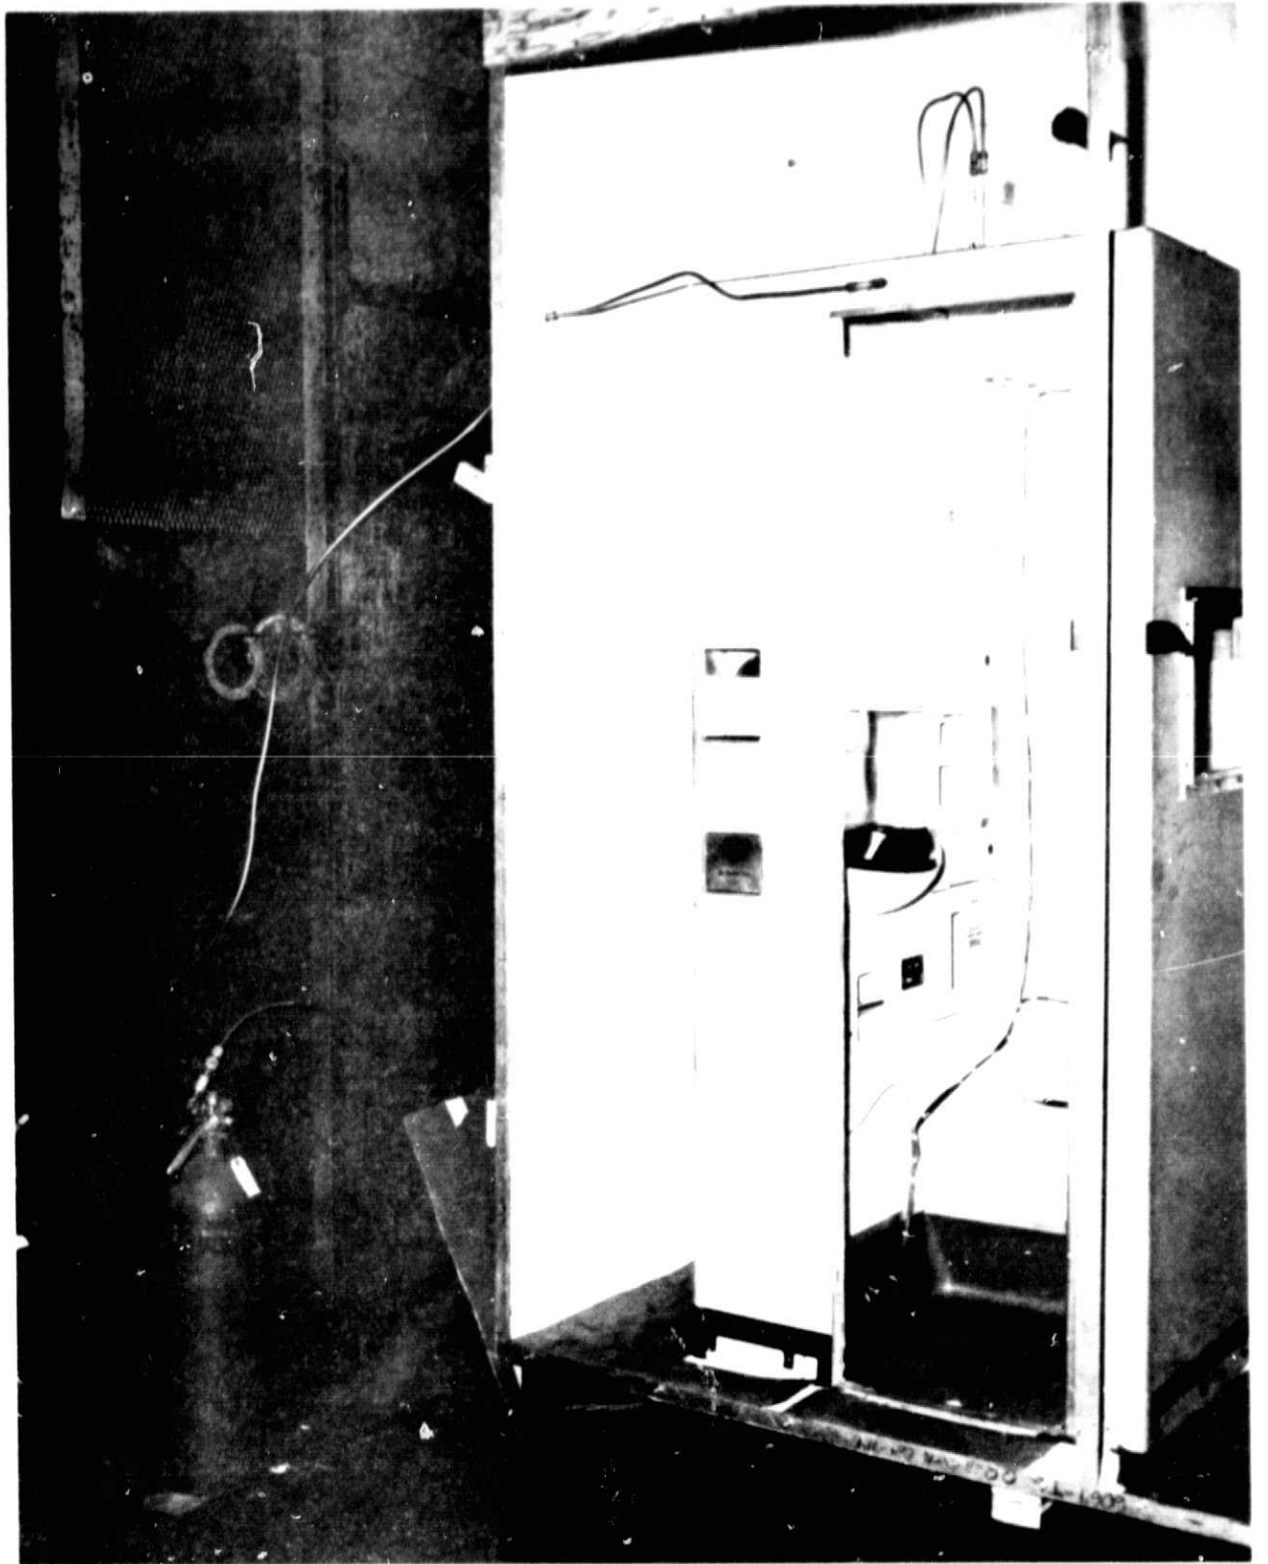
Figure 7.—Lavatory prior to the test.

The lavatory prior to fire testing is shown in figure 7.

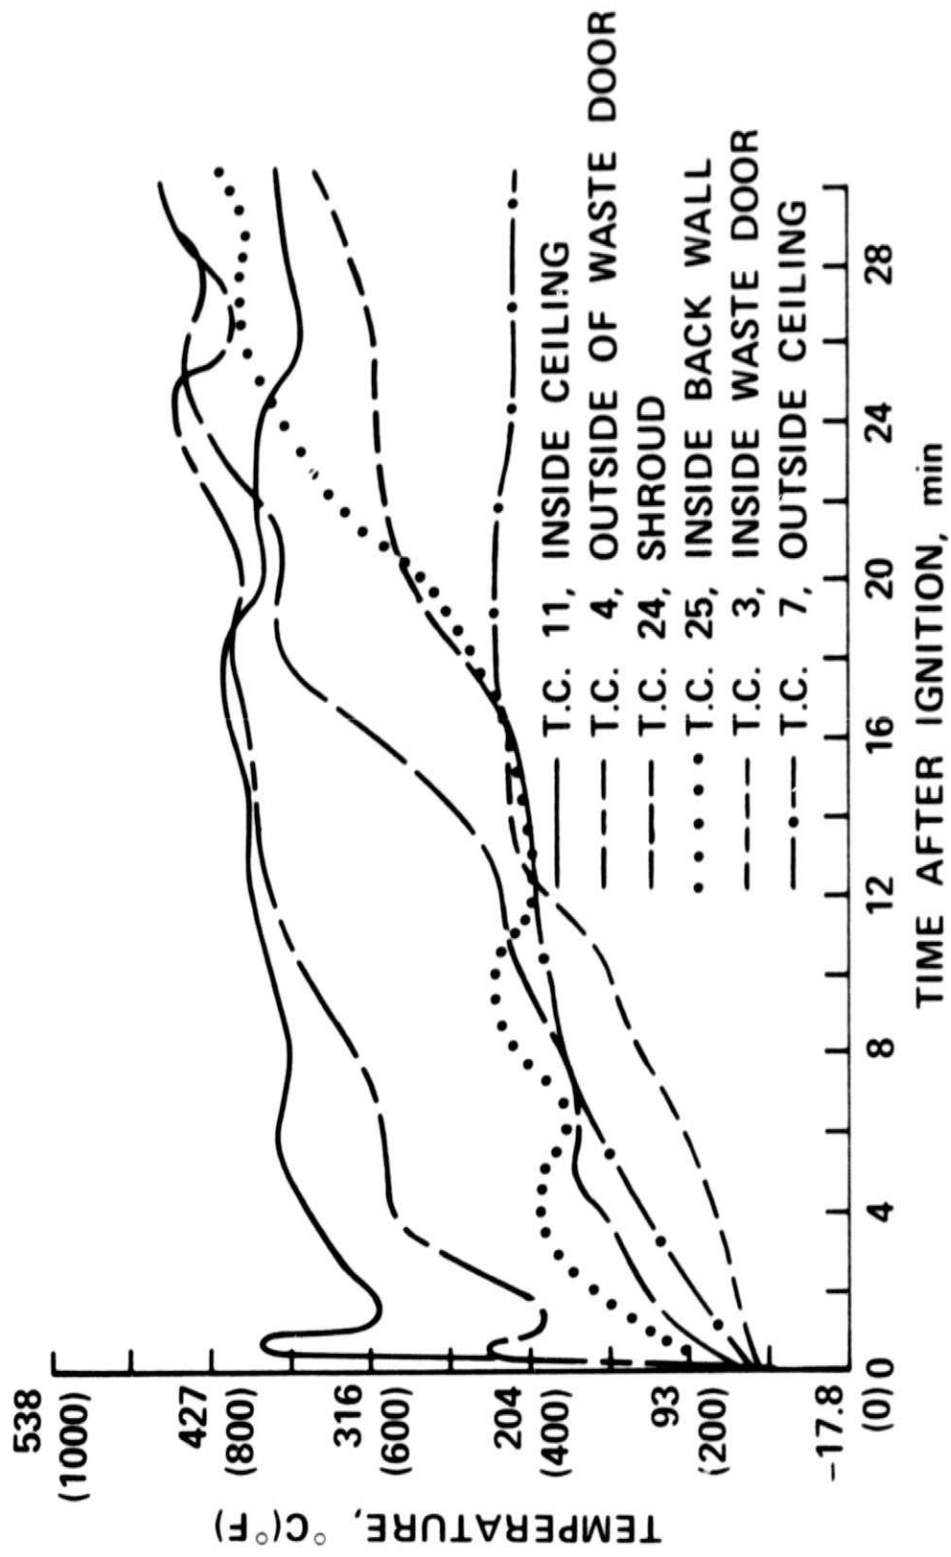
Figure 8.—Surface temperature in lavatory.

Figure 8 presents the readings of some of the thermocouples on the test lavatory. Thermocouples inside the lavatory were 2.54 cm (1 in.) away from the surface to obtain the environment temperature. The thermocouples inside the lavatory were numbers 4, 11, 24 and 25. The other thermocouples were bonded to various lavatory surfaces.

After the initial increase in temperature during the first six minutes, the ceiling temperature stabilized at 343-399°C (650-750°F). This shows that the rate of burning in the module was fairly constant as it was controlled by the ventilation rate. The thermocouples show how the fire developed during the late stages in the waste burning against the waste compartment, the shroud and the corner between the cabinet and back wall.

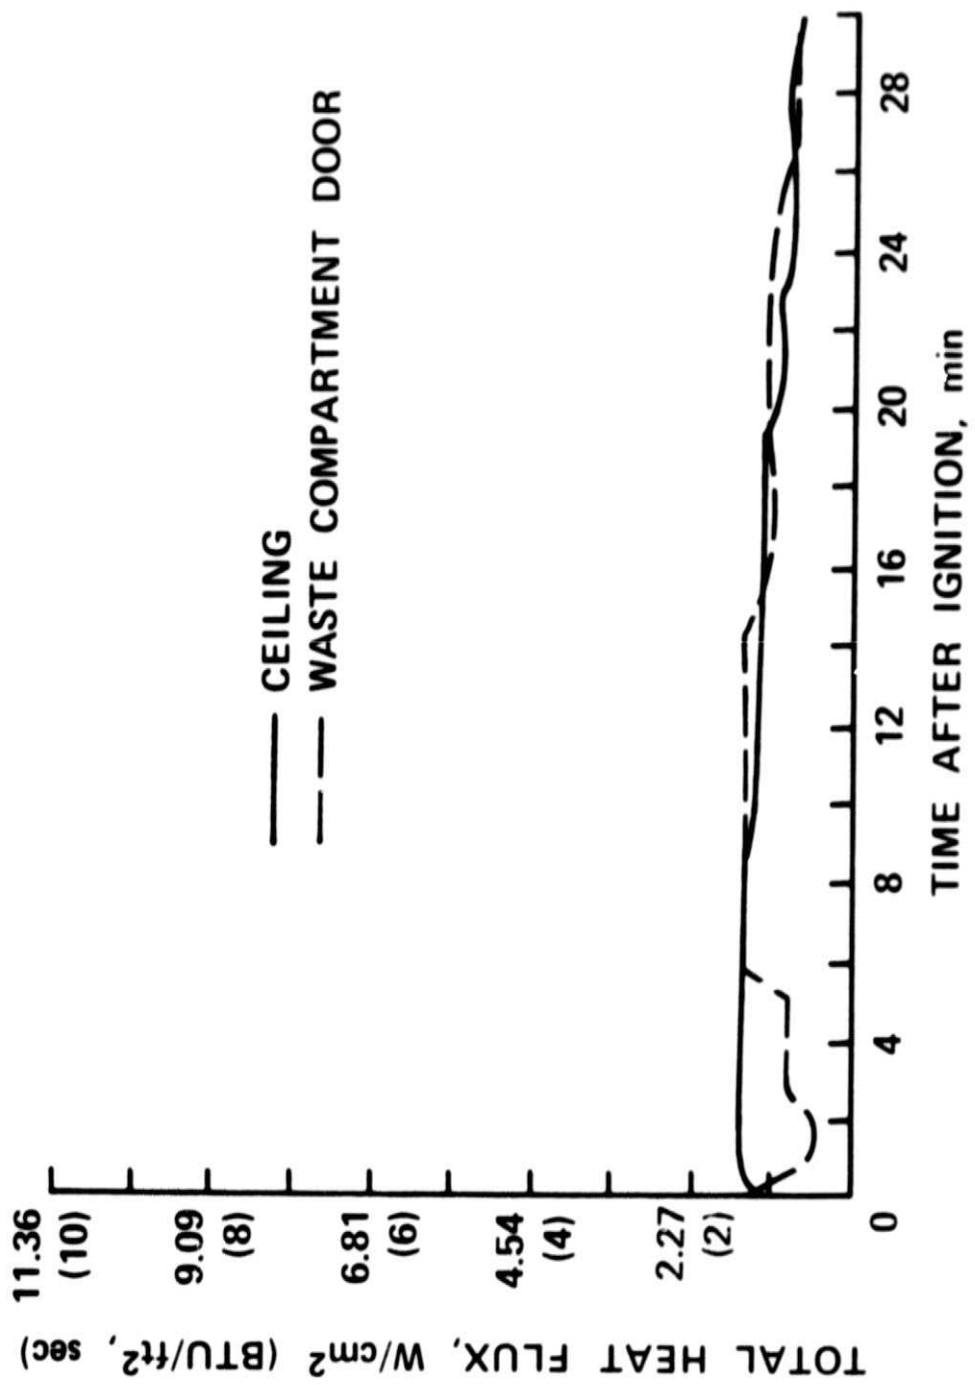
Figure 9.—Heat flux rate in lavatory.

The maximum total heat flux was measured by the two calorimeters whose output is graphed in figure 9. The only air temperature recorded in the test enclosure was that near the AETS cage (fig. 10).

- Maximum temperatures were recorded at the lavatory ceiling within 15 minutes.
- Heat flux levels did not exceed 1.58 W/cm^2 ($1.4 \text{ Btu/ft}^2 \text{ sec}$) possibly due to a fuel rich condition which produced a smoldering situation.

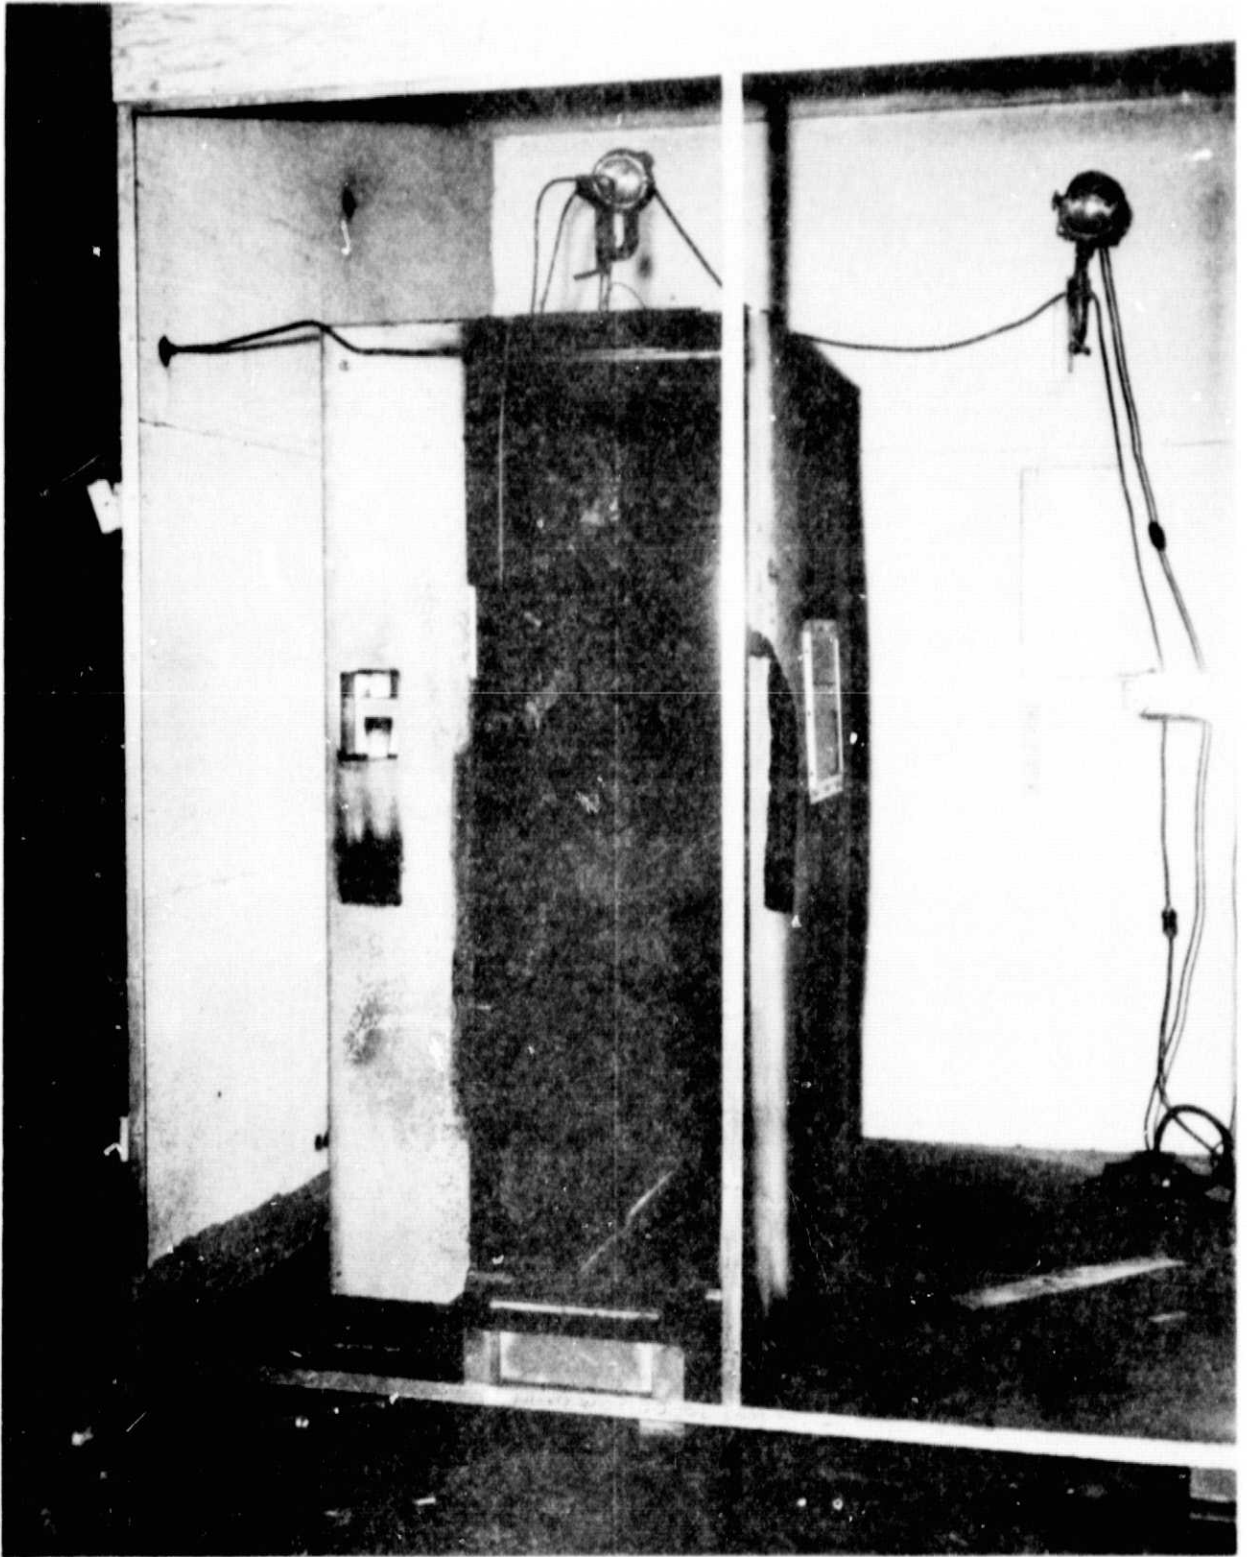
Figure 21.—Lavatory after the test.

Throughout the 30 minute test there was no flame penetration of walls or ceiling. A small amount of smoke escaped through the passenger service access hole in the ceiling over the amenities cabinet; a larger amount of smoke and a few small flames escaped past the door hinge when the fire burned on the floor, distorting the door and leaving a gap in the jamb.

The test was terminated 30 minutes after ignition by discharging CO₂ into the lavatory and the test enclosure. Approximately one hour after ignition the door was opened and two fires still burning were extinguished with water fog. These deep-seated fires were located in the undersink waste compartment and in the waste still burning on the shroud in the cabinet and backwall corner.

Figure 21 is an overall view of the lavatory after the test. All the interior cabinet sandwich panels were charred and delaminated. None of the lavatory walls nor the ceiling were penetrated by flames. The wall opposite the cabinet was distorted and bowed outward. A small area of resin on the outside wall of the waste compartment was scorched. The bifold lavatory door suffered the most damage, delaminating and distorting. It cannot be determined how the observation windows cut in this door may have affected the extent of the damage.
