NASA CR-1444

FINAL REPORT ON DEVELOPMENT OF A SEALED BEARING FOR SPACE SUITS

> Prepared Under Contract NAS 9-14399

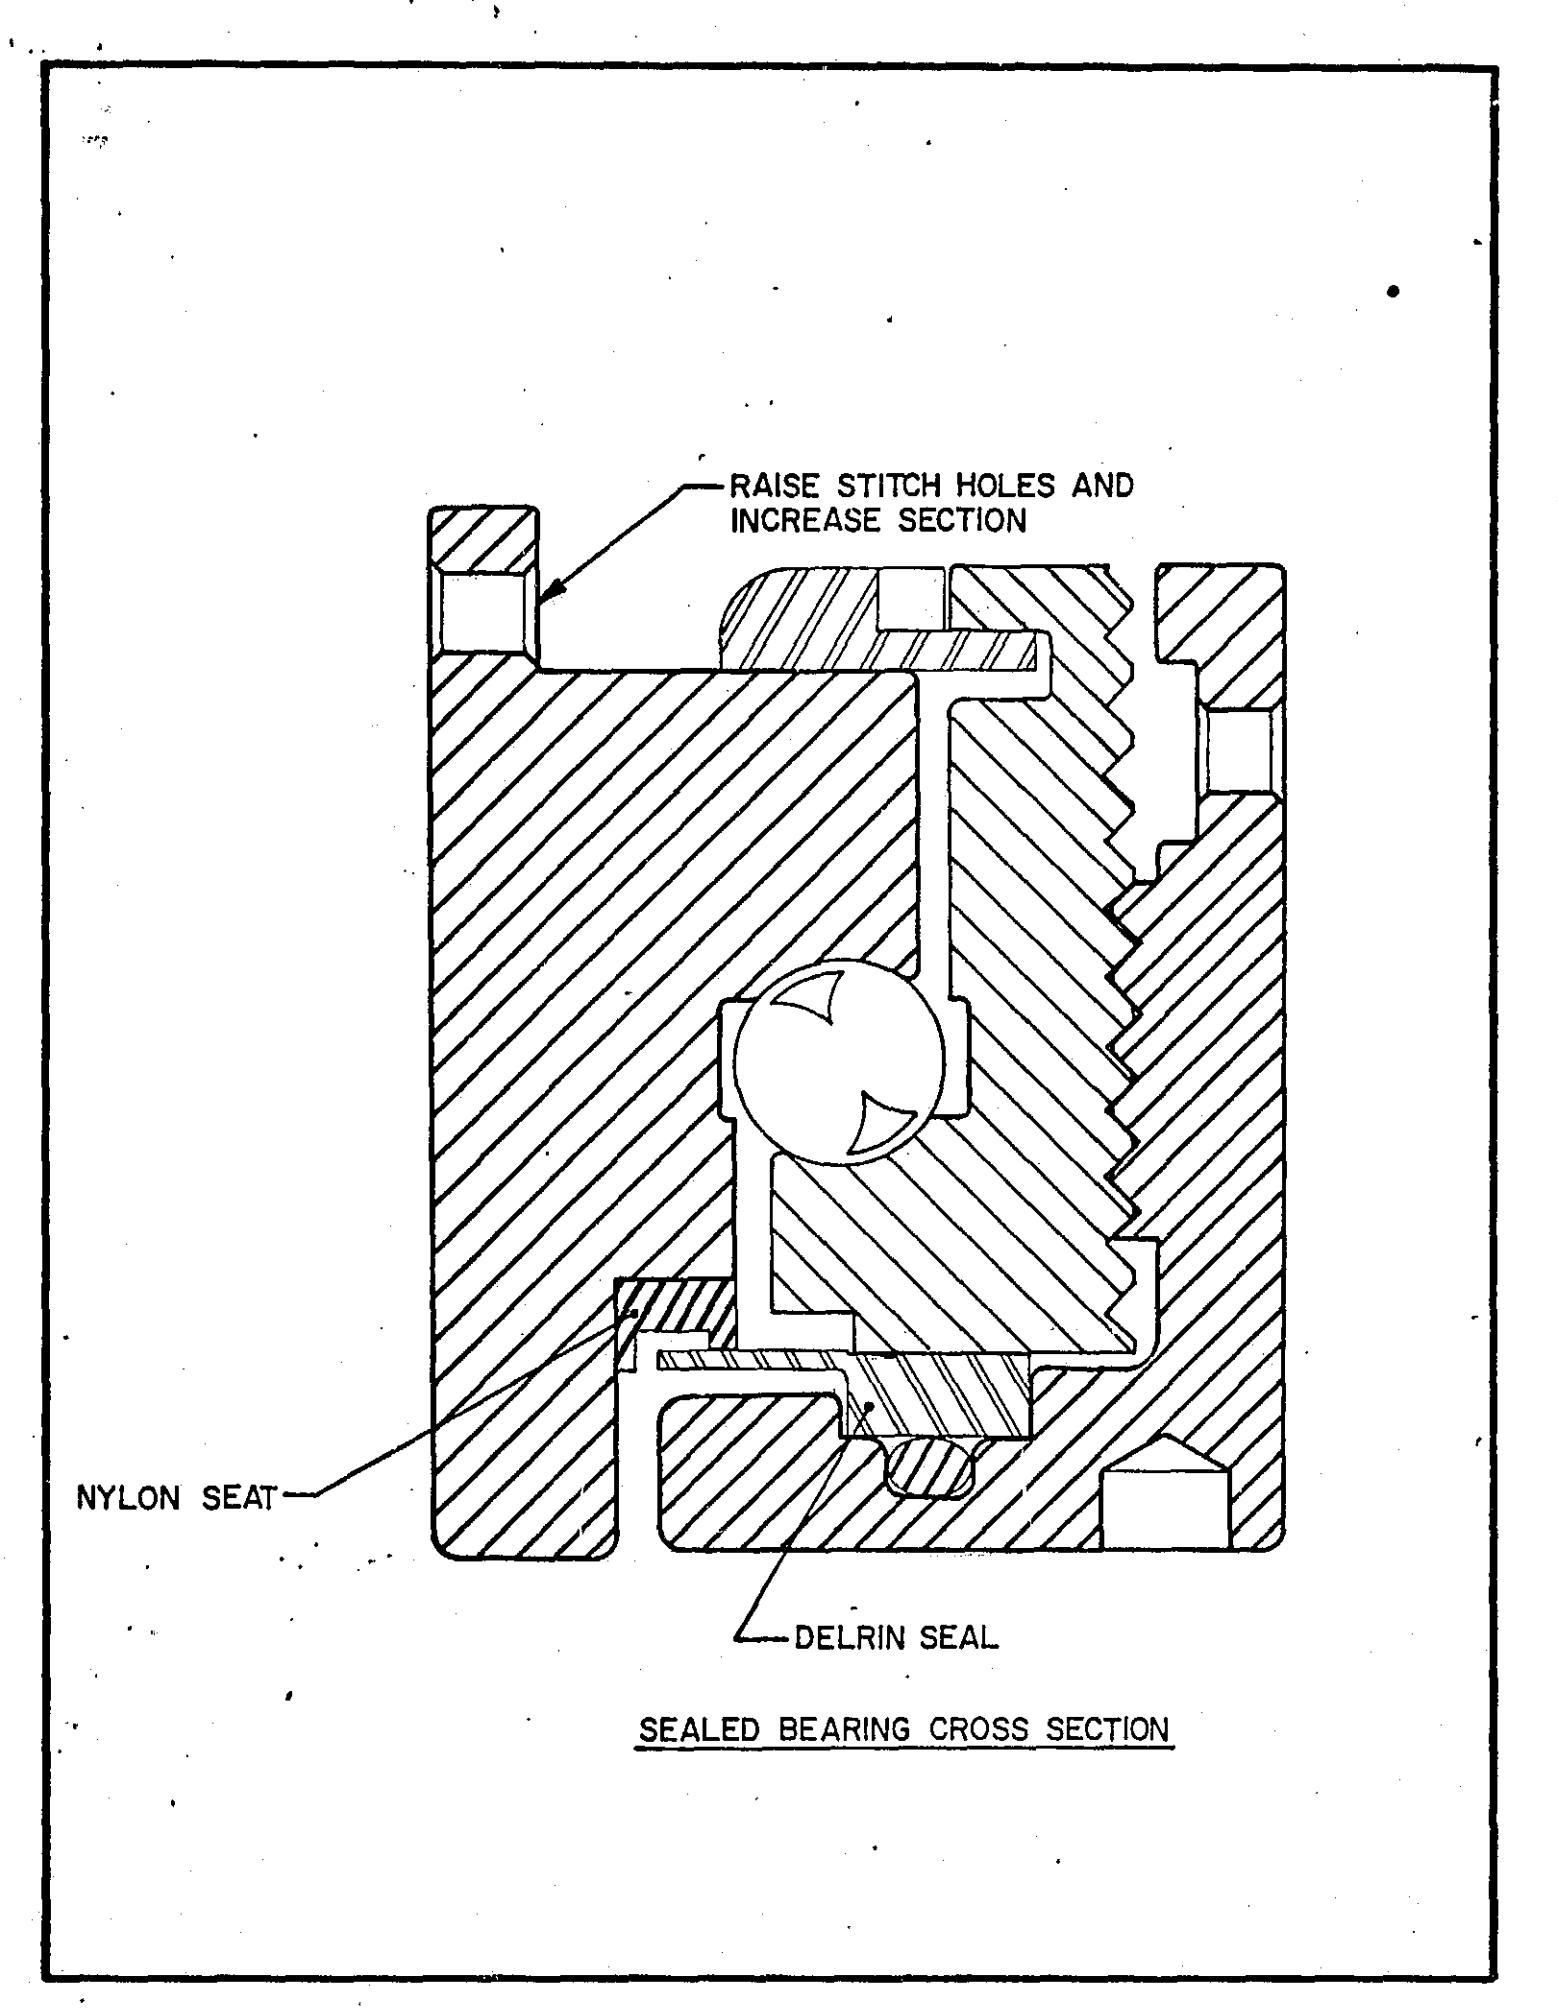
The final configuration, successfully bench-cycled and delivered to NASA, is shown in Figure 1.
