NASA TECHNICAL NOTE

NASA TN D-7992

APOLLO EXPERIENCE REPORT GUIDANCE AND CONTROL SYSTEMS:
MISSION CONTROL PROGRAMER FOR
UNMANNED MISSIONS AS-202,
APOLLO 4, AND APOLLO 6

Gene F. Holloway Lyndon B. Johnson Space Center Houston, Texas 77058

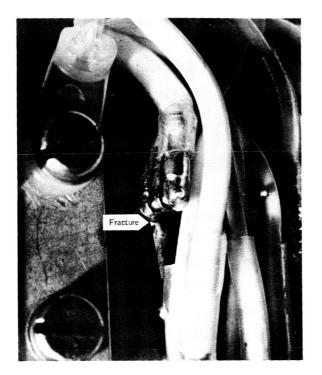
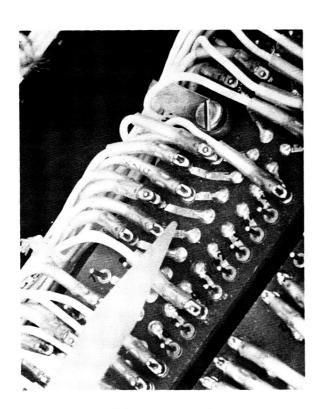
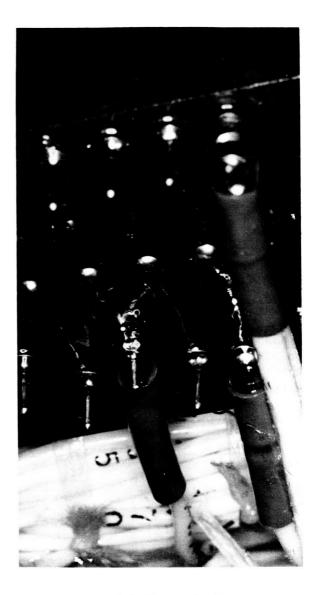
Figure 14.- Fractured solder terminals.

The MCP production unit 3 (qualification test unit 1) entered the vibration environment portion of the qualification test on April 2, 1966. The vibration effects to be investigated were the resonances of each package (resonance search) and the susceptibility of the MCP to random vibration. The postvibration physical inspection of the MCP indicated 35 instances of fractured solder joints on the pins of the SCC control assembly connector boards (fig. 14). The GCC had 10 loose or broken solder joints around similar pins. However, no functional test failures were attributed to the solder fractures around the pins. The corrective action for the cracked-solder-joint problem included soldering the terminals on both sides of the circuit strip (fig. 15) and adding a bracket to improve the wire-bundle routing. The corrective action was successful, and the problem did not recur during future vibration tests.

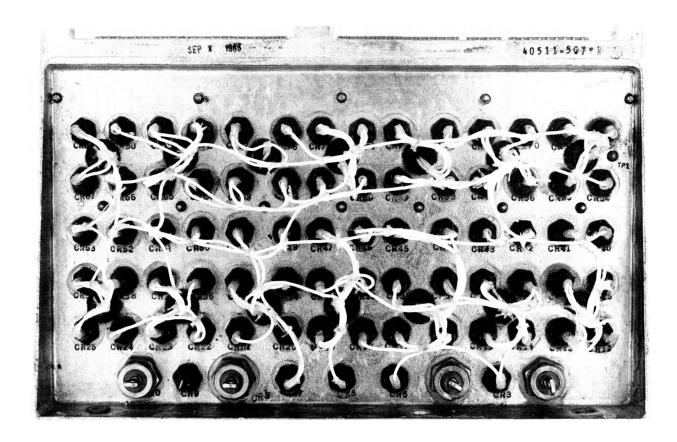
Figure 16. - Typical diode mounting bracket.

The second significant problem was detected during the humidity and posthumidity functional test portions of the qualification program. The reverse impedance of the MCP diode quads was below the specification limits after the 16-hour humidity test. These impedances were within the specified value (greater than 700 kilohms) after about 1 hour of drying. The diodes in the SCC were affected after being exposed to 95 ± 5 percent relative humidity; but, for normal unmanned flight, humidity was not expected to be a problem. The corrective action was to provide added protection by applying polyurethane (polycoat) to the control assemblies containing the diode quads (fig. 16). On April 22, 1966, after the polyurethane was applied to the control assemblies in qualification unit 2, the unit was retested in the humidity environment and satisfactorily met the specifications. The qualification tests were completed on April 23, 1966, and the test report was released on May 31, 1966.

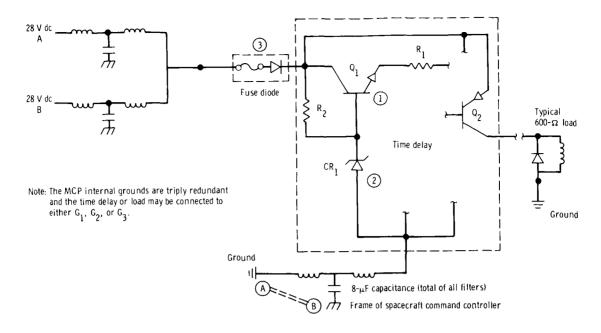
Figure 17. - Time-delay circuit schematic.

For a 14-month period ending in April 1967, NASA and various aerospace industry representatives combined their efforts to resolve the MCP time-delay and fuse-diode failures. The failure mode was readily established shortly after the first time-delay circuit failed. Transistor \mathbf{Q}_1 (fig. 17) of the time-delay circuit shorted (collector to base) causing zener diode \mathbf{CR}_1 to overload, exceed the thermal rating, and fail, so that

the fuse diode on the time-delay input was overloaded and failed (open circuit). Numerous attempts were made to establish the cause of the failure. The following list of significant events in the investigation indicates the amount of study on this problem.

Laboratory tests of transistor \mathbf{Q}_1 , used in the time-delay circuits (fig. 17), were performed to determine the collector-to-base breakdown strength under pulse conditions. The test consisted of superimposing a positive pulse on a 28-V dc signal on the collector of transistor \mathbf{Q}_1 in a time-delay circuit. The circuit was repeatedly pulsed, increasing amplitudes in 10-volt increments to 228 V dc (maximum pulse amplitude plus 28 V dc) or until failure, whichever occurred first. Fifty-six transistors were tested in the laboratory under these conditions, and 35 transistors failed. Each time a transistor failed, zener diode \mathbf{CR}_1 was also overstressed and failed. The failed

transistor and zener diode had degraded or shorted junctions that were essentially the same as the failed parts in the SCC units of the MCP. During the laboratory test, the lowest pulse input to cause failure was at 108 V dc (28 V dc plus an 80-volt pulse). Six failures occurred at input signals of less than 150 V dc, 10 at less than 170, 20 at less than 198, and 35 at less than 228. Thirty of the transistors failed on the first voltage pulse at the failure level, five transistors failed by the fifth pulse. The 21 transistors that did not fail were ultimately pulsed 170 times at 228 V dc. After the cause of failure had been determined, it remained to be proved that the components that had not failed were not degraded by the megohm tests, even though they seemed to function satisfactorily. Three of the 21 transistors were selected at random and were pulsed for a minimum of 43 000 cycles without a failure. Therefore, the misapplication of the megohm test could cause immediate failures but would not cause the components to be degraded and susceptible to subsequent failure.

On the basis of the vendor's successful isolation of the cause of the failures, its proper corrective action to prevent future occurrences, and its demonstration that existing time-delay transistors in the MCP were not degraded, the problem was closed on April 6, 1967.
