NASA TM X-64086

TEST OF LOX COMPATIBILITY FOR ASPHALT
AND CONCRETE RUNWAY MATERIALS

John F. Kennedy Space Center
Kennedy Space Center, Fla. 32899

December 1973

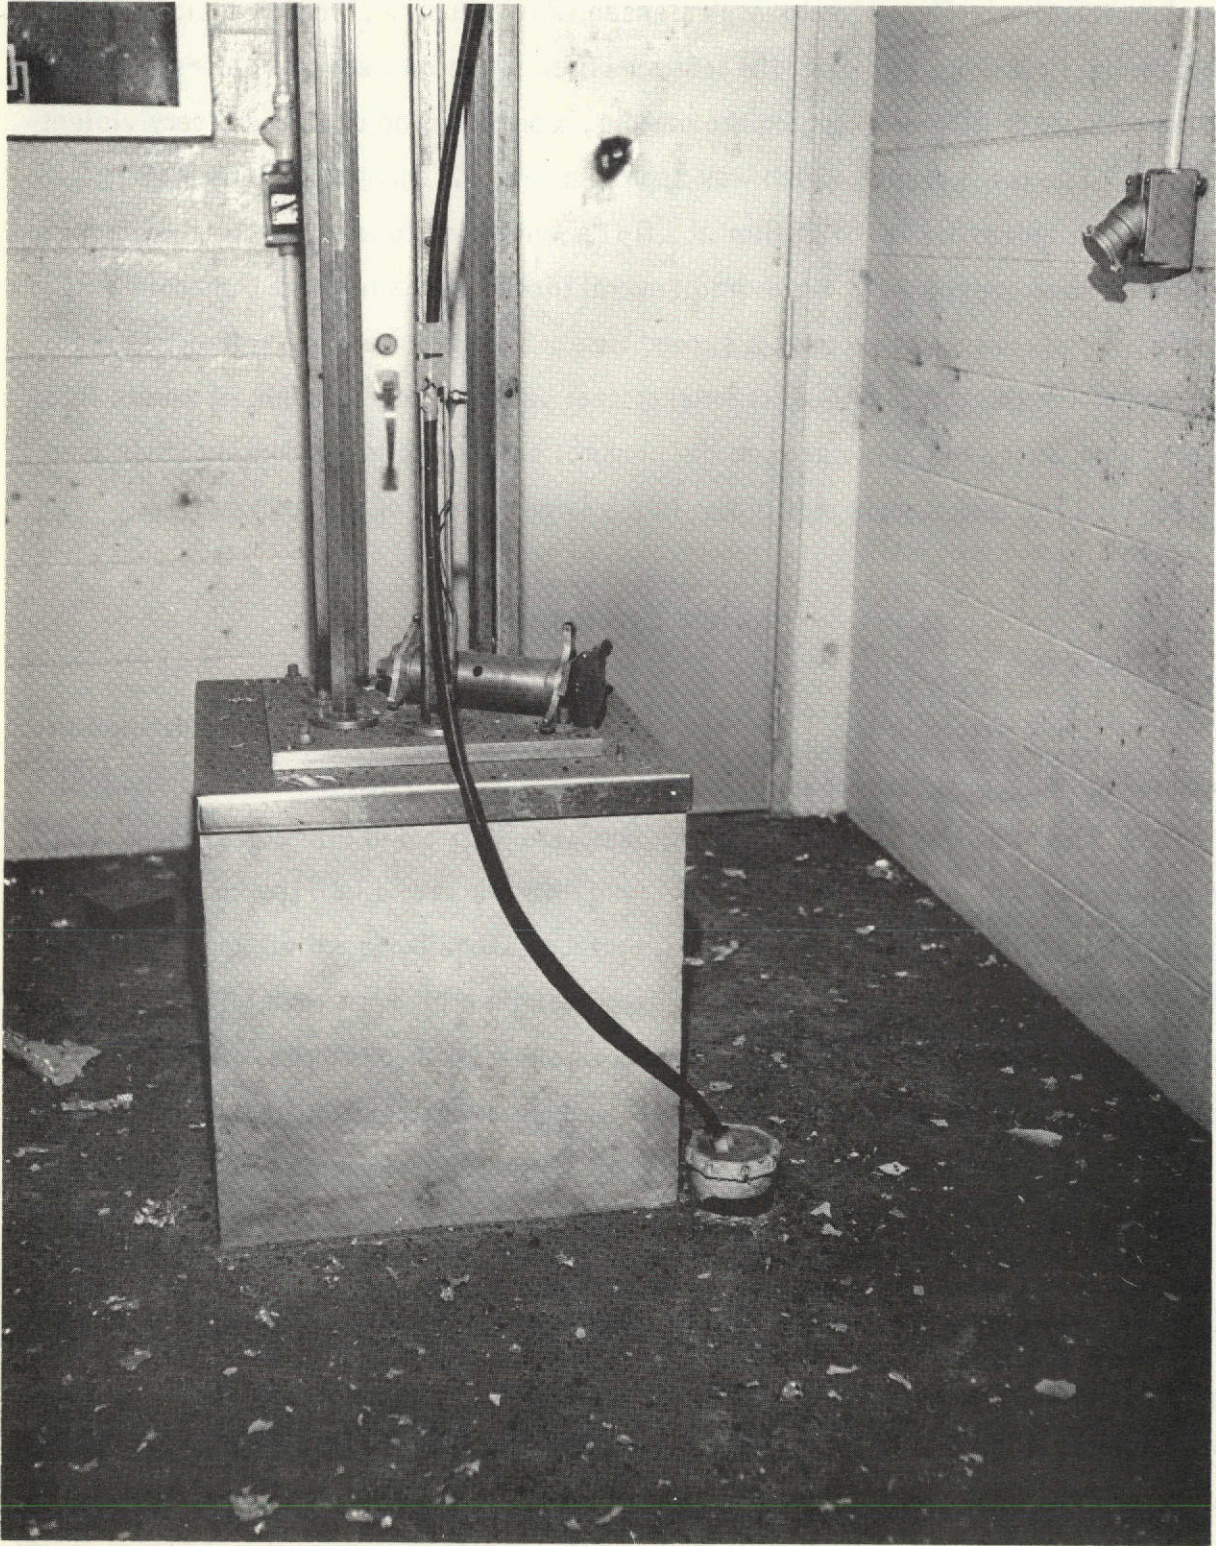
a violent reaction. The second sample, essentially a cube 7.5 cm on a side, failed to react on the first drop; however, the test specimen broke into several pieces. Without adding additional LO_2 or changing the sample, a second drop produced a very violent reaction. The last sample, which was approximately 12 cm by 12 cm by 7.5 cm (immersed in approximately 0.5 liter of LO_2) again failed to react on the first drop; but, like the second specimen, it broke into several pieces. Again without changing the sample, the plummet was dropped a second time. This time another violent reaction occurred which threw a 5.89-kg stainless steel backup plate a couple of meters into an aluminum door, and also damaged the plummet spider and four mounting studs (see Figure 1). The test sample was blown into a large number of tiny pieces.

Figure 1. LOX Impact Test Cell after LOX/Asphalt Reaction.

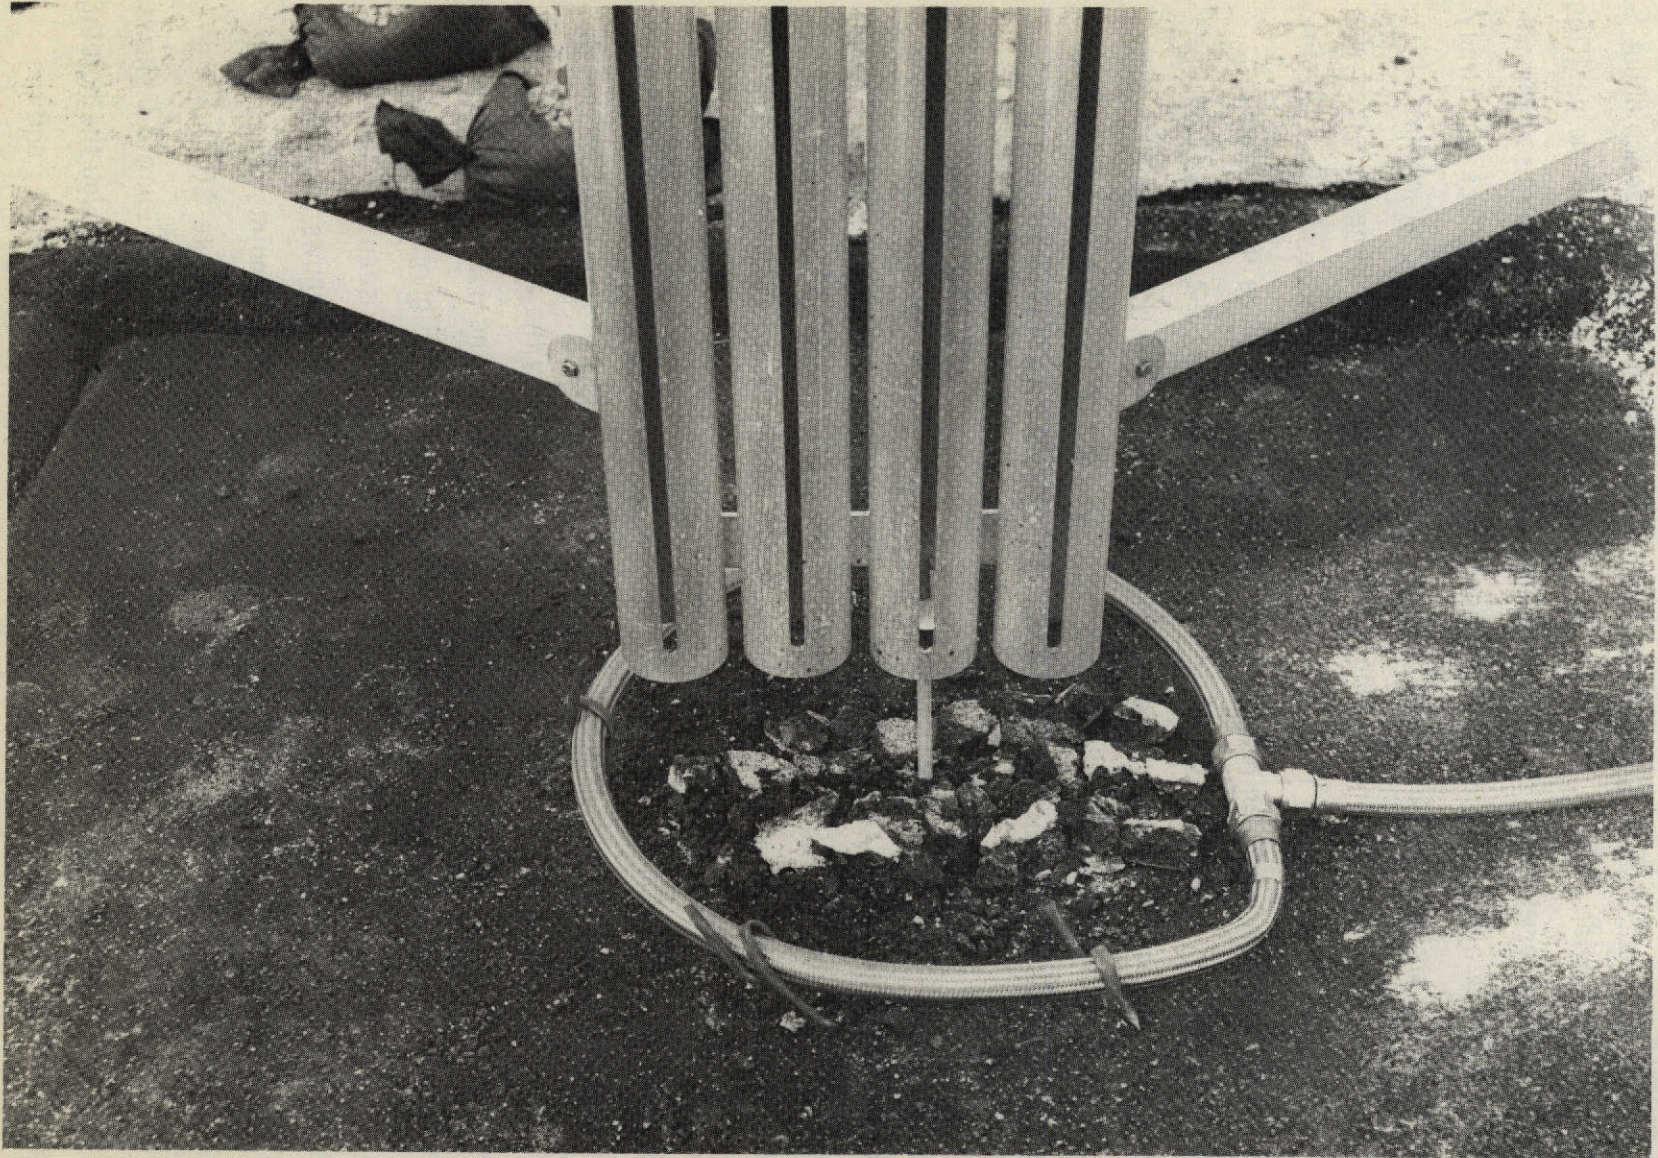
Sixth Trial, Impact. - The test stand was then removed, and a trench about 50 cm long, 10 cm wide, and 1.2 cm deep was chiseled in the asphalt. In the position where the second plummet would strike, an additional cavity was excavated to accommodate a 2.5-cm thick aluminum block, 9 cm wide and 10 cm long. The block was firmly seated with its top surface slightly below the level of the slab surface. A mixture of broken old and new asphalt pavement, ranging from small pea size to large nut size, was piled in the trench and tamped by foot. The pile was from 1 to 2 cm above the slab surface. The test stand was then repositioned. No change was made in the plummet tips, but a striker pin, consisting of a 1.2-cm threaded rod about 22 cm long, with a 7.5-cm teflon disc at the top was placed on the asphalt under the third plummet, with the disc inside the tube to support it. Figure 5 shows the impact points prepared for this trial. Beer cans were positioned as shown in Figure 2. LO_2 was allowed to flow for 10 minutes, the camera switch was activated, and the first plummet was released, with no reaction. The second plummet was then released, and a detonation occurred. The test stand was destroyed, and it is estimated that pieces of it rose 30 meters in the air. When the test site was inspected, it appeared that a reaction had occurred over the entire slab surface, but only a small proportion of its material has been consumed to an estimated depth of 2.5 cm. The reaction appeared to have initiated at two points, above and below the aluminum block. The plummet tip impression in the aluminum block was several times deeper than one made by simply dropping the plummet from the same height. A cavity was found in the asphalt under the position occupied by the aluminum block. It was found that the camera had not been actuated by the switch, and no film of the reaction is available. Still photographs were made of the debris in situ. Figures 6 and 7 show the impact site. In Figure 7, the outline of the asphalt slab can be seen. Fragments have been assigned identification numbers 1 through 33. Figure 8 shows fragments 16, 17, and 18 at a distance of approximately 30 meters from the impact point. Figure 9 shows fragment 15, approximately 9 meters from the impact point. Figure 10 shows a plummet, fragment 28, approximately 12 meters from the impact point. Figure 11 shows a leg, fragment 22, approximately 47 meters from the impact point. Although the holding pond was contaminated, two objects were retrieved from it: the first plummet, and the

Figure 5. Points of Impact Prepared for Sixth Trial.

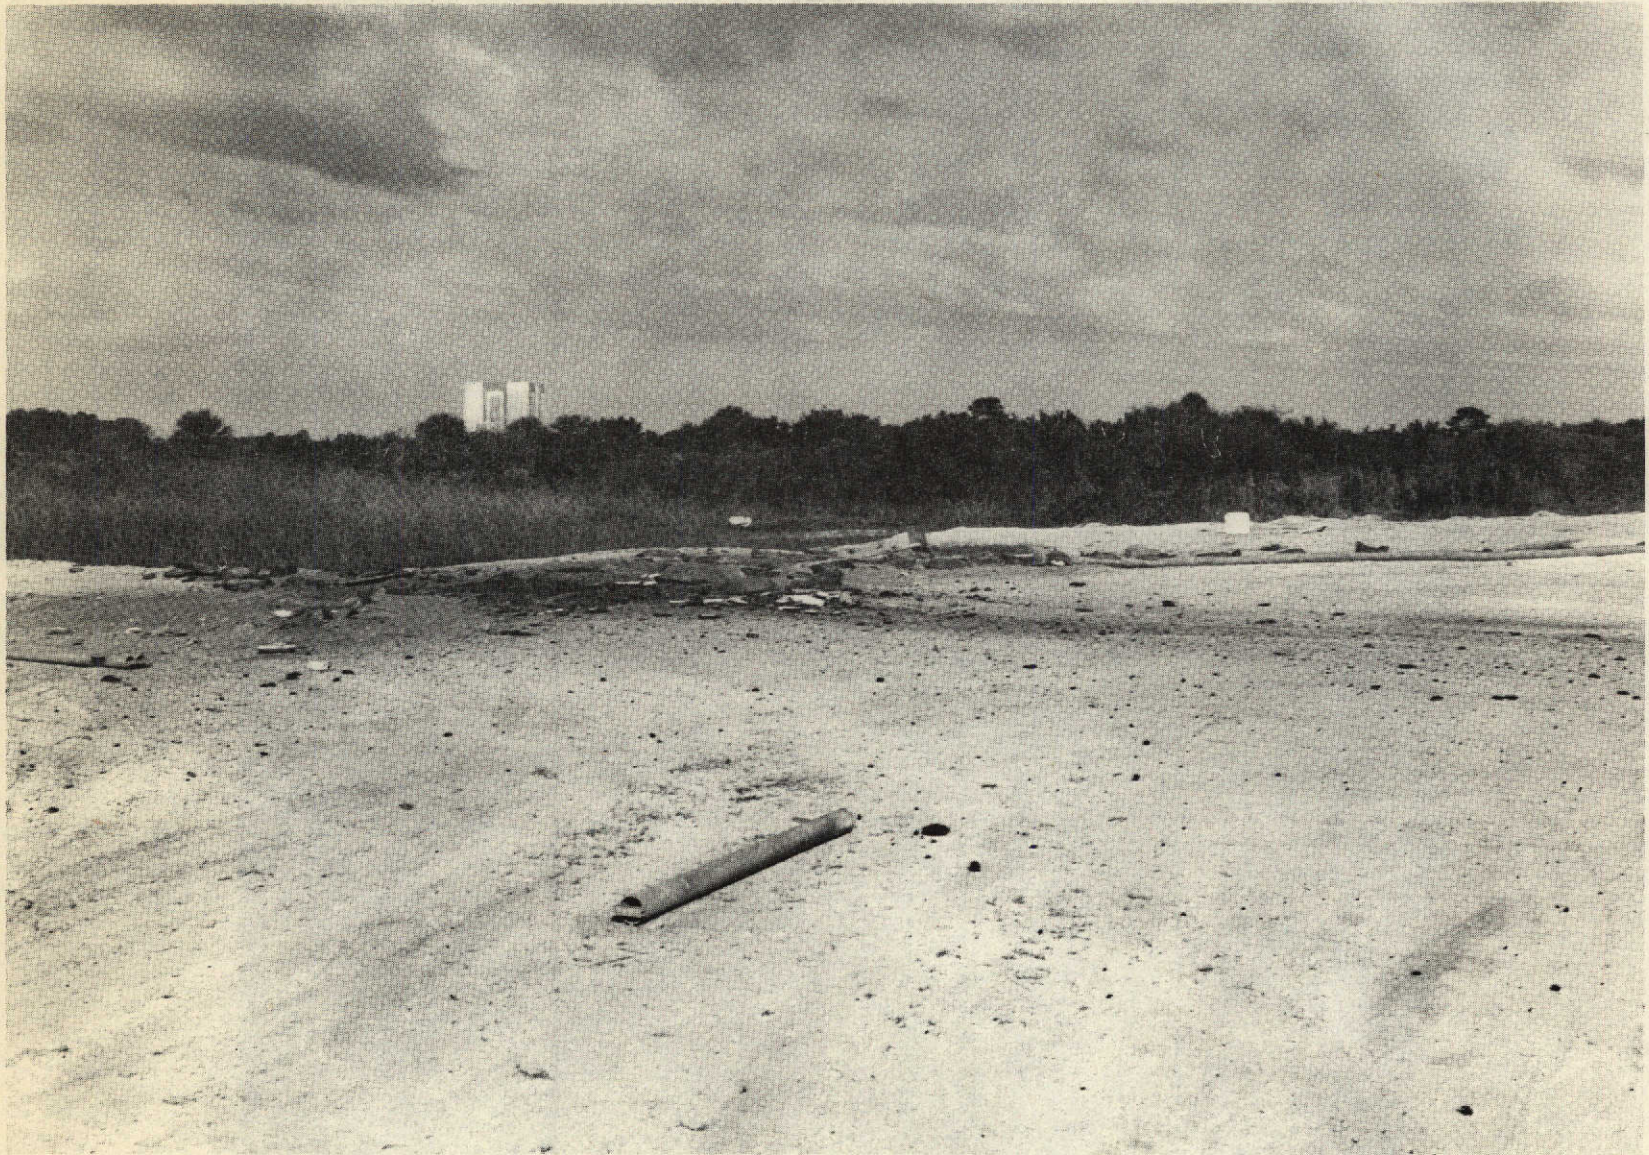
Figure 6. General View, Impact Site after Detonation.

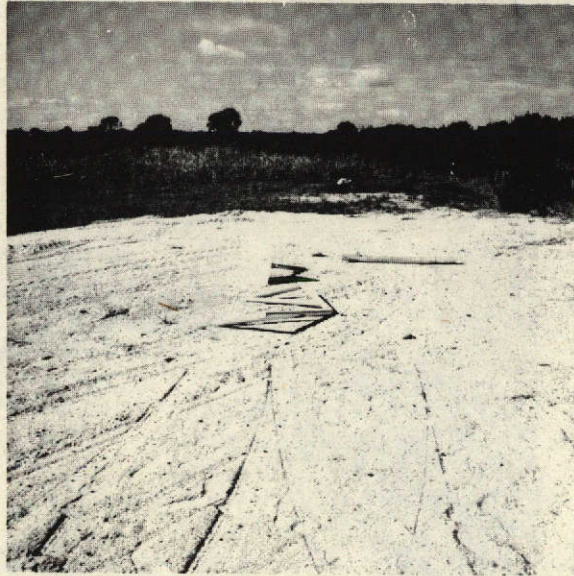
Figure 8. View to North. Fragments 16,
17, and 18.

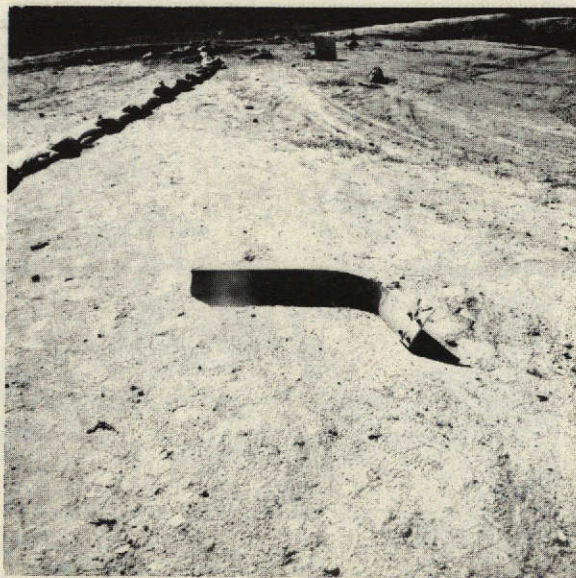
Figure 9. View from Northeast.
Fragment 15.

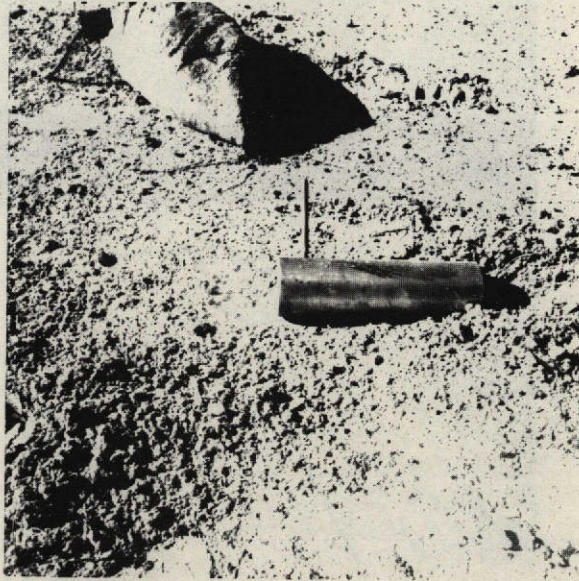
Figure 10. Plummet, Fragment 28.

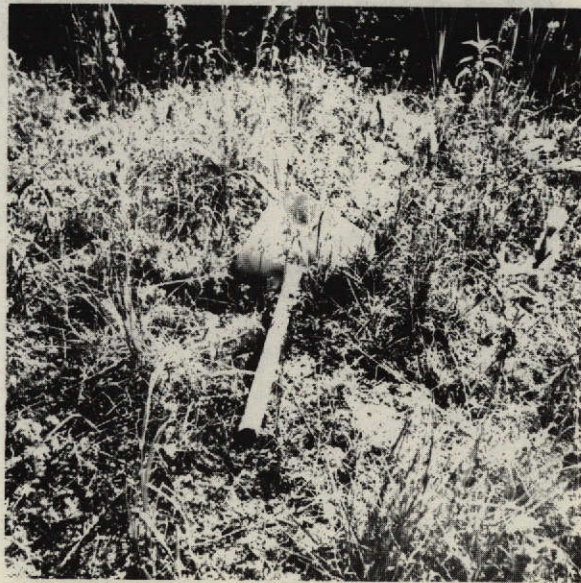
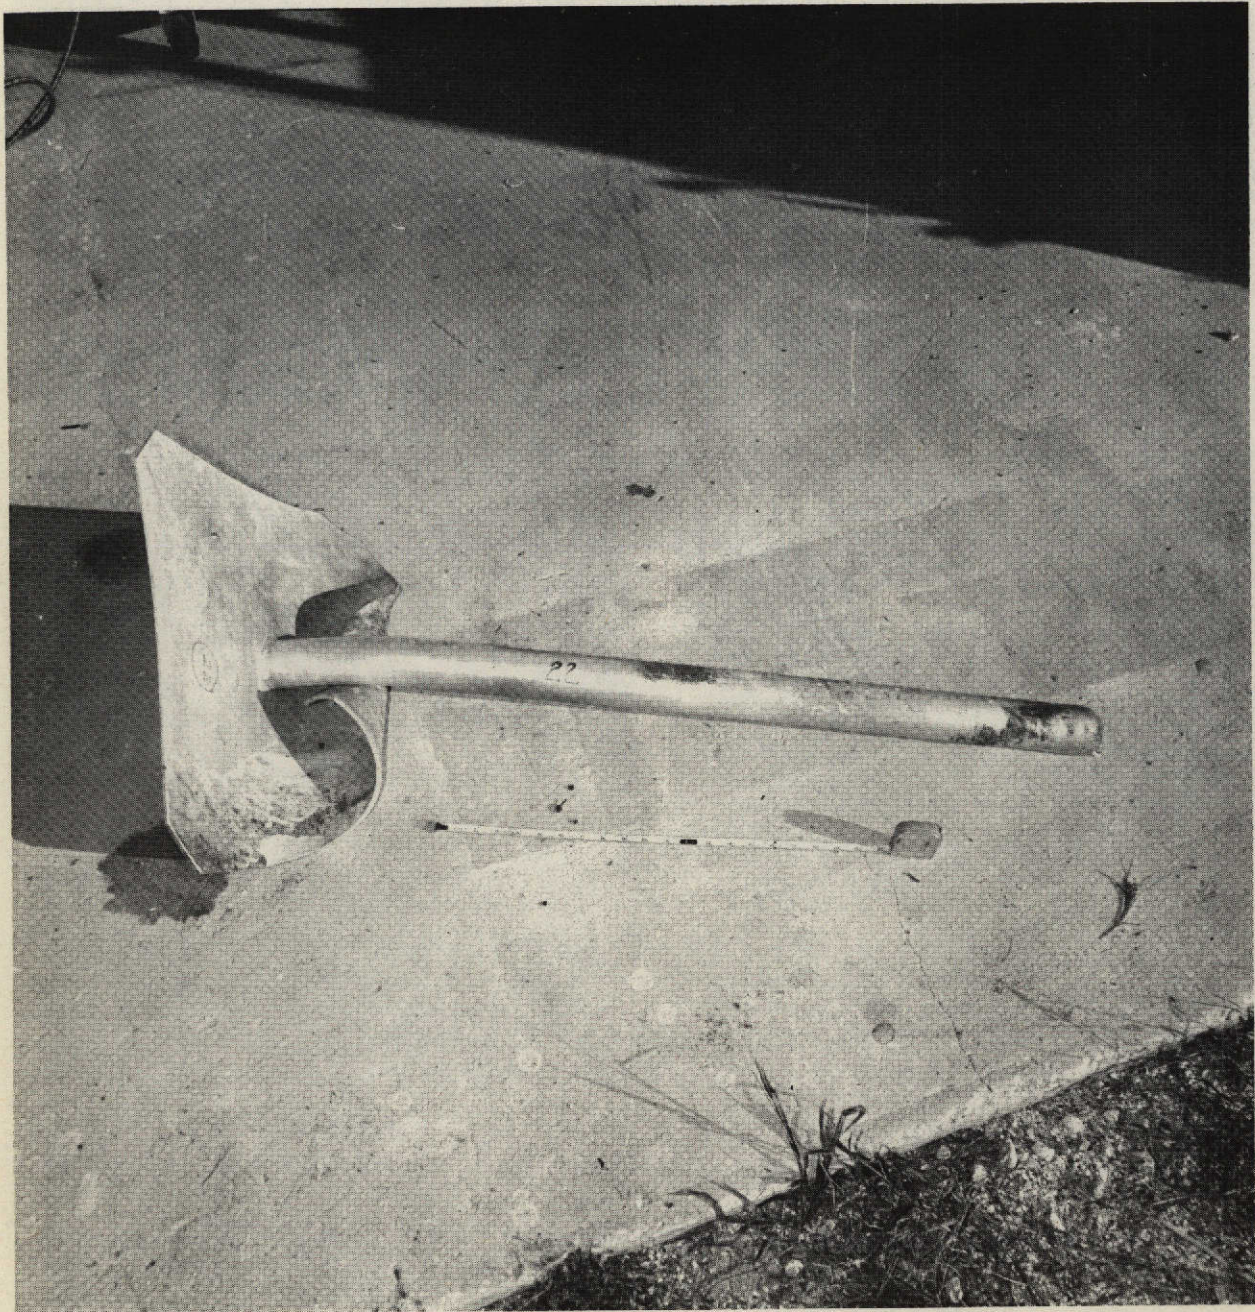
Figure 11. Leg, Fragment 22.

Figure 16. Leg, Fragment 22.

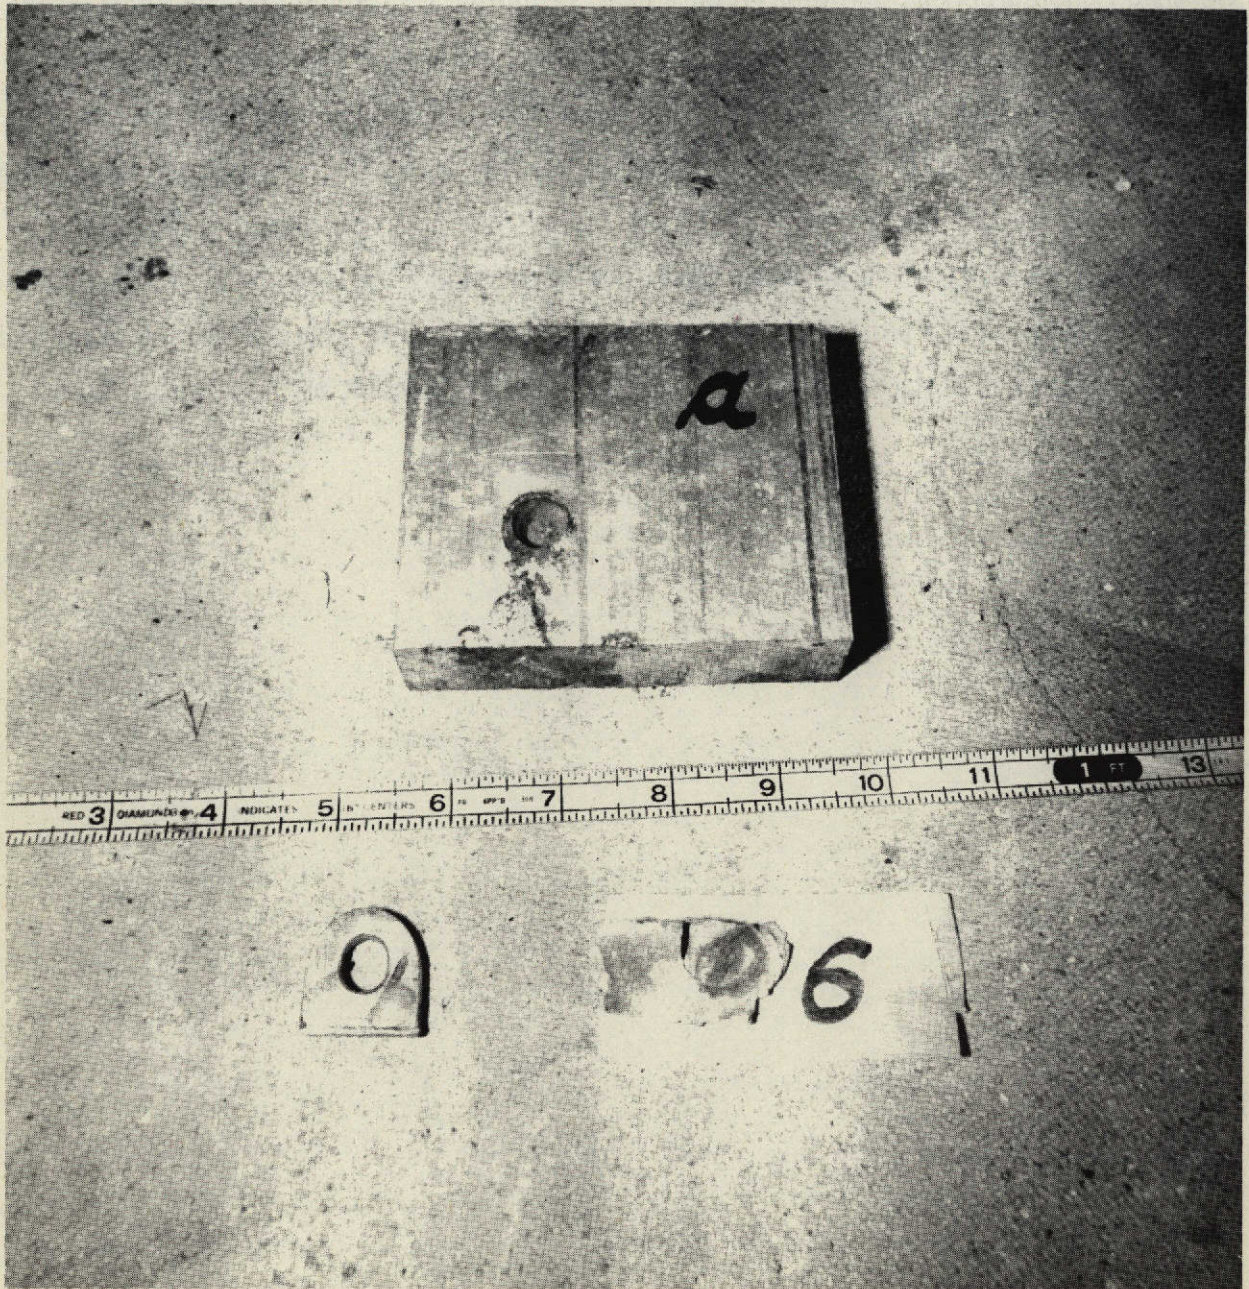
aluminum block which had been placed under the second plummet. The block (a, Figure 12) was approximately 18 meters at 92° from the impact point. The plummet was approximately 33 meters at 94° from the impact point. The fragments were then located, collected, weighed, photographed, and plotted on a map. Figures 13 through 19 are photographs made at that time showing representative fragments. Figure 20 is a map of the area, showing the position of fragments after the detonation. Table 2 shows the weights, distances, and azimuths for the fragments. In the last trial, three conditions were different from those of the previous trials: first, the asphalt had dried out during a dry, warm weekend before this trial, while all other trials had been made after wet slabs were sponged dry; second, asphalt at the point of impact was broken, presenting a larger surface area; and third, an aluminum block was placed beneath the broken asphalt at the point of impact.

Figure 12. Aluminum Block.

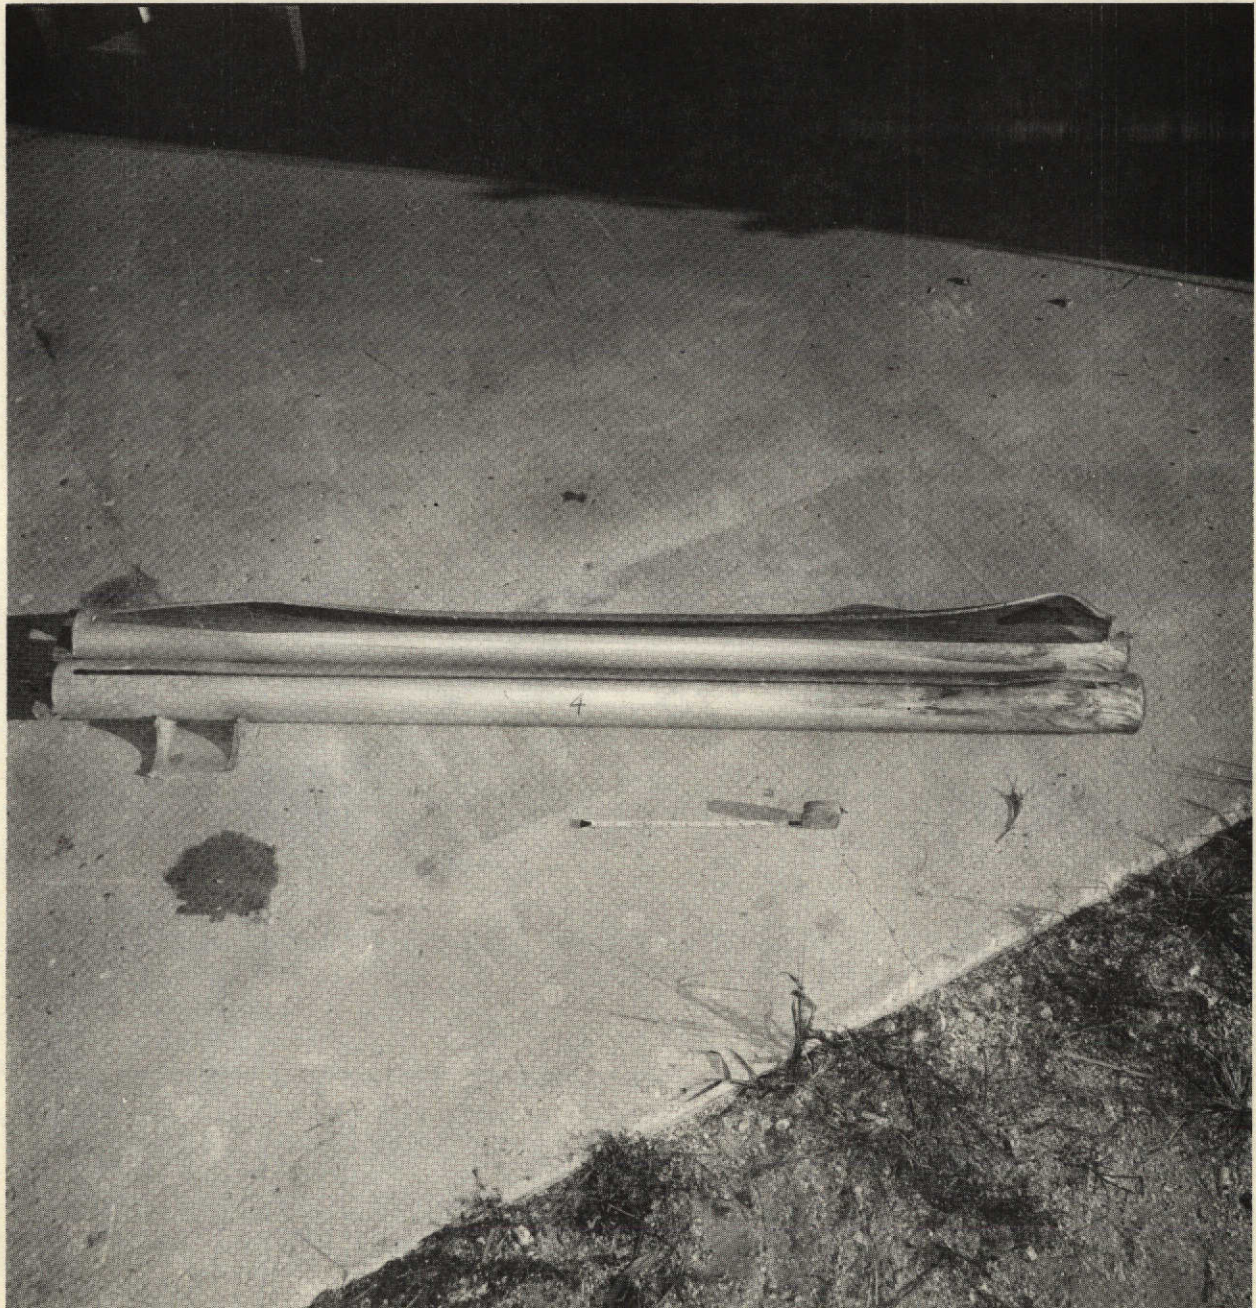
Figure 13. Guide Tubes, Fragment 4.

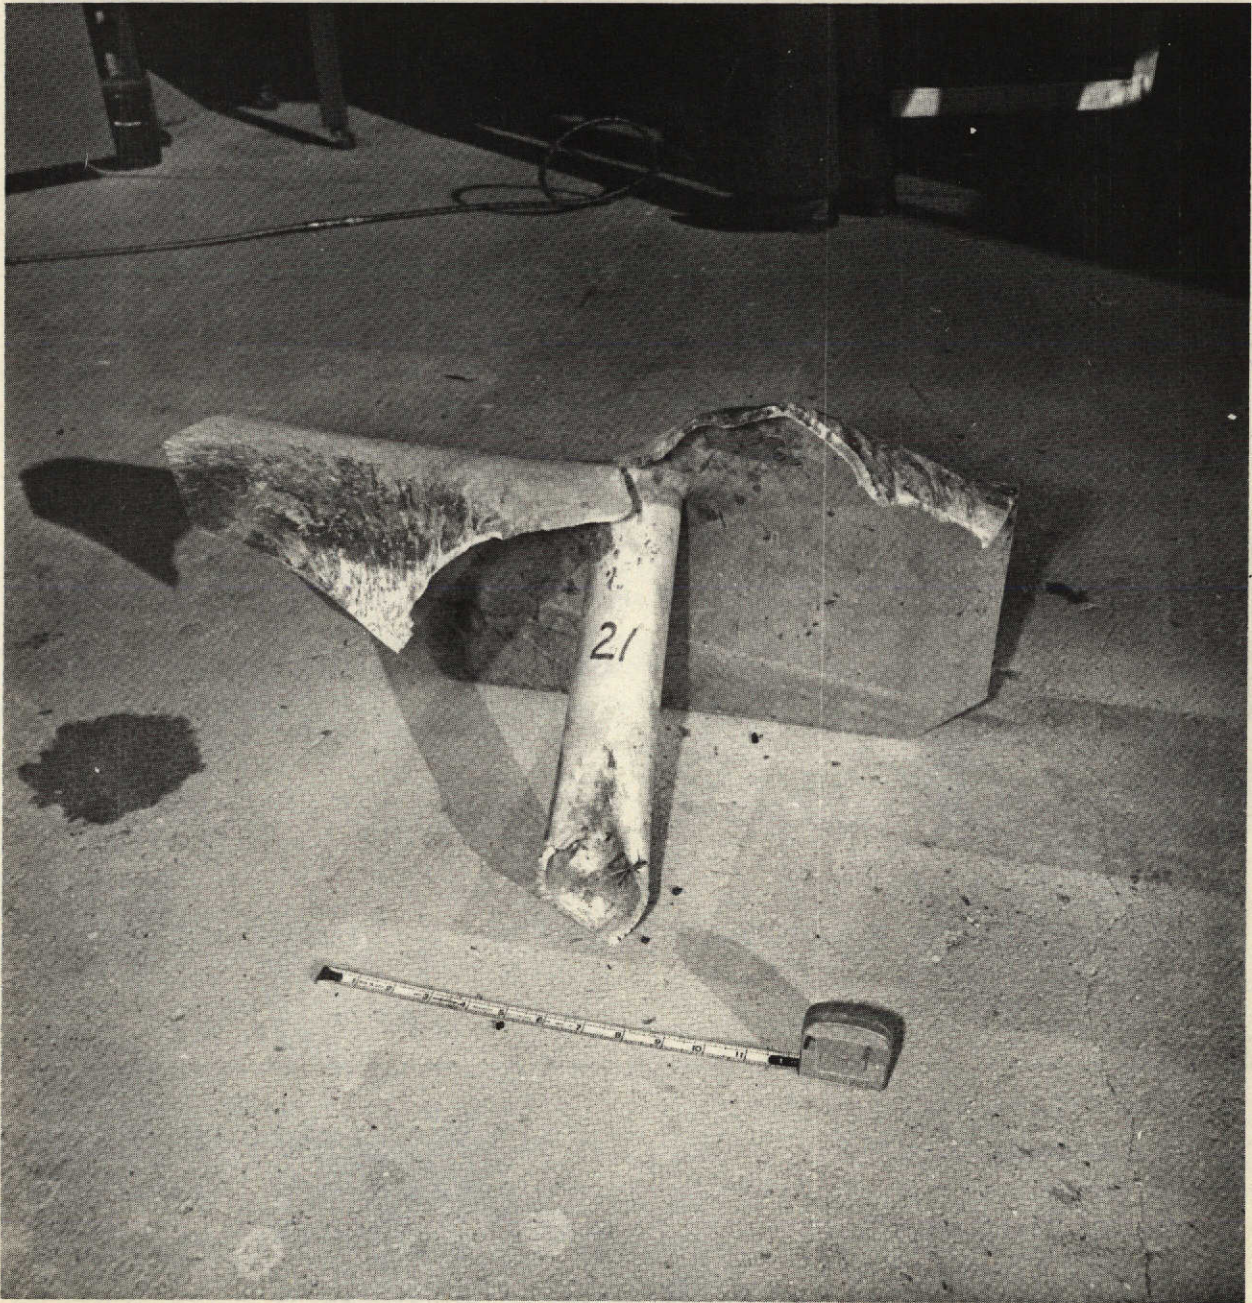
Figure 15. Leg, Fragment 21.

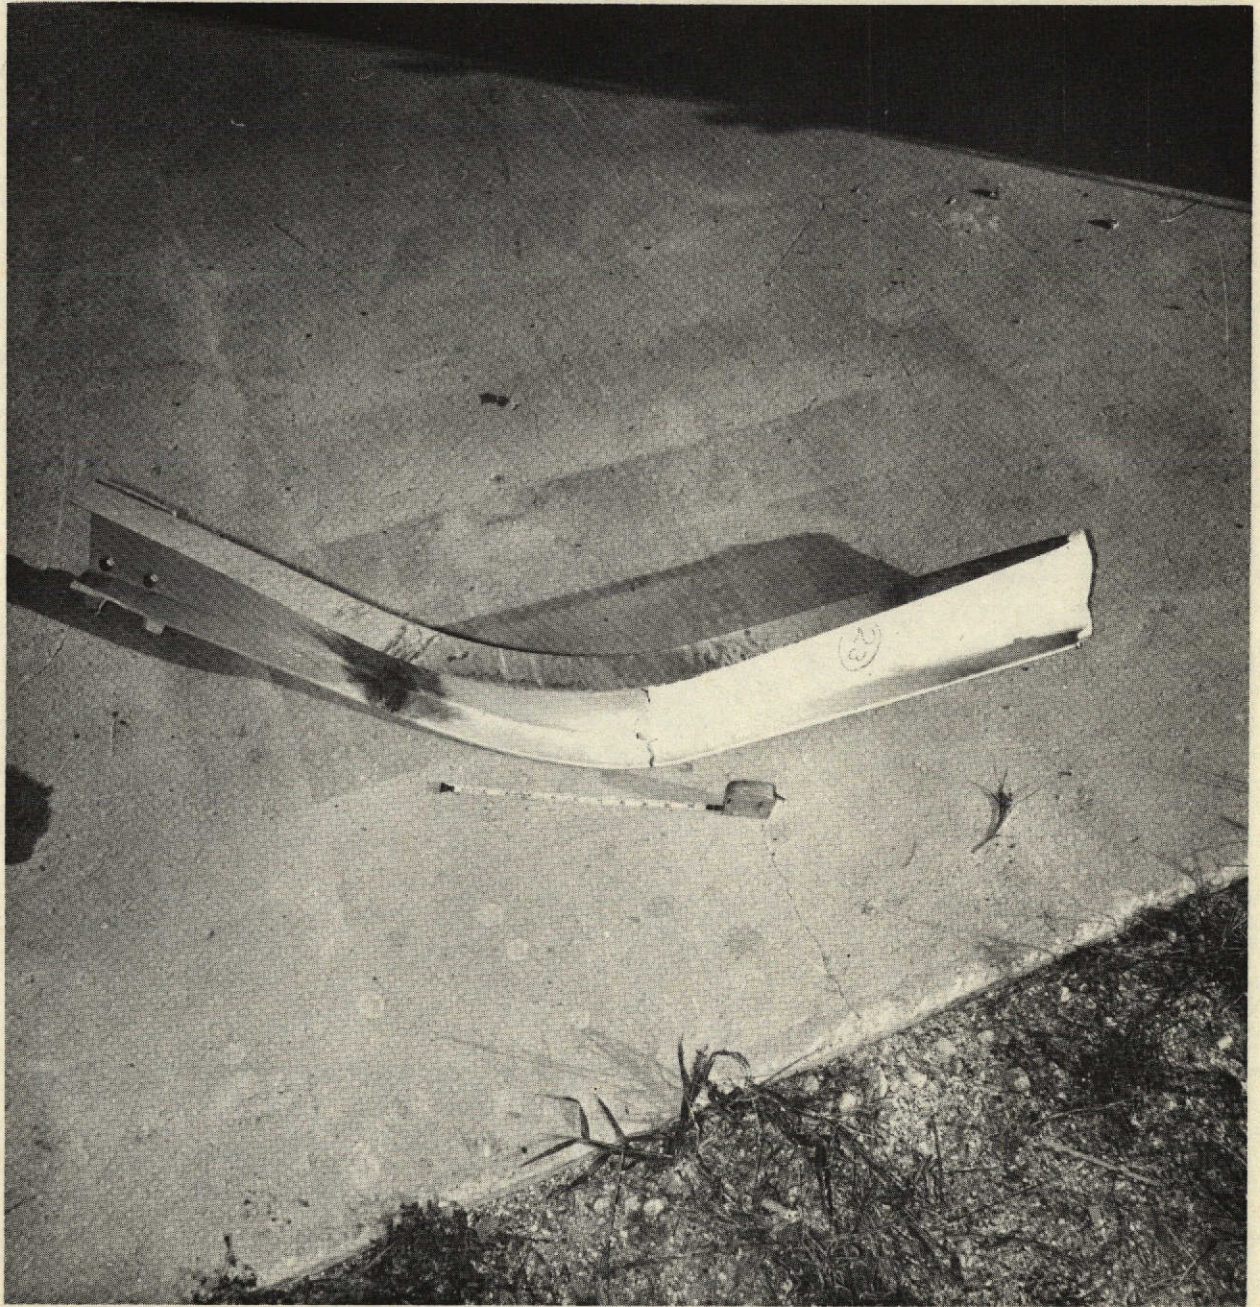
Figure 17. Channel, Fragment 23.

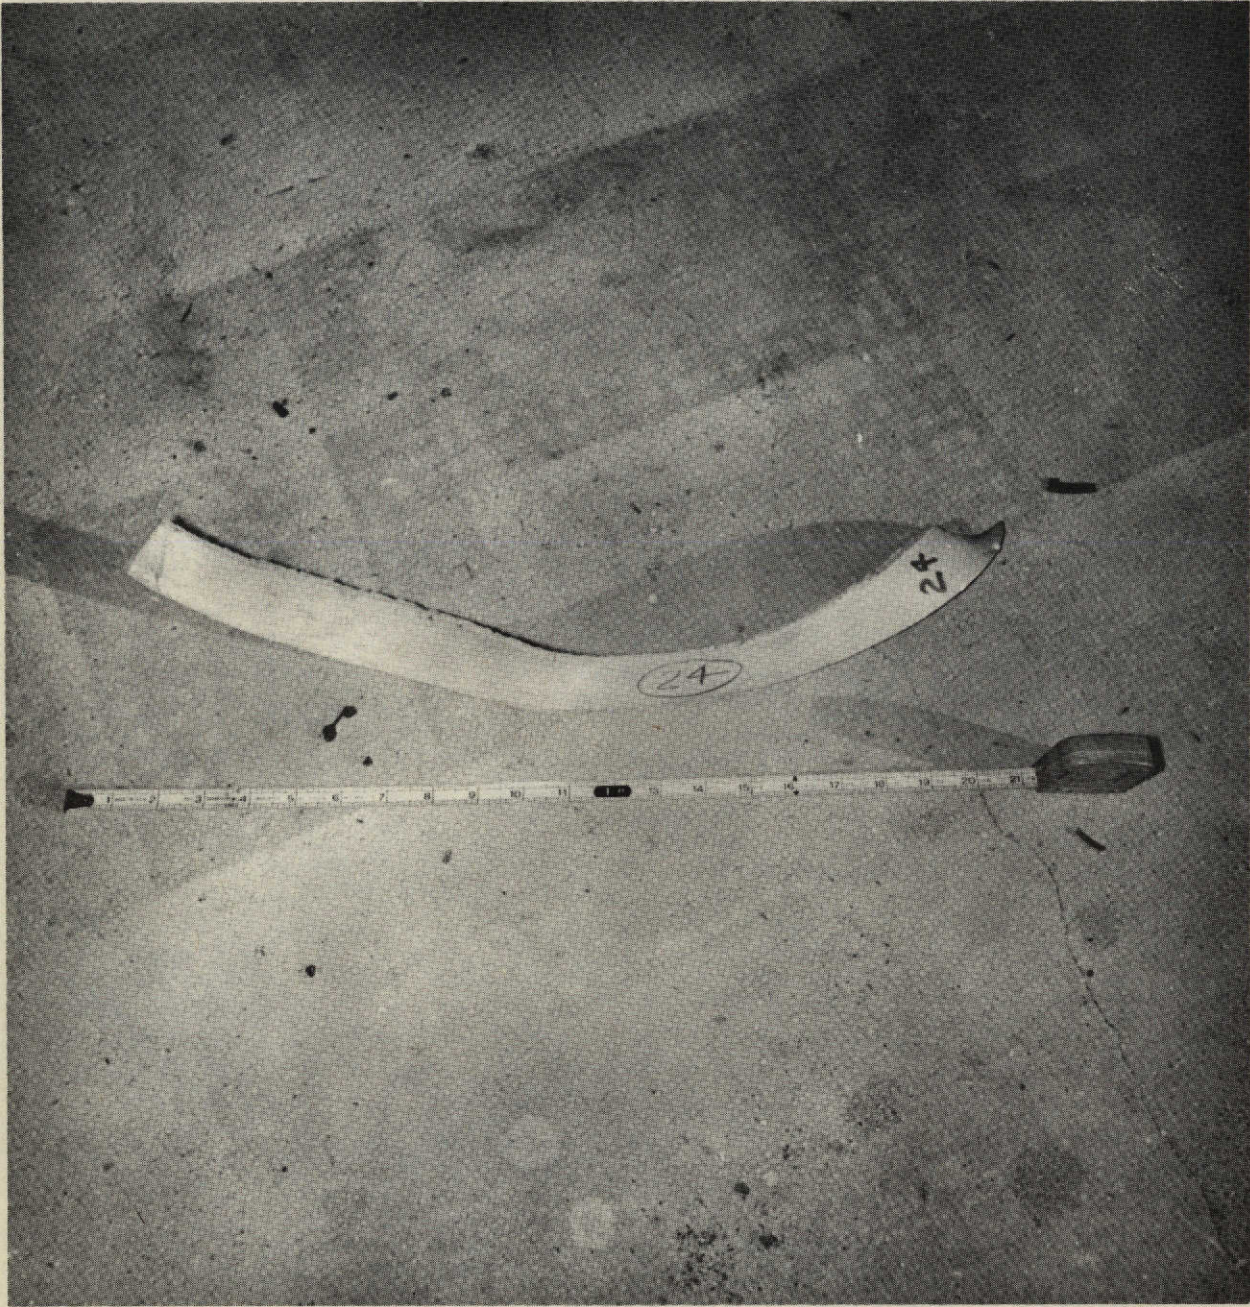
Figure 18. Aluminum Fragment 24.

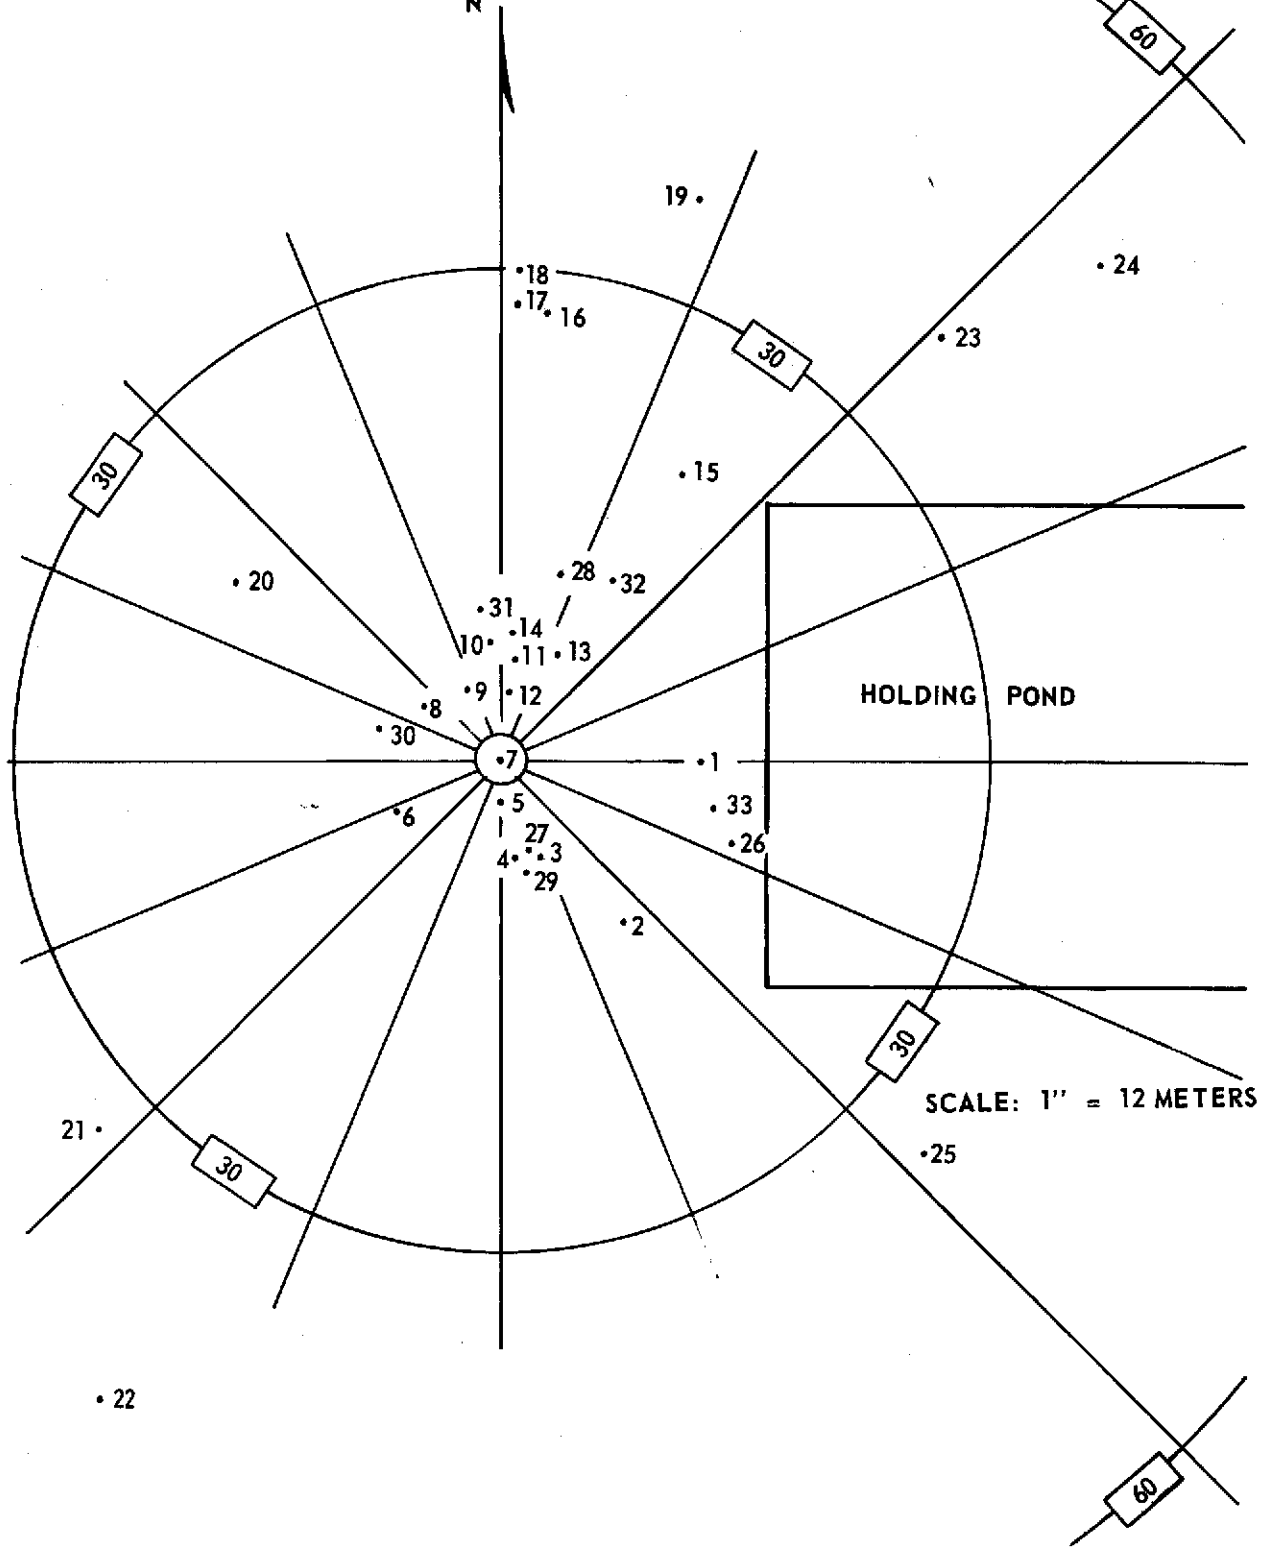
Figure 20. Map of Fragment Location
