The Correlation of Non-Destructive Measurements and Toughness Changes in Adhesive Joints During Environmental Attack

K. VINE, P. CAWLEY and A.J. KINLOCH

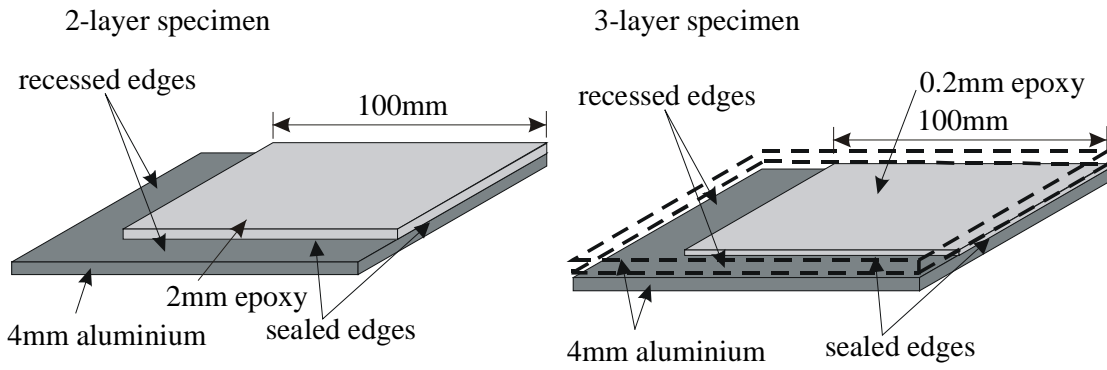
Figure 1 Two and three-layer specimen design.

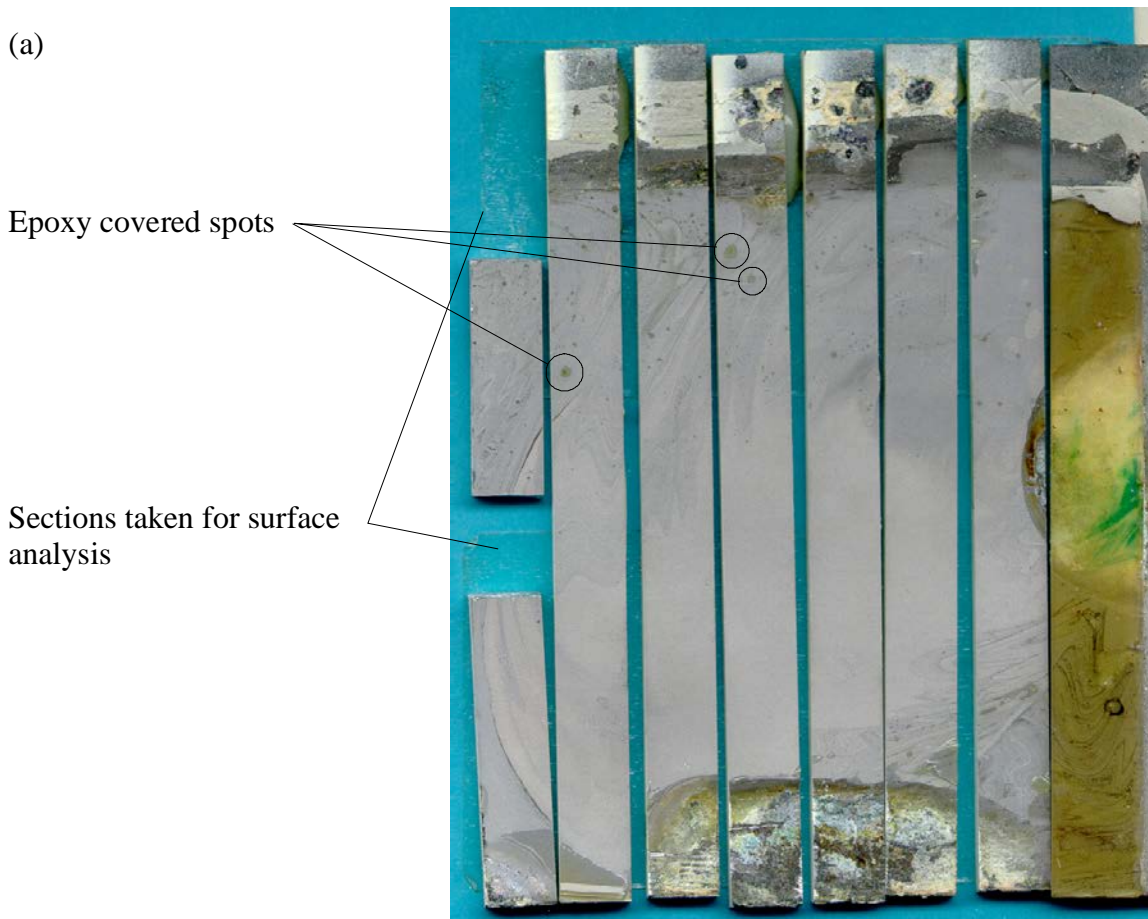
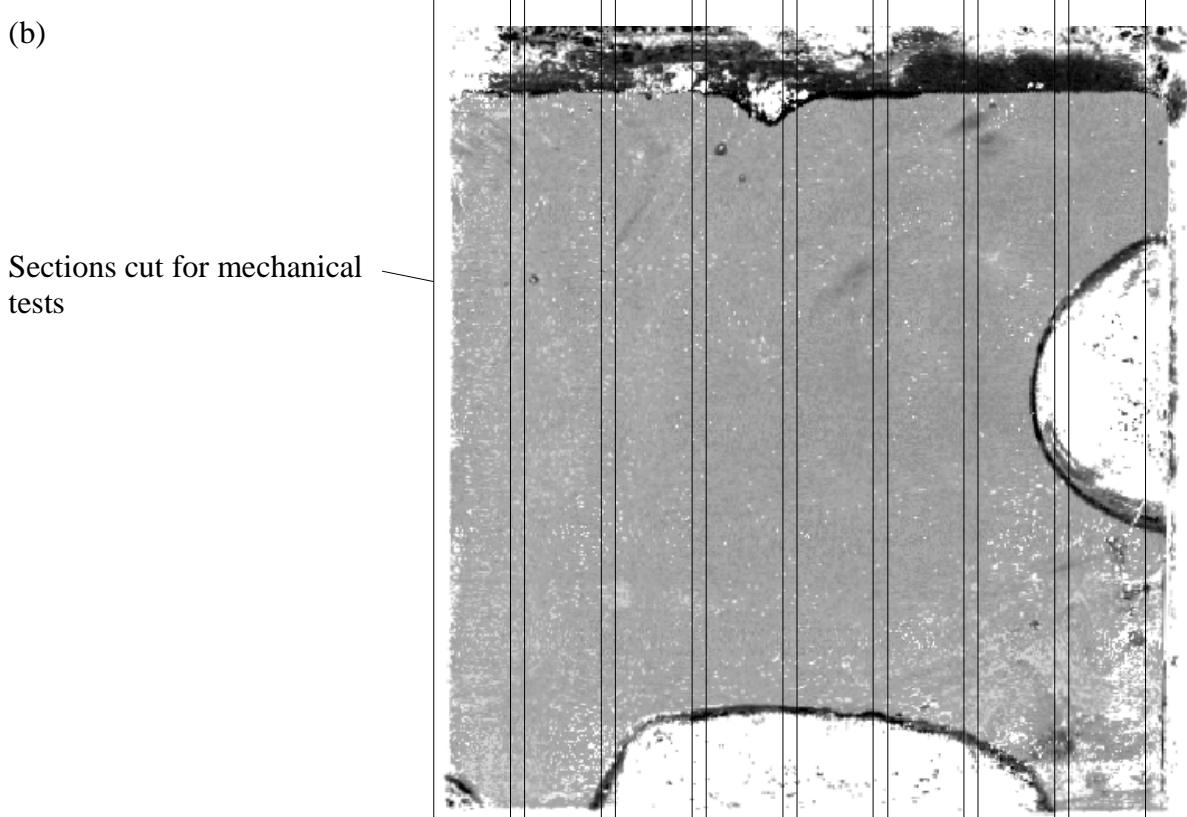
Figure 4 Two-layer grit-blast specimen after 223 days in water: (a) failure surface; (b) normal-incidence ultrasonic scan.

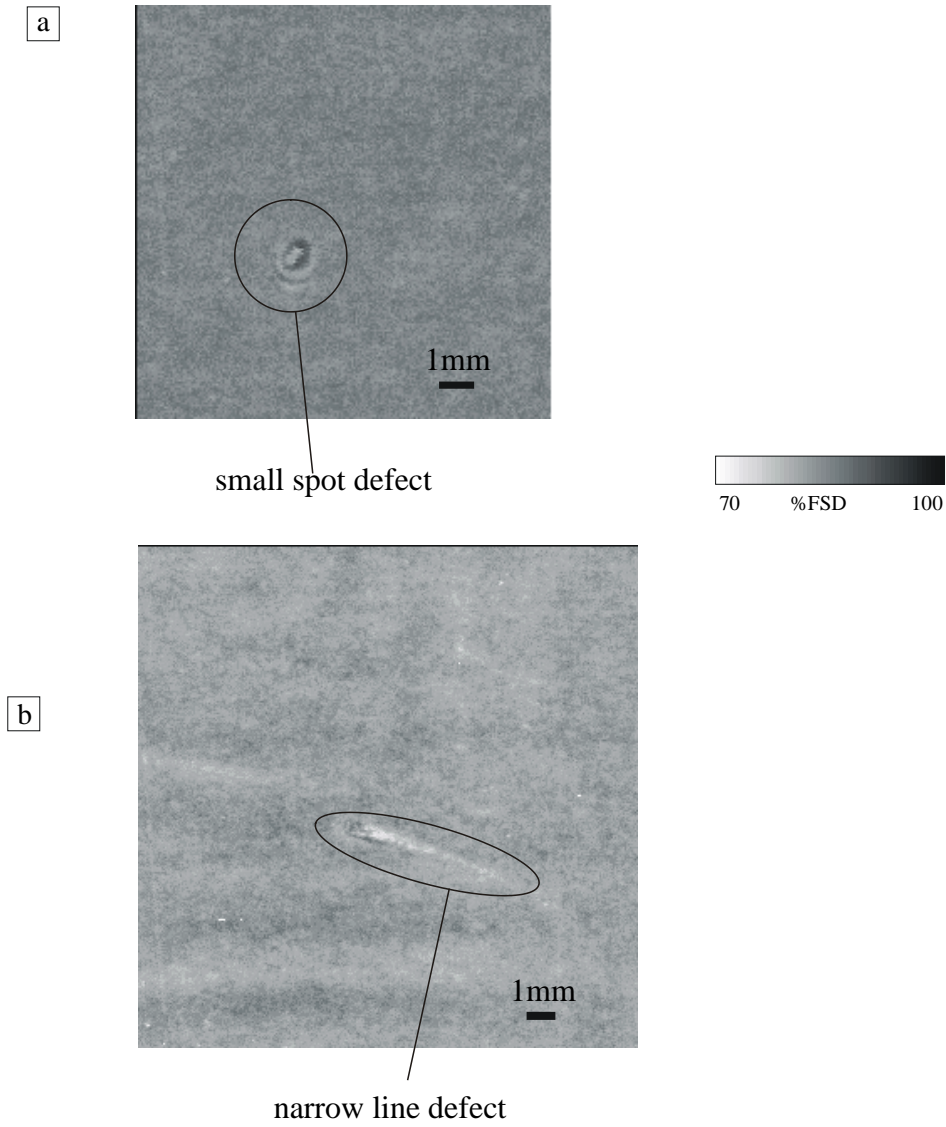
Figure 6 Normal-incidence ultrasonic high-resolution scans of (a) a small spot micro-defect taken from a CAE specimen after 154 days in water at 50°C and (b) a narrow line micro-defect from the same CAE specimen after 194 days in water at 50°C.

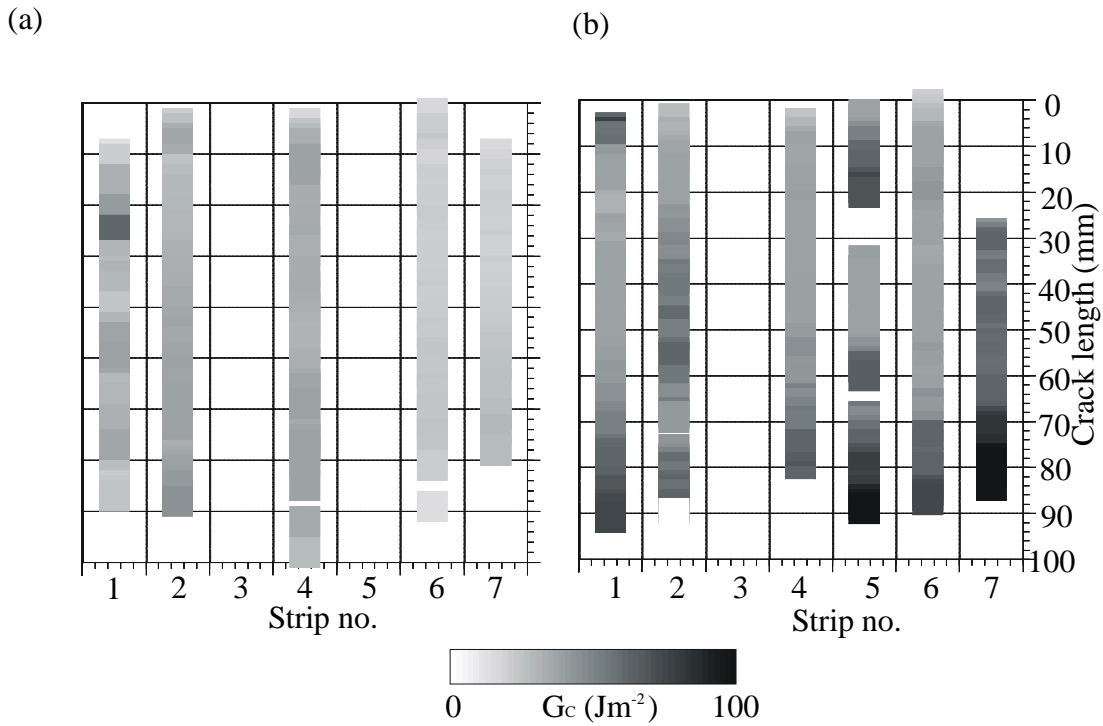
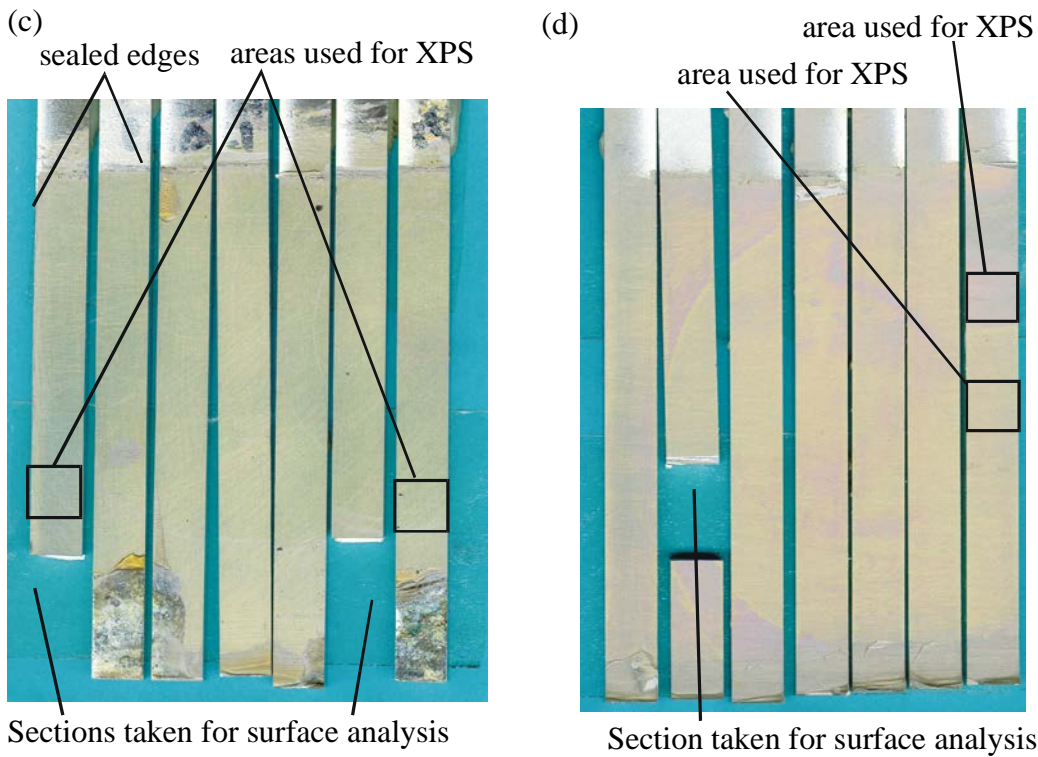
Figure 7 Mechanical test results from the two-layer PAA specimens. Fracture toughness map from: (a) specimen after 393 days in water at 50°C; (b) control 'dry' specimen. (c) photograph of the failure surface corresponding to (a); (d) photograph of the failure surface corresponding to (b). (The bottom and right-hand edges were the unsealed edges.)

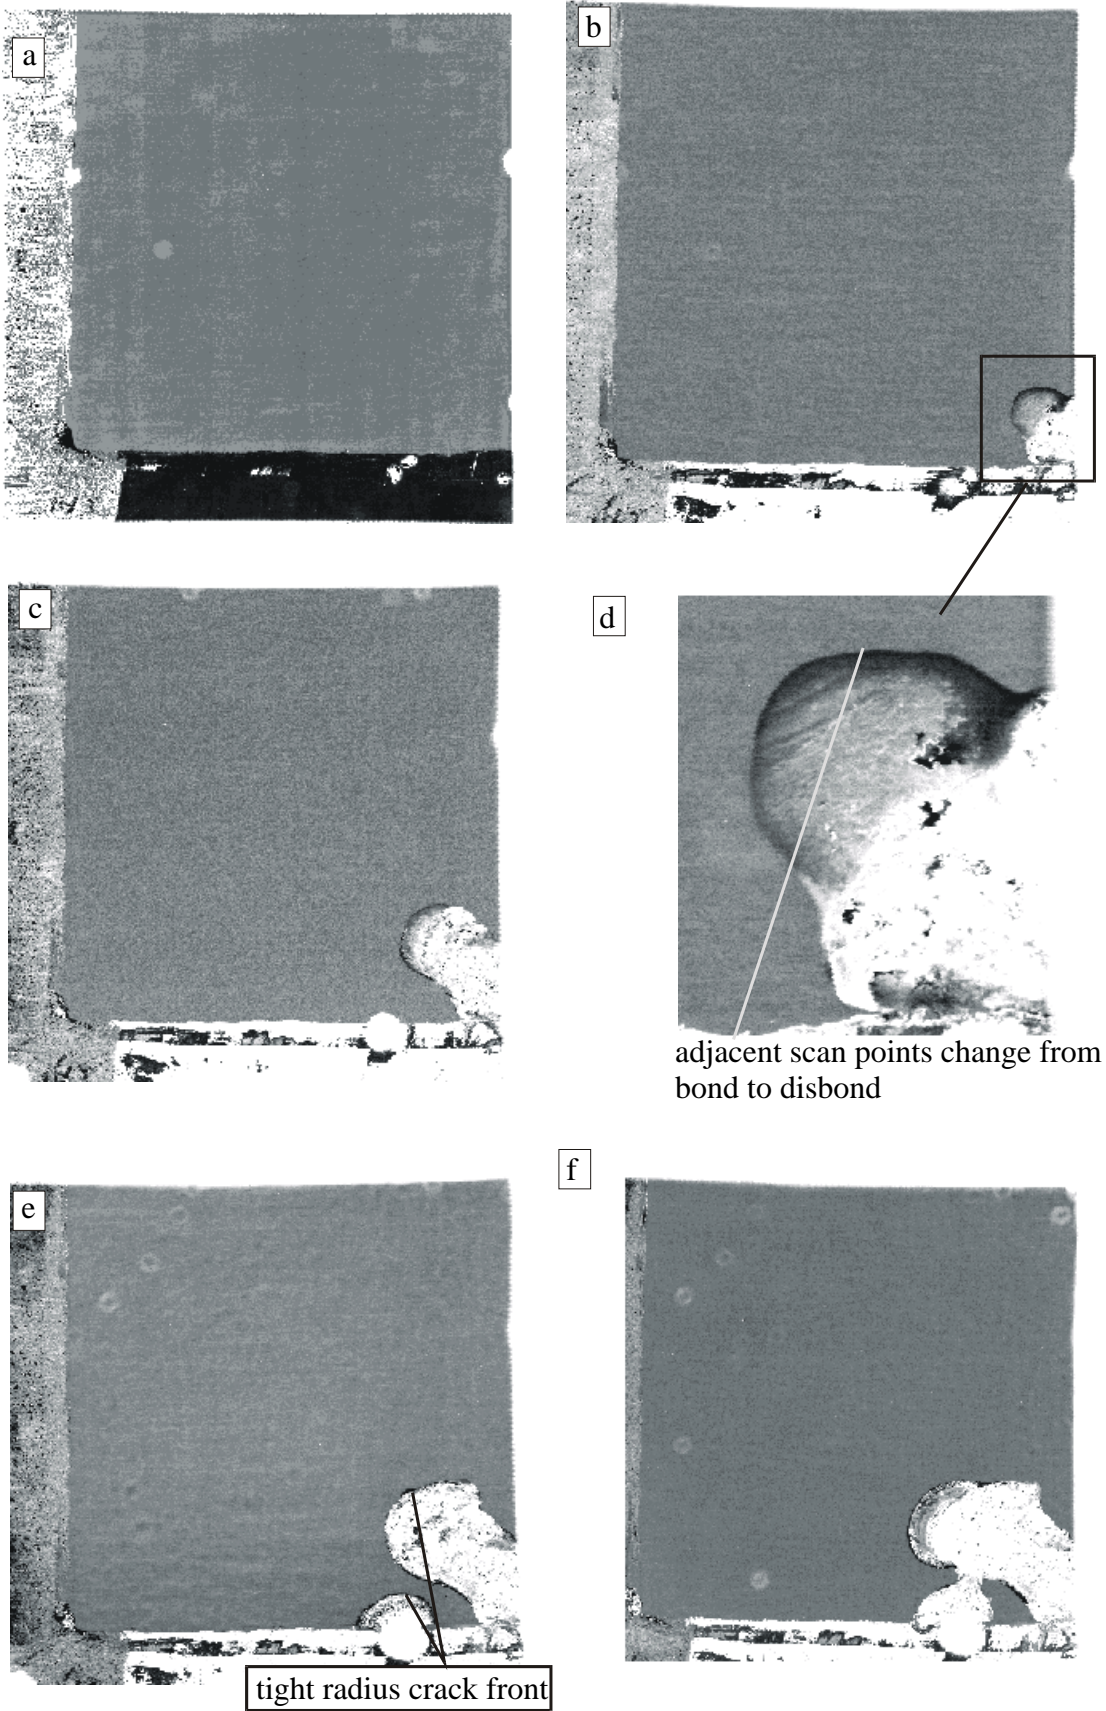
Figure 8 Normal-incidence ultrasonic scans from the two-layer CAA specimen after: (a) 0; (b) 103; (c) 175; (e) 309; (f) 465 days in water at 50°C; (d) high resolution scan of an edge-disbond in (b).

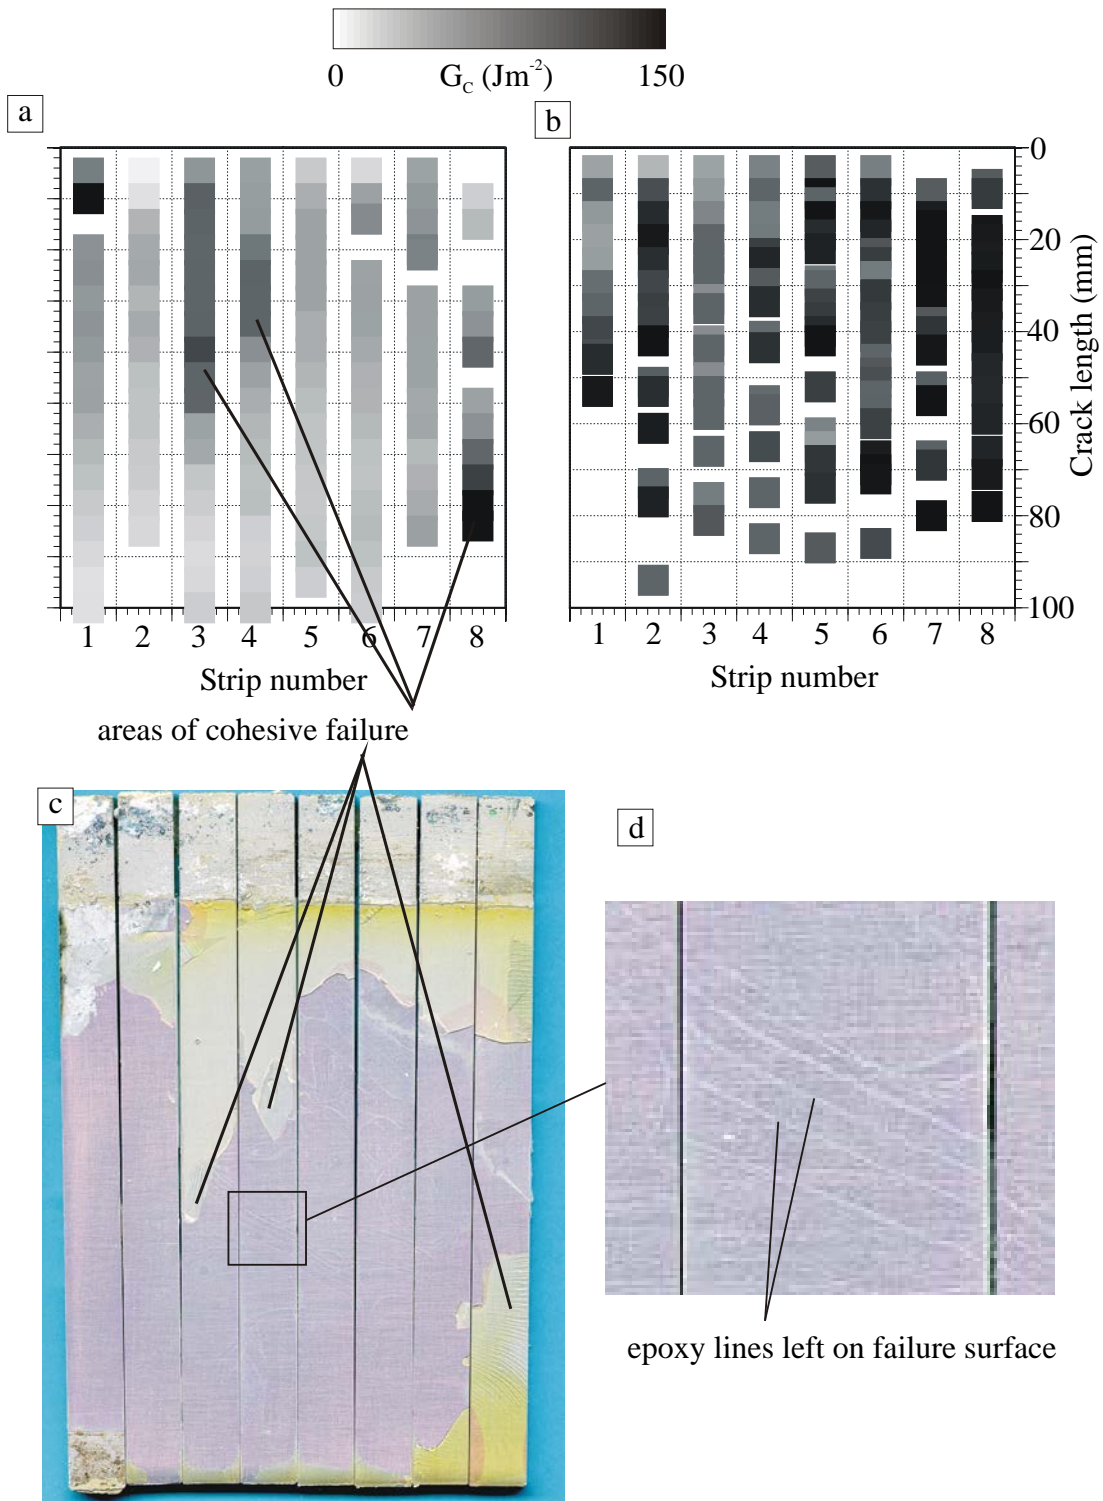
Figure 9 Mechanical test results from three-layer PAA specimens. Fracture toughness map from: (a) specimen after 566 days in water; (b) control specimen. (c) failure surface corresponding to (a); (d) expanded view of section from (c) showing lines of epoxy on failure surface.

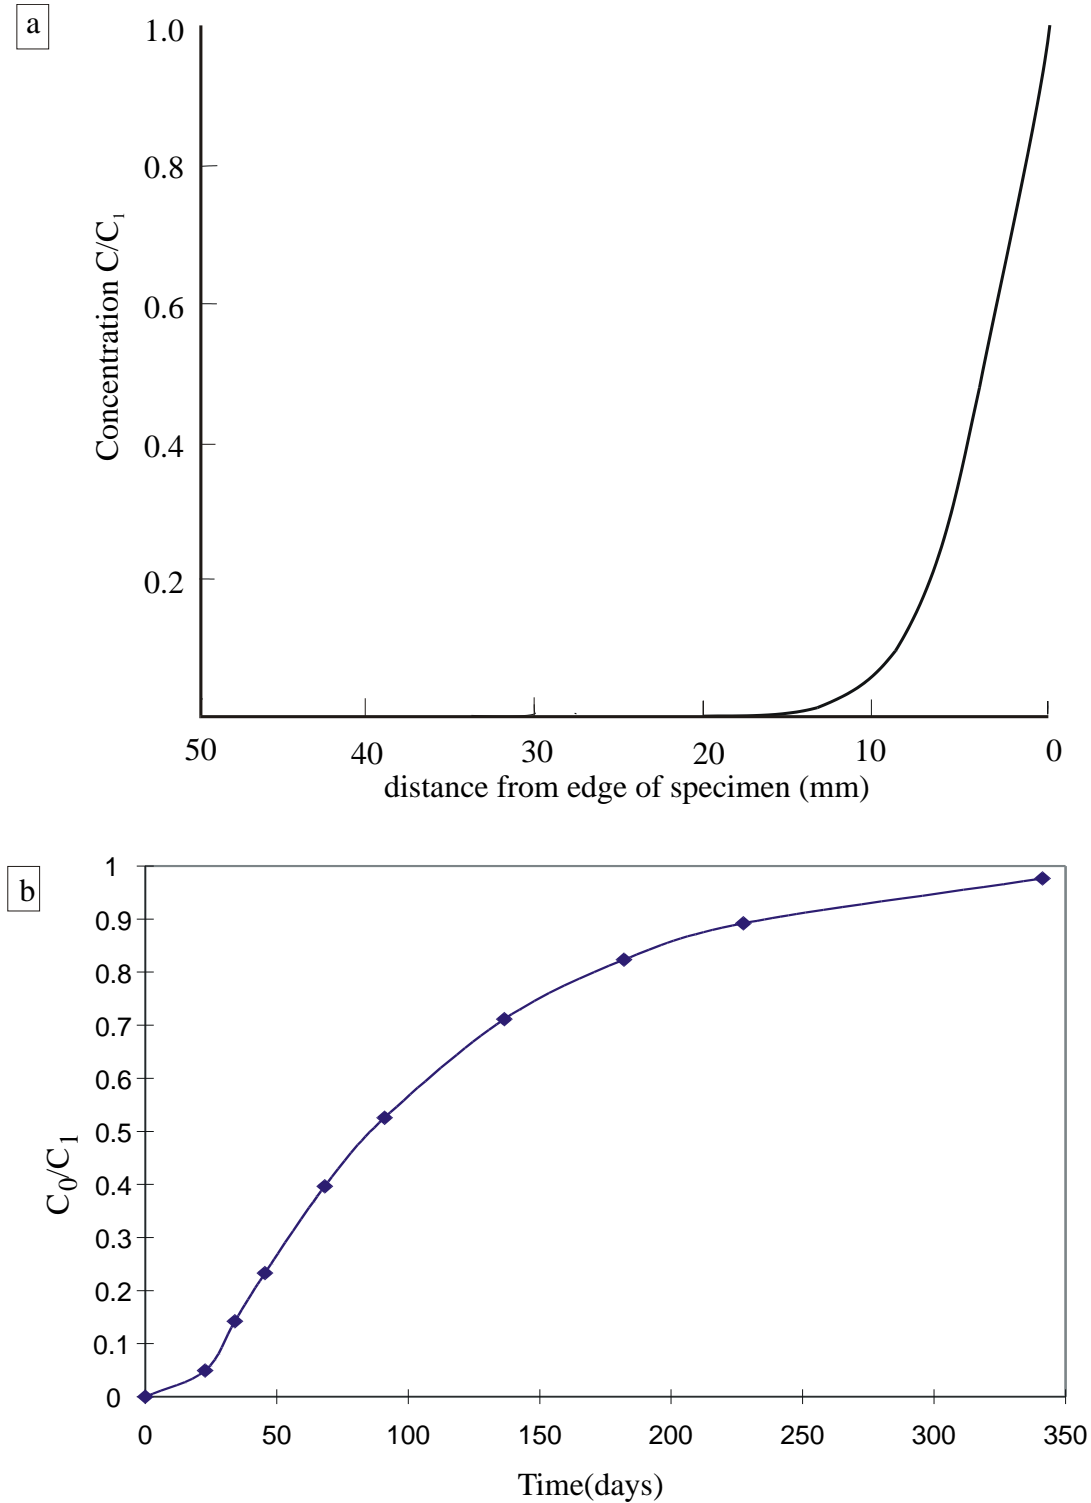
Figure 10 Predicted water concentration in the specimens as a fraction of saturation for: (a) in the epoxy layer of a three-layer specimen as a function of spatial position after 700 days in water at 50°C; and (b) at the aluminum/epoxy interface of a two-layer specimen as a function of time in water at 50°C.
