CASE REPORT

Inadvertent malposition of a permanent pacemaker ventricular lead into the left ventricle which was initially missed and diagnosed two years later: a case report

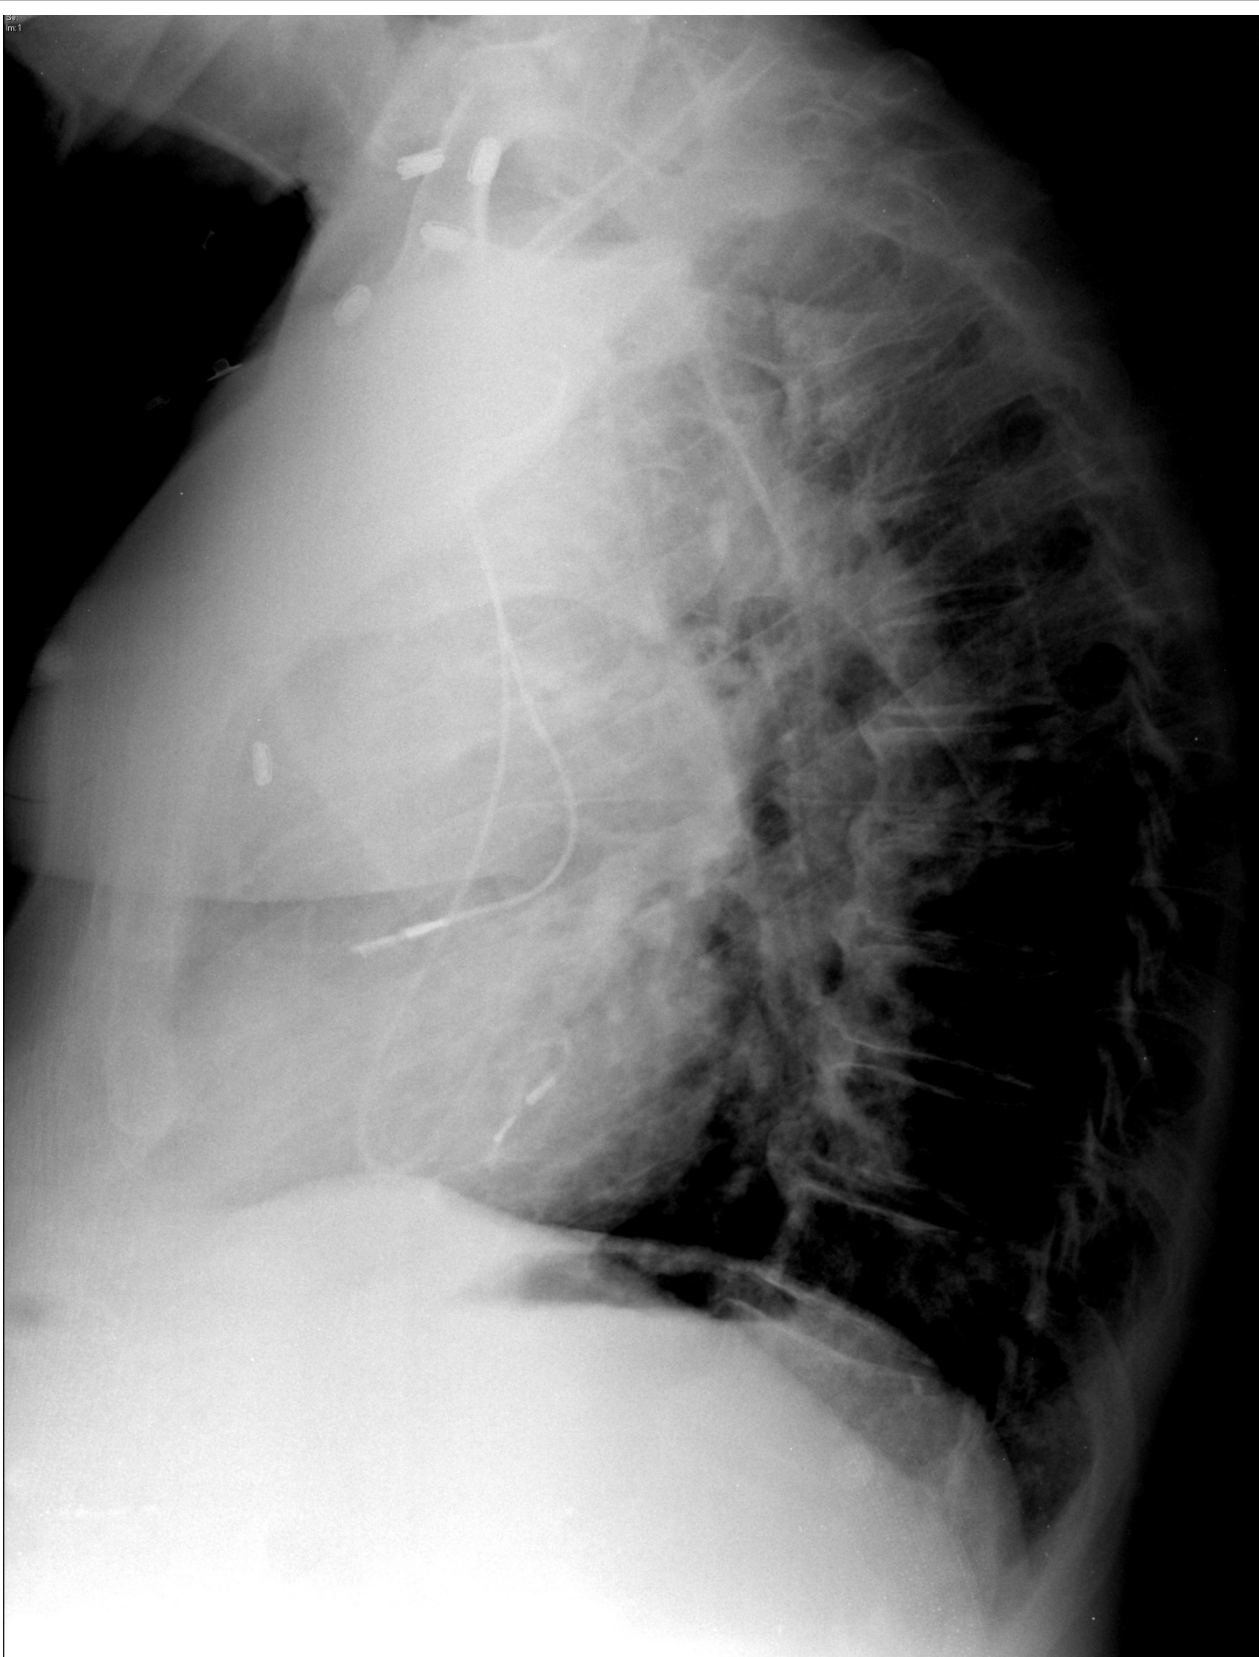
Figure 1 Chest radiograph lateral projection showing the ventricular lead to be pointing posteriorly, suggesting a left ventricular site.

ventricular lead was directed posteriorly after looping in the right atrium, which should have raised suspicion of malposition into the LV (Figure 1). Also, the diagnosis of malpositioned pacing leads can easily be missed during routine pacemaker interrogation because of the use of modified or a limited number of surface leads. A 12-lead ECG in ventricular pacing mode that shows an RBBB pattern should raise suspicion about the ventricular lead position. Consequently, echocardiography or other imaging modalities will confirm the exact position of the wire. In our case, the chest radiograph was misinterpreted, and the ECG was not done in ventricular pace mode.

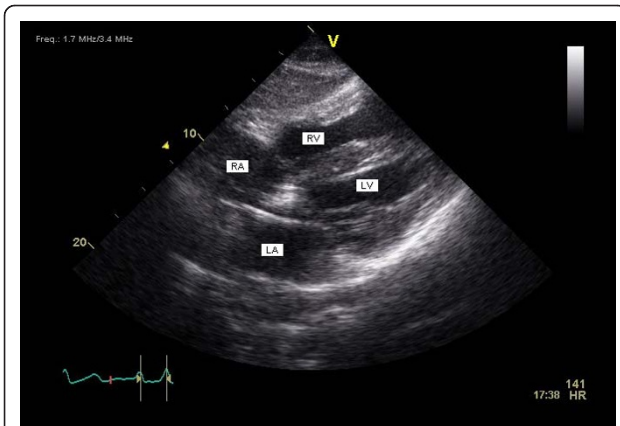
The patient had uneventful follow-up for two years. However, a routine follow-up echocardiogram showed the ventricular pacing wire to pass from the right atrium to the left atrium and then through the mitral valve to the LV with no visible attached thrombi (Figure 2). A 12-lead ECG during magnet application (DOO mode) showed atrioventricular pacing with RBBB morphology

Figure 2 Transthoracic echocardiography, subcostal long axis view showing the pacing lead to pass from the right atrium via the patent foramen ovale to the left atrium, then via the mitral valve to the left ventricle. RA, right atrium; LA, left atrium; RV, right ventricle; LV, left ventricle.

(Figure 3). No history of systemic embolization or transient ischemic attacks was reported. The decision was made to leave the pacing wire in place and continue lifelong warfarin therapy. To date, 40 months after insertion of the pacemaker, the patient remains asymptomatic with no manifestations suggestive of systemic embolization.

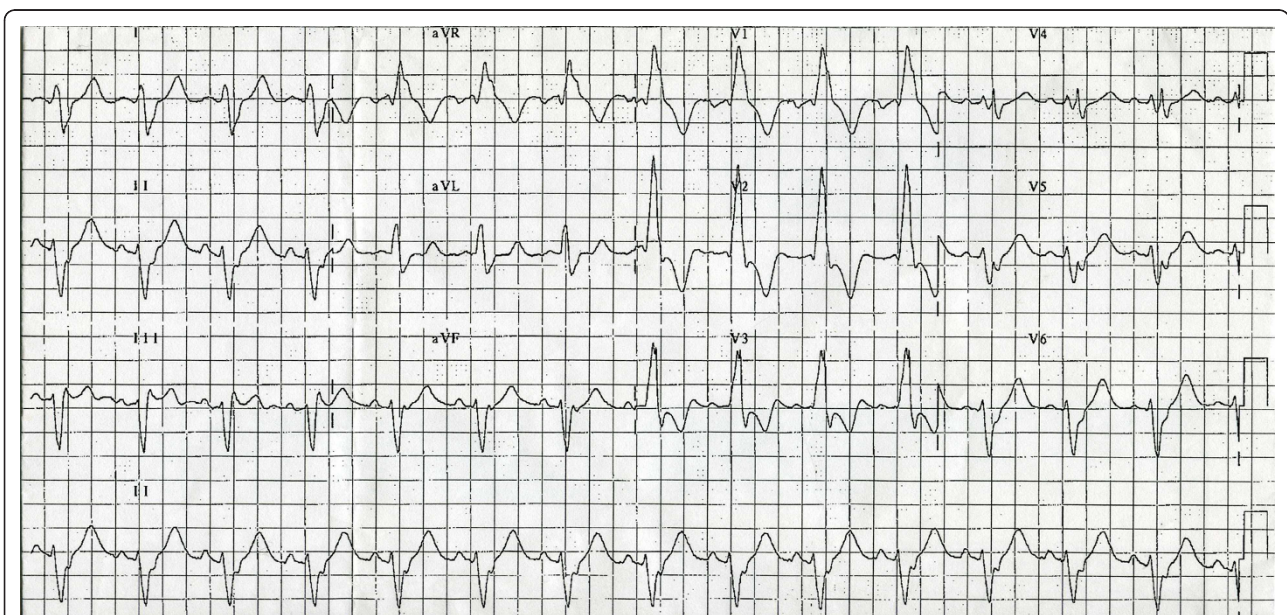
Figure 3 A 12-lead electrocardiogram during magnet application.
