Procedia Materials Science 3 (2014) 1723 - 1728

# 20th European Conference on Fracture (ECF20)

# Bucket wheel excavator damage by fatigue fracture - case study

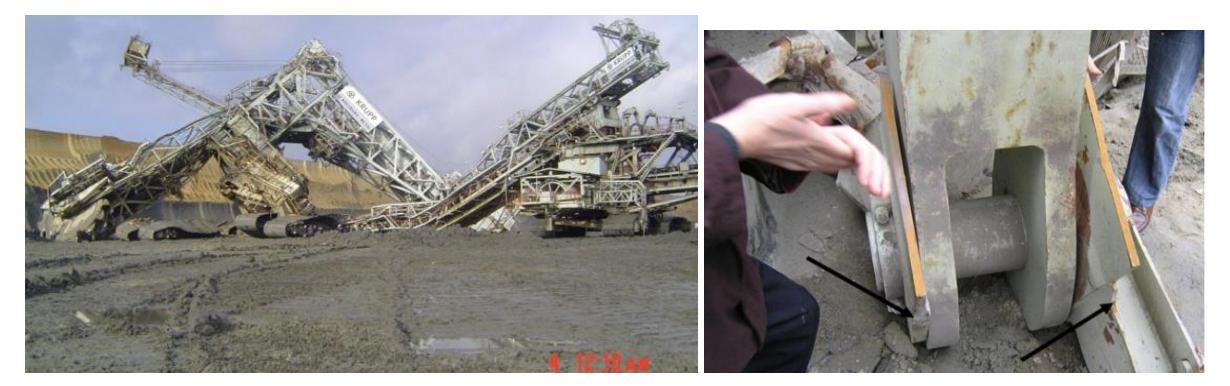
BWE SchRs 1760, unexpectedly and with no warning catastrophically failed in 2004, after 17 years of regular service, on an open surface mine in Serbia (Fig. 1). Fatigue fracture, initiated in welded joint and developed in lugs of counterweight holder (Fig. 2), followed by final fast fracture, had been the cause. Cracks initiated in the sites of stress concentration and inhomogeneous microstructure of welded joints, primarily in HAZ, under the effect of external loads and residual stresses /Sedmak et al (2009), Danicic (2010)/.

Fig. 1. Collapse of bucket wheel excavator SRs 1760 [10]

Fig. 2. Fracture of two lugs on counterweight holder

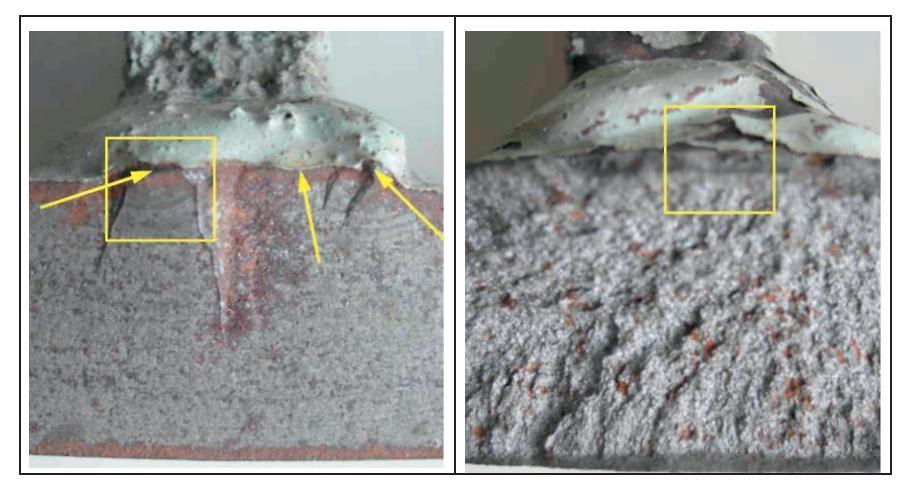
The design details (Fig. 3) indicate that fillet welds applied between rib (pos. 60) and the lug (pos. 68) had been performed without penetration, since the joint had been considered as an auxiliary one. These welded joints had not been manufactured according to welding procedure specification (WPS) and were not inspected properly. This explains heterogeneous microstructure and presence of defects and imperfections, discovered by investigation after collapse.

Fig. 3. Welded joints between web and lugs (pos. 68, left, pos. 62 right).

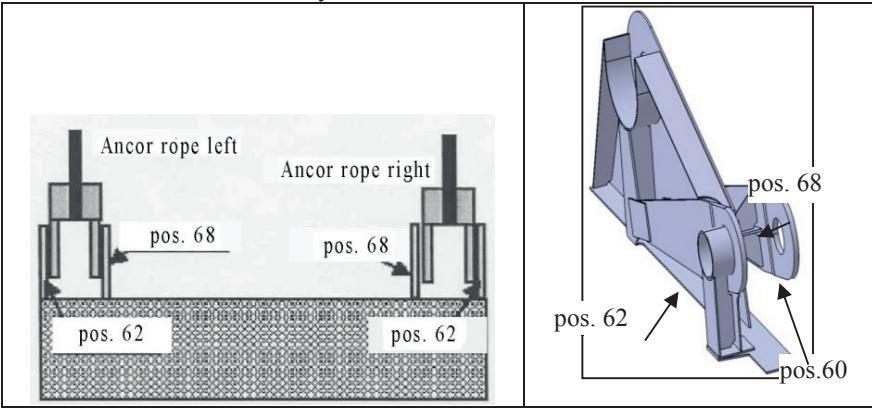
Fig. 4. (a) Design scheme of anchor ropes. (b) Presentation of connection of the main rope and a structure of the counterweight.

had more than one unfavourable solution. Double lugs design is used (Fig. 4) and the load distribution in structure is non symmetric regarding direction of the load. From Fig. 4.b it is clear that the tension force is transferred to the positions 62 and 68 through the ribs, pos. 60. In this way the distribution of load to the lugs is unbalanced. Ribs, although transferred the load, were treated as auxiliary elements and strict requirement for welding inspection was not prescribed.

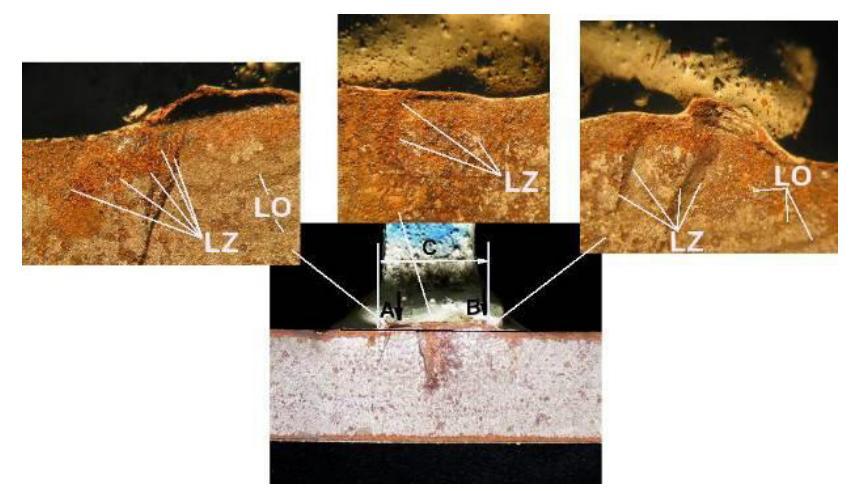
In BWE welded structure with defects (Fig. 3 and Fig. 5), and inevitably heterogeneous microstructure, exposed to load characterized by maximum initial static value and operational variable load, crack might be locally initiated by brittle fracture in microstructure region of low fracture toughness, by combined low cycle fatigue and crack tip blunting followed by stable crack growth in the more ductile region or by high cycle fatigue due to variable loading. Since the change in microstructure is sharp, crack initiation can include in both lugs all three, brittle, ductile and fatigue cracks, Fig. 3. The stress concentration, constraint and residual stresses, in addition to the variation of mechanical properties due microstructure heterogeneity can govern the mode of crack growth. Interrelation between influencing factor is decisive for the dominant type of a crack, but the fatigue crack will be surely present at the transition of welded joint to a lug, as can be concluded from Fig. 5.

Fig. 5. Initiation of dominant fatigue cracks in lug, pos. 68: details in locations A and B, LZ- ratchet marks, LO- beach marks, critical region C.

Very interesting is development of fatigue fracture in lug, pos. 68. More details about fatigue crack transition to the lug, pos. 68. They might be used in explanation of fatigue crack initiation in this lug. Variable loading exerted its effect only to pos. 68, and not in pos. 62, what is attributed to fixation of the later to main structure.

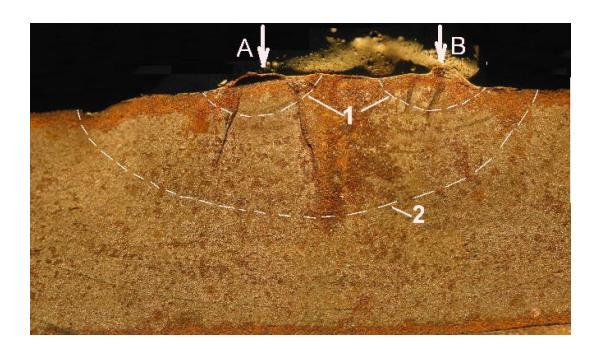
Ratchet marks, beach marks and striations, as typical for fatigue, can be recognized on fracture surface (Figs. 7 and 8), which entered in lug as two separated fatigue cracks 1 in an early step and merged in a dominant fatigue crack 2 (Fig. 6). It is interesting to note that cracks 1 started in the HAZ of low fracture toughness of lug material, and crack 2 developed through the material of more homogeneous microstructure of parent metal.

Fig. 6. Merged early fatigue cracks 1, points A and B, in a dominant crack 2.

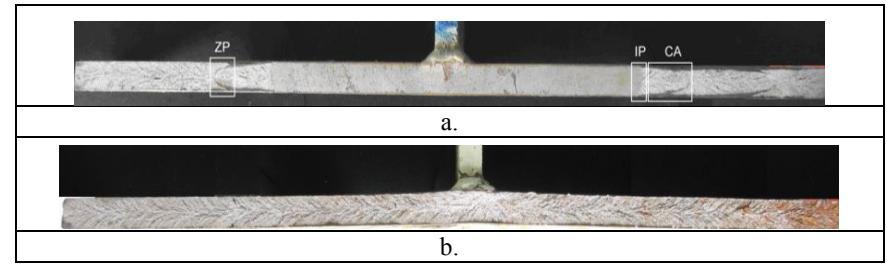
The fracture surfaces of left lug, pos. 68 (Fig. 4.a) and right lug, pos. 62 (Fig. 4.b) are substantially different. Right lug fractured in brittle manner, due to an overloading. Brute fracture in left lug took place when the loaded cross section area was significantly reduced after extended fatigue cracks on both sides of welded rib (Fig. 3). Flat fatigue crack growth in pos. 68 had been interrupted by stable crack growths, with visible shear lips.

Three regions of stable crack growth by tearing fracture had been registered in Fig. 3.a. They occurred when applied maximum stress in analyzed component locally exceeded yield stress of material, the energy had been consumed for tearing fracture and crack tip blunting, followed by shear lips and development of stretch zone, according to maximum shear stress, under 45° to acting force. But among these three regions there is the difference in starting condition. In the case on the left side (Fig. 7a) high cycle fatigue preceded stable crack growth, which had been arrested by final stretch zone (FSZ) in the region ZP. At the end of FSZ final fast fracture took place. On the right side, in the region IP low cycle fatigue preceded the tearing segment CA, which had been arrested by FSZ. After this new FSZ, crack had to continue to grow, again by tearing fracture, up to the formation of FSZ before final fast fracture.

Fig. 7. (a) Lug (pos. 68) fracture (fatigue, stable crack growth and brute fracture) (b) Brittle fracture of lug (pos. 62), indicating single initiation point from both sites.

It is to notice that in all three cases plane stress dominated and shear lips are present. However, the sequence of occurrence individual tearing fracture regions is not clear and request further analysis. After stress redistribution, fatigue crack continued to grow continuously, by low cycle process beyond final stretch at CA and by high cycle process on the other side, up to simultaneous transition to tearing mode on both sides. Fracture process ended by fast fracture on both ends, after probably simultaneous development of final stretch zones (FSZ).
