Epilepsy & Behavior Case Reports

Case Report

Mitigating bit flips or single event upsets in epilepsy neurostimulators

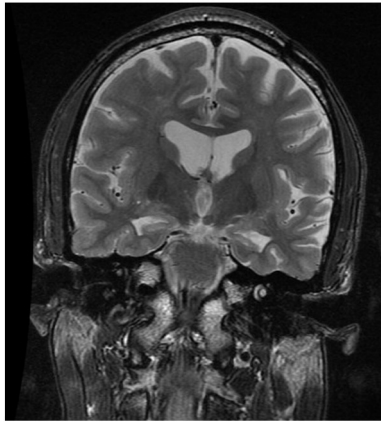
Fig. 1. Coronal T2 MRI showing bilateral left > right hippocampal atrophy.

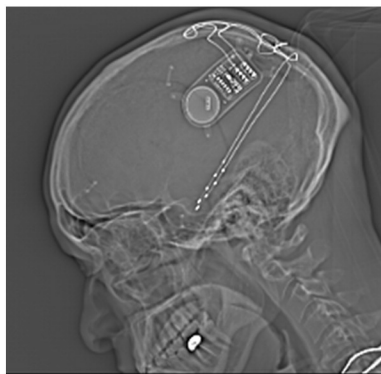
While uploading data from the neurostimulator to his interrogation computer, a SEU error was noted on June 18, 2015. A total of 1215 bits stored to the random access memory (RAM) of his device switched from either a 0 to 1 or a 1 to 0. In the week leading up to the bit flip, the patient was not exposed to high levels of electromagnetic radiation such as cauterly or MRI and had not traveled in a commercial jet, which can amplify exposure to terrestrial cosmic radiation [1]. The RNS System device performed as designed in the event of SEU; it reset to a default or safe mode where stimulation was not enabled, and when the device data were next uploaded by the patient from home to a centralized data server, this SEU was apparent and triggered alerts to our treating team. At our request, the patient returned to clinic to have the neurostimulator interrogated, and during this process, the neurostimulator automatically reprogrammed to settings prior to the day of the SEU. No seizures or other adverse events were noted during this SEU. The patient's cardiac pacemaker was not affected during this time period. The neurostimulator remains implanted and continues to perform as intended.

Fig. 2. Lateral skull films showing RNS device and 4 contact depth electrodes over left and right hippocampi.
