European Journal of Radiology Open 2 (2015) 3–6

## Technical Note

## Metallosis: A diagnosis not only in patients with metal-on-metal prostheses

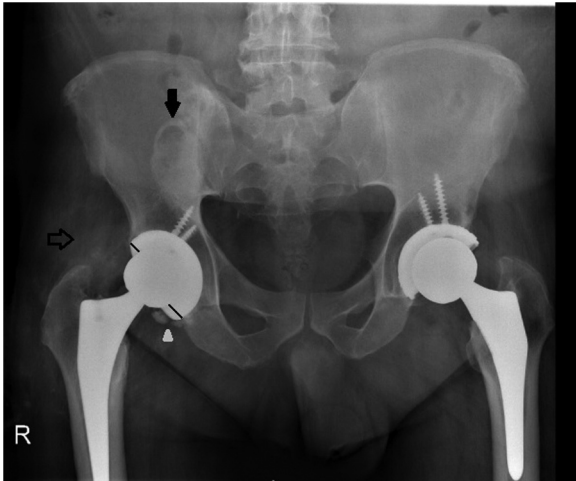
Fig. 1. A 55-years-old man with metallosis. Plain film of pelvis, revealing two round high-density images, one denser projected on the right iliac bone and the other above the right femoral neck (arrows). High density fragments adjacent to the inferior acetabular border were also noted (arrowhead). There is also an eccentric position of the femoral head in the acetabular dome (non equal distance between the femoral head margin and the acetabular border – trace lines).

In the emergency department he performed a pelvic plain film that revealed a subtle misalignment, with eccentric location of the right femoral head, and two rounded high-density images: one denser image projected on the right iliac bone and the other above the femoral neck (Fig. 1).

Imaging findings in plain films and CT studies include misalignment of the femoral head in the acetabular roof, and loss of joint space suggesting wear or fracture of the prosthesis liner; the “cloud sign” – amorphous densities in the peri-prosthetic tissues and the “bubble sign” – hyper-dense rounded images with a higher contour (metal deposits) [1,8,9]. Subtle changes may be difficult to detect on radiographs, but all of the described signs could be found in the radiographic study of the presented case (Fig. 1).

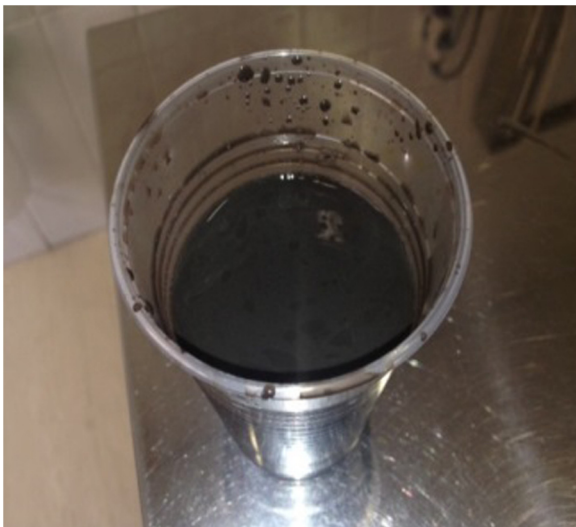
A non-imaging guide puncture to the periarticular right hip mass was performed in the emergency department with drainage of abundant black liquid (Fig. 2) indicating metallosis diagnosis. The black liquid color is due to the metallic components debris and basic chemistry is usually not necessary for the diagnosis.

Fig. 2. A 55-years-old man with metallosis. Photograph of the black fluid drained after the right hip fluctuating mass puncture.

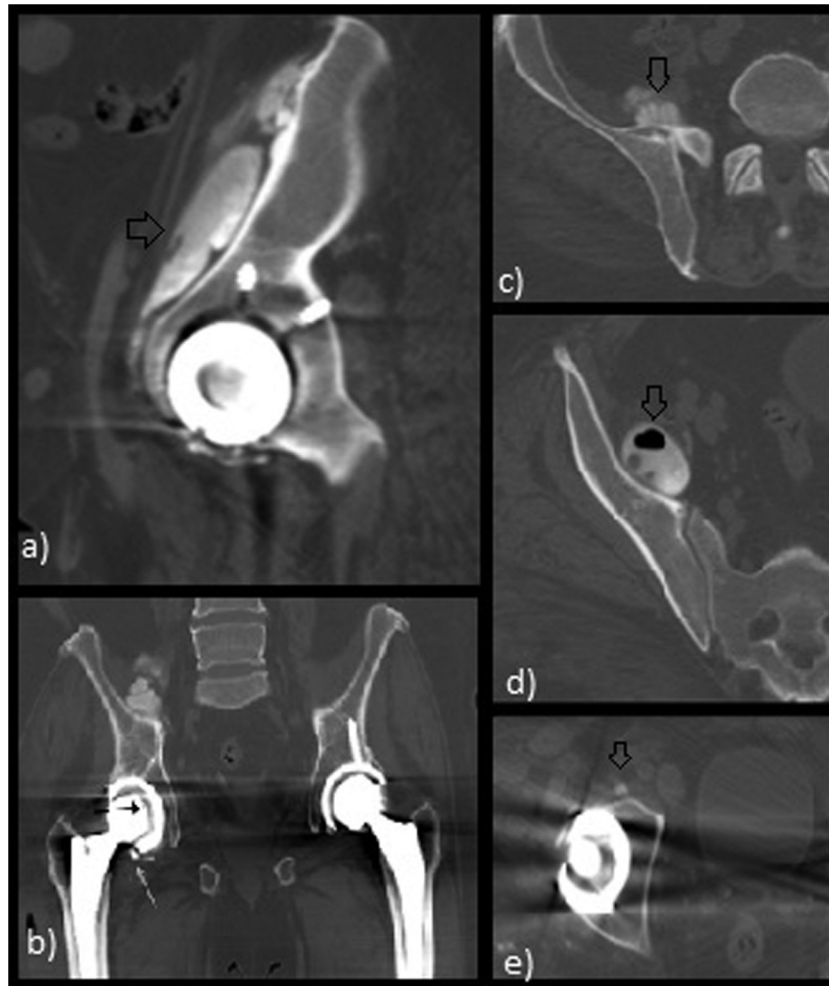
values return to normal values. He was then discharged home, with referred appointment control in a week. Four days later, he returned to the emergency department, complaining of malaise. Analytical control in the emergency department revealed worsening of anemia and hyperglycemia levels. A CT scan was then performed. CT findings revealed a large elongated collection of high density content, extending from the articular space in to the pelvis along the right psoas muscle (Fig. 3), in relation with metallic components debris.

Fig. 3. A 55-years-old man with metallosis. CT findings revealed a large elongated collection of high-density content, extending from the articular space into the pelvis along the right psoas muscle, in relation to metallic components debris.

To avoid continuous absorption of the metallic particles, urgent surgical procedure to provide collection drainage was necessary. Due to the patient's systemic clinical impairment, a temporary pulsatile cleaning system was installed. An incision was made in the right lateral the hip and a draining cleaning system provided the liquid outlet. High-dose corticosteroid therapy and blood transfusion were performed, and after rising in red blood cells count, the patient underwent a second revision of the right hip prosthetic device. Intra-operative findings confirmed the extensive metallosis; metal impregnation of the replaced polyethylene liner component, as well as wear of the acetabular metal dome. To allow direct access to the pelvic collection along the right psoas muscle, a trans-acetabular perforation was made and abundant black liquid was drained (Fig. 4). After surgery the patient made a good recovery, with improvement of all clinical parameters and analytical values.

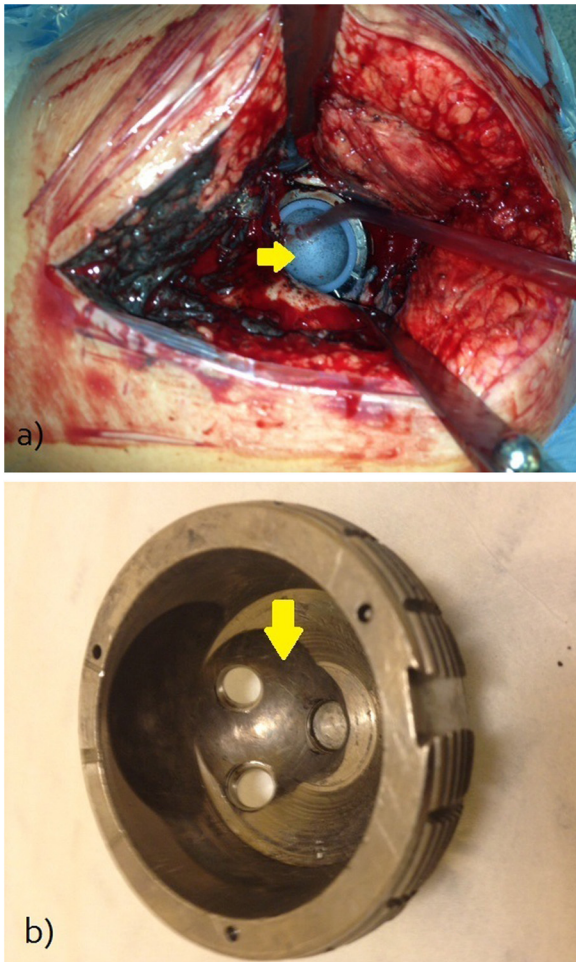
Fig. 4. (a and b) A 55-years-old man with metallosis. Intra-operative pictures of the procedure showing extensive metallosis; metal impregnation of the replaced polyethylene liner component (a), as well as wear of the acetabular metal dome (b).

extensive tissue damage [9]. In the reported case, drainage of the large pelvic collection was also required. CT imaging allowed not only the diagnosis of the initially missed pelvic collection, but also contributed to the correct surgical planning. A successful collection drainage through a transacetabular approach during the prosthesis revision was performed.
