**IMAGING VIGNETTE**

MDCT Assessment of Mechanical Circulatory Support Device Complications

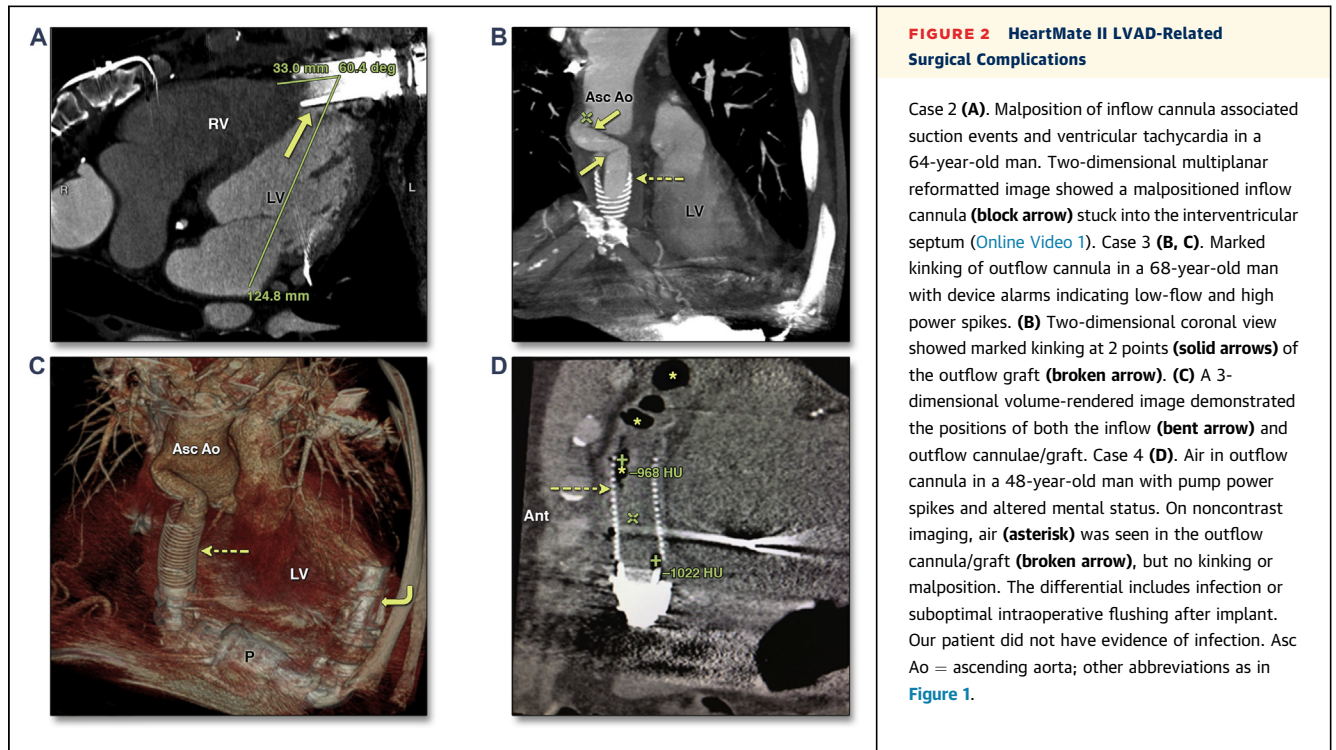
FIGURE 2 HeartMate II LVAD-Related Surgical Complications

Case 2 (A). Malposition of inflow cannula associated suction events and ventricular tachycardia in a 64-year-old man. Two-dimensional multiplanar reformatted image showed a malpositioned inflow cannula (**block arrow**) stuck into the interventricular septum ([Online Video 1](#)). Case 3 (B, C). Marked kinking of outflow cannula in a 68-year-old man with device alarms indicating low-flow and high power spikes. (B) Two-dimensional coronal view showed marked kinking at 2 points (**solid arrows**) of the outflow graft (**broken arrow**) of the inflow (bent arrow) and outflow cannulae/graft. Case 4 (D). Air in outflow cannula in a 48-year-old man with pump power spikes and altered mental status. On noncontrast imaging, air (**asterisk**) was seen in the outflow cannula/graft (**broken arrow**), but no kinking or malposition. The differential includes infection or suboptimal intraoperative flushing after implant. Our patient did not have evidence of infection. Asc Ao = ascending aorta; other abbreviations as in [Figure 1](#).

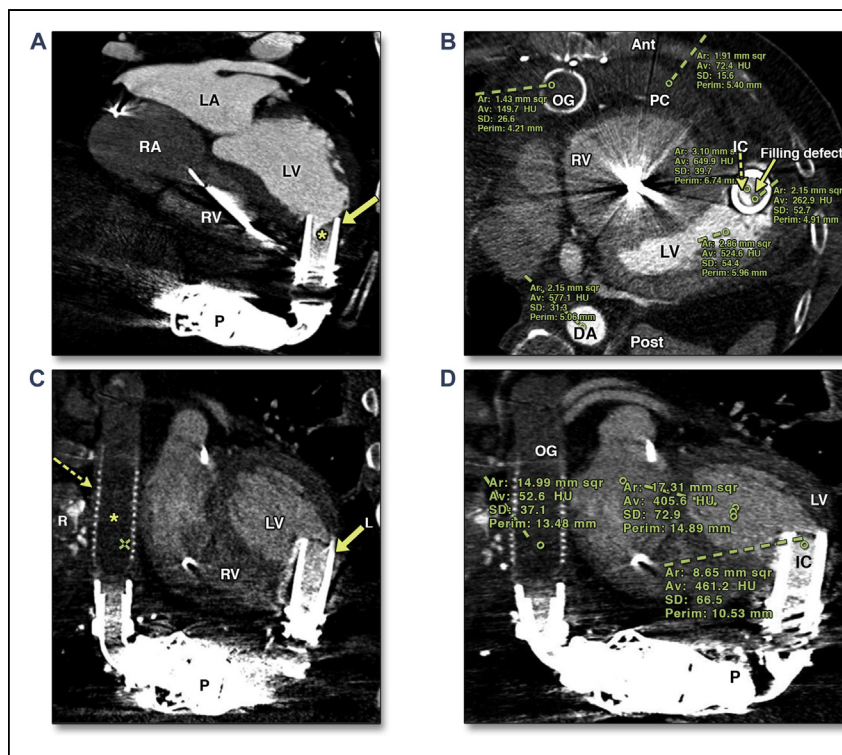
FIGURE 3 HeartMate II LVAD Thrombosis

Case 5 (A and B). Thrombus of inflow cannula (IC) in a 57-year-old man with power spike alarms 1 week post-implantation. Multiplanar reformatted (A) and axial (B) views showed a large filling defect (**asterisk**) in the external half of the IC (**block arrow**) that is due to stasis/slow-flow or thrombus as suggested by the much lower computed tomography (CT) attenuating number compared with the internal half of the cannulae and LV/DA (B). Successful device exchange confirmed presence of thrombus. Case 6 (C and D). Thrombus in LVAD outflow cannula/graft in a 58-year-old man with device alarms and clinical hemolysis. (C) Coronal oblique view revealed absence of contrast (**asterisk**) within the outflow cannula/graft (**broken arrow**). (D) Very low CT attenuating number is suggestive of thrombus. **Block arrow** (C) indicates IC with sub-optimal contrast enhancement similar to LV (D) is likely due to low-flow state. Successful device exchange confirms presence of thrombus with sparing of the IC. DA = descending aorta; OG = outflow graft; PC = pericardium; other abbreviations as in [Figure 1](#).

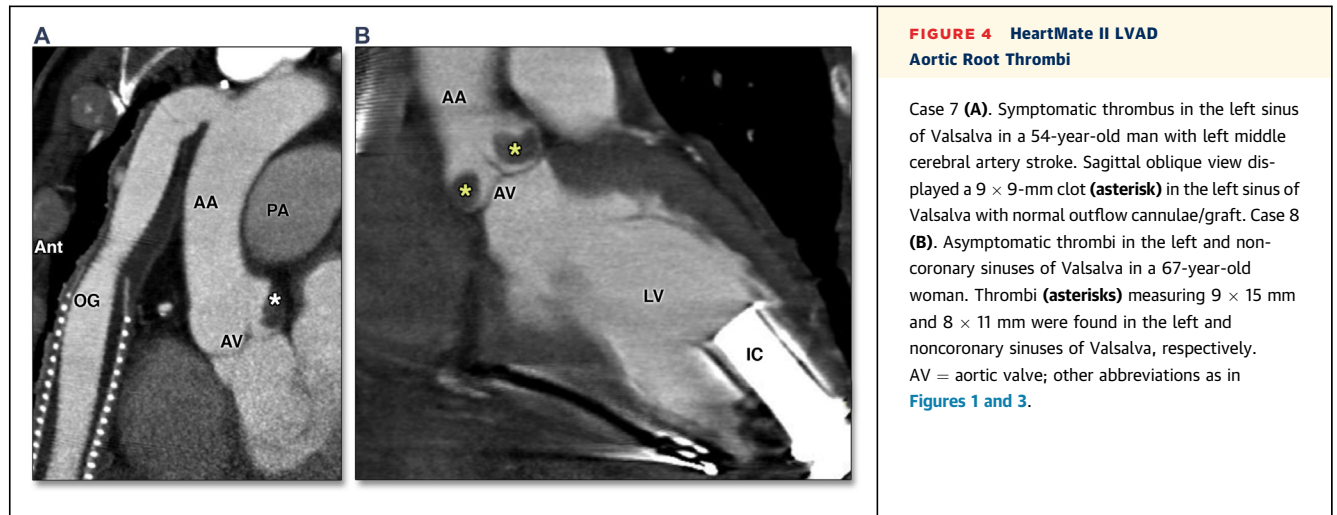
FIGURE 4 HeartMate II LVAD Aortic Root Thrombi

Case 7 (A). Symptomatic thrombus in the left sinus of Valsalva in a 54-year-old man with left middle cerebral artery stroke. Sagittal oblique view displayed a 9 × 9-mm clot (asterisk) in the left sinus of Valsalva with normal outflow cannulae/graft. Case 8 (B). Asymptomatic thrombi in the left and non-coronary sinuses of Valsalva in a 67-year-old woman. Thrombi (asterisks) measuring 9 × 15 mm and 8 × 11 mm were found in the left and noncoronary sinuses of Valsalva, respectively. AV = aortic valve; other abbreviations as in Figures 1 and 3.

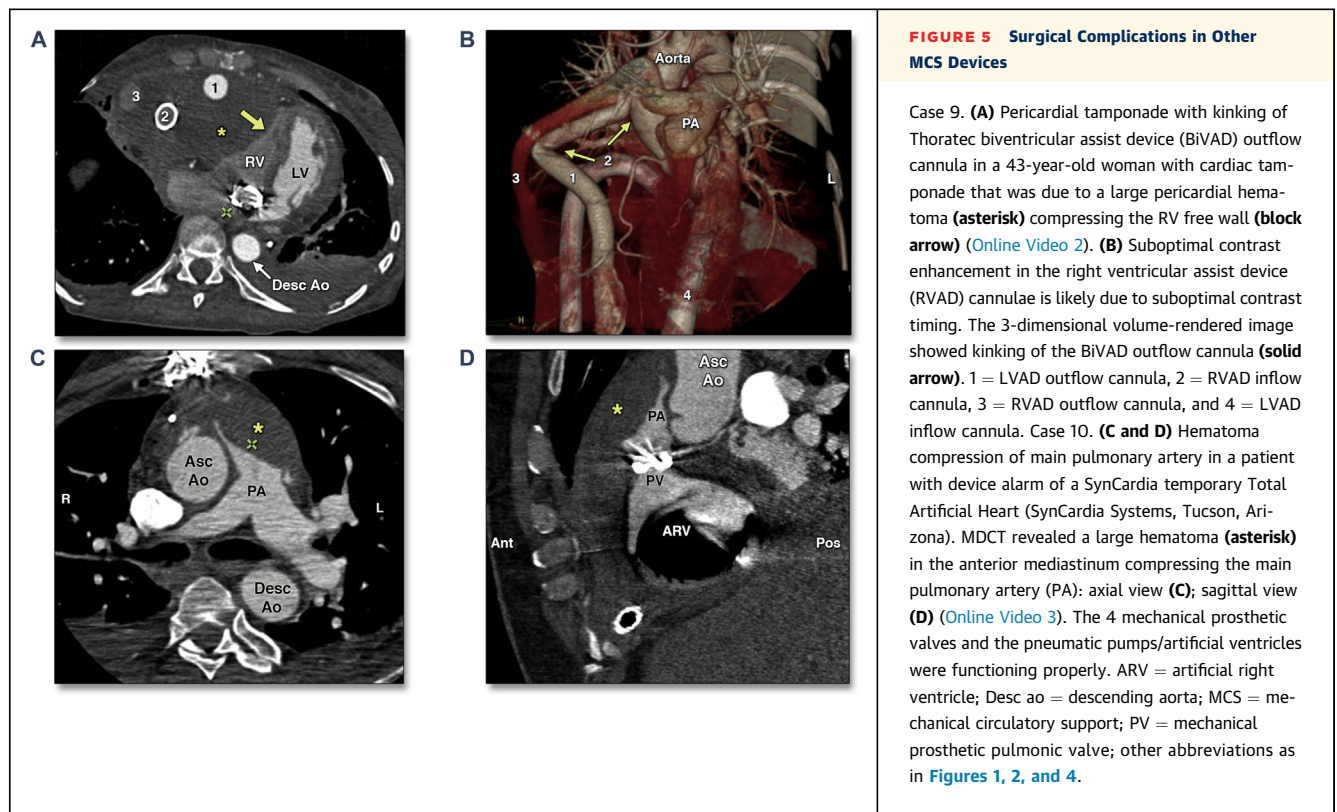
FIGURE 5 Surgical Complications in Other MCS Devices

Case 9. (A) Pericardial tamponade with kinking of Thoratec biventricular assist device (BIVAD) outflow cannula in a 43-year-old woman with cardiac tamponade that was due to a large pericardial hematoma (asterisk) compressing the RV free wall (block arrow) (Online Video 2). (B) Suboptimal contrast enhancement in the right ventricular assist device (RVAD) cannulae is likely due to suboptimal contrast timing. The 3-dimensional volume-rendered image showed kinking of the BIVAD outflow cannula (solid arrow). 1 = LVAD outflow cannula, 2 = RVAD inflow cannula, 3 = RVAD outflow cannula, and 4 = LVAD inflow cannula. Case 10. (C and D) Hematoma compression of main pulmonary artery in a patient with device alarm of a SynCardia temporary Total Artificial Heart (SynCardia Systems, Tucson, Arizona). MDCT revealed a large hematoma (asterisk) in the anterior mediastinum compressing the main pulmonary artery (PA): axial view (C); sagittal view (D) (Online Video 3). The 4 mechanical prosthetic valves and the pneumatic pumps/artificial ventricles were functioning properly. ARV = artificial right ventricle; Desc ao = descending aorta; MCS = mechanical circulatory support; PV = mechanical prosthetic pulmonic valve; other abbreviations as in Figures 1, 2, and 4.
