298 DOCUMENT NO. 66SD4505 216
15 NOVEMBER 1966

4
3 NINTH QUARTERLY PROGRESS REPORT,
FOR THE
APPLICATIONS TECHNOLOGY SATELLITE
GRAVITY GRADIENT
STABILIZATION SYSTEM 4

71 JULY THROUGH 31 OCTOBER
25 CONTRACT NO. NAS 5-9042 29ACV

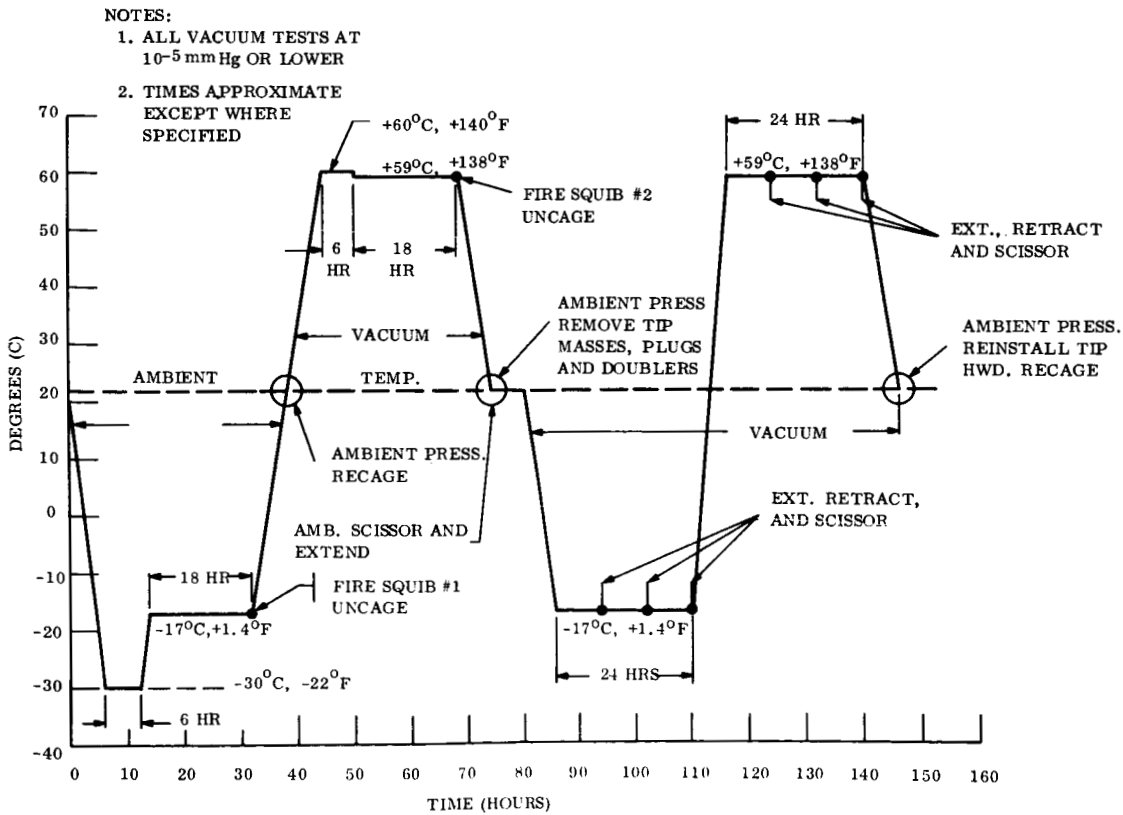
Figure 3-1. ATS Primary Boom, Qual T/V Cycle

The extension motor stalled during thermal-vacuum testing but only at the minimum scissor angle of 11 degrees; all other qualification tests were conducted successfully.

When the unit was in the thermal-vacuum environment and functioned in the operational phase (i. e., without tip masses), attempts to extend or retract the booms resulted in a stall condition of the extension motor as evidenced by high armature current (between 2.5 and 3.5 amperes). Motor stalling occurred at both extremes of temperature and vacuum, and also at ambient temperature and pressure only at the extreme negative of scissor angle; they were operated normally at any other scissor angles, including the positive scissor limit (i. e., 30⁰). The high armature current was a measure of the fact that a high mechanical resistance existed to motor torque. An investigation of the gear mechanism revealed that the polycarbonate housing was the cause of the resistance.

The polycarbonate housing is basically a plastic ring that is part of the erection unit suspension system on which the erection unit moves about the scissor axis. There is a slot on the circumference of the ring to allow clearance of the gear in the scissor drive train. When the scissor motion was moved to one of the extremes, slot clearance was exceeded, and the gear was stopped against the edge of the slot, thus effectively stalling the extension motor. The corrective action taken to prevent this motor stall condition was to sufficiently widen the slot in the polycarbonate ring so that the gear would not contact the ring even at minimum scissor angle.

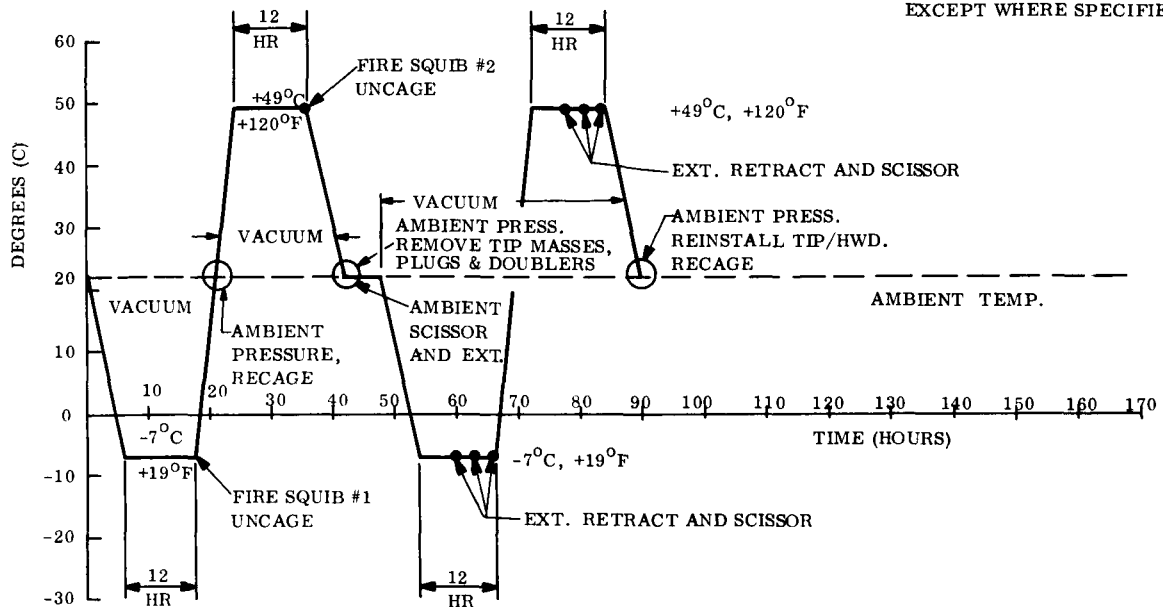
During the thermal-vacuum test (see Figure 3-2 for the temperature profile) both units encountered an uncaging difficulty at low temperature and with the tip mass deployment trolleys installed; the trolleys are part of the test equipment. Failure was attributed to the action of the test trolleys and repetition of the tests, without the trolleys, resulted in proper operation in every test. However, the details of the malfunctions are reported in GE Failure Analysis Report 255-E-26 (S/N 10 unit) and 249-E-25 (S/N 101 unit). The highlights of both failure reports are presented here for reference.

The F-1b Primary Boom (S/N 10) failed to uncage during thermal-vacuum test at cold temperature (-7°C) on 20 September 1966. This followed a similar failure of the F-1a Primary Boom (Reference Failure Analysis Report 249-E-25). Flight pyro release mechanism and live squibs had been installed and the vibration test performed. For thermal-vacuum, the test trolleys were aligned to the unit and attached to the tip masses. After Squib 1 was fired, a 200 millisecond pulse at 26 volts produced only a slight movement of the tip plugs. Three additional pulses from the uncaging panel and several using the deploy panel produced no further movement of the tip plugs or tip masses.

Figure 3-2. ATS Primary Boom, Acceptance T/V Cycle

There was no malfunction of the pyro release mechanism and it operated properly. Although the S/N 101 unit uncaged at room temperature with the test trolleys attached, analysis of the S/N 10 and S/N 101 failures indicates that both are associated with the use of test trolleys at cold temperature. That this is the actual cause is confirmed by the successful uncaging of both units at cold temperature with the trolleys removed. Incomplete uncaging with partial movement of the tip plug, and the observed backwinding, were probably caused by trolley misalignment and binding.

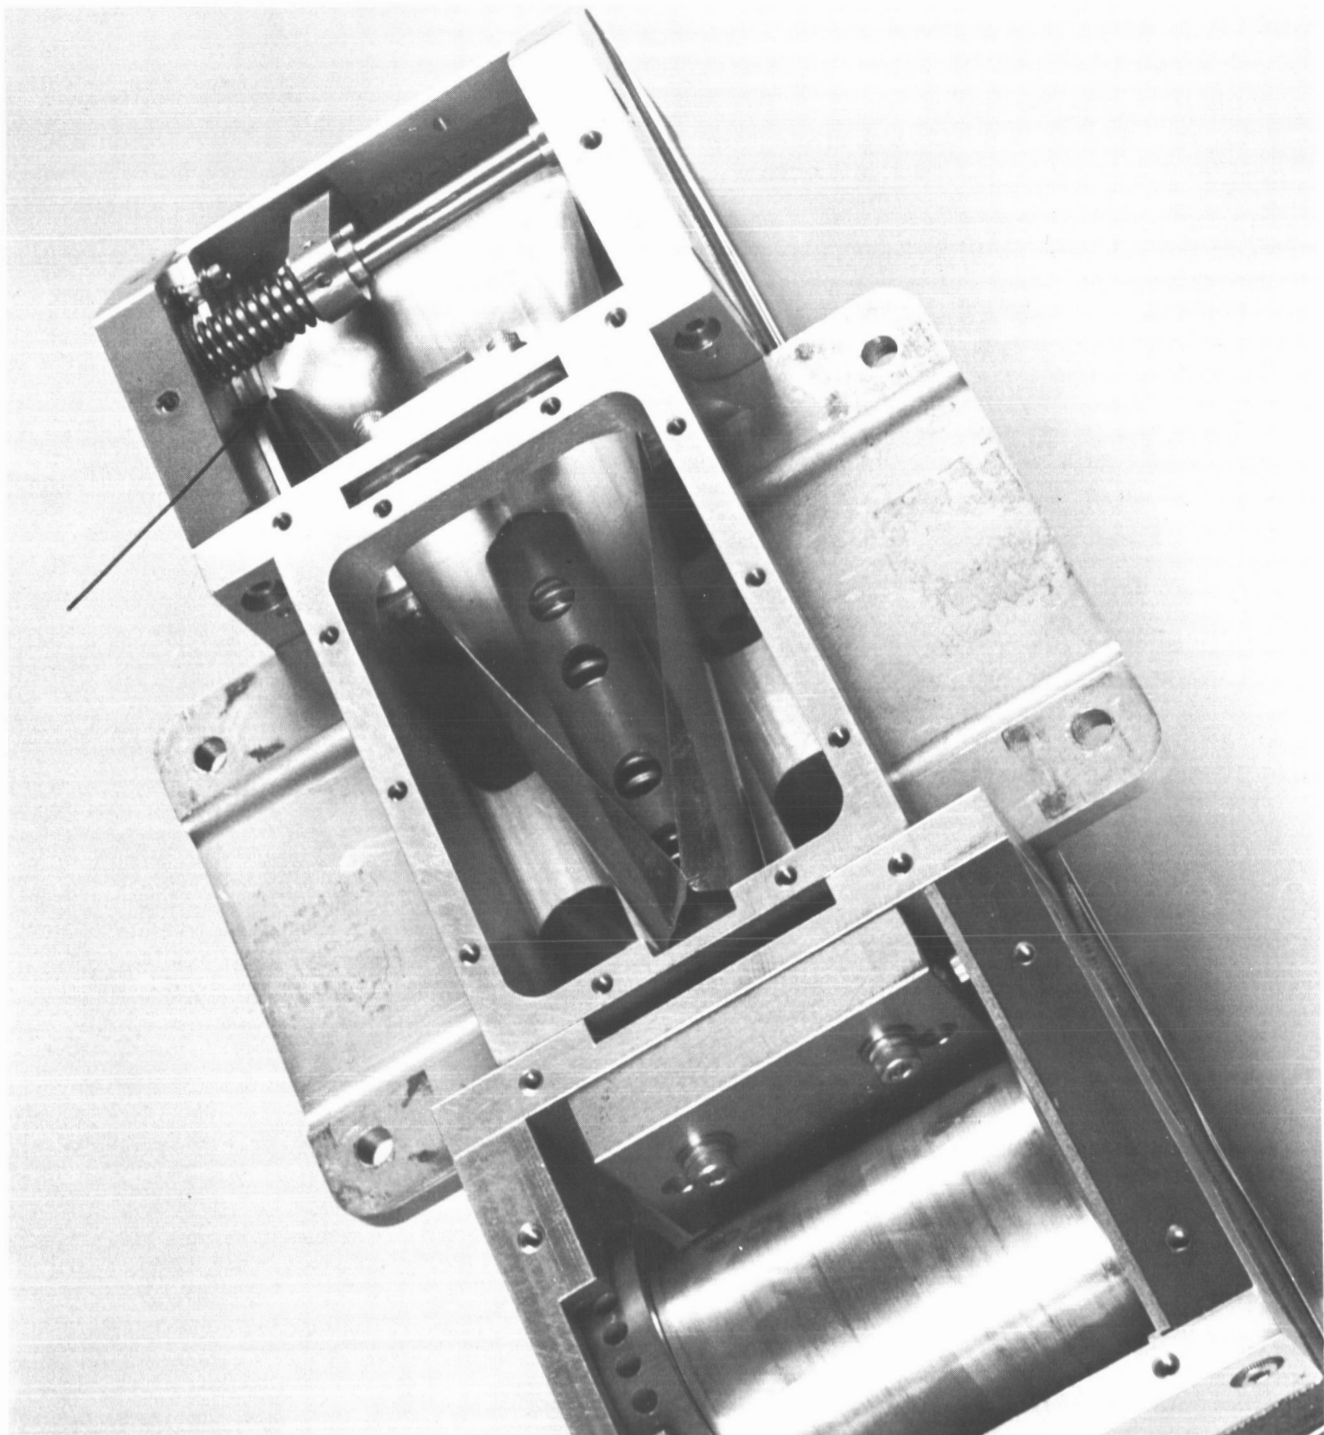
During three vibration tests the Prototype 1 Damper Boom Assembly developed two tears in boom element tapes, and failed to deploy as a result of a rough storage drum bearing.

The Damper Boom was returned to deHavilland on 22 June 1966 for deployment and examination. Deployment was normal and within specification. When the covers were removed it was found that one tape had sustained a tear approximately 5/32-inch long at one edge. This tear was located at the point where the tape is tangent to the storage drum in stored condition. DeHavilland issued Operation Difficulty Report No. 18, dated 14 July 1966. The tear was in the Boom B element tape (No. 2 erection unit) but was designated tape A in this report, apparently in error. The torn tape attached nearest to the damper mounting flange of the center section.

Figure 3-3. Tear in Boom Element B Following First Vibration

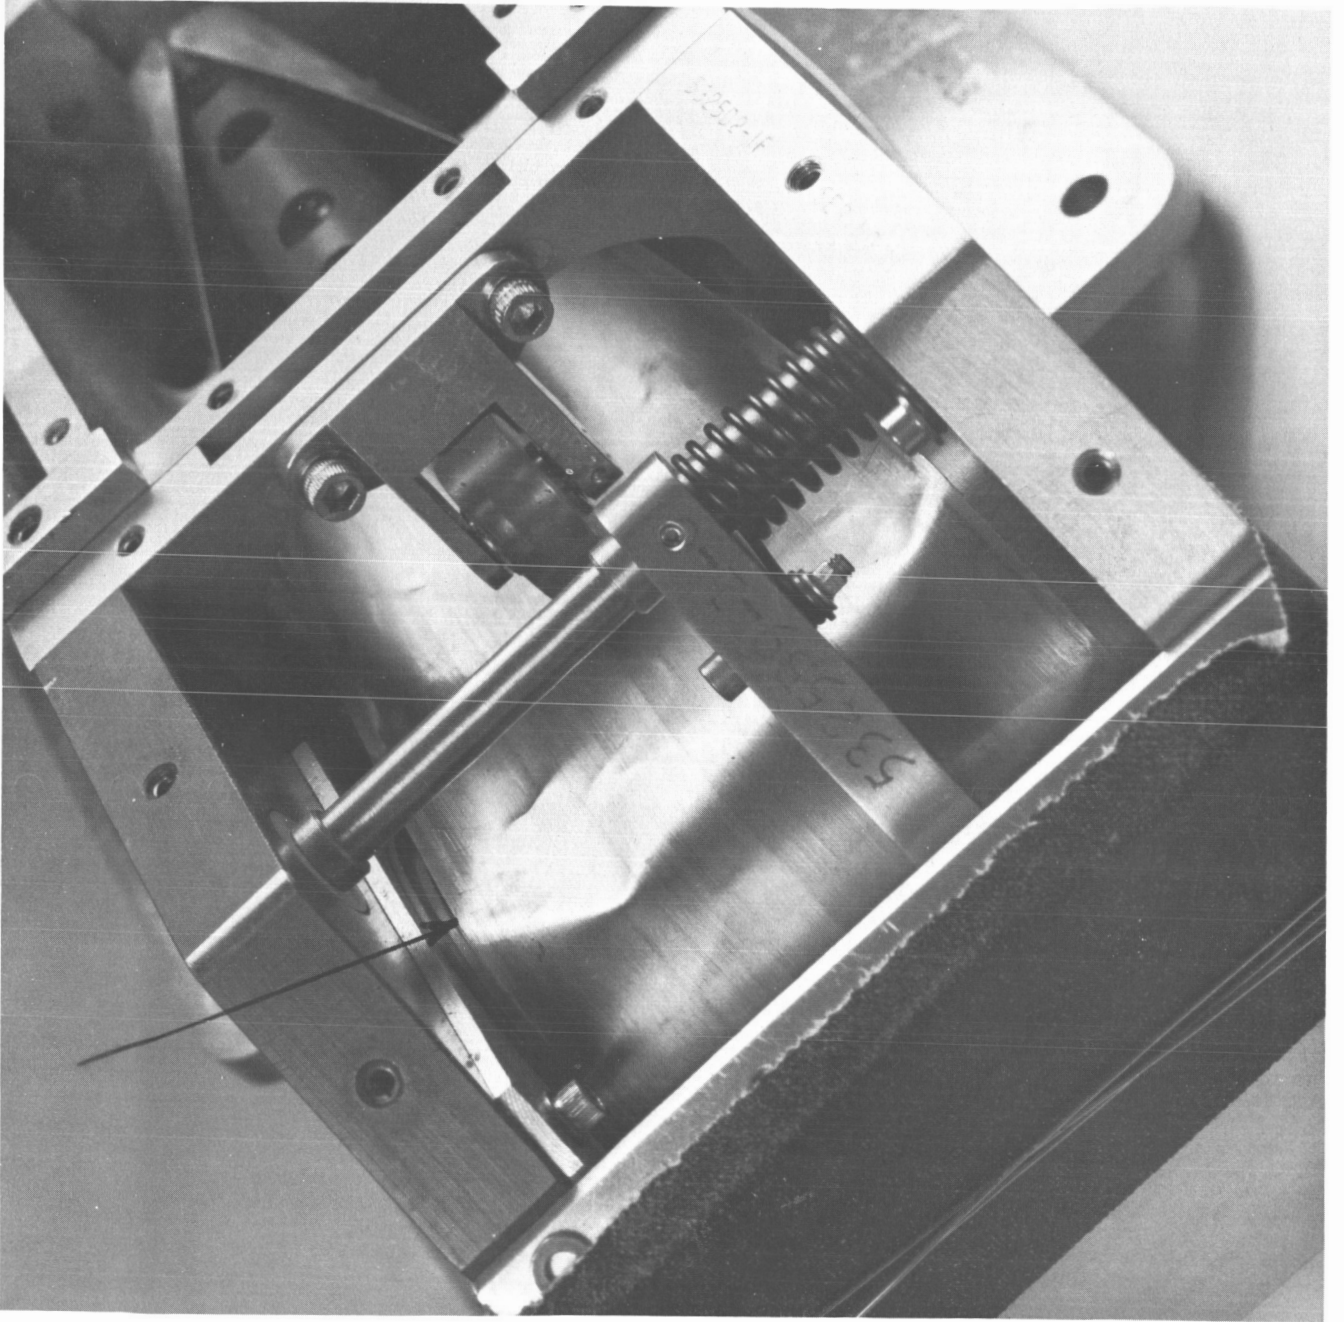
The Damper Boom Assembly was again vibrated to qualification levels on 27 July while mounted on the dynamic model CPD. It was oriented correctly with the boom axis in the plane of the Z (launch) axis. On completion of the test, the A tape was found to be cracked near the storage drum tangent point. (The opposite tape cracked on the earlier vibration test.) Both tapes were distorted and billowed on the storage drum. IR 15668 was written,

Figure 3-4. Wrinkling in Boom Element A (Untorqued)

and was dispositioned to remove the doubler tapes and to replace the old tapes with new elements. The tapes were replaced at GE by deHavilland representatives. The tapes were rewound and retorqued to a revised procedure intended to prevent billowing under vibration.

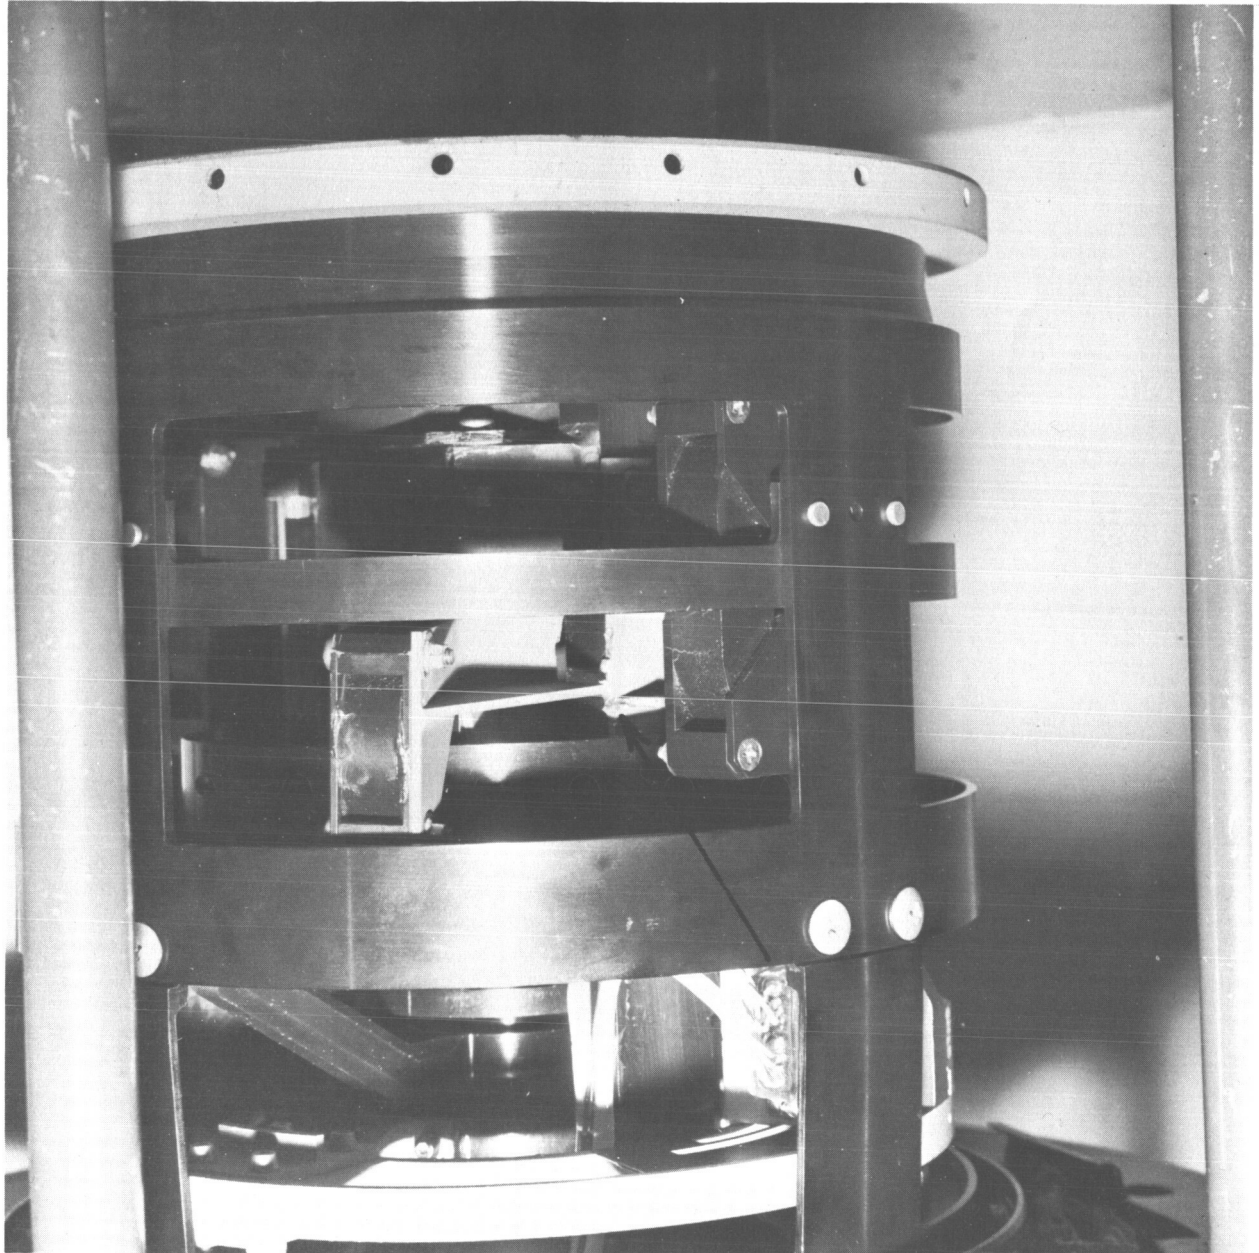
A major problem was discovered during CPD Qualification testing. The eddy-current torsional restraint magnet mounting brackets failed during the second qualification-level vibration test. Detailed analyses of the failure resulted in a design change which was incorporated into the flight equipment. Discussions of prototype qualification and flight unit acceptance testing are included in Section 4.

Figure 4-1. Failed Torsional Restraint Magnet Bracket-Quadrant II
