LADING OF THE LATE BRONZE AGE SHIP AT ULUBURUN

A Thesis

Lading of the Late Bronze Age Ship at Uluburun. (May 2003)

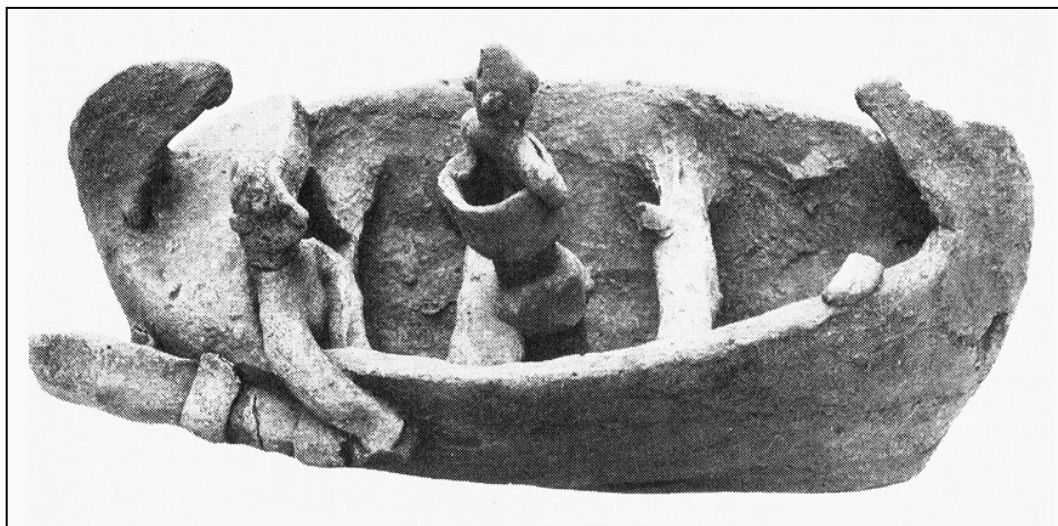
Fig. 2.4 Clay models from Cyprus possibly similar to the Uluburun ship in historical period and general hull form. The upper model measures L. 31 cm, W. 9 cm, H. 7 cm (After Westerberg, 1983, 28, 102, Fig. 32). Lower model measures L. 30 cm, W. 14 cm, H. 10 cm (From Westerberg, 1983, 22, 95, fig. 23).

Near-contemporaneous depictions of Near Eastern merchant ships include Egyptian wall paintings (fig. 2.2 and 2.3) and various clay models (fig. 2.4) from the Late Bronze Age and later periods. From these examples, several common features are observed. These ships are double-ended vessels with a mast carrying a square sail located near midships and steered by two quarter rudders. Through-beams are spaced uniformly along the length of the hull and weather fencing runs along the full length of the sheer strake. The keel protrudes inside the hull rather than outside towards midships, and narrows towards the extremities.

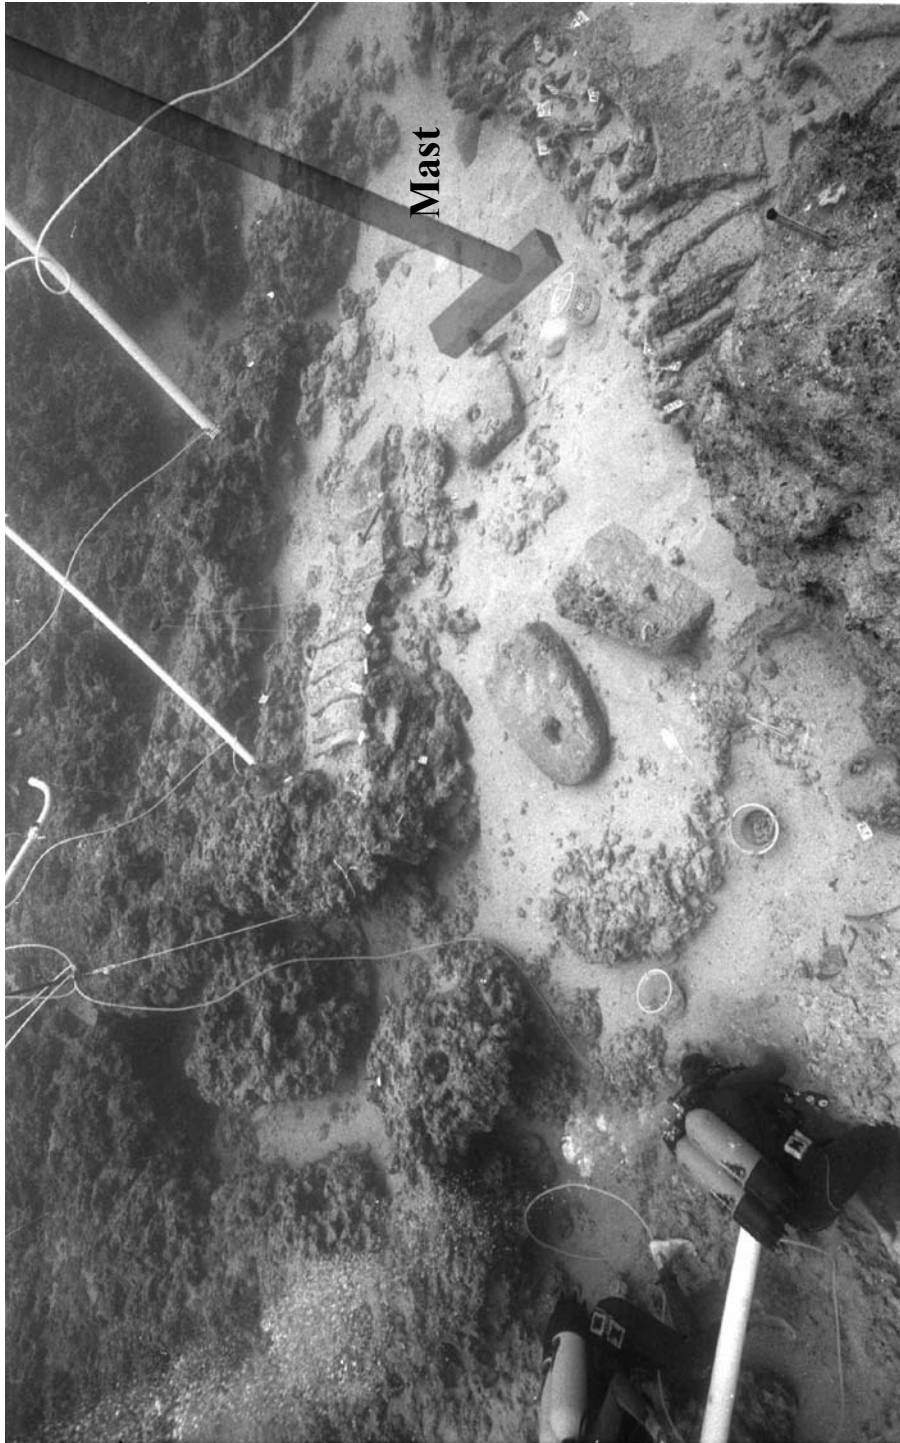
Fig. 2.6 Hypothetical placement of the mast behind row 2 of oxhide ingots. (Photograph courtesy of Institute of Nautical Archaeology, modified by author).

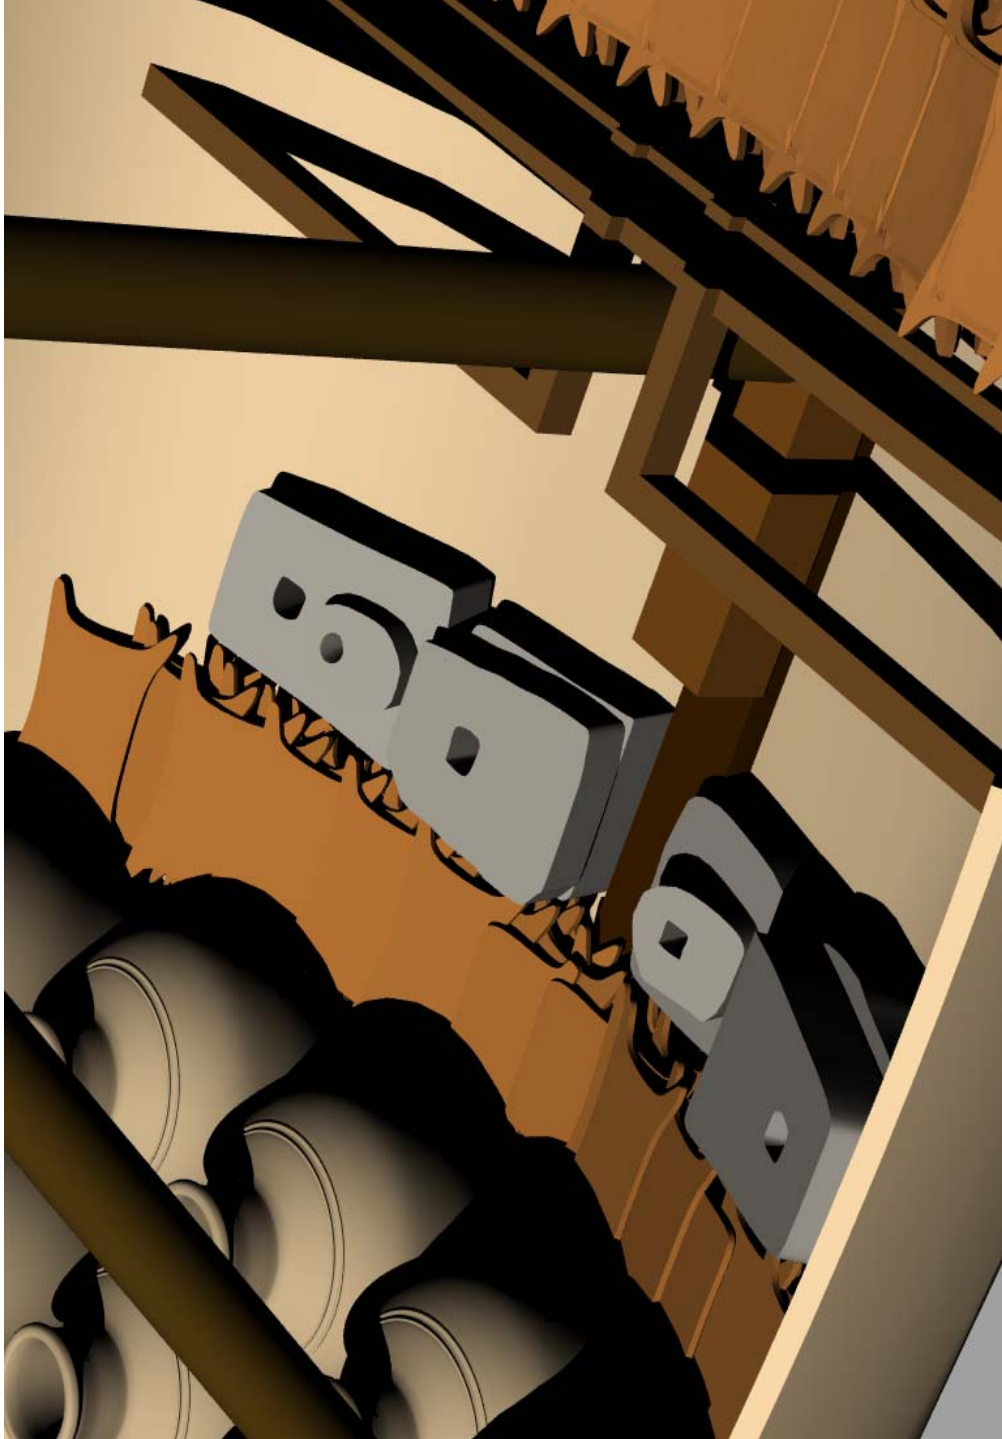
Fig. 2.7 Hypothetical placement of the mast and mast step.

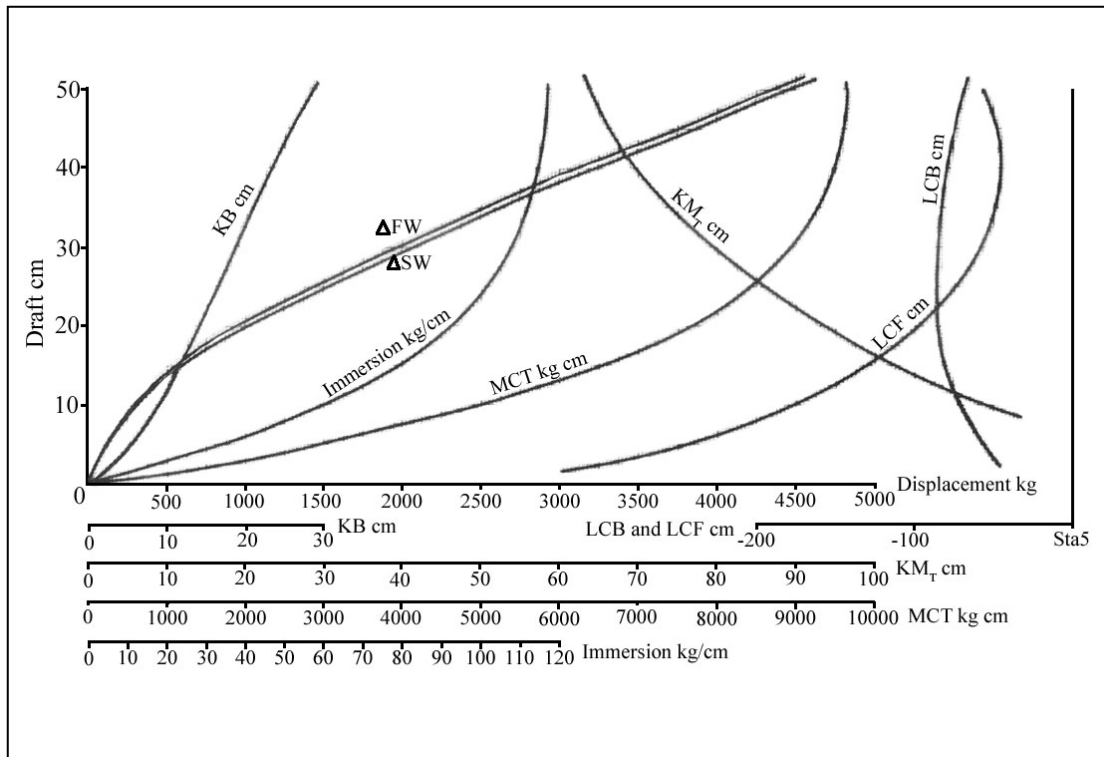
Fig. 2.15 Example of hydrostatic curves chart from the Poole logboat. (After McGrail 1987, 14, fig. 3.2).

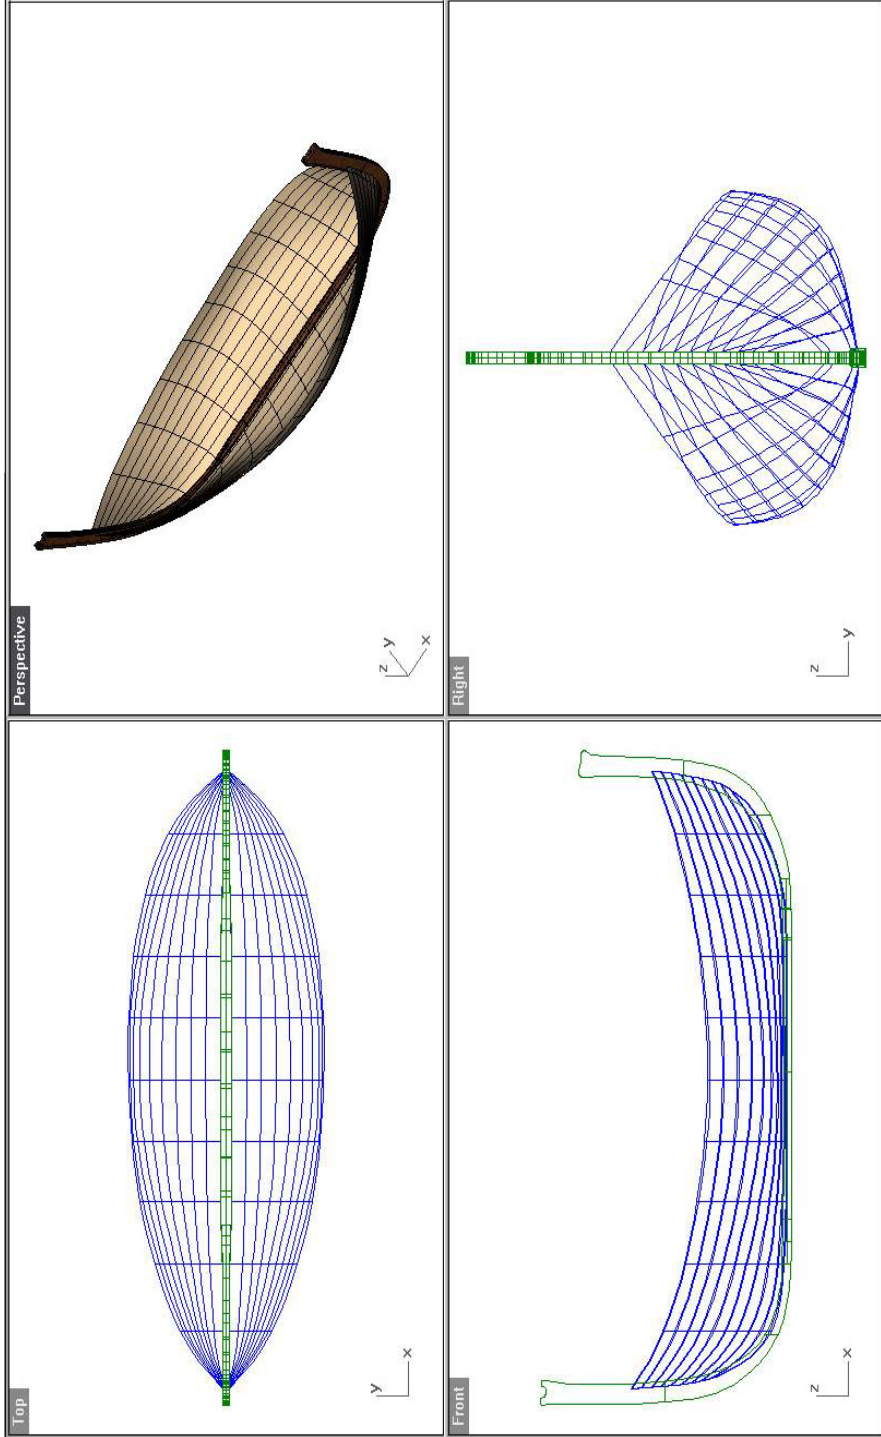
Fig. 2.21 Hypothetical hull no. 2.

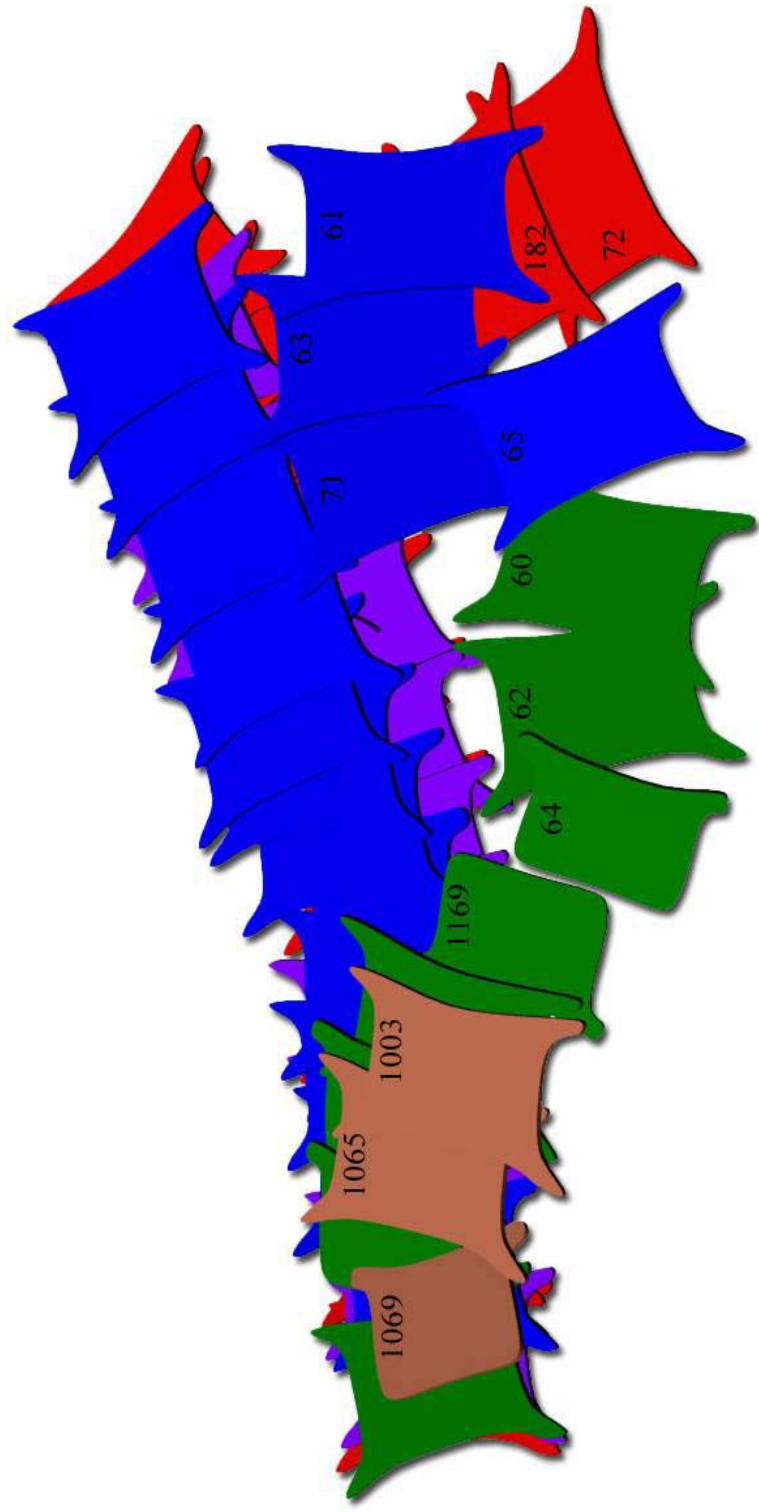
Fig. 4.2 Row 1 of copper oxide ingots as found, color coded by layers.

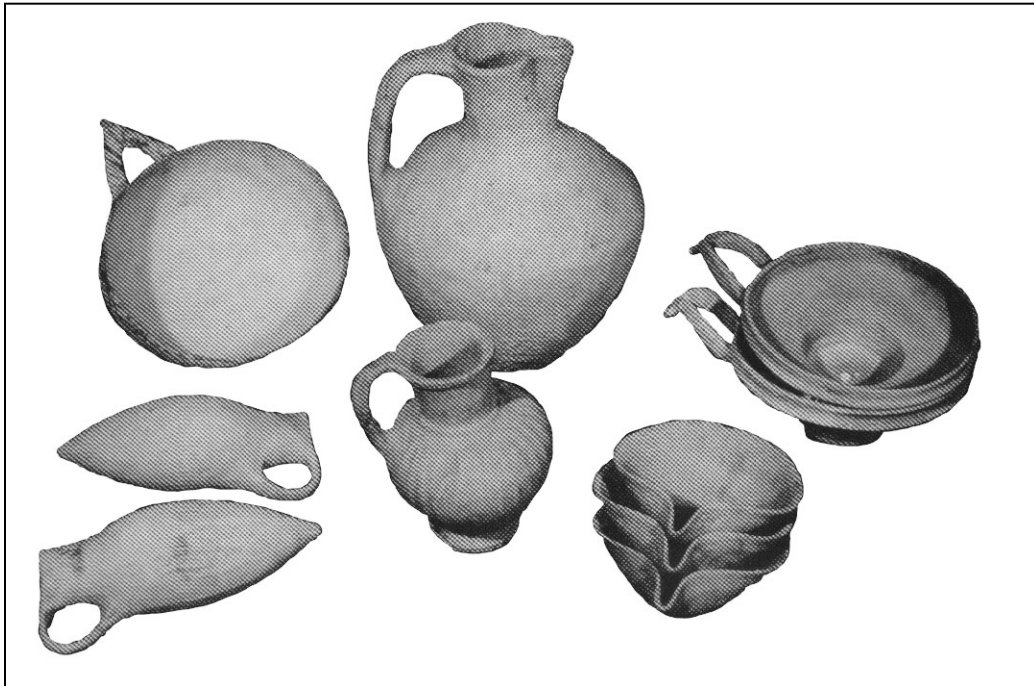
Fig. 5.2 Types of pottery found inside pithos KW 251. Shown above: White Shaved juglets (left front), White Slip II milk bowls (left back), Base Ring II bowls (right back), oil lamps (right front), and Bucchero jugs (center front). Trefoil mouth pitchers (center back) were also closely associated with the pithoi. (After Pulak, 2001, 41, fig. 3).

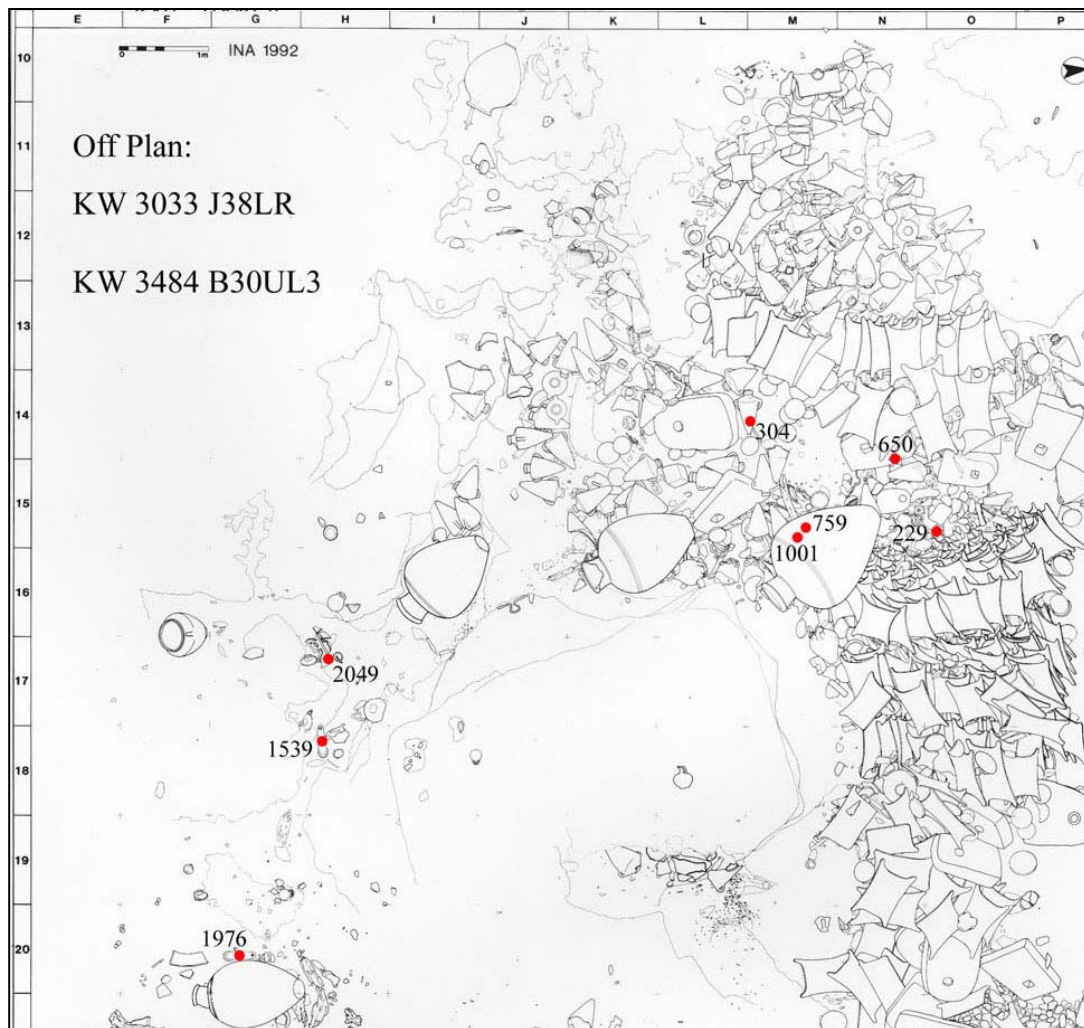
Fig. 5.3 Distribution of wall brackets.
(After Pulak 1998, 192, fig. 4).

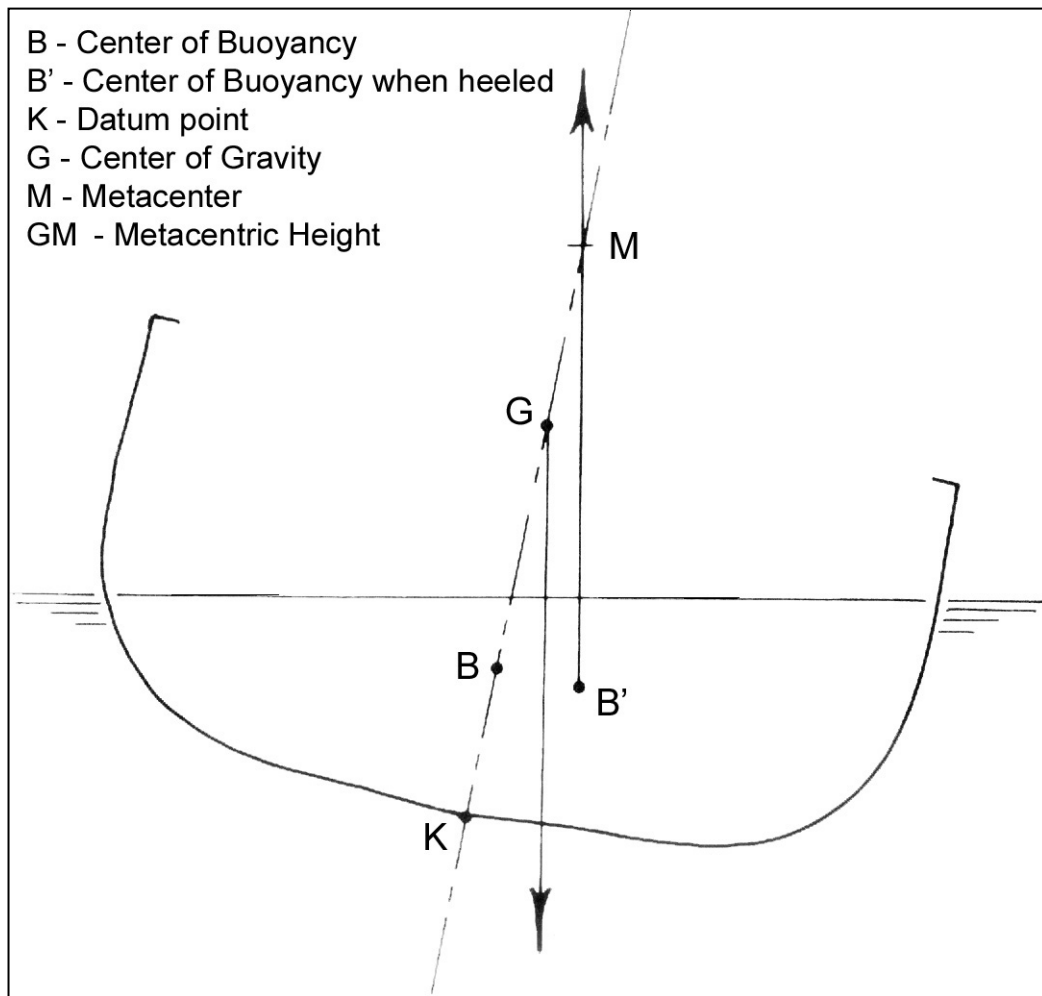
Fig. 7.4 Diagram illustrating the factors of transverse stability. (After McGrail 1987, 15, fig. 3.3).
