MILKING MACHINES and PRACTICES on 60 Illinois Dairy Farms

By L. R. Fryman
and J. L. Albright

CIRCULAR 851

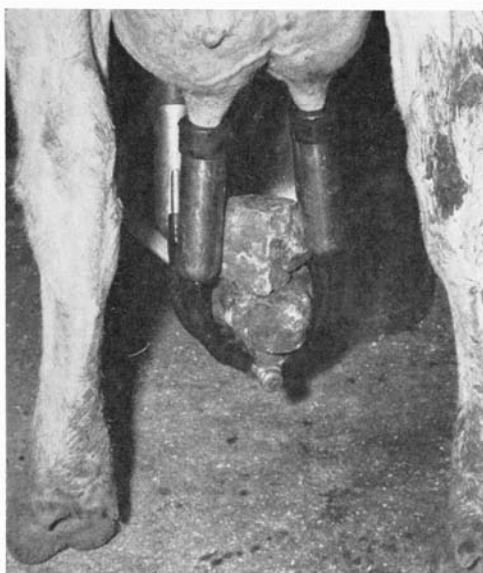
Because of inadequate vacuum reserve, rocks have been placed on this milker claw to add weight and thus help increase the rate of milking. (Fig. 3)

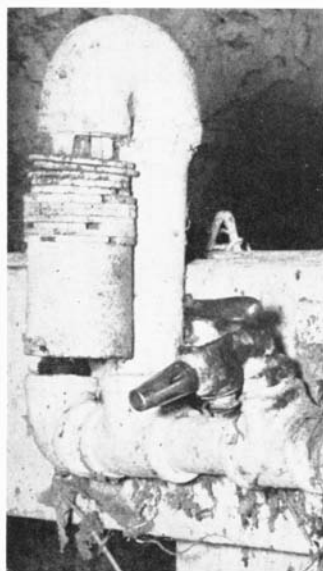
On more than half the farms, the vacuum control valve was at the end of the line. (Fig. 4)

Only 18 percent of the installations in this survey had the valve located near the pump. In about 60 percent of the installations, the valve was located at the far end of the vacuum line (Fig. 4), while in 22 percent it was in about the middle of the line.

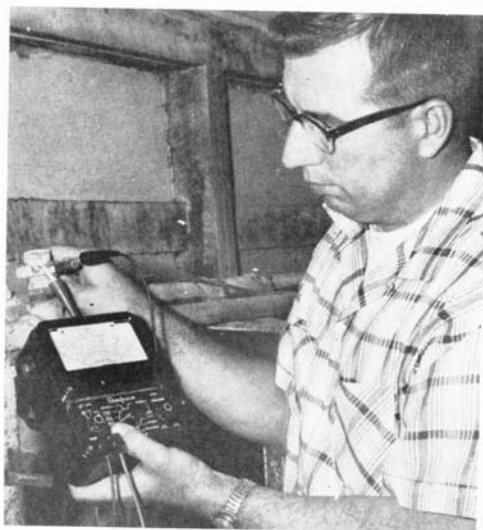
Voltage at the stall cock locations on all of the magnetic installations was within the range recommended by the manufacturer (Fig. 8). Thus, voltage apparently did not contribute to the problems observed with the functioning of the pulsator on this type of machine.

Using a volt meter to check the voltage on the line. (Fig. 8)

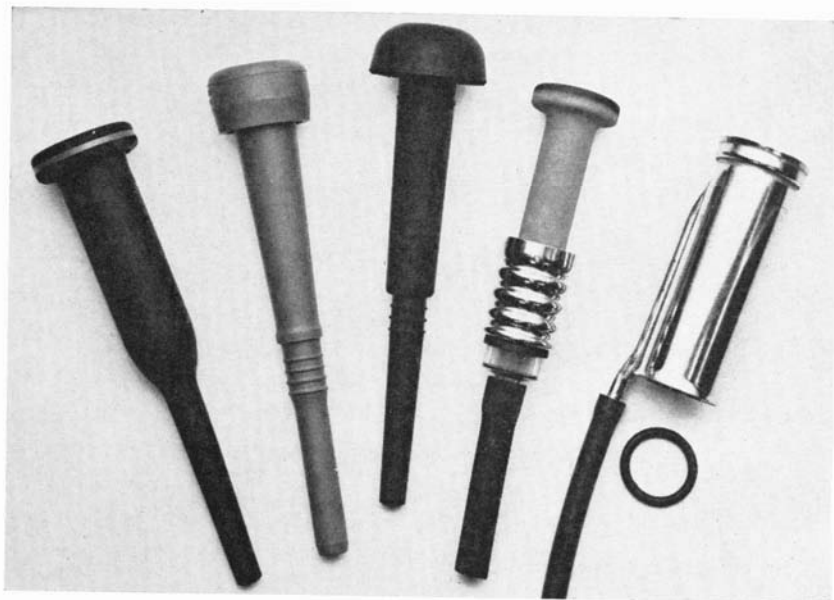
Some of the types of available inflations are shown below. (Fig. 9)

Type of inflation. Most of the dairymen reported that they were satisfied with the type of rubber inflations they were using (Fig. 9). A few said they had tried the narrow bore for a short time but had changed back to the standard bore. Two who were using the standard bore inflation had given some thought to changing to the narrow bore.

About 75 percent of the dairymen were using the standard bore inflations while 25 percent used the narrow bore. Two dairymen used both types in the same barn, but took care not to switch from one type to the other on the same cow.
