Erosion and Accretion Trends Along the Lake Michigan Shore at North Point Marina and Illinois Beach State Park

**Year-2 (1996) Report of a Four-Year Study of Coastal Geology and
Coastal Geologic Processes**

Illinois State Geological Survey
Coastal and Wetlands Geology Section
615 E. Peabody Drive
Champaign, Illinois 61820-6964

Illinois State Geological Survey / Open File Series 1997-8

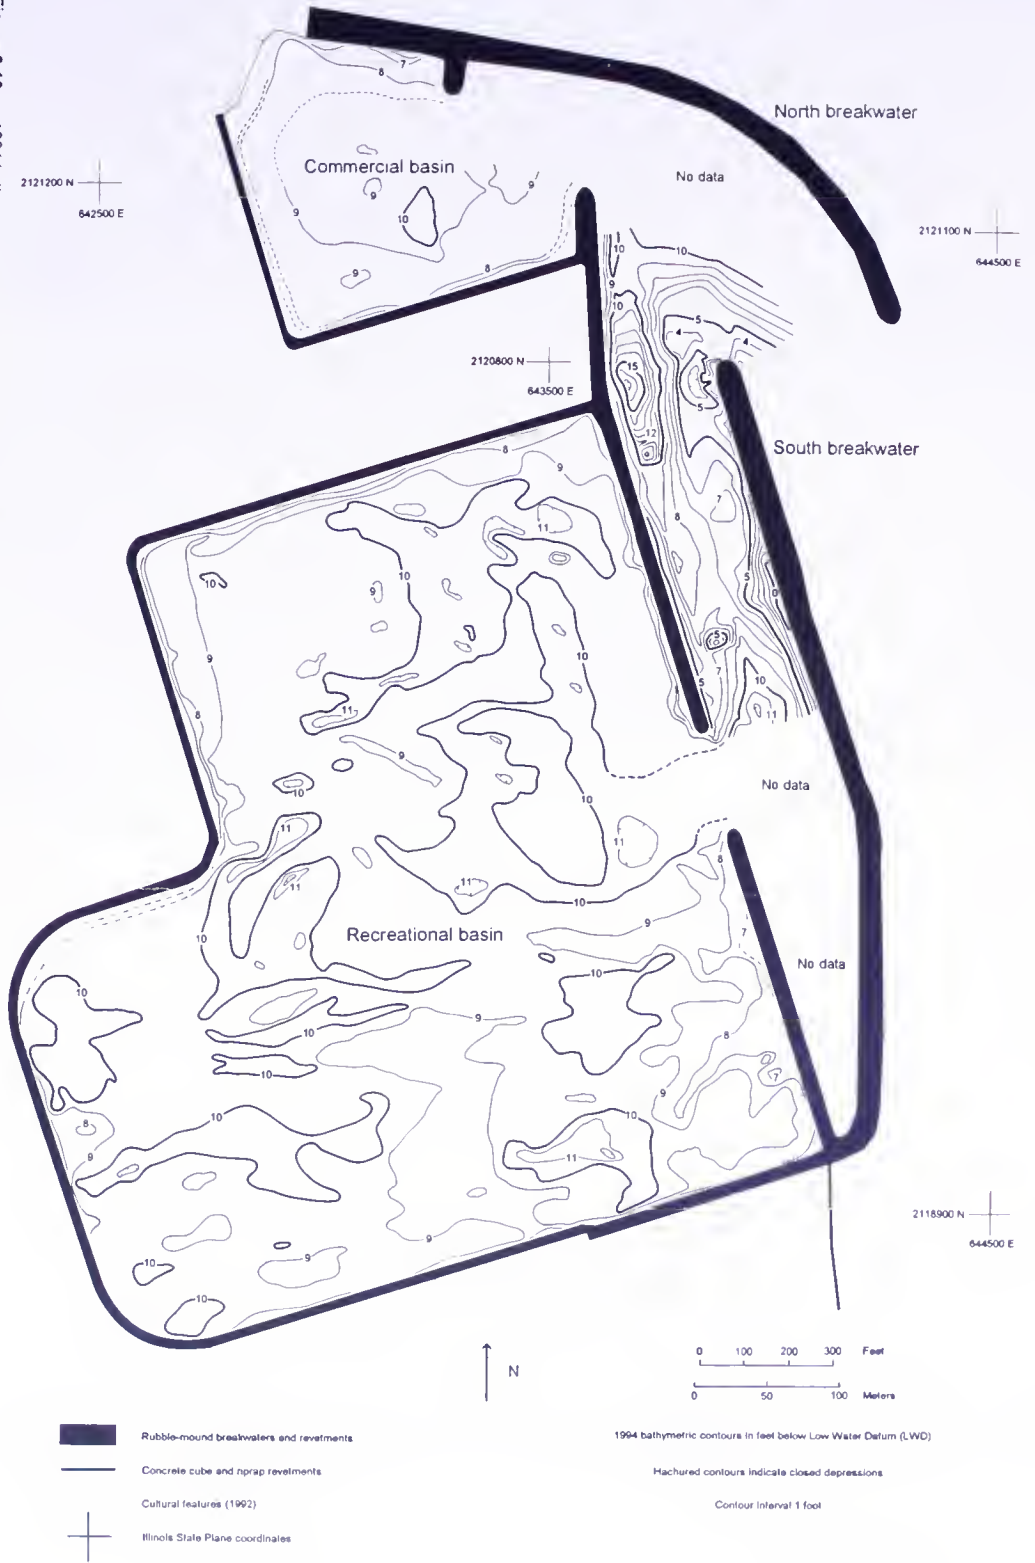
Figure 3-11 1996 bathymetry in the North Point Manna basins and approaches. Data from ISGS surveys in summer and autumn 1996.

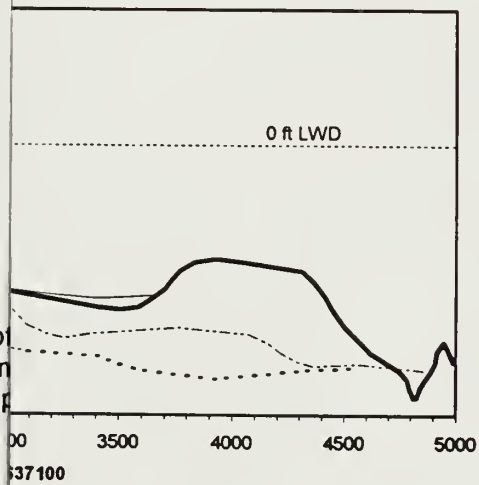
Figure 3-25 Comparative bathymetric profiles for Range Lines 642600, 639300, and 637100. Profiles are shown for Range Lines 642600, 639300, and 637100. Profiles are shown for 1910, 1974, and 1996 (see Appendix 3).

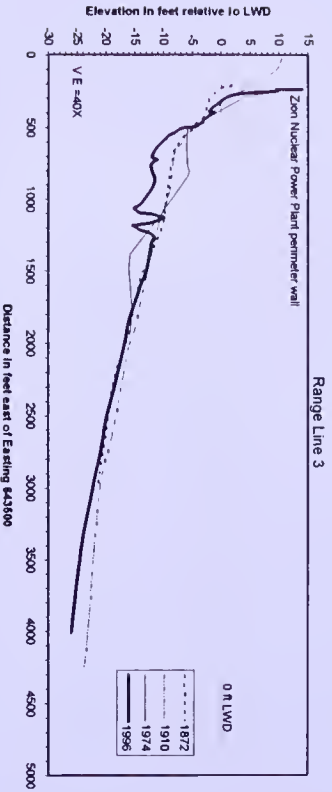
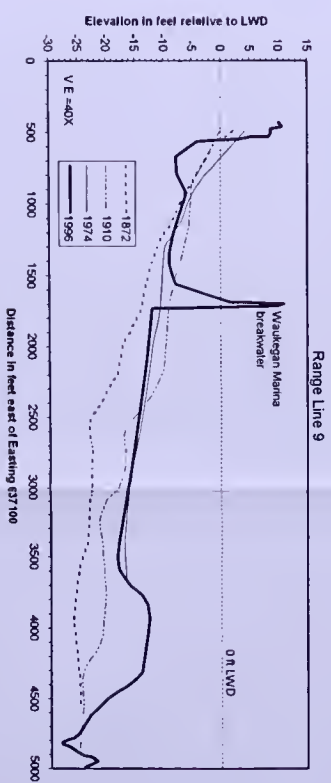
Figure 3-25 Comparative bathymetric profiles within the SLWH coastal reach (1872-1996). Profiles are shown for Range Lines 1, 3, 5, 7, and 9 and show bathymetry during 1872, 1910, 1974, and 1996 (see Appendix J for profile locations).

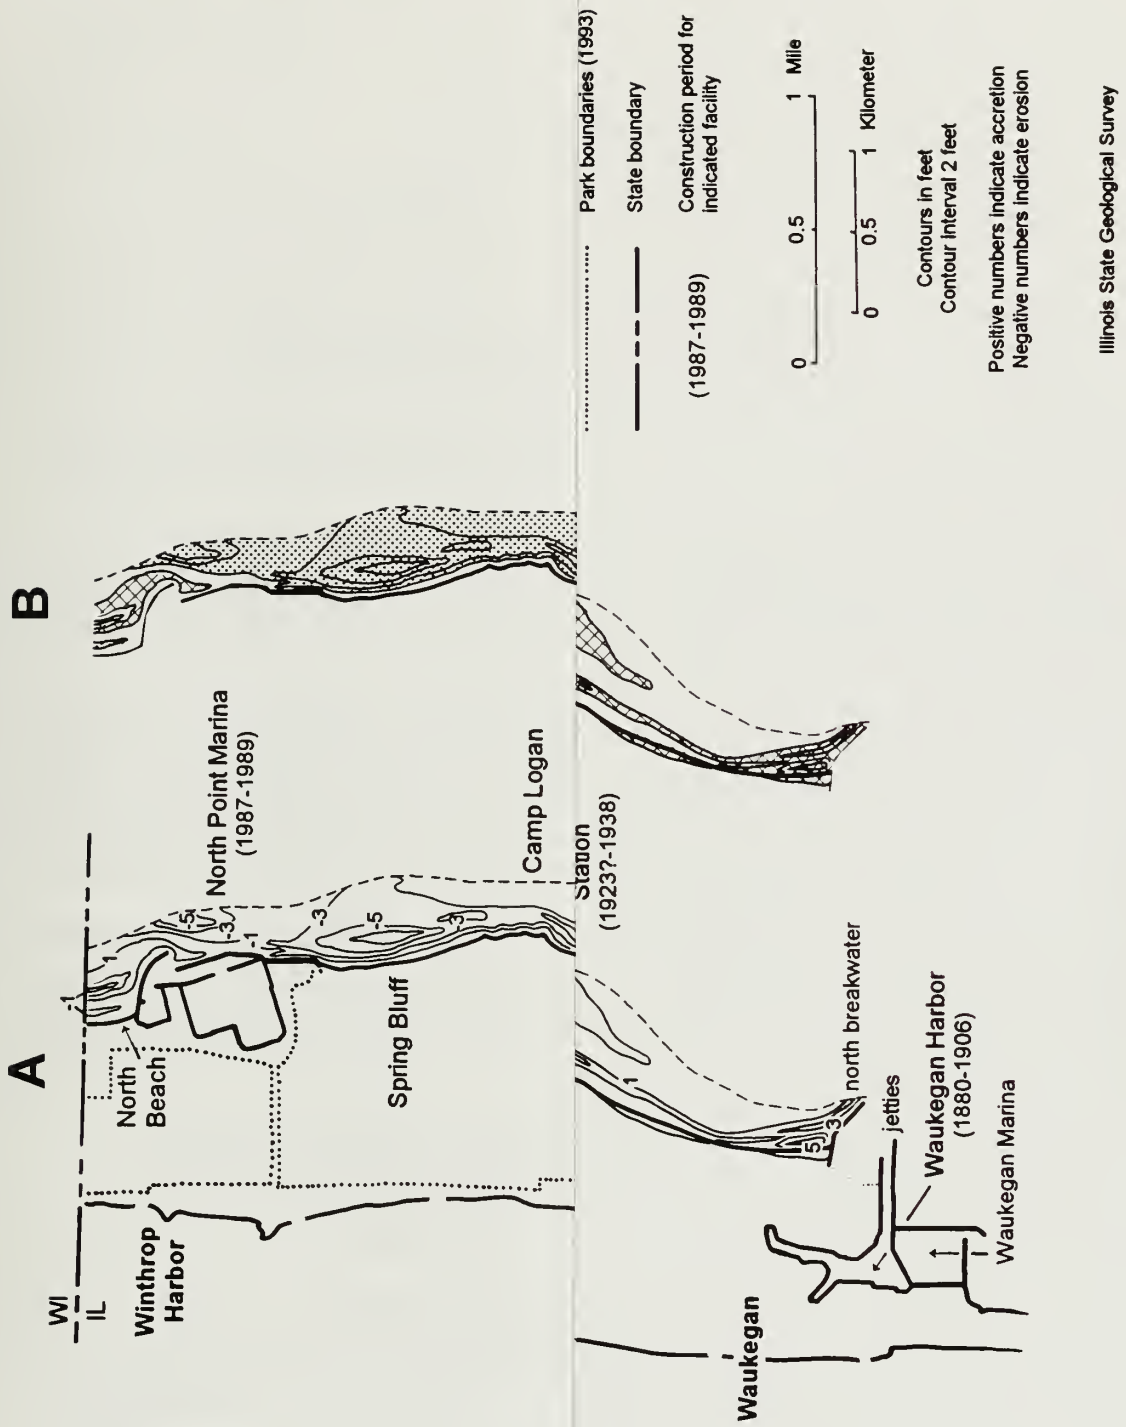
Figure 3-28 1974-1996 lake-bottom change in contour format (A) and shade
