CRWR Online Report 12-03

Ground Penetrating Radar Survey for Risk Reduction at Imja Lake, Nepal

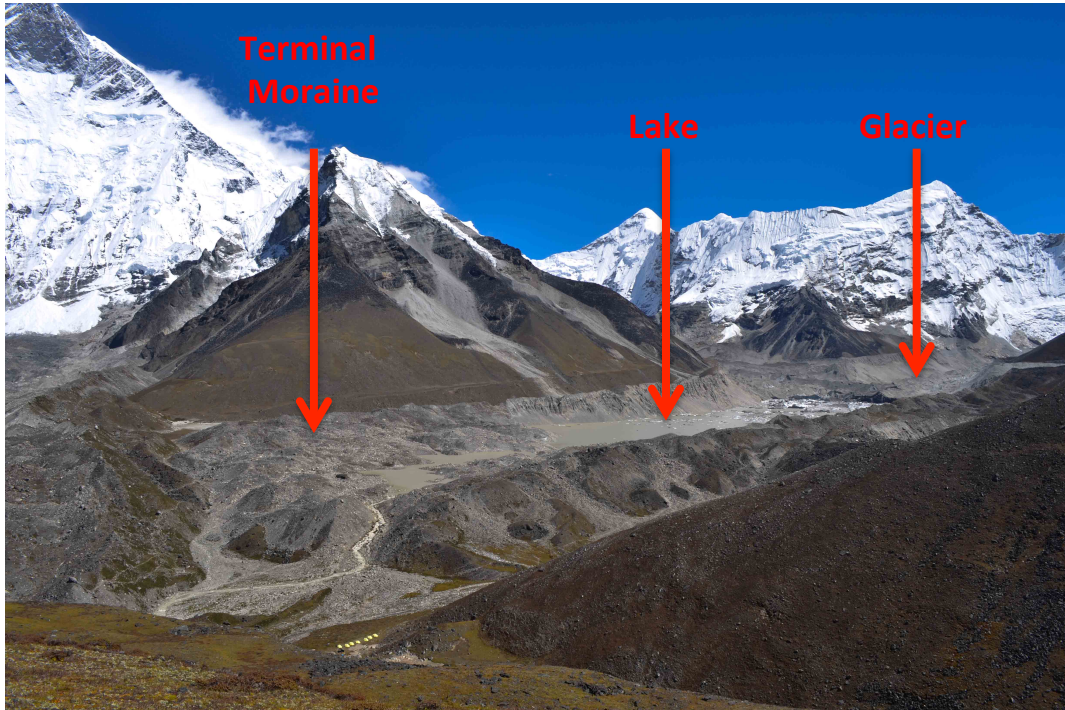
Figure 3. Photo of Imja Lake, September 2012 (Photograph: Daene McKinney)

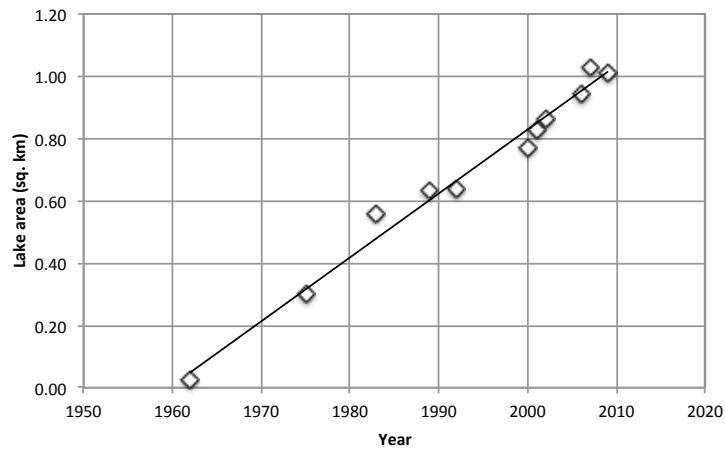
Figure 4. Imja Lake Expansion 1962-2009.

Table 2. Imja Lake Area Expansion 1962 to 2009.

Year	Area (km ²)	Source
1962	0.03	Bajracharya. et al. (2007a)
1975	0.30	Bajracharya. et al. (2007a)
1983	0.56	Bajracharya. et al. (2007a)
1989	0.63	Bajracharya. et al. (2007a)
1992	0.64	Yamada and Sharma (1993)
2000	0.77	Bajracharya. et al. (2007a)
2001	0.83	Bajracharya. et al. (2007a)
2002	0.86	Sakai et al. (2003)
2006	0.94	Bajracharya. et al. (2007a)
2007	1.03	Watanabe et al. (2009)
2009	1.01	Watanabe et al. (2009)

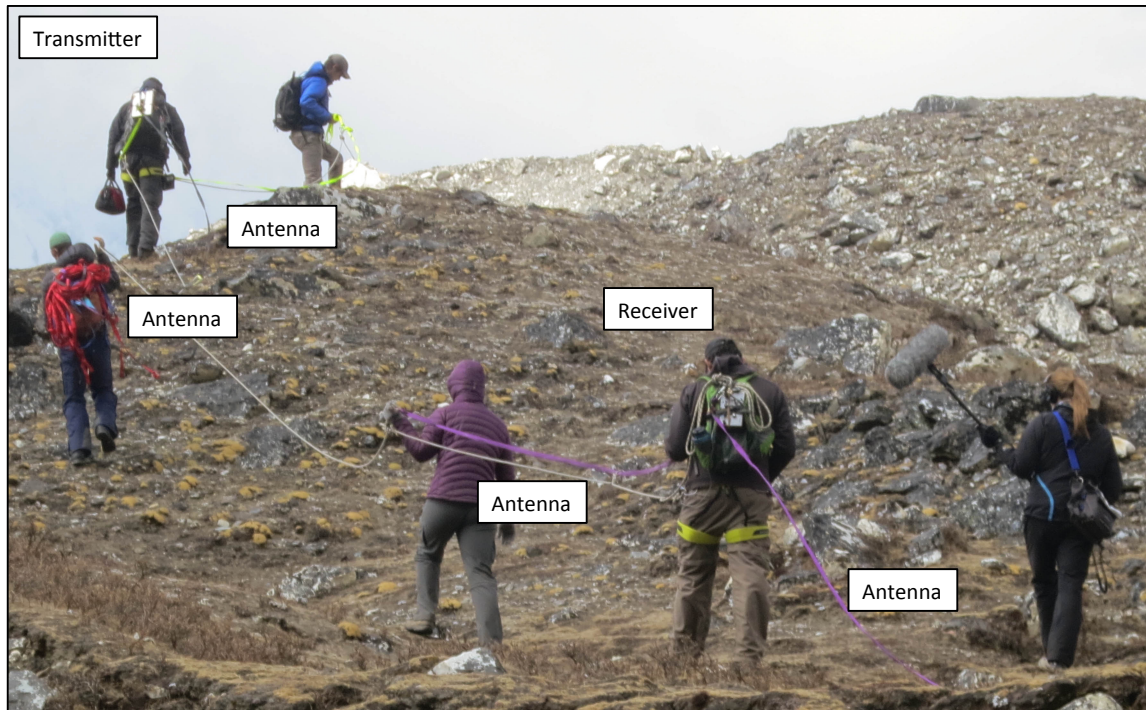
Figure 5. Backpack mounted GPR system deployed in the field at Imja Lake. (Photograph: Alton Byers)

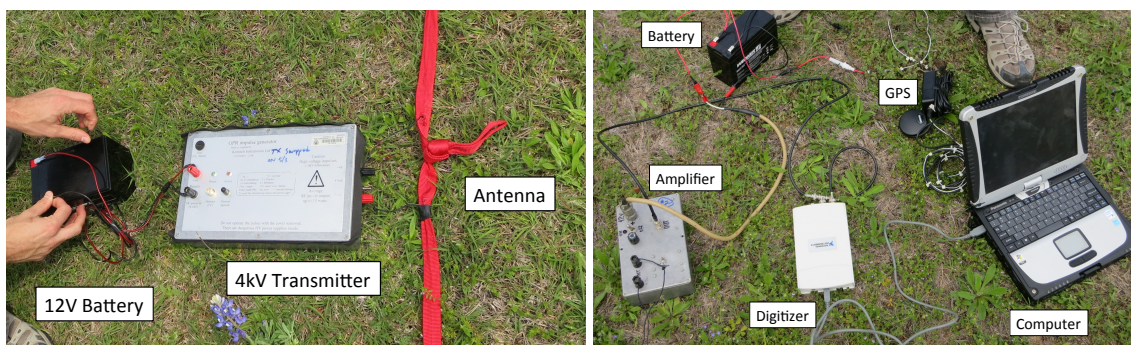
Figure 6. GPR transmitter (left) and GPR receiver (right) (*Photographs: Daene McKinney*)

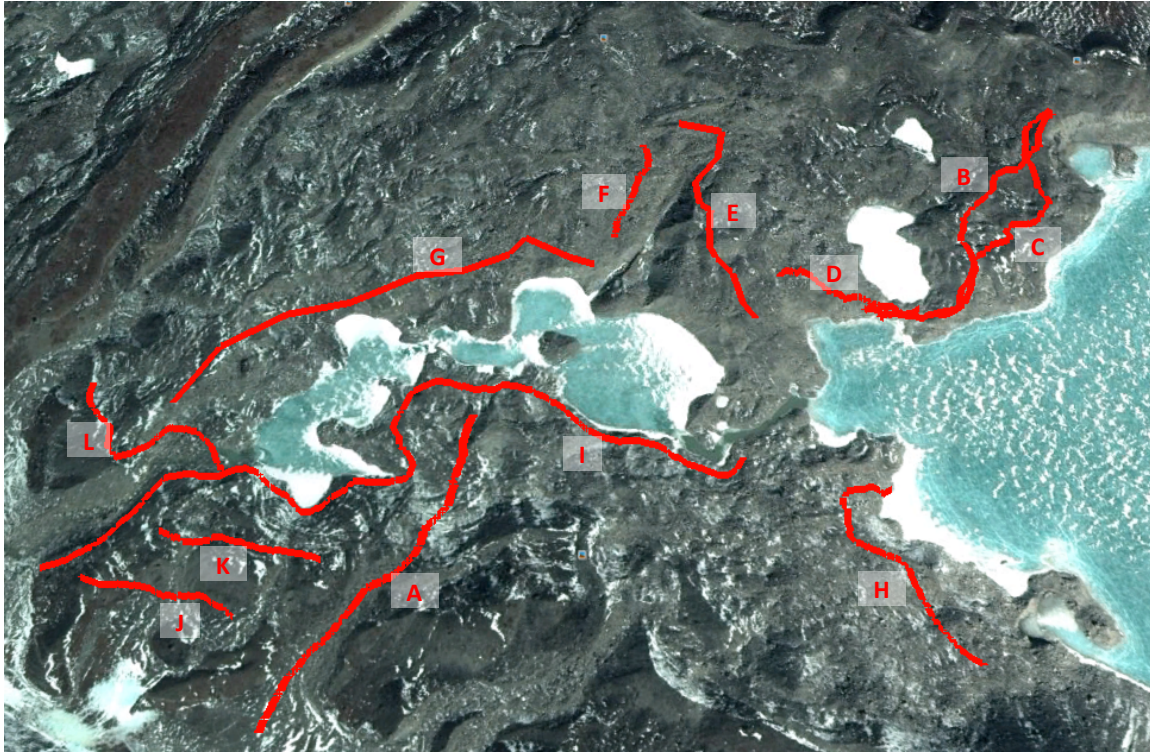
Figure 7. Mapping of GPR transects at the terminal moraine of Imja Lake taken in May 2012. (Source: Google Earth, 2010)

Table 4 lists the GPR transects conducted at the terminal moraine of Imja Lake and one on the Imja glacier 22-26 May and 21-25 September 2012. Figure 7 shows the layout of GPR transects on an image of the lake.

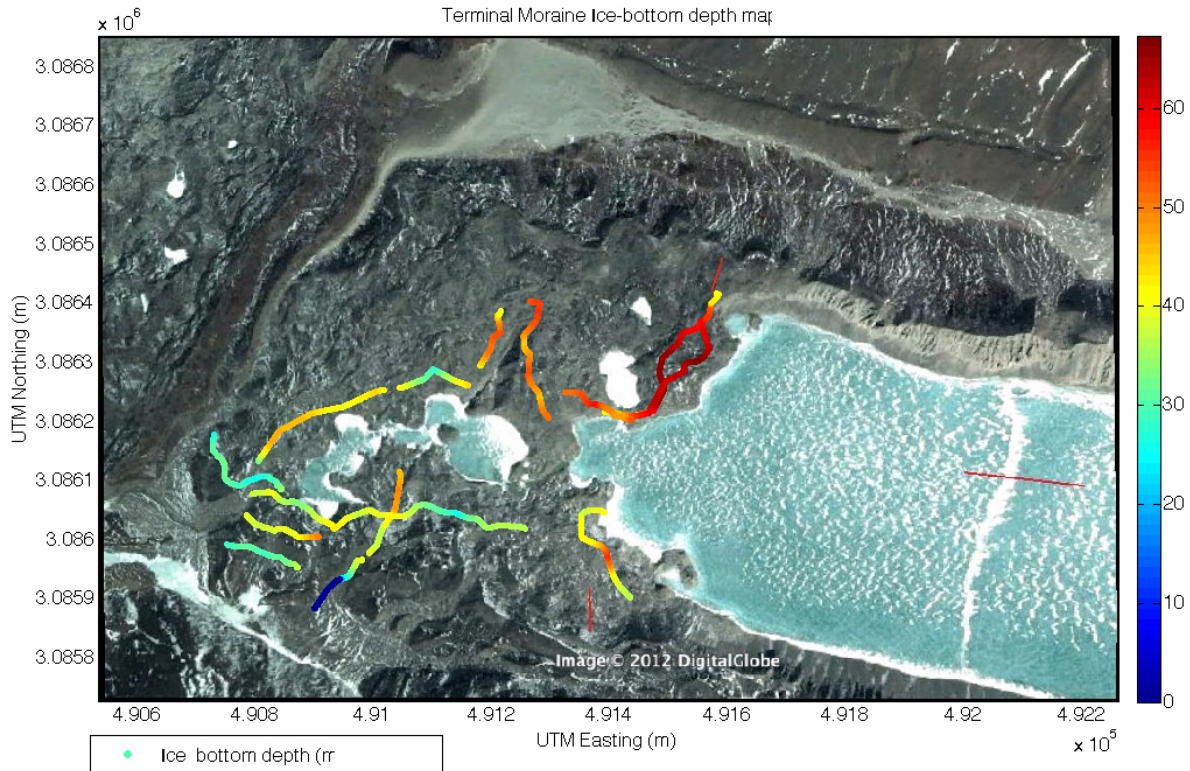
Figure 8. Imja lake ice-bottom depth (m) within the terminal moraine area.

The results of the GPR survey show that there is extensive ice present in the core of the terminal moraine complex at Imja Lake (see Figure 8). The thickest areas of ice are in the moraine near the western end of the lake on the northern side of the lake outlet. The ice in this region is several tens of meters thick and up to fifty meters thick in some places. Along the northern and southern sides of the lake outlet, the ice is between ten and twenty-five meters thick. In some portions of the moraine on the southern side of the outlet the ice thickness is up to forty meters.

Surface elevations were measured by GPS during the GPR transects. The GPS data were collected using both a Garmin BU-353 and a handheld Garmin Etrex Vista HCx unit. Figure 8 shows the depth of the bottom of the ice (m) in the Imja Lake terminal moraine interpreted from the GPR transects assuming a velocity of propagation in the subsurface material of 110×10^6 m/s.

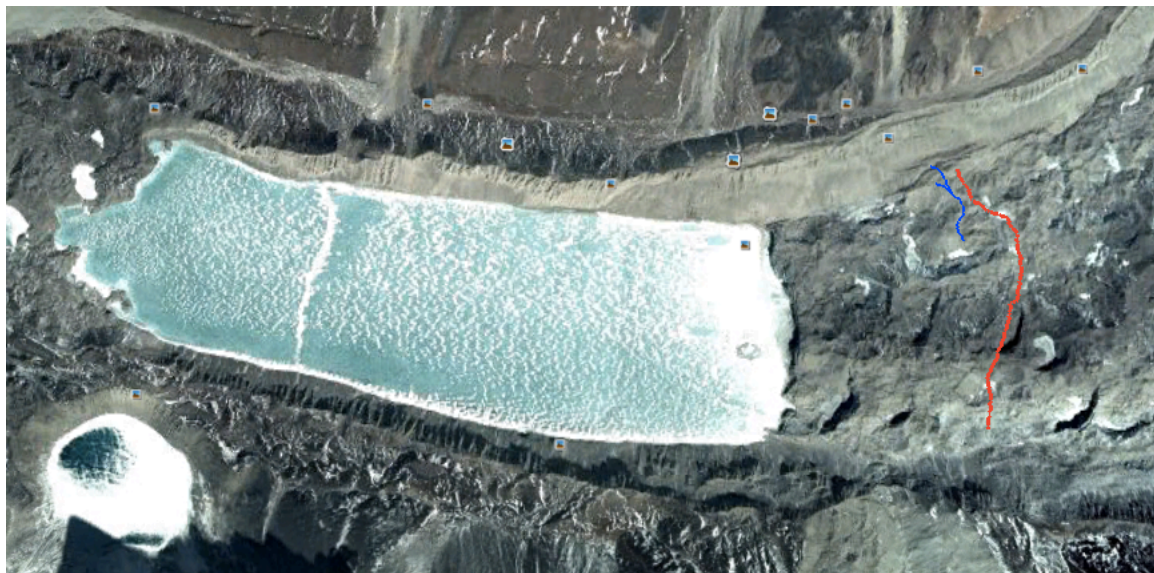
Figure 9. Mapping of GPR transects at Imja glacier taken May 25, 2012 (Blue) and September 25, 2012 (Red). (Source: Google Earth, 2010)

Figure 9 shows the location of the GPR transect taken on the Imja glacier. Figure 10 shows the resulting GPR data from the transect, clearly illustrating the transition from layered ice (upper left) to bedrock (lower right). The GPR data were processed assuming a velocity of propagation through the ice of 167×10^6 m/s, typical of a debris containing ice. Figure 11 illustrates the nature of the glacier with its thin layer of debris overlying the thick ice formation. The thin layer of debris has contributed to the rapid melting of the Imja glacier since the 1960s.

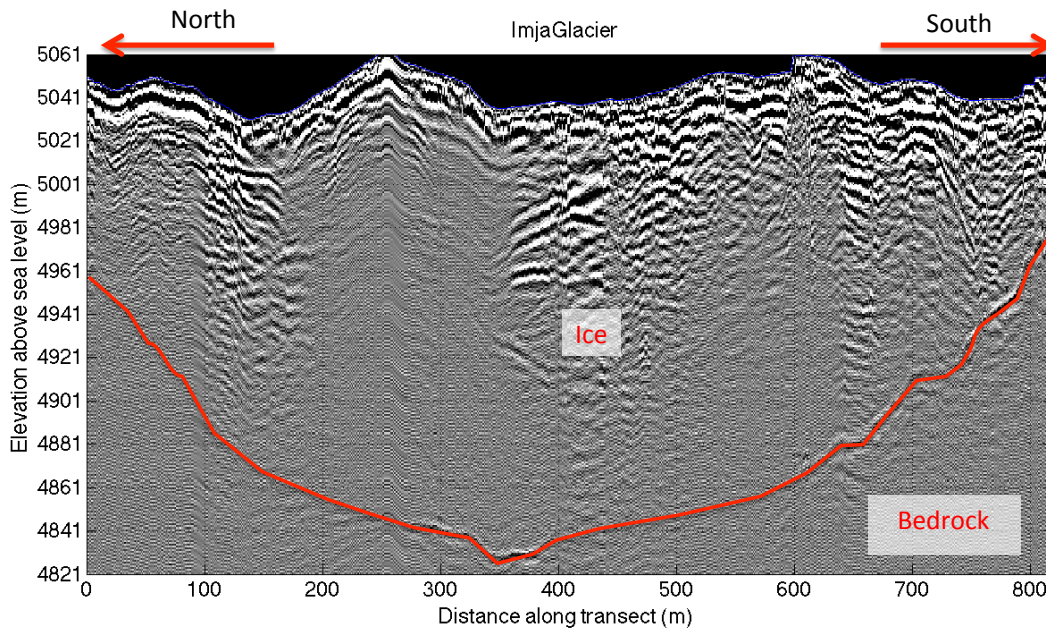
Figure 10. GPR transect at Imja glacier at Imja Lake crossing from north to south on September 25, 2012 using a 10 MHz antenna assuming a velocity in ice of 167×10^6 m/s.

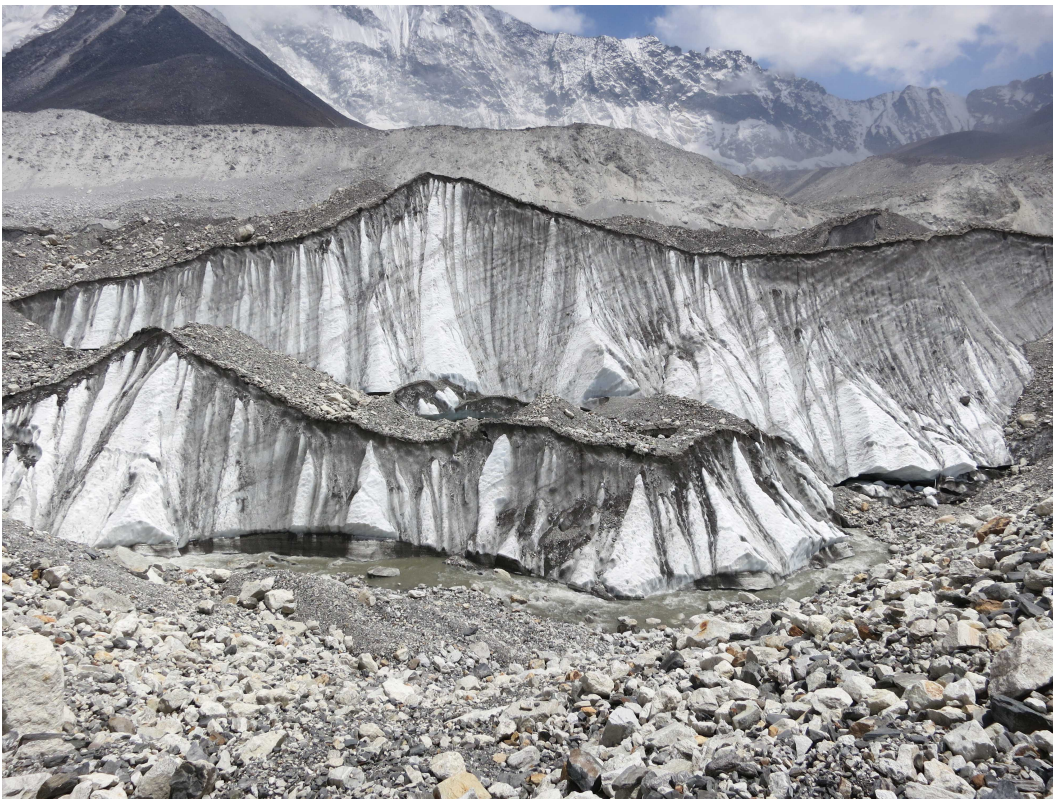
Figure 11. Photo of the Imja glacier showing the thin debris cover and ice structure beneath. (Photograph: Daene McKinney)

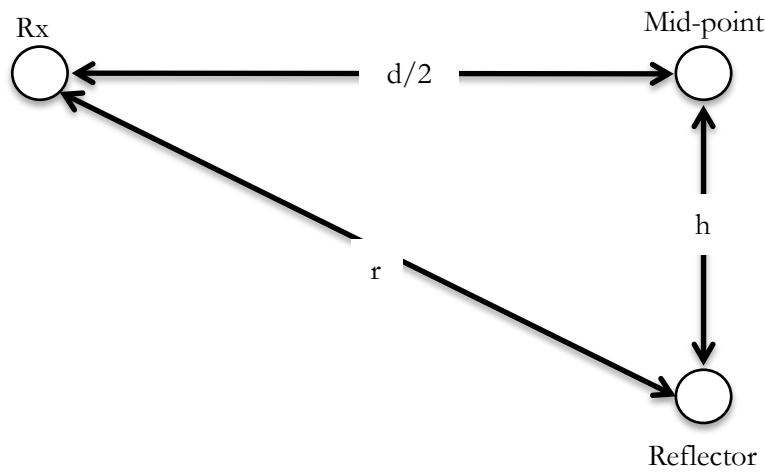
Figure 12. Common Mid-Point (CMP) method setting.

The common mid point (CMP) method (Annan 2001) was used to estimate the propagation velocity of the GPR signal in the terminal moraine at Imja Lake. In order to achieve that we took a set of five static GPR measurements on September 25, 2012 at the location of Transect B (see Fig. 7) on the terminal moraine on the north side of the outlet of the lake. The 5 sets of measurements have different distances (20, 25, 30, 35 and 40 m) from the transmitter (Tx) to the receiver (Rx) with a constant (common) midpoint location. From now on the transects are going to be identified by their distance from the Rx to Tx. Figure 12 shows an idealized sketch of the field setting. We have three important variables, the distance from Rx to Tx which is known, the depth of the reflector point (h) which needs to be calculated and the distance traveled by the signal from the reflector to the receiver (r) which also needs to be calculated.

$$r^2 = (h)^2 + \left(\frac{d}{2}\right)^2 \quad (1)$$

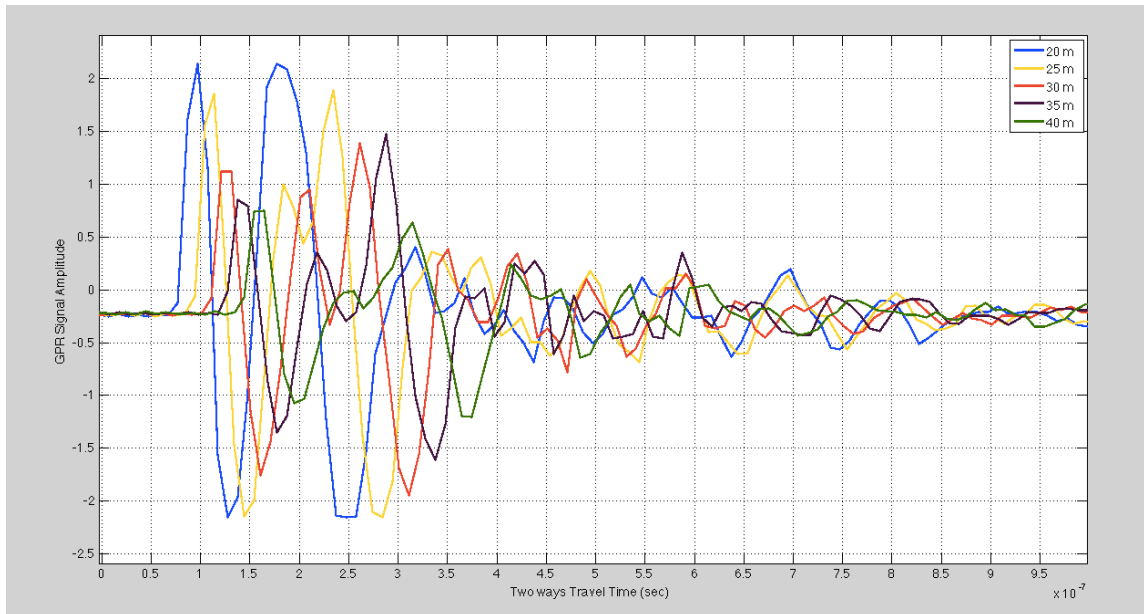
Figure 13. Static data collected at the Imja Lake moraine using a common mid point (CMP) for different distances from the transmitter to the receiver.

The data collected at Imja Lake terminal moraine for the CMP calculation is shown in Figure 13 and the results are shown in Table 5. The average earth wave velocity is estimated in 118×10^6 m/s. The average velocity from the reflector is 124×10^6 m/s $\pm 8.1 \times 10^6$ m/s. The vertical distance from the surface to the reflecting point is $16.3 \text{ m} \pm 0.2 \text{ m}$.

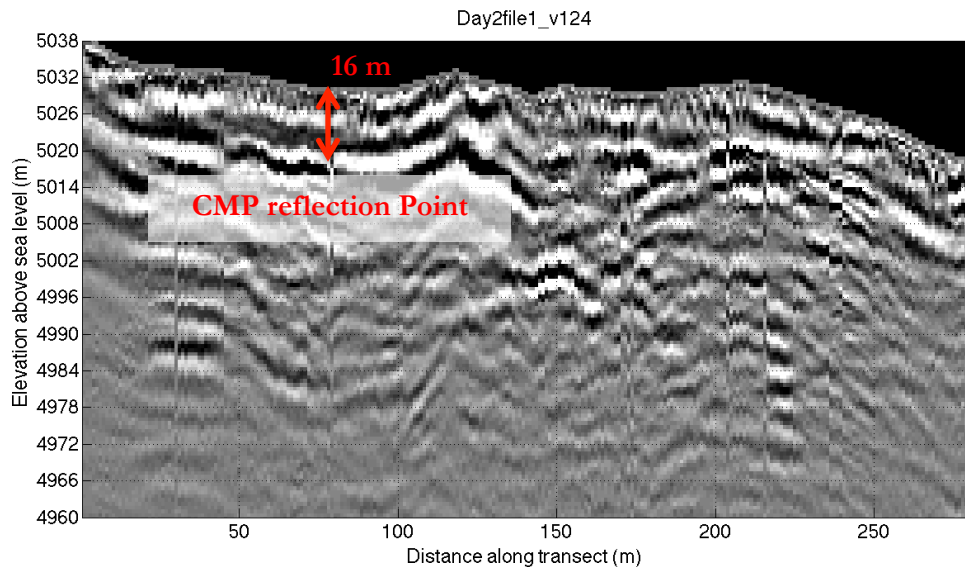
Figure 14. Location of the CMP measurement in Transect B (see Fig. 7). The velocity used in this echogram is 124×10^6 m/s.

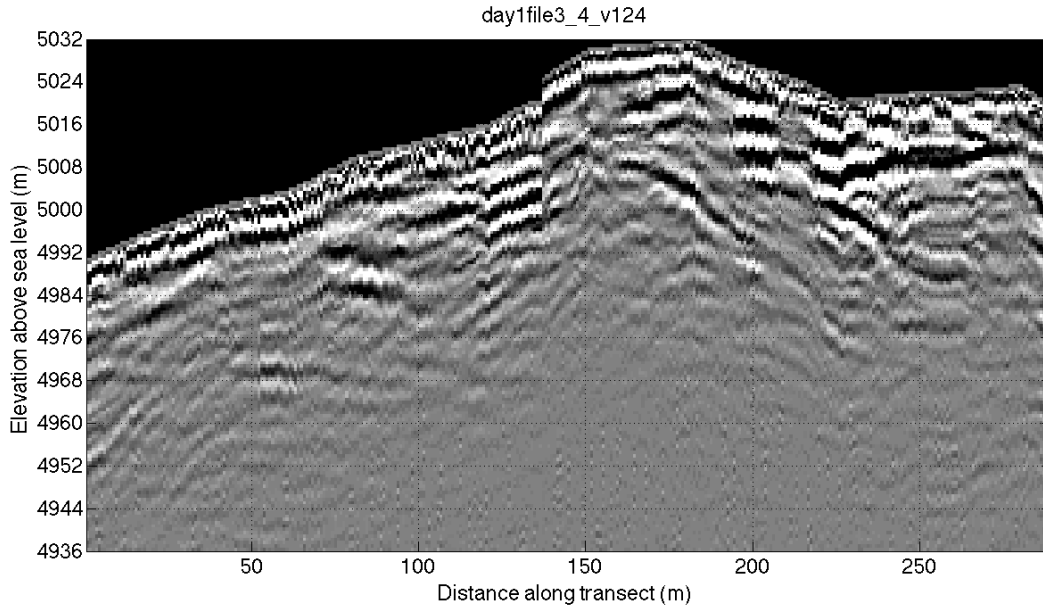
Figure 15. GPR transect A (Day1file3_4) at Imja Lake on the south lateral moraine crossing from south to north using a 10 MHz antenna and assuming a velocity of 124×10^6 m/s.

Figure 15 shows the GPR transect at the south lateral moraine crossing from south to north using a 10 MHz antenna (see Fig. 7 for location of Transect A). After 50 m along the transect high reflections indicate ice underneath. Around 75 m, more areas with high reflections are visible with ice thickness from 30 m at the outer side of the moraine to 70-80 m in the inside of the moraine.

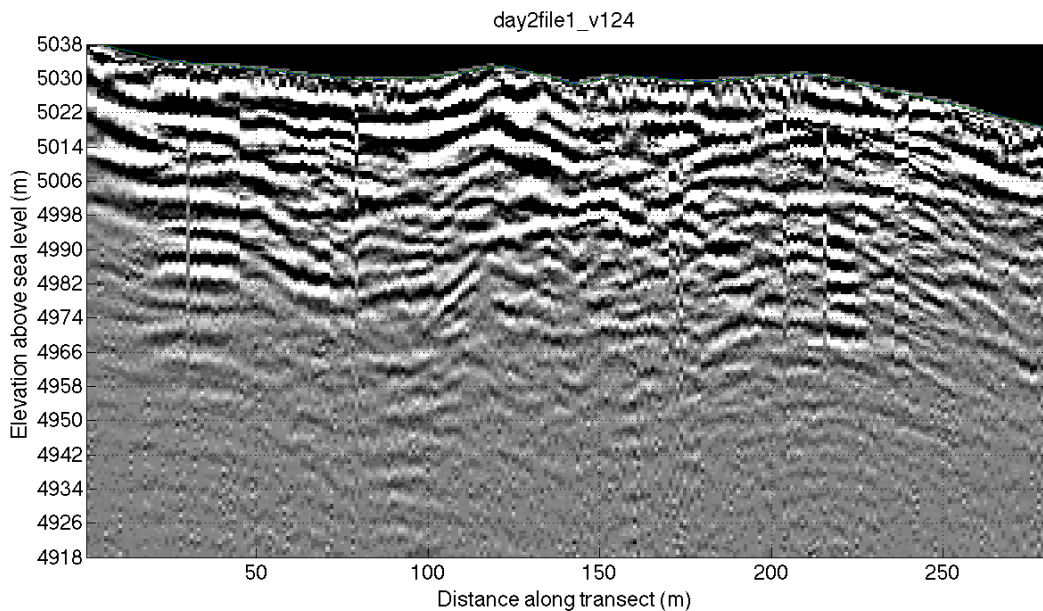
Figure 16. GPR Transect B (Day2file1) at Imja Lake from north to south on the terminal moraine above the north-west shore using a 5 MHz antenna and assuming a velocity of 124×10^6 m/s.

Figure 16 shows GPR Transect B (Day2file1) moving from north to south on the terminal moraine above the north-west shore of Imja Lake using a 5 MHz antenna. In the center of the transect (after about 150 m) the depth of the ice is about 60 m. On the face of the moraine, this ice is collapsing into the lake according to observations in the field (see Figure 17).

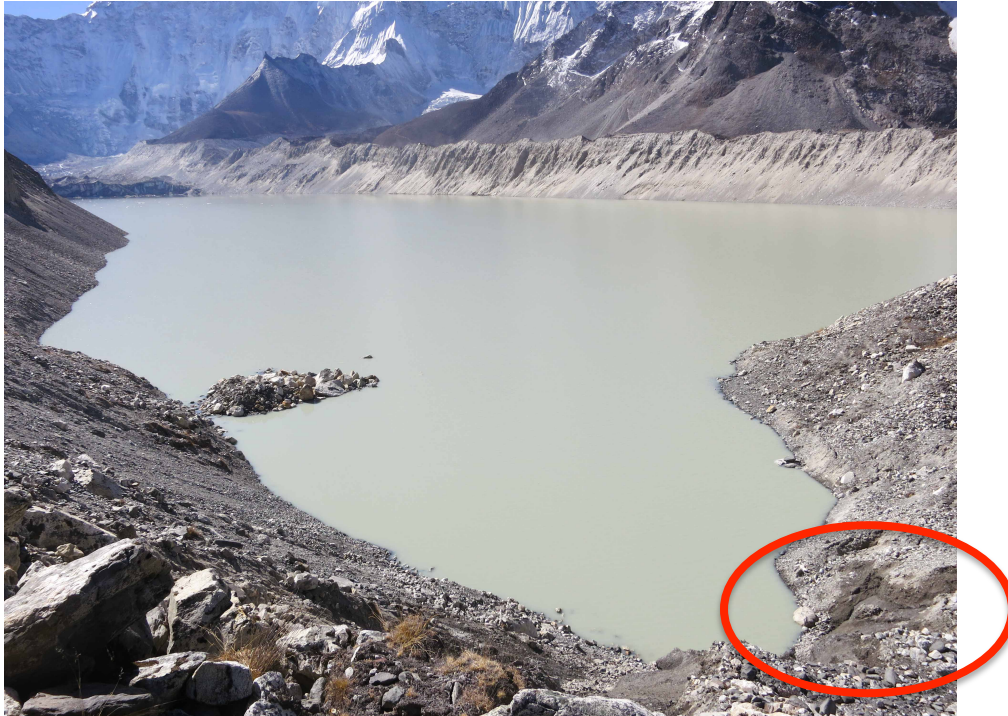
Figure 17. Ice on the face of moraine on Transect B, May 23, 2012. (Photograph: Daene McKinney)

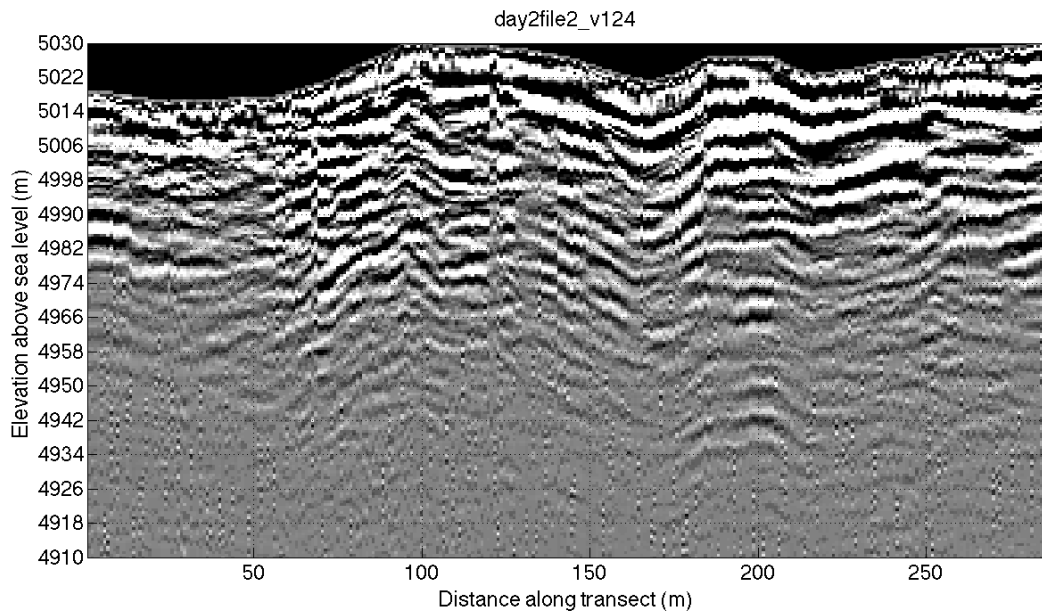
Figure 18. GPR Transect C (Day2file2) at Imja Lake moving from south to north on the terminal moraine above the north-west shore with a 5 MHz antenna and assuming a velocity of 124×10^6 m/s.

Figure 18 shows GPR Transect C (Day2file2) moving from south to north on the terminal moraine above the north-west shore of Imja Lake with a 5 MHz antenna. In the center of the transect the depth of the ice is about 60 m.

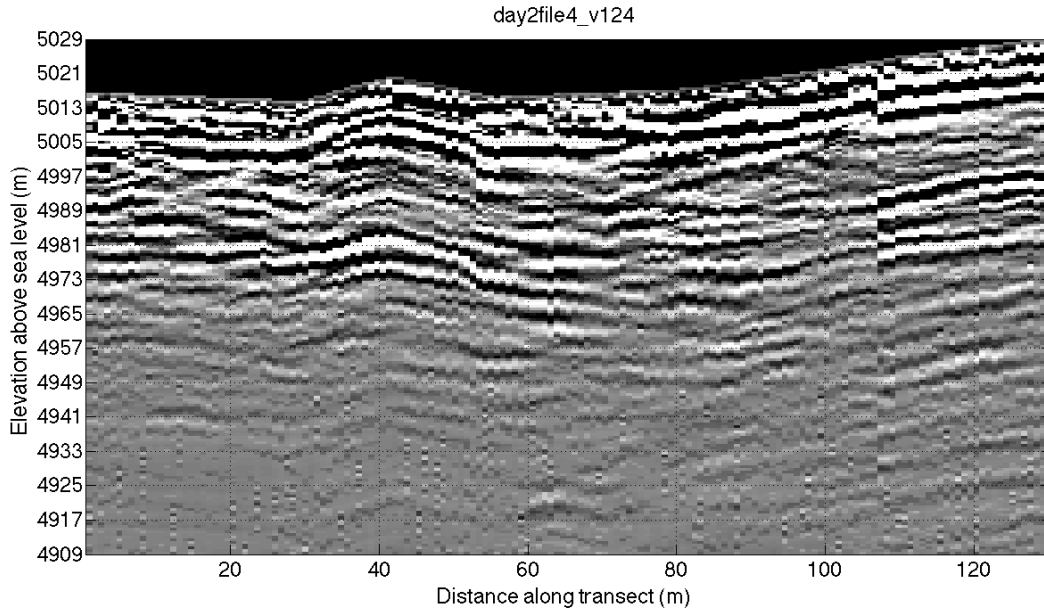
Figure 19. GPR Transect D (Day2file4) at Imja Lake crossing between the blue pond at the north side of the outlet using a 10 MHz antenna and assuming a velocity of 124×10^6 m/s.

Figure 19 shows GPR Transect D crossing between the blue pond at the north side of the outlet using a 10 MHz antenna. Figure 20 shows the exposed ice face on the side of the moraine above the blue pond.

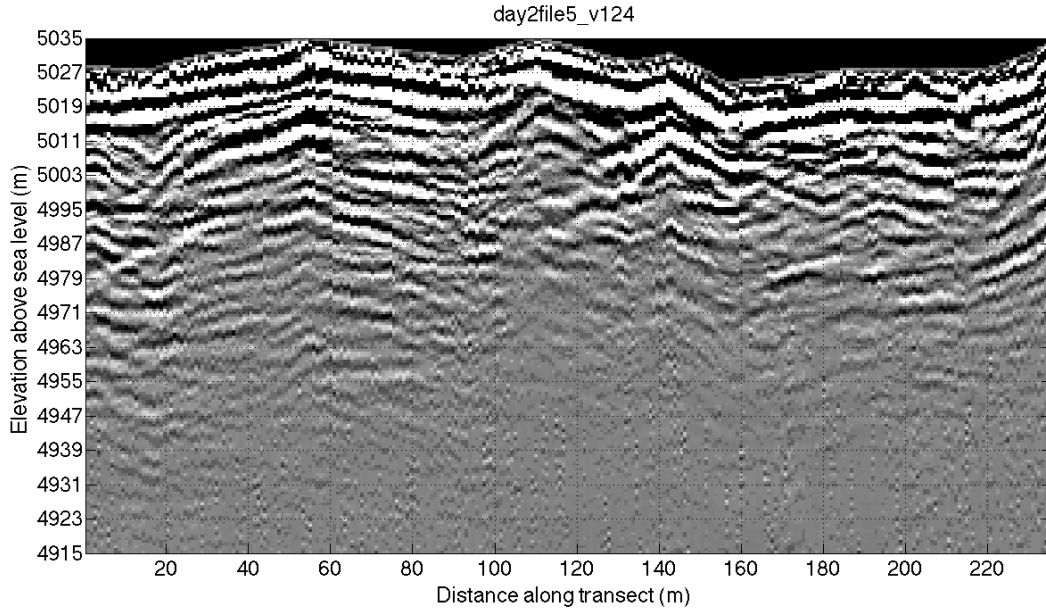
Figure 20. Transect E (Day2file5) at Imja Lake moving in the direction of the northern lateral moraine with a 10 MHz antenna and assuming a velocity of 124×10^6 m/s.

Figure 20 shows GPR Transect E near the middle of the terminal moraine, starting from the outlet and moving in the direction of the northern lateral moraine with a 10 MHz antenna. This transect corresponds to the highest surface elevation points of the moraine. Reynolds Geoscience Ltd. (RGS 2003; Reynolds 2006; Hambrey et al. 2008) deployed a Sensors and Software PulseEKKO 100 system with an antenna center-frequency of 100 MHz at Imja Lake in 2001 along two profiles across the terminal moraine complex (one transverse from the north lateral moraine to the lake outlet (similar to Transect E reported here) and one longitudinal along the north side of the outlet (similar to Transect G reported below) to determine depths of the debris cover over ice within the moraine complex, and to estimate ice thickness (Hambrey et al. (2008)). The results from one transect (near Transect E) show an ice-cored inner zone at the western end of Imja Lake comprised of debris-covered ice tens of meters thick. They note that the presence of ice is clearly indicated, especially by ERT and that the morainic debris is layered. The electrical resistivity measurements reported by Hambrey et al. (2008) are interpreted to show a debris cover about 5 – 20 m thick with 20 – 30 m of ice below that. Their GPR measurements are only reported in terms of two-way-travel time and not converted to depth since the velocity of GPR wave propagation in the subsurface was unknown.

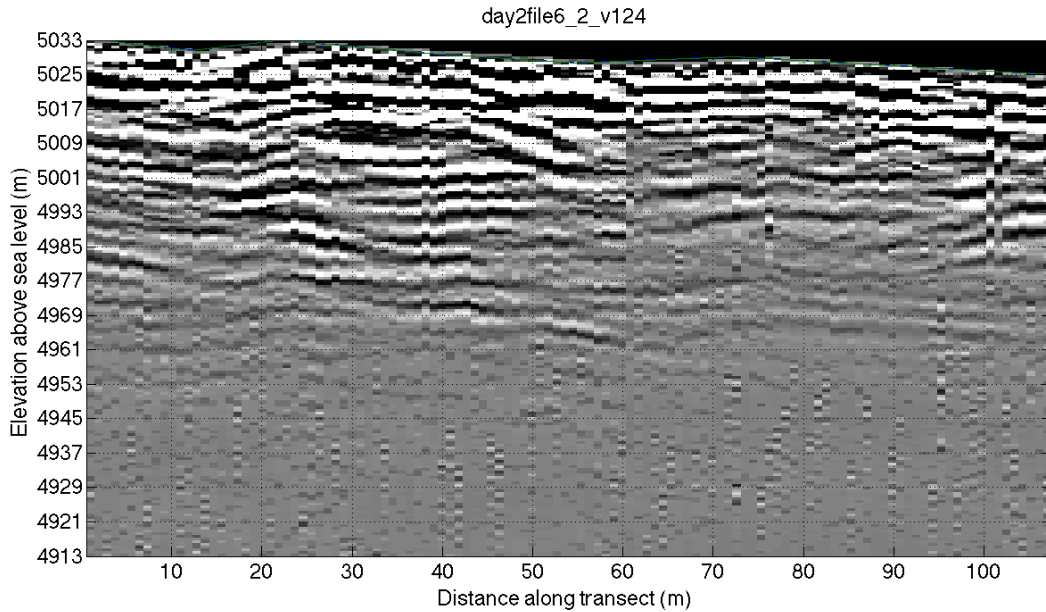
Figure 21. GPR Transect F (Day2file6) at Imja Lake moving in the direction of the northern lateral moraine with a 10 MHz antenna and assuming a velocity of 124×10^6 m/s.

Figure 21 shows GPR Transect F on the north side of the outlet near the middle of the terminal moraine, starting north of the outlet and moving in the direction of the northern lateral moraine with a 10 MHz antenna. This transect reflects a shallow thickness of ice, especially at the end of the transect.

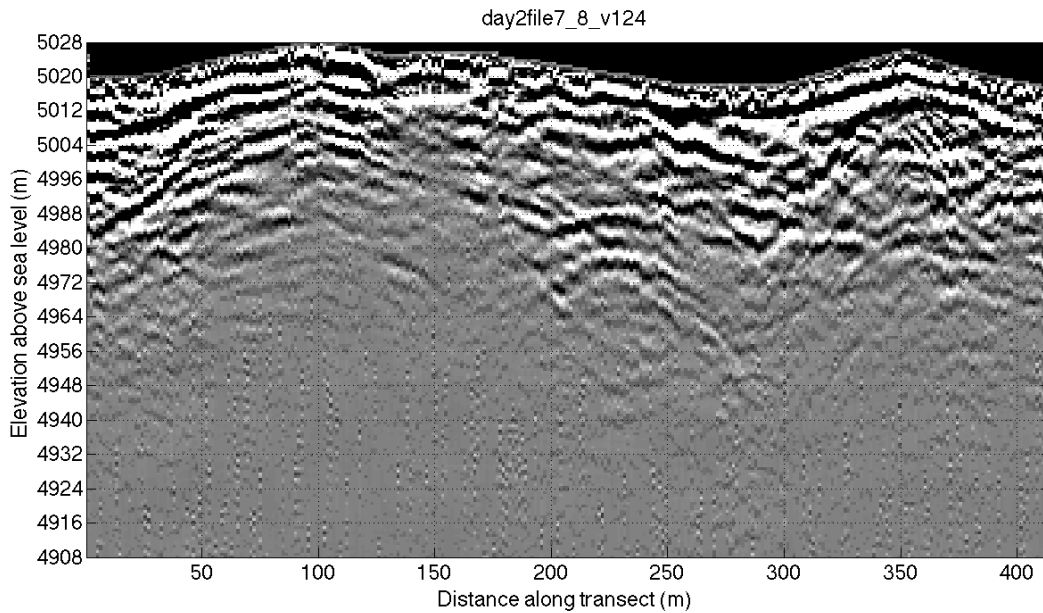
Figure 22. GPR transect G (Day2file7_8) at Imja Lake on the north side of the outlet using a 10 MHz antenna and assuming a velocity of 124×10^6 m/s.

Figure 22 shows GPR Transect G which is a longitudinal transect on the north side of the outlet using a 10 MHz antenna. This profile illustrates the presence of a debris cover up to 10 m and then ice of 20-30m thick over most of the transect. In the middle of the transect (from 120 to 160 m) the data was lost which explains the vertical fringe without changes in that range. After that it is possible to see some ice

with a thickness of 20-30 m. The results from the second transect of Reynolds (Hambrey et al., 2008) (near Transect G) show a relatively ice-free zone several hundred meters wide forming the outer part of the moraine complex. They report surface debris from 5 to 10m thick overlying an intermediate layer, believed to be water-saturated moraine. This layer, in turn, overlies a basal zone, the top of which is about the same elevation as the outlying floor of the valley. This report shows considerably more ice in this area than Hambrey et al. (2008) show. However, they used a 100 MHz antenna, so the penetration was limited to a few meters and we used a 10 Mhz antenna resulting in much deeper penetration. The depth of penetration for the 100 MHz GPR system used by Hambrey et al. (2008) is unlikely to be greater than 15 – 20 m (Jol, 1995). Hambrey et al. (2008) do not consider the lake to pose a threat in the short term, contrary to Yamada (1998) and Bajracharya et al. (2007).

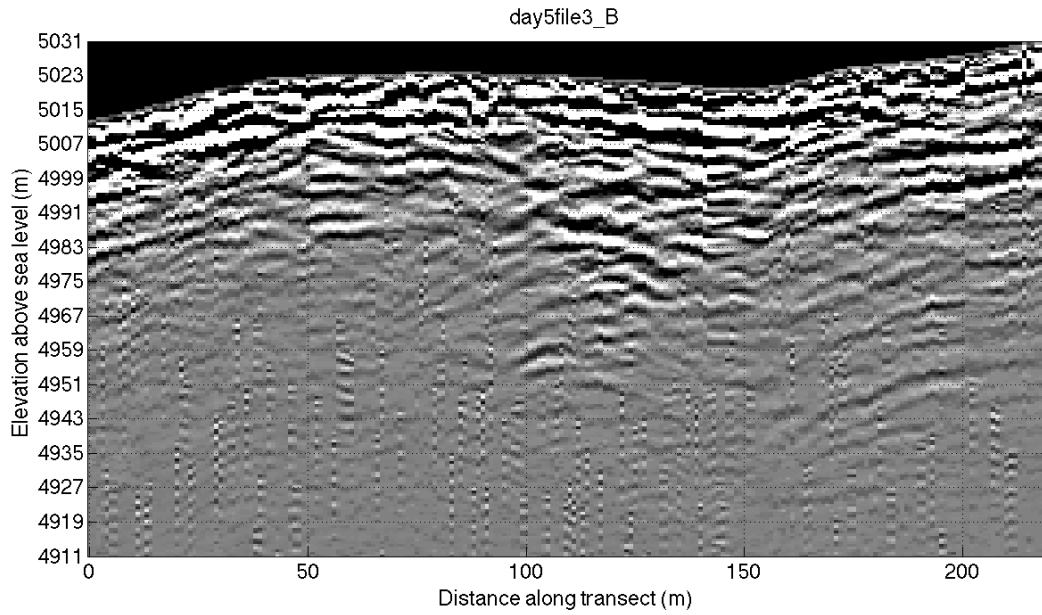
Figure 23. GPR transect H (Day5file3_B) at Imja Lake on the south side of the outlet using a 10 MHz antenna and assuming a velocity of 124×10^6 m/s.

Figure 23 shows GPR Transect H along the shore of the lake at the south lateral moraine in an area where ice is visible from a small peninsula in the lake (see Figure 24) using a 10 MHz antenna. Since we were able to see the first 20 m depth of this profile from the lake, this transect helped us to interpret the data from other areas. The debris in this area appears to be about 10 m thick with about 20 - 30 m of ice below that.

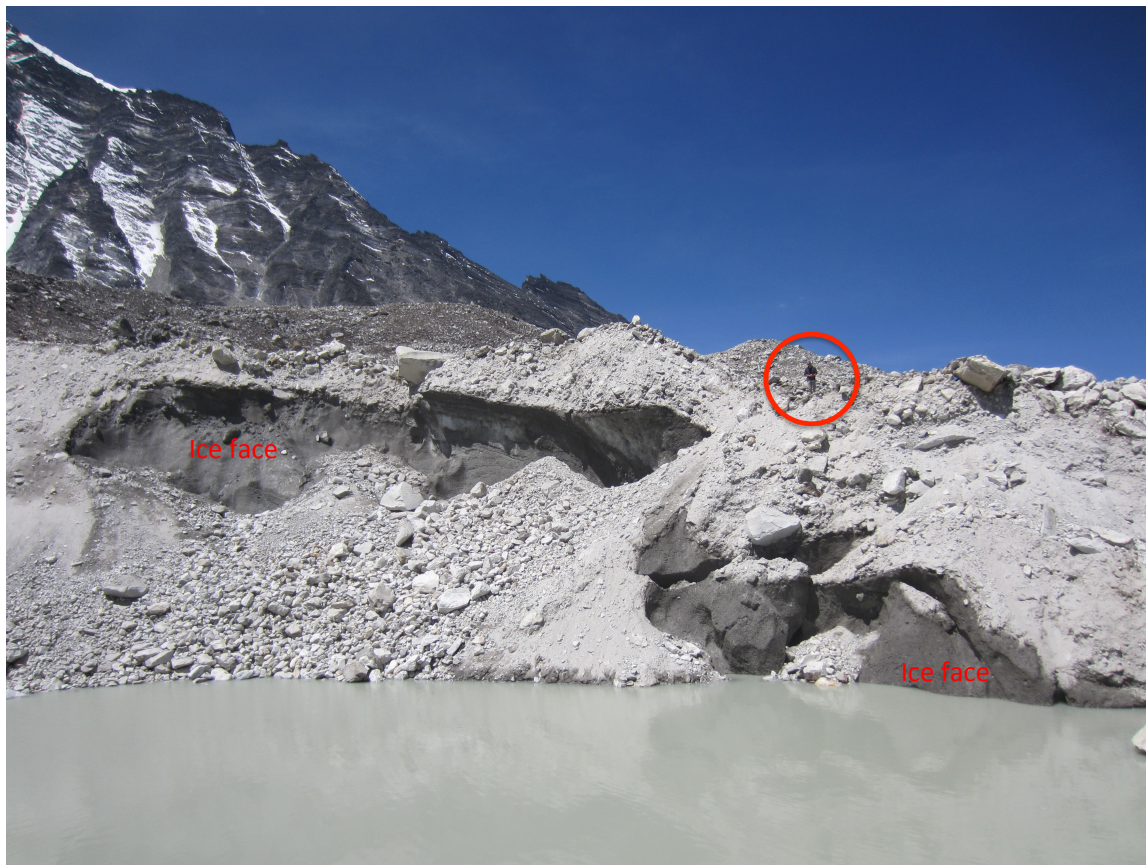
Figure 24. Ice visible below GPR transect H seen from a small peninsula near the shore of the lake. (Photograph: Marcelo Somos-Valenzuela)

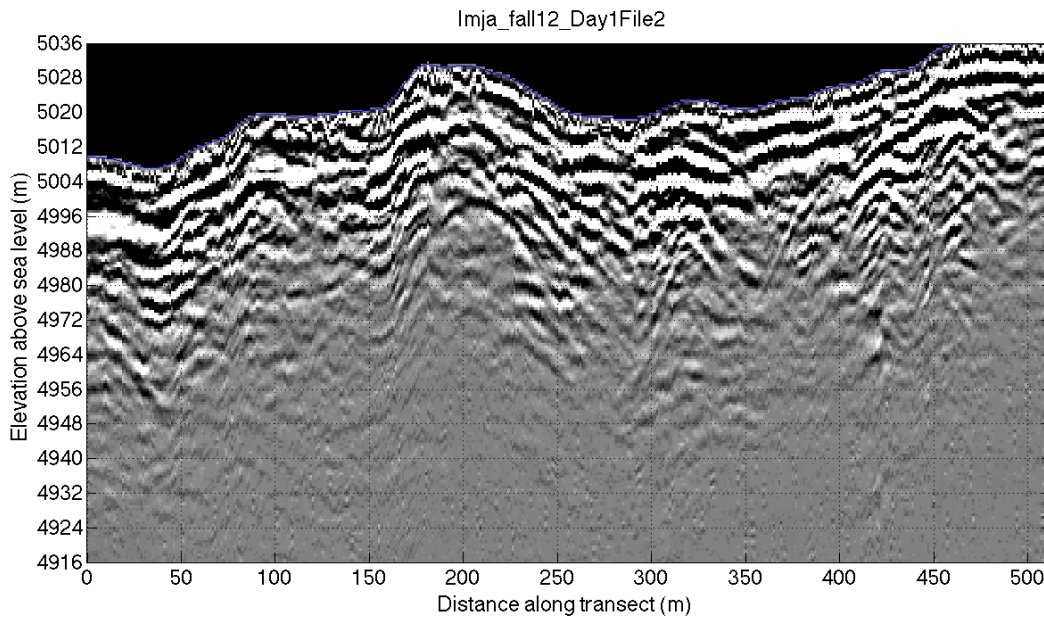
Figure 25. GPR transect I (Fall12_Day1File2) along the south side of the outlet from the lake to the bottom of the outer side of the terminal moraine using a 10 MHz antenna and assuming a velocity of 124×10^6 m/s.

Figure 25 shows the long GPR Transect I (from September 21, 2012) along the south side of the outlet from the lake to the bottom of the outer side of the terminal moraine using a 10 MHz antenna. The image shows a debris layer about 10 m thick with ice present under the debris in the first 300 m of the transect and some ice present near the lake outlet.

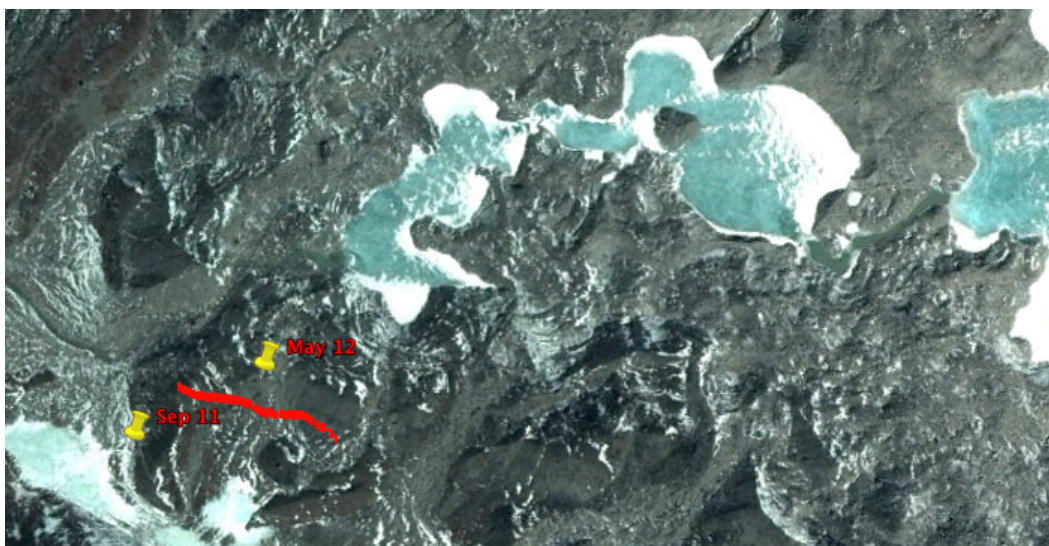
Figure 26. Location of seepage observations at the terminal moraine of Imja Lake in September 2011 and May 2012. (Source: Google Earth, 2010)

Extensive seepage from the base of the southern portion of the terminal moraine was observed in September 2011 and May 2012. The location of the seepage was different during these two times (see Figure 26) with the September 2011 observation (see Figure 27, left) being on the western side of the terminal moraine and the May 2012 observation being farther east and on the other side of a small ridge (see Figure 27, right).

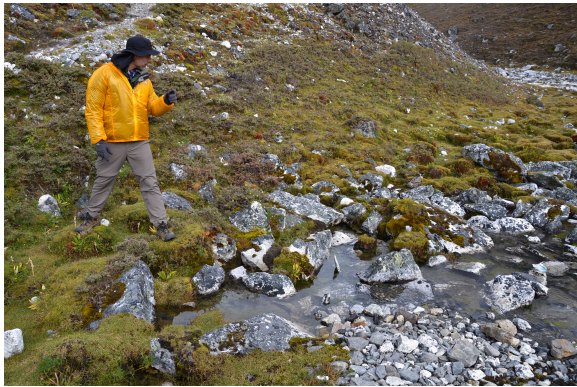
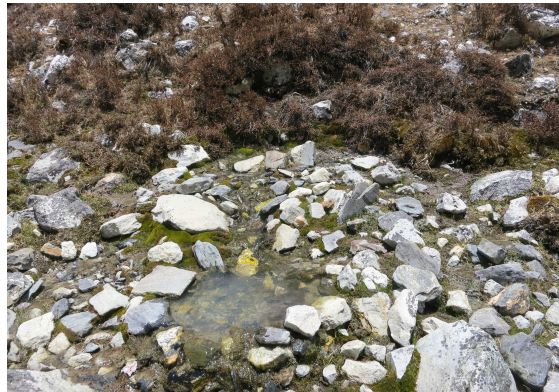
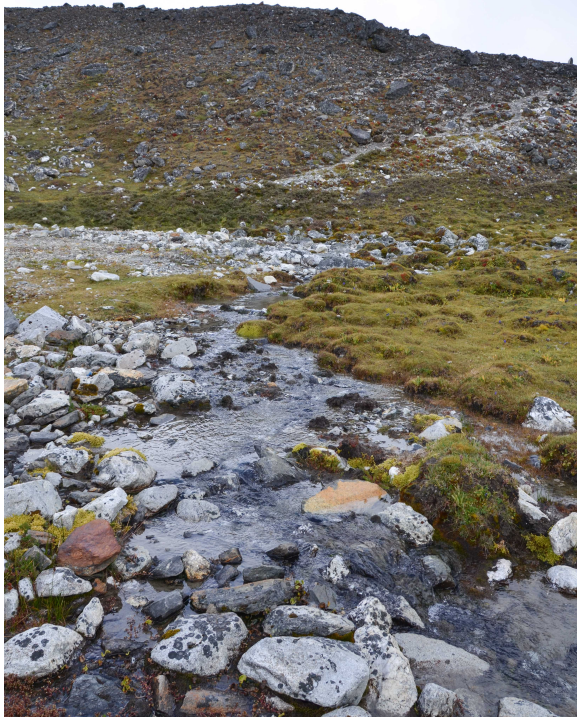
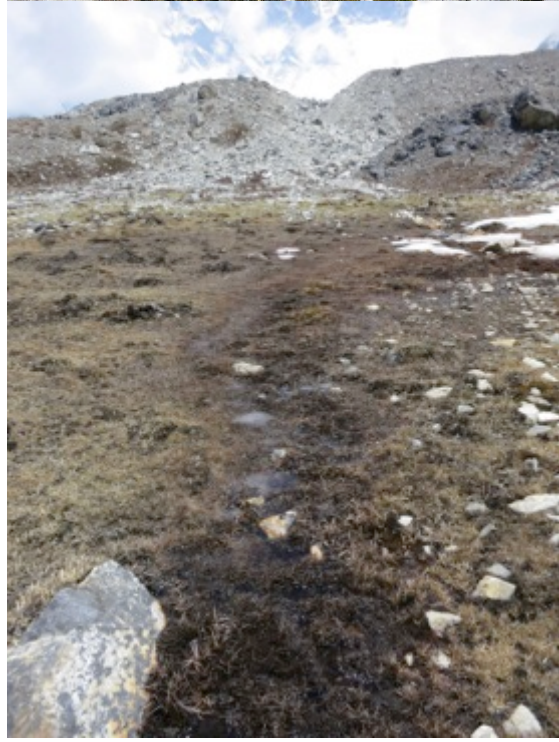
Figure 27. Seepage from the base of the terminal moraine at Imja Lake observed in September 2011 (left) and May 2012 (right). (*Photograph: Daene McKinney*)

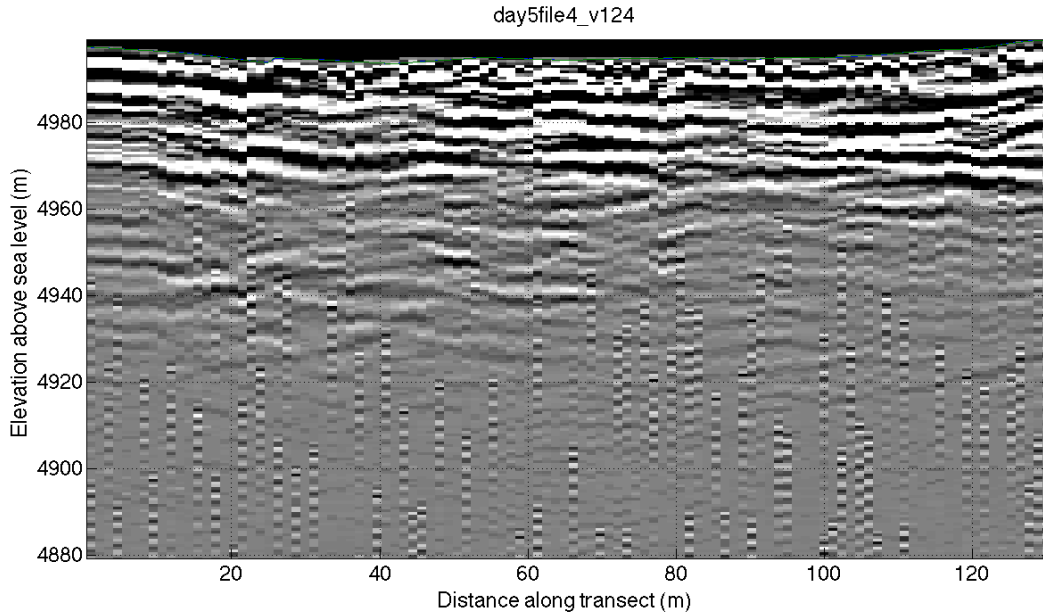
Figure 28. GPR Transect J (Day5file4) at the middle of the outer face of the south lateral moraine below a major seepage point using a 10 MHz antenna and assuming a velocity of 124×10^6 m/s.

Figure 28 shows GPR Transect J at the middle of the outer face of the south lateral moraine above a seepage point using 10 MHz antenna. We observed water running 15 meters below the ridge of the moraine. This transect has the same pattern as an area in which there is ice. The image indicates about 10 m of debris cover with about 10 m of ice below that. We observed water running just above this transect, about 15 meters below the ridge of the moraine (see Fig 27, right). Figure 29 shows GPR Transect K at the middle of the outer face of the south lateral moraine above Transect J and above a major seepage point using a 10 MHz antenna. This transect has the same pattern as Transect J (see Figure 28) except that the ice layer is much thicker, about 20-30 m.

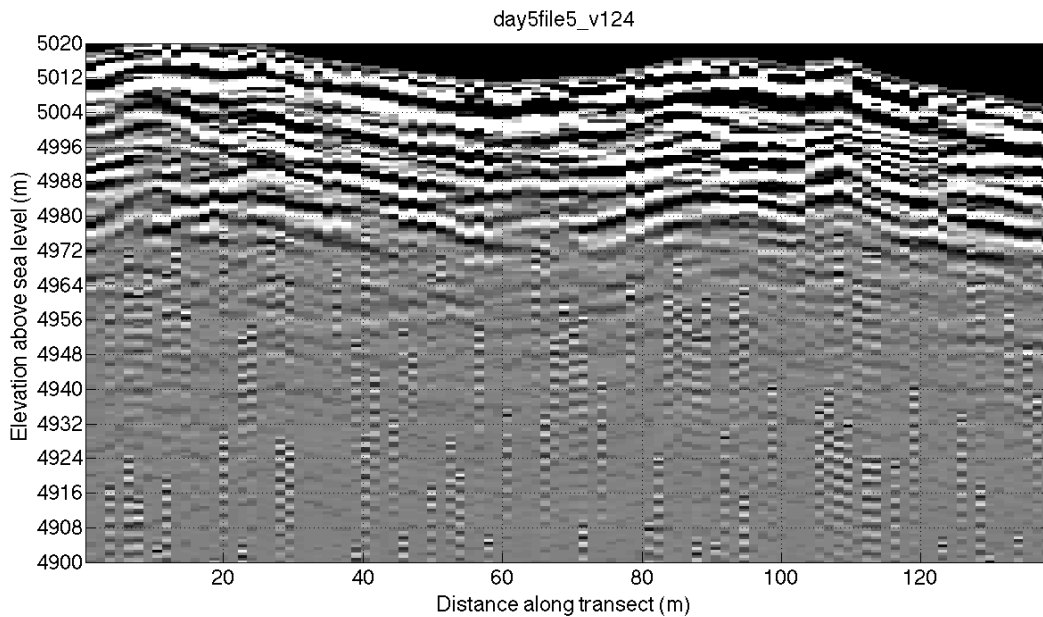
Figure 29. GPR Transect K (Day5file5) at the middle of the outer face of the south lateral moraine above transect J and above a major seepage point using a 10 MHz antenna and assuming a velocity of 124×10^6 m/s.
