CRWR Online Report 12-03

Ground Penetrating Radar Survey for Risk Reduction at Imja Lake, Nepal

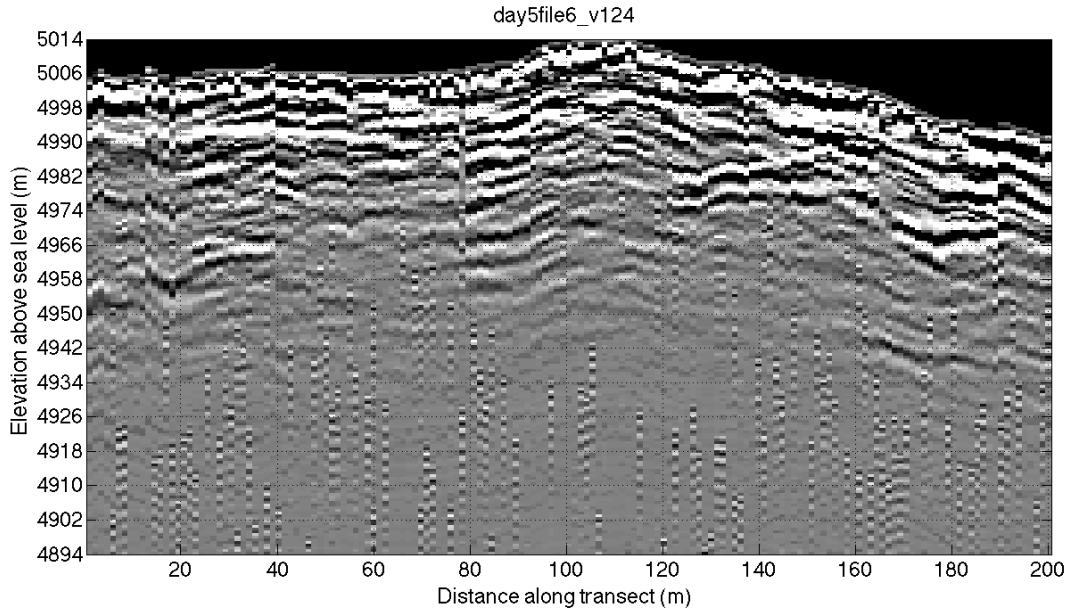
Figure 30. GPR Transect L (Day5file6) crossing the outlet from south to north heading down to the outer face of the terminal moraine using a 10 Mhz antenna and assuming a velocity of 124×10^6 m/s.

Figure 30 shows GPR Transect L crossing the outlet from south to north heading down to the outer face of the terminal moraine using a 10 Mhz antenna. This transect indicates that some ice is present in the end of the terminal moraine at the north side of the outlet, perhaps as much as 20-30 m thickness.
